Feasibility Study for the
Soldiers' Monument at the Santa Fe Plaza - FINAL REPORT

VOLUME I

December 5, 2025

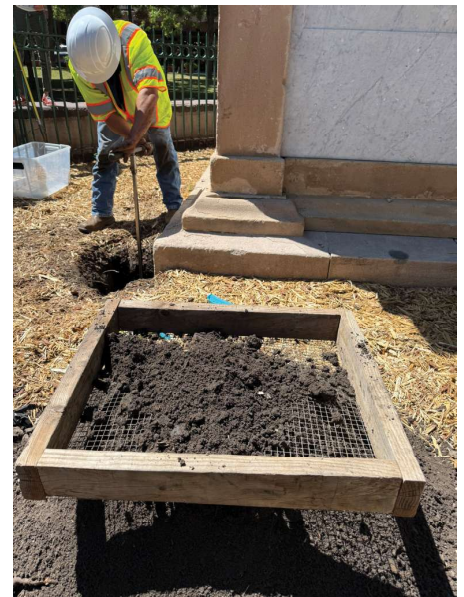
SOLDIER'S MONUMENT ELEVATIONS AS IT STAND TODAY

The monument's plinth is in fair to poor condition. The plinth appears to have a slight tilt to the southwest, but appears to be stable and unmoving. The bottom stones are slightly buried and continue below the grade at least 32". No visible sign of a footing was found when a small hole was dug to investigate it further. See structural report for more information.

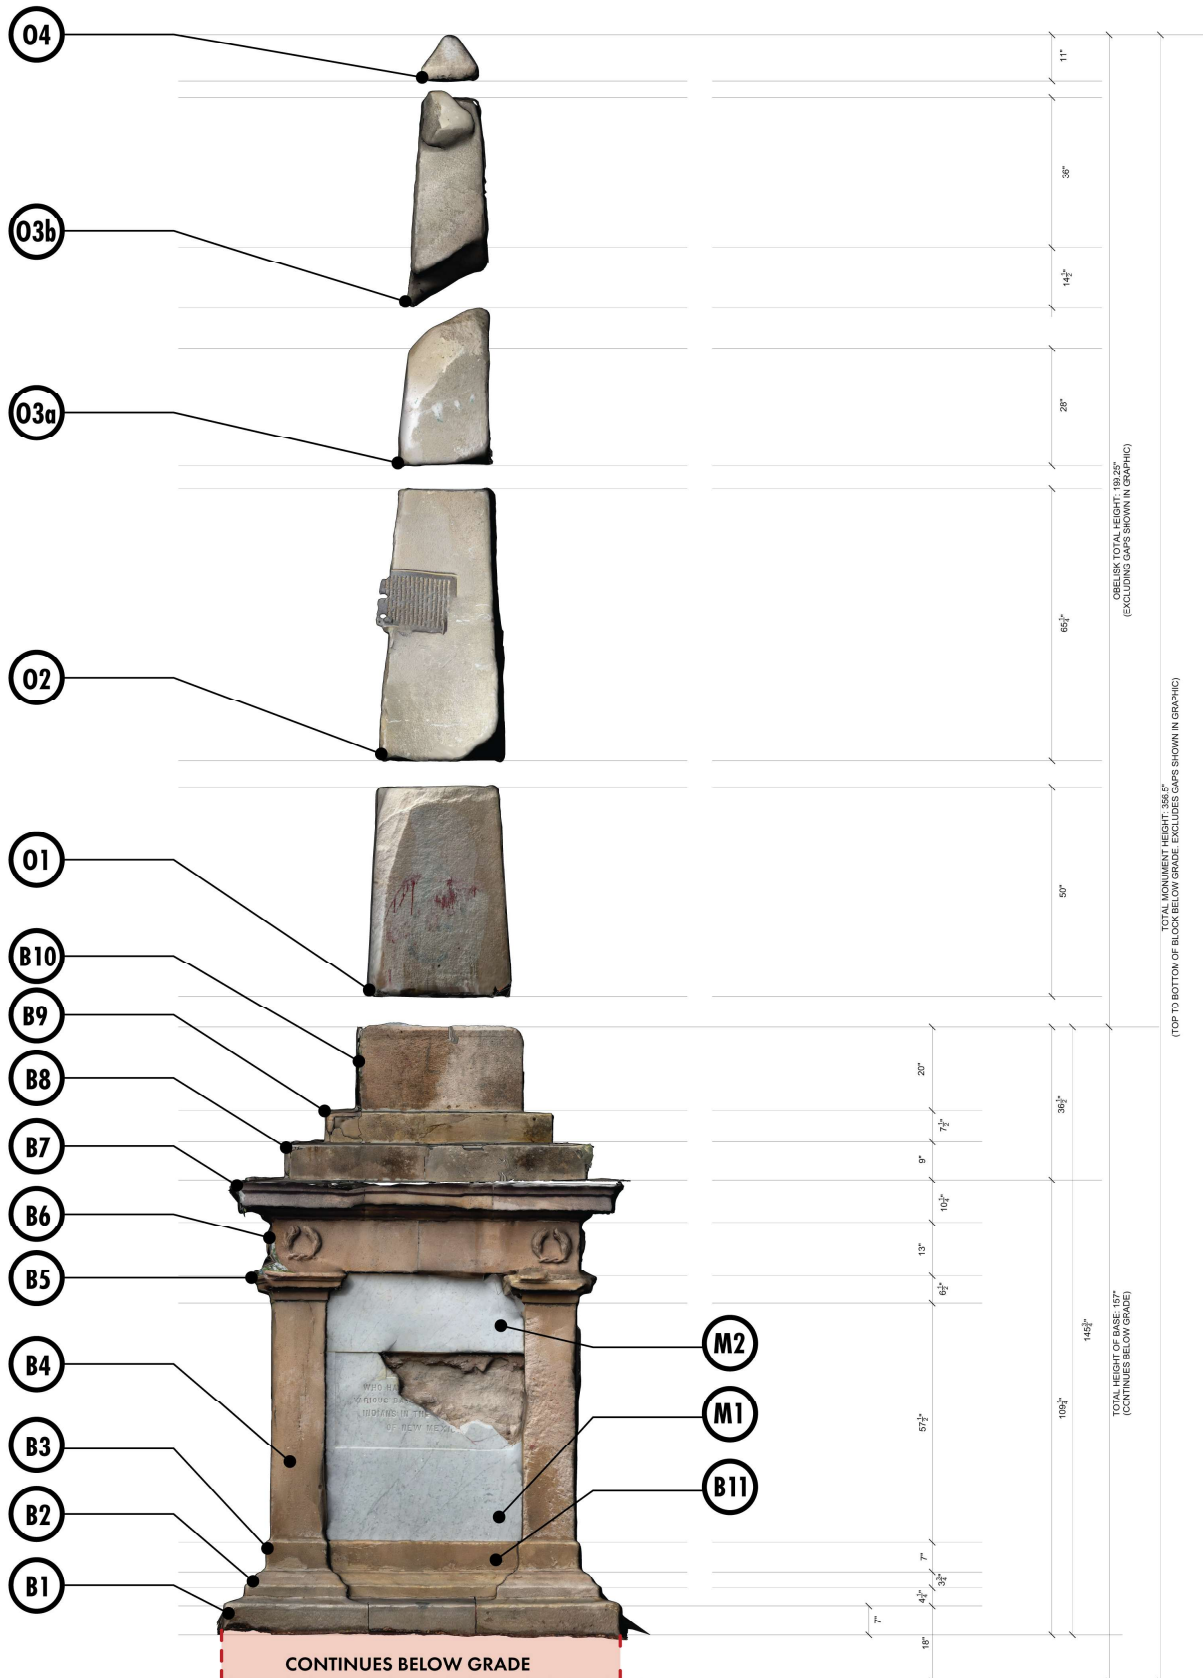
02.b.3.0 COMPONENTS: *The components of the complete monument are labeled and dimensioned below.*

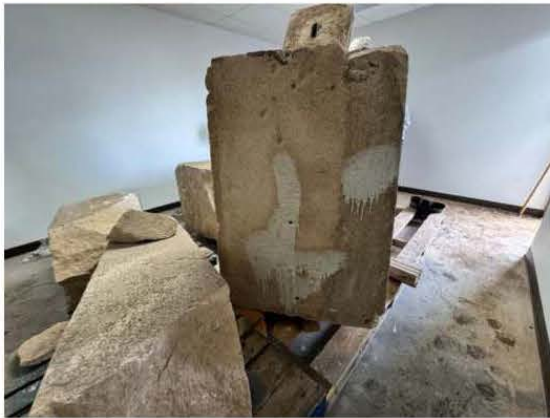
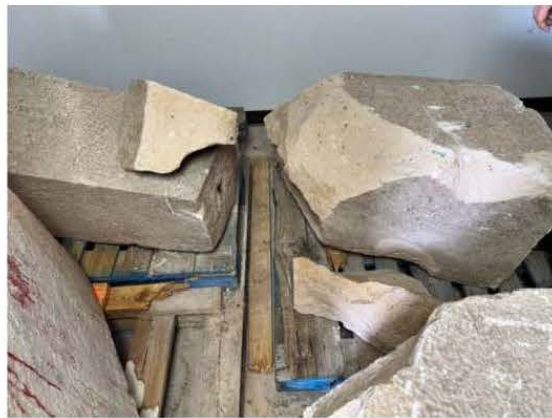
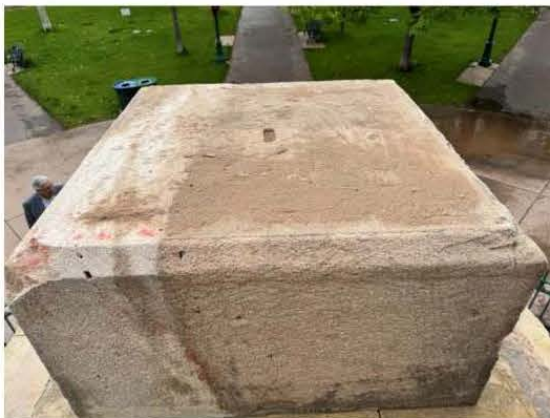
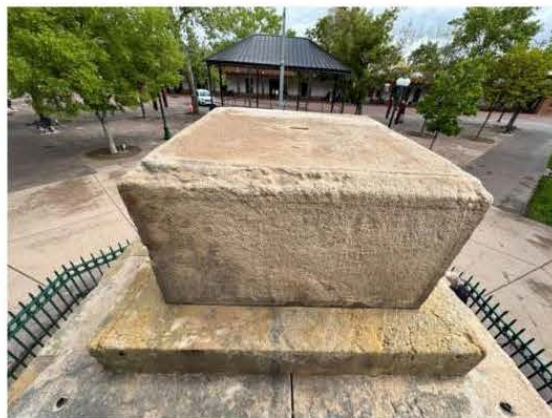
- **Construction & Assembly**
 - The pieces were inspected within a storage facility.
 - The obelisk is comprised of four separate stacked pieces, jointed with masonry joints.
 - Some pieces have holes or spaces possibly for dowels, but it is unclear if dowelling was used or if these features are original.
- **Condition & Damage**
 - Ends, corners, and edges of all pieces were severely damaged.
 - Most remaining pieces do not show cracks or punctures, except for one.
 - All pieces are weathered, chipped and dimpled.
- **Plinth Connection**
 - The top piece of the plinth is clean and has a hole, likely for doweling, lifting or erection.

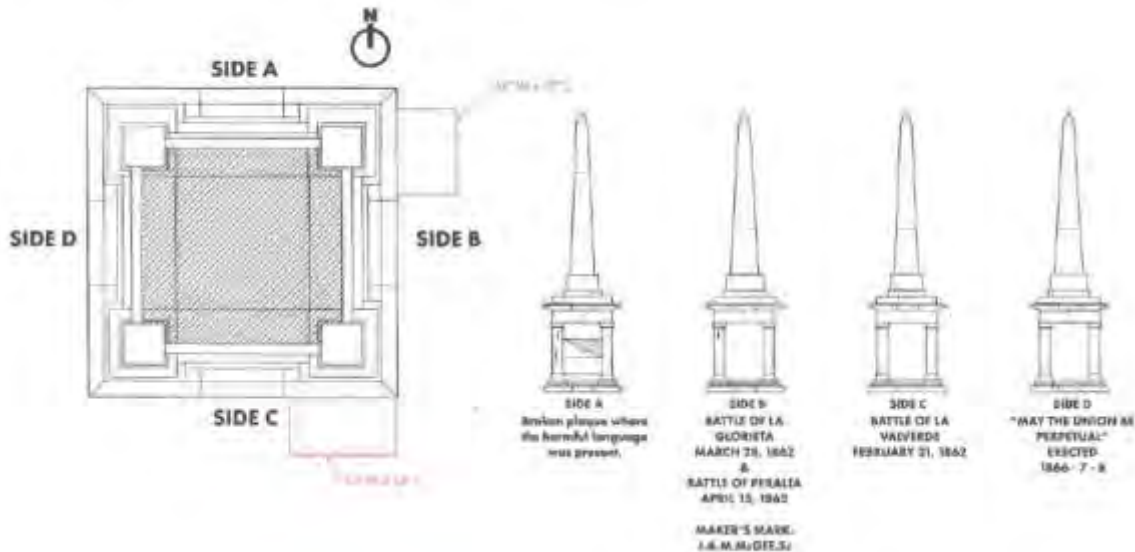
Figure 1. Soldier's Monument Site Plan and Elevations.

The assessment consisted of following the Soldier's Monument site and elevations plan (Figure 1) provided by CSR which identified the locations where two 12" wide by 12" long windows to the foundation on the northeast and southwest corners of the structure. Only the northeast window was considered as the engineer believed that there was enough information to give a proper evaluation of the structure's foundation. Given the limited visibility of the proposed northeast window the archaeologist and engineer exceeded the dimensions to 2' wide by 2' long and excavated down to 32" respectively (Figures 2-7).
