RE: Status Review for 507 Coronado (currently non-contributing)

Historic Cultural Properties Inventory (HCPI) Base Form (FORM 1)

1. Name of property: Ted and Josephine Lopez Property	2. Location: 507 and 509 East Coronado Road Downtown and Eastside Historic District – Santa Fe	3. Local Reference Number: Santa Fe ID: N/A 4. County: Santa Fe Parcel # 910009184 & 910009187

8. Name of Project: HDRB Status Evaluation		
9. Lat/Long: 35.6747853,-105.9386578		
10. Photo Information: John W. Murphey, photographer. Photo 1: South (front) elevation, facing northeast.

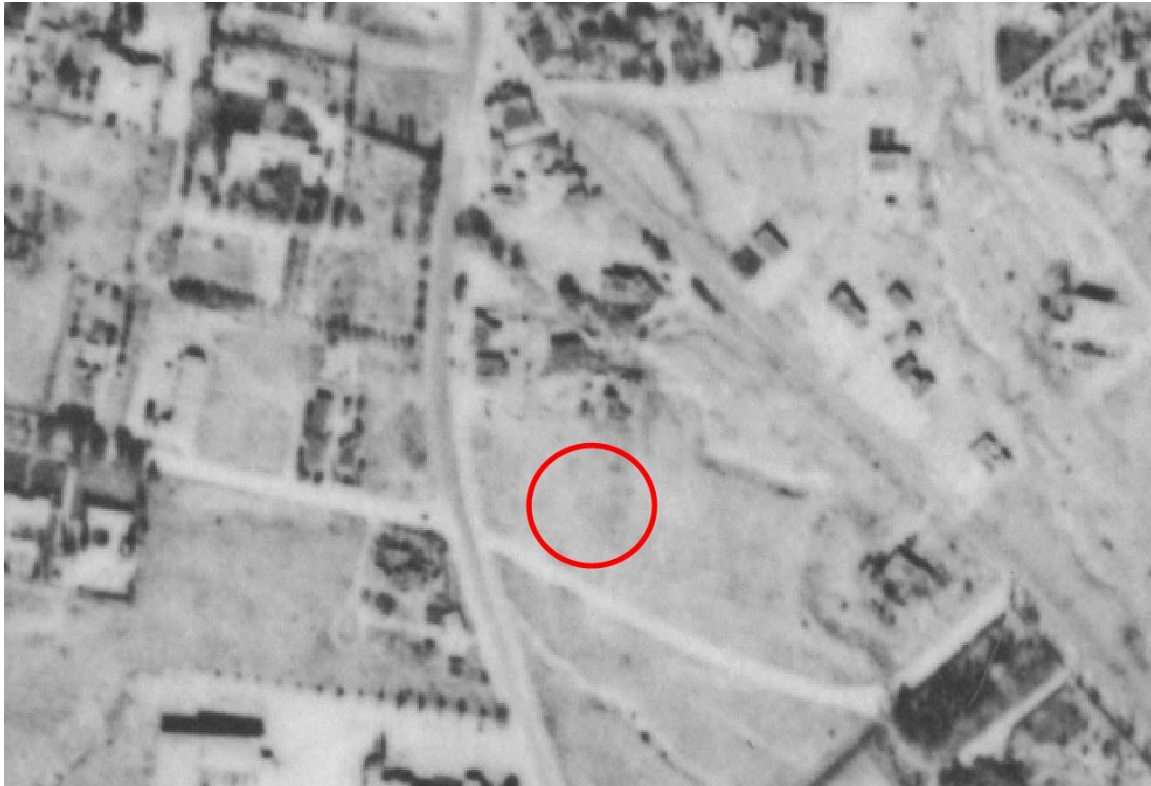
Figure 2: October 25, 1948, aerial photograph. No structures present; trace of historic Santa Fe Trail visible.

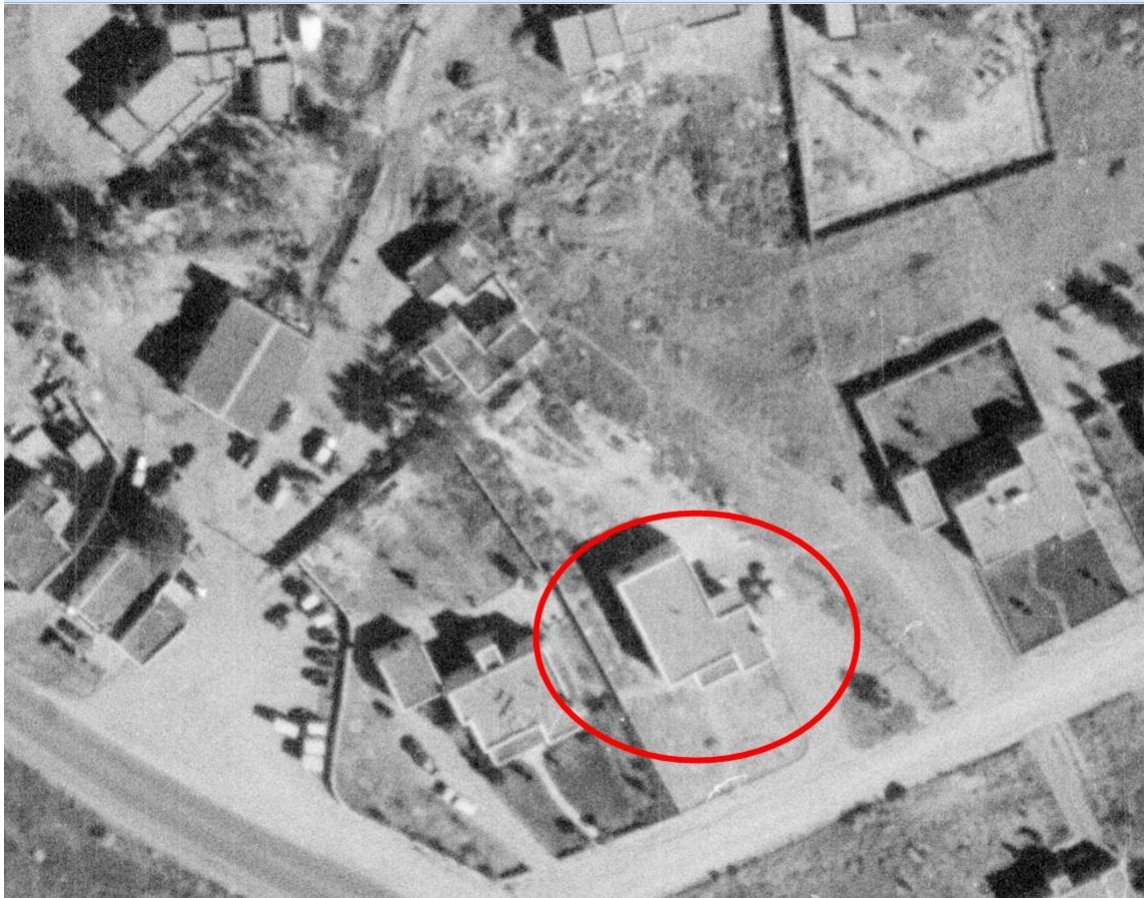
**Figure 3: November 10, 1958, aerial photograph.
 Subject house with original footprint configuration.**

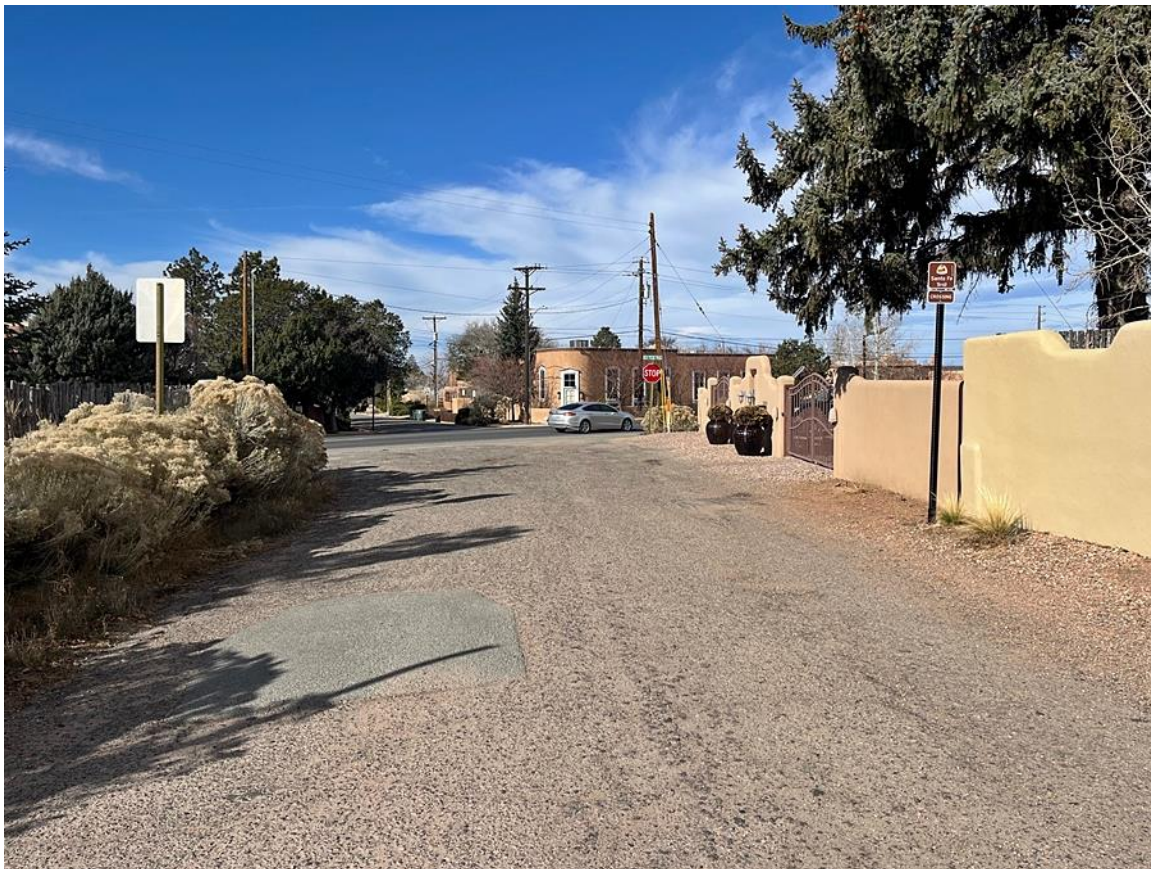
The former property of Ted and Josephine Lopez is located approximately 100 feet southeast of Old Pecos Trail, a busy and historic transportation corridor (Photo 2). Ruts of the historic Santa Fe Trail cross an adjacent property. For many years, the asphalt-surfaced road carried traffic associated with U.S. Highways 66 and 85. The subject property consists of two historically separate parcels that fit together like a puzzle, forming a roughly rectangular lot. The parcel containing the primary house is the larger of the two, and together the parcels comprise approximately 0.63 acres.

Photo 2: Setting. East Coronado Road in front of property. Camera facing northwest.

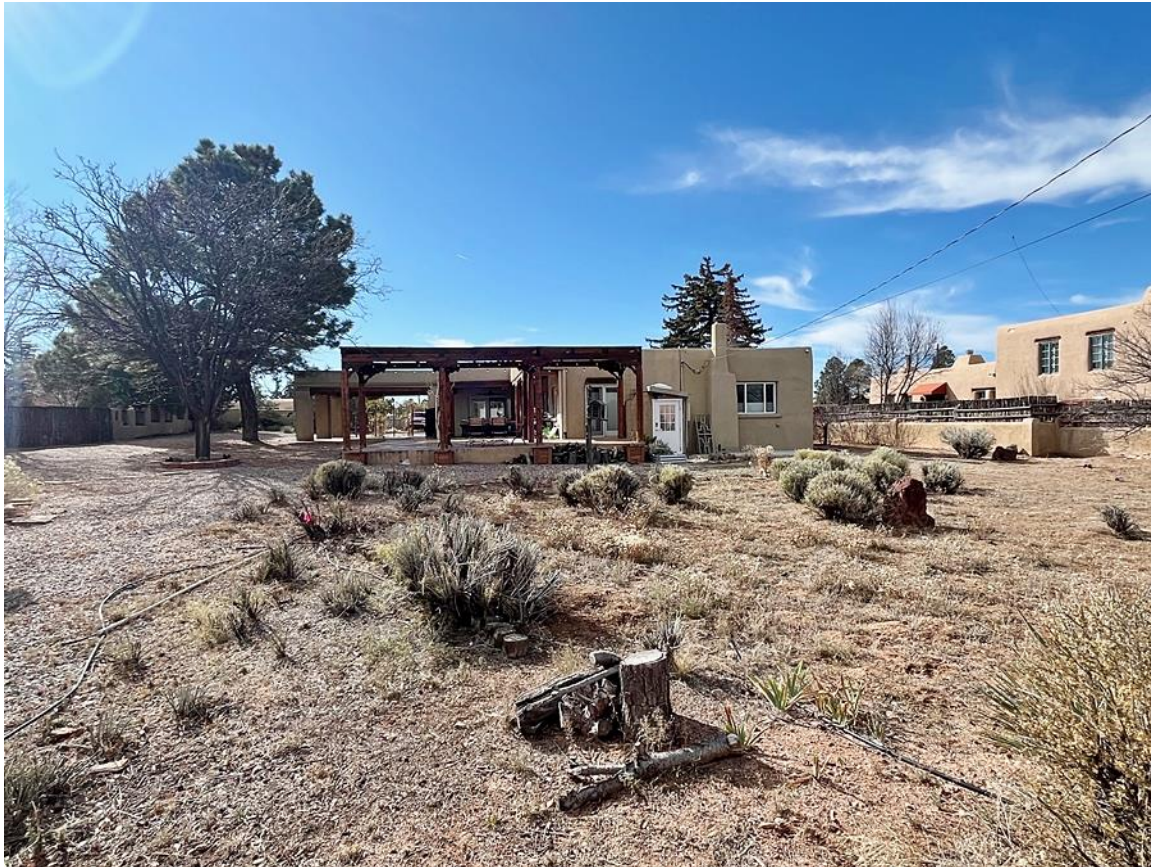
Photo 3: Setting. Backyard. Camera facing southwest.

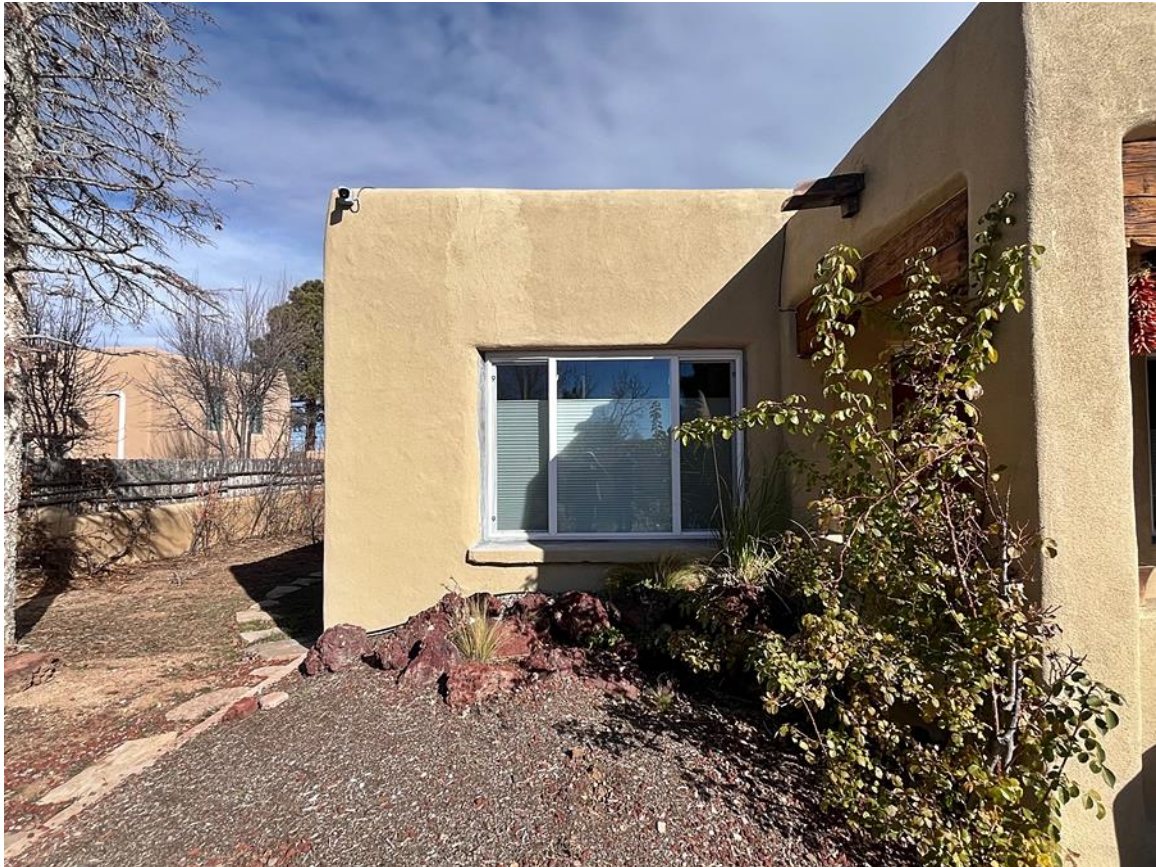
The front elevation presents a typical Pueblo Revival composition of a planar façade with a portal and a projecting cubic volume (Photos 1 & 6). In this case, the portal is slightly larger than typical proportions. The façade begins at the west with a combination window set above a heavy stuccoed lug sill serving the sitting room (Photo 7). The window unit, of vinyl-metal construction, likely replaced an earlier steel sash unit

Photo 7: South elevation. West section at sitting room. Camera facing northeast.

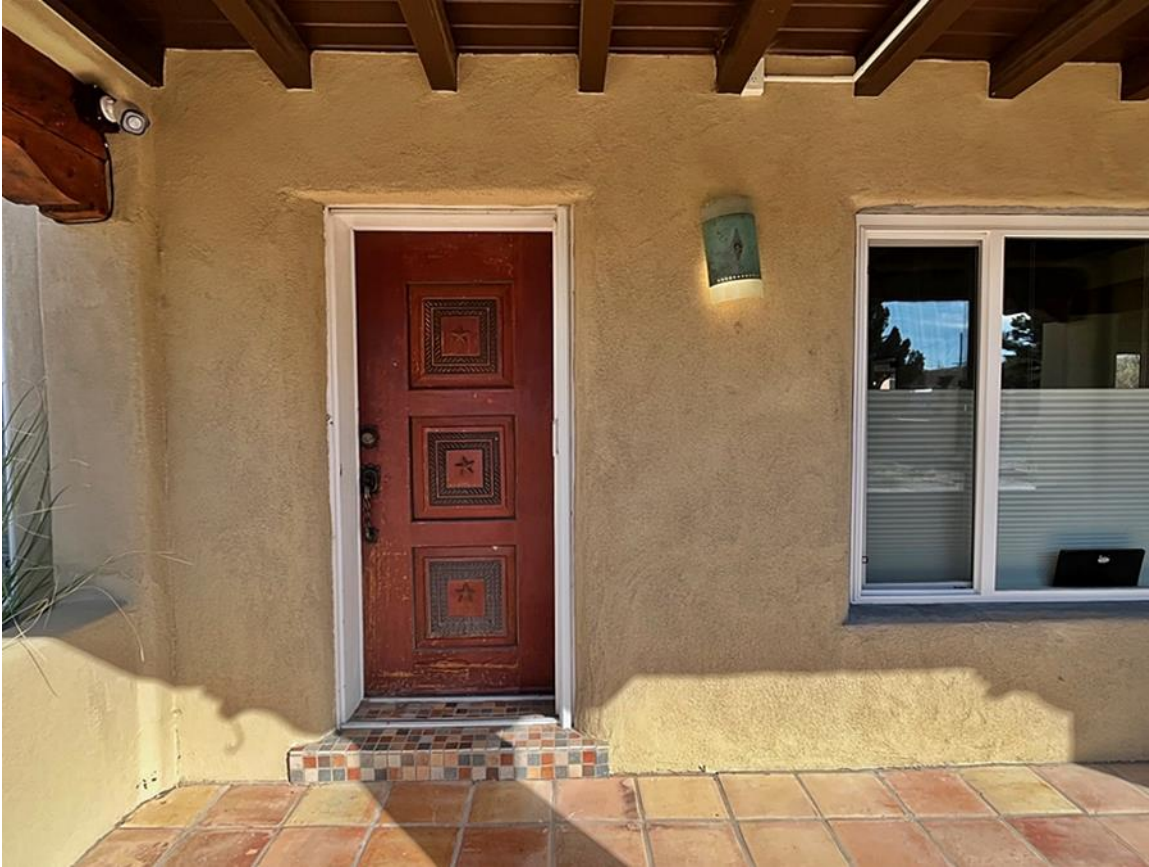
The house is approached by a short flight of steps flanked by a solid balustrade leading to the portal (Photo 8). The portal’s decking and floor have been replaced, and the exterior beams and corbels are overly rustic in character, also suggesting replacement. The decorative wood-panel entry door is of recent vintage (Photo 9). The projecting volume at the east end of the façade contains the living room and, like the rest of the house, is fitted with a vinyl-metal combination window (Photo 10).

Photo 9: South elevation. Entry door. Camera facing northeast.

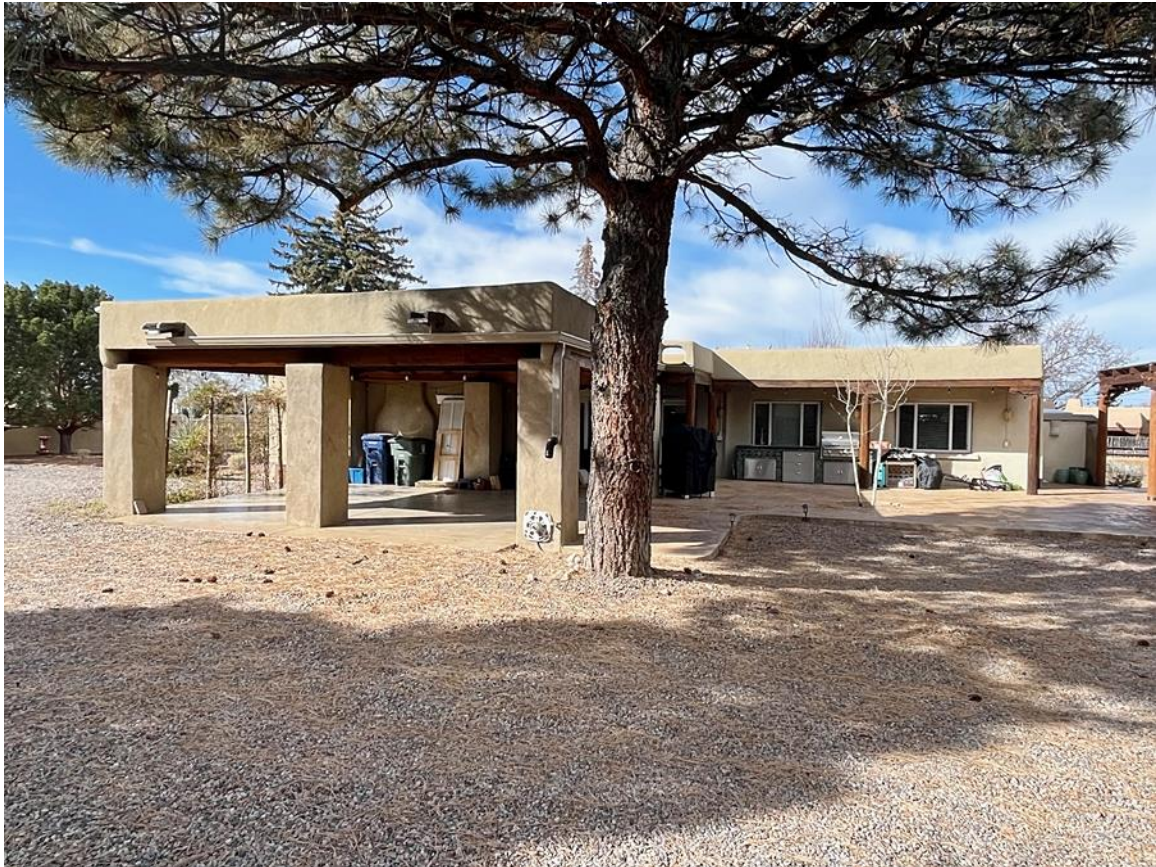
The east elevation is dominated by the carport and a long, shallow *portal* that was originally constructed in the 1970s and later modified, likely in conjunction with construction of the carport (Photo 12). The south end of the portal shelters a patio that is accessed from the house through two vinyl sliding doors (Photo 13). The design and placement of these doors are not characteristic of 1950s construction. The remainder of the elevation is fenestrated with vinyl-metal combination windows (Photo 14).

Photo 12: East elevation. Camera facing northwest.

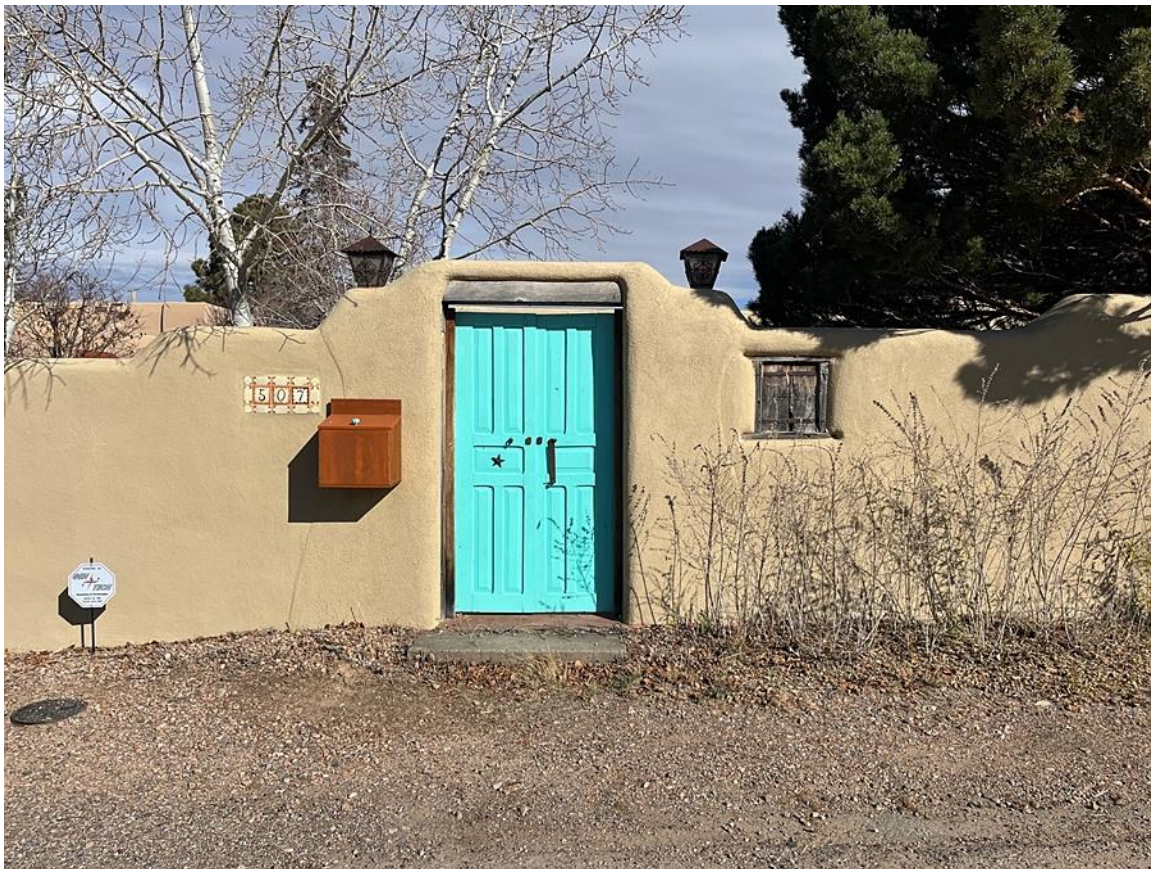
Built along the front property line is a tall stucco-on-block privacy wall arranged in two sections (Photo 5). The western section, in front of the primary dwelling, reaches a height of 83½ inches at its west end and includes a pedestrian entry gate (Photo 22). Near the center of the wall is a Corten-steel vehicular gate, set back approximately 20 feet. The wall terminates at the east at a height of 74 inches. The privacy wall is of recent construction and does not appear on a 1978 aerial photograph (Fig. 23)

Photo 22: West section, pedestrian section. Camera facing north.
