# Historic Cultural Properties Inventory (HCPI) Base Form (FORM 1)

For HPD Office use only: HCPI No. _____ District No. _____ NRHP ___ SRCP ___ Criteria ___A___B___C___D		
1. Name of property: 619 West Alameda	2. Location: 619 West Alameda, Santa Fe, NM	3. Local Reference Number: Santa Fe ID #:

14. Setting: ___Suburban ___Rural ___Village ___X___Urban If Urban: ___Commercial ___Industrial ___X___Residential ___Public		
15. Relationship to Surroundings: ___X___Similar ___Dissimilar Comments: N/A

**PROJECT** 2025-010664-HDRB, 619 W Alameda St., Westside-Guadalupe Historic District,  
**DESC:** non-contributing, Dura Build Construction, agent for Max Scott, owner, requests a historic status review with primary facade(s) designation, if applicable, for a residential structure.

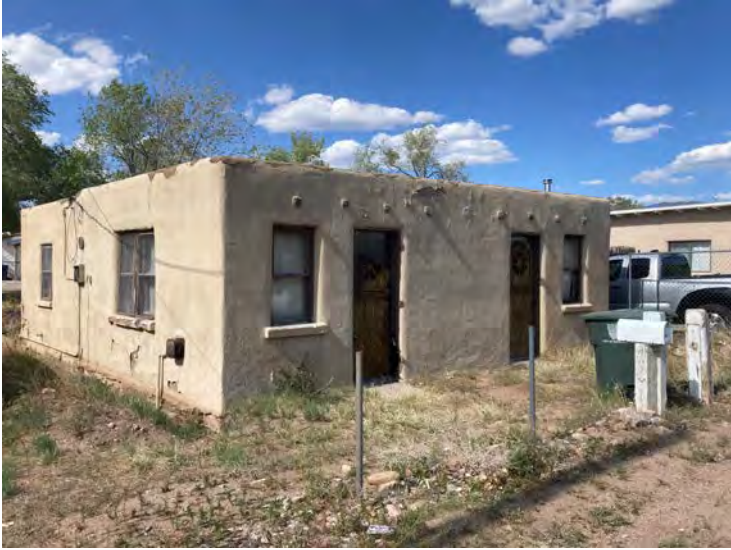
7. Previous Survey Date(s): N/A		
8. Name of Project: HDRB Status Review		
9. Lat/Long: 35.689134, -105.950314		
10. Photo Information: May 12, 2025		View: Looking northeast from sidewalk
<p>11. Brief Description of the Property: This building is located in the City of Santa Fe, on a small city lot on West Alameda, in the Westside-Guadalupe Historic District. Early documentation on the property is scarce. Reportedly, the house was built in 1943, but no actual documentation of this exists. The building is a small, simple, low Pueblo Revival style structure, with a flat roof. It is approximately square, measuring about 26-1/2 feet in either direction. The exterior walls are constructed of adobe and pen tile. The setback, size, scale, style, and detailing of the building is somewhat typical of other buildings on the street. A small rectangular wood framed addition had been added to the north side of the building, but it collapsed in late 2024 or early 2025. All that remains of this addition is the foundation.</p> <p>Note: A detailed description of the property, and more documentation is included in the continuation sheets at the end of this document, beginning on page 5.</p>
