RPA & Associates LLC

JOB	DATE
1121 Paseo de Peralta, Santa Fe, NM 87501	01/22/2026

RPA & ASSOCIATES, LLC | WINDOW & DOOR CONDITION AND INTEGRITY CODES

JOB	DATE
1123 Paseo de Peralta, Santa Fe, NM 87501	01/22/2026

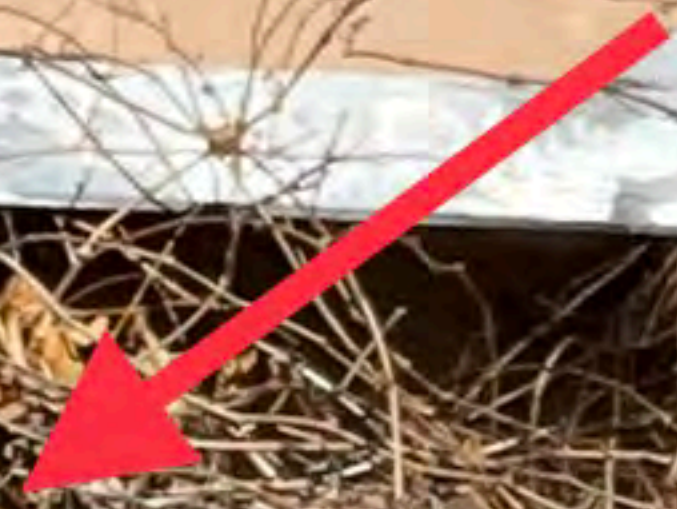
South Elevation
Window
G

Windows F, G, H, I, K, L, M, N, O, and P are non-historic.

The windows and doors that are non-historic and unrestorable are to be replaced in “like and kind” to the windows of that era, wood divided lite (simulated or TDL), insulated Low-E glass (such as Kolbe or Weathershield manufactured). K-KRON would be a good alternative because of exterior low maintenance. K-KRON exterior has a 15-year warranty, whereas paint is approximately 3-5 years.

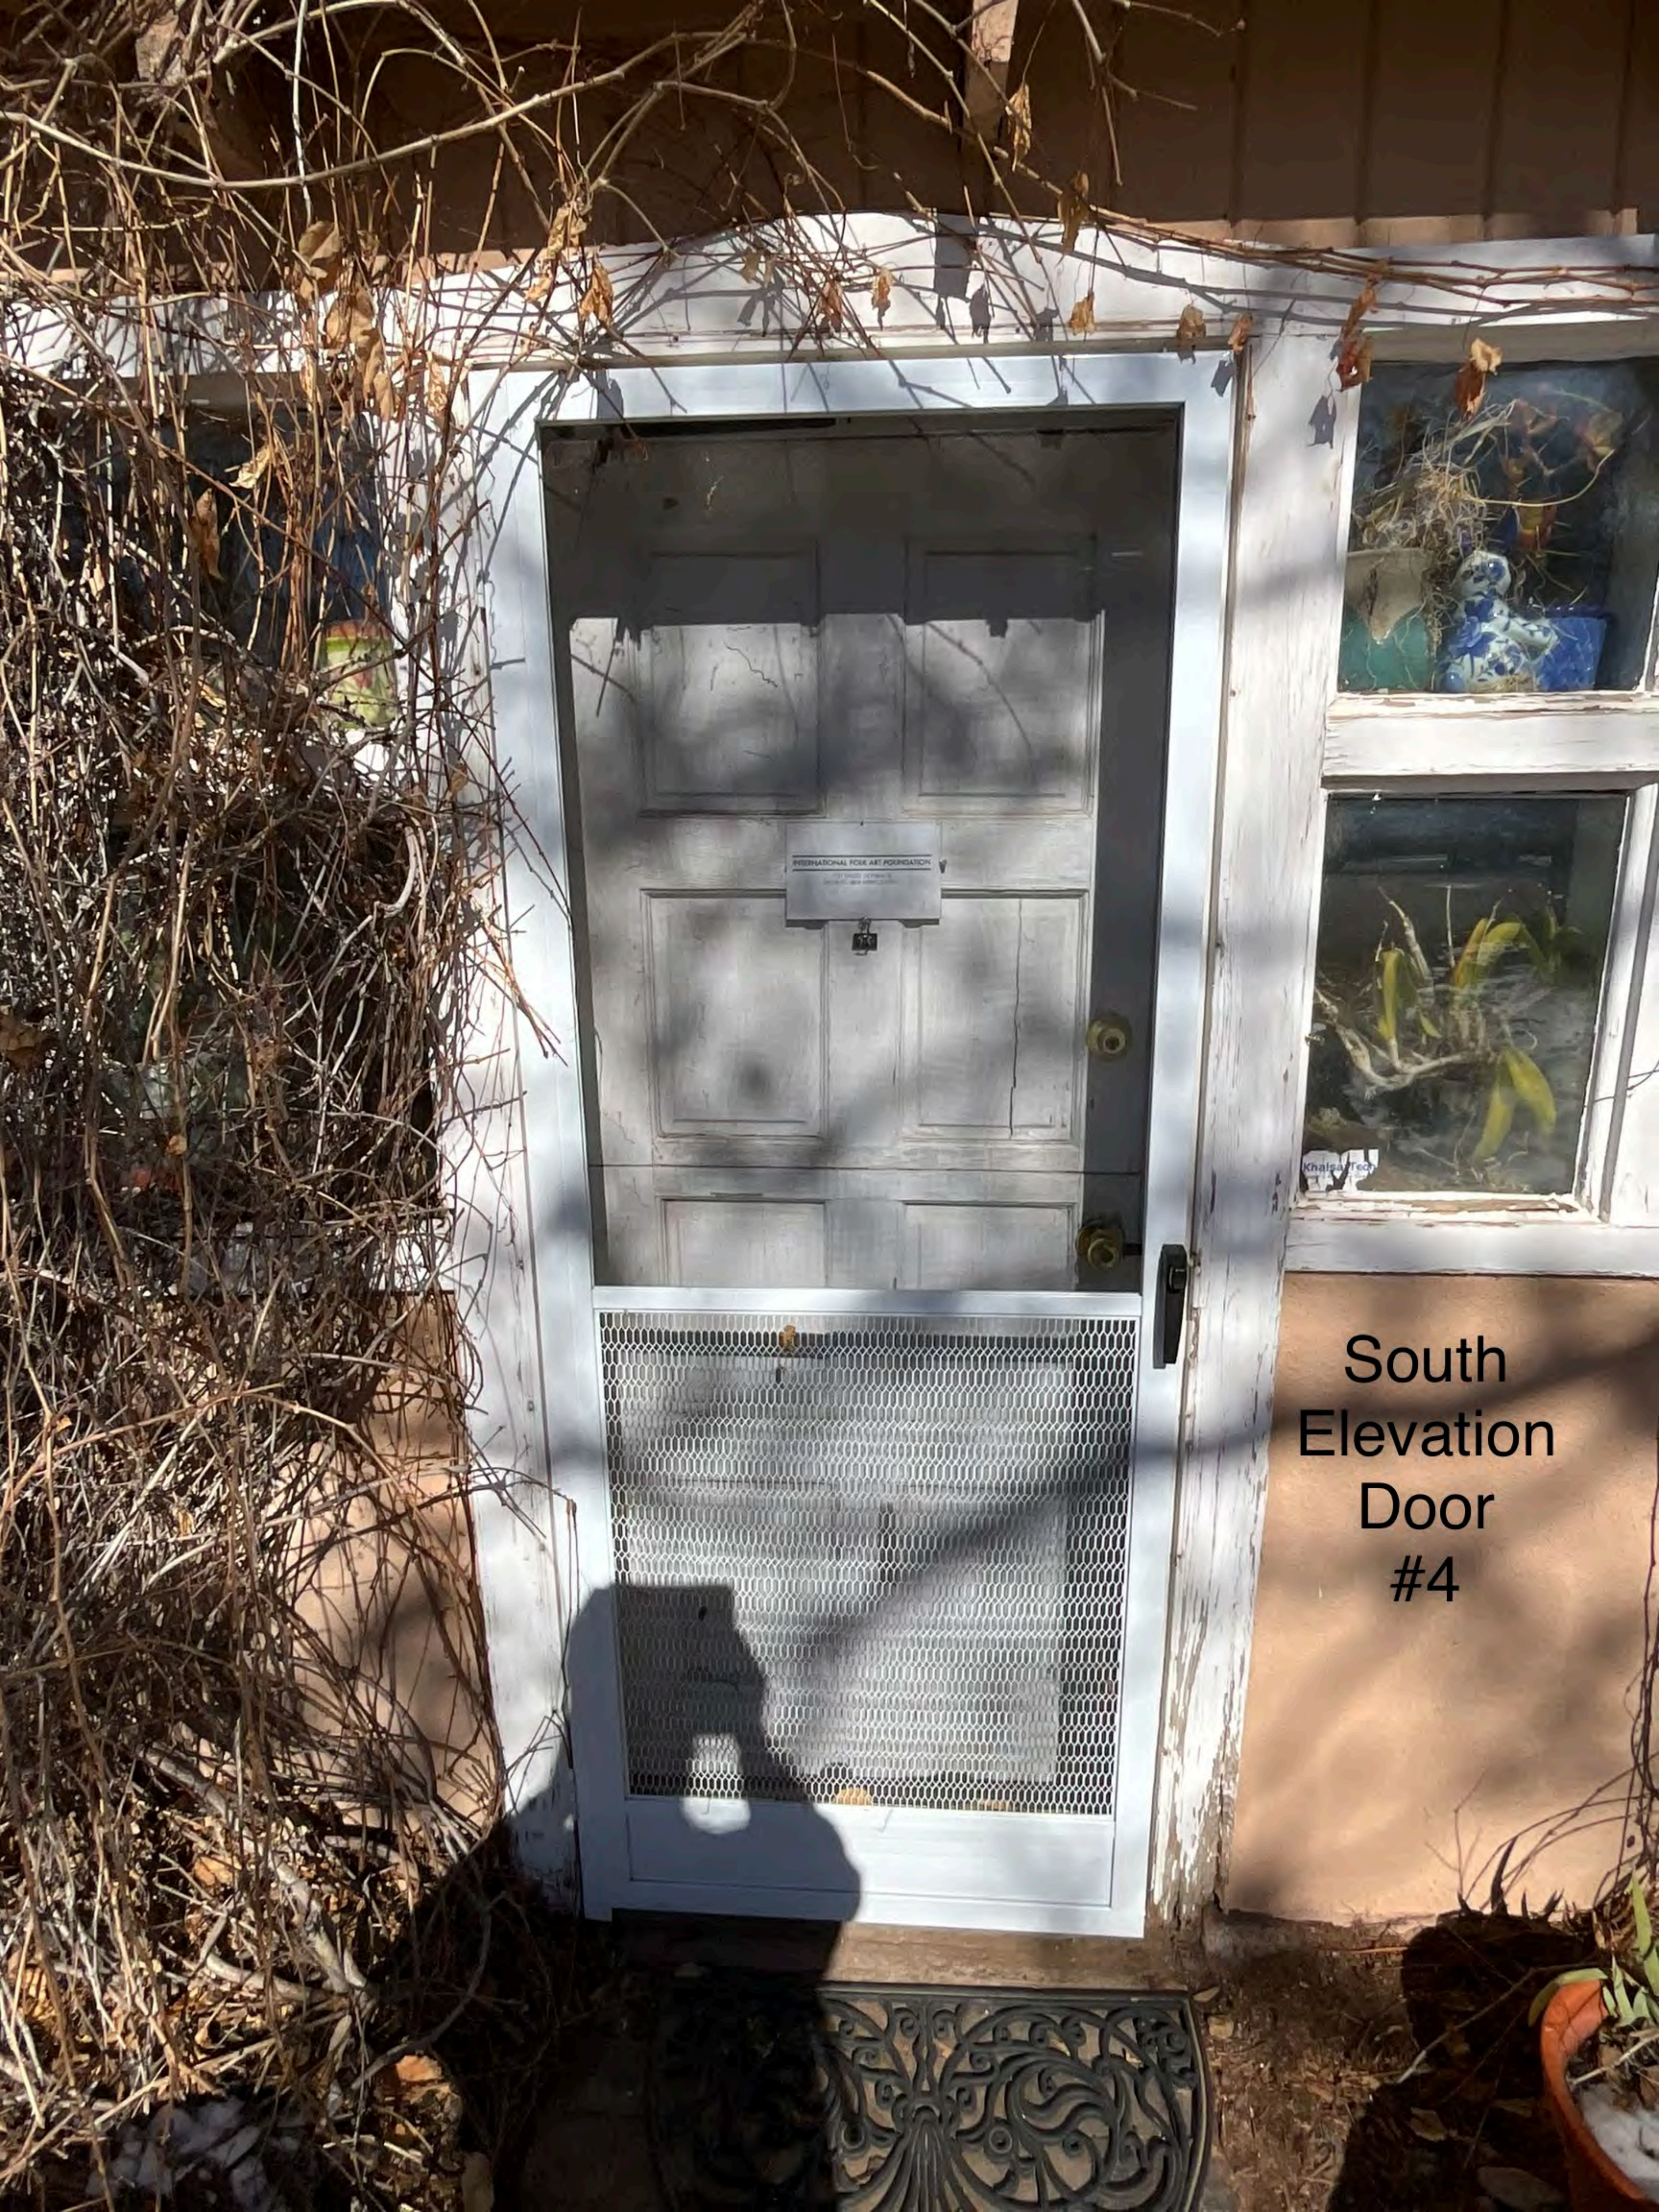
South
Elevation
Door
#4

Doors #1, #2, #3, #4, #6, #7, #8, and #9 are non-historic.

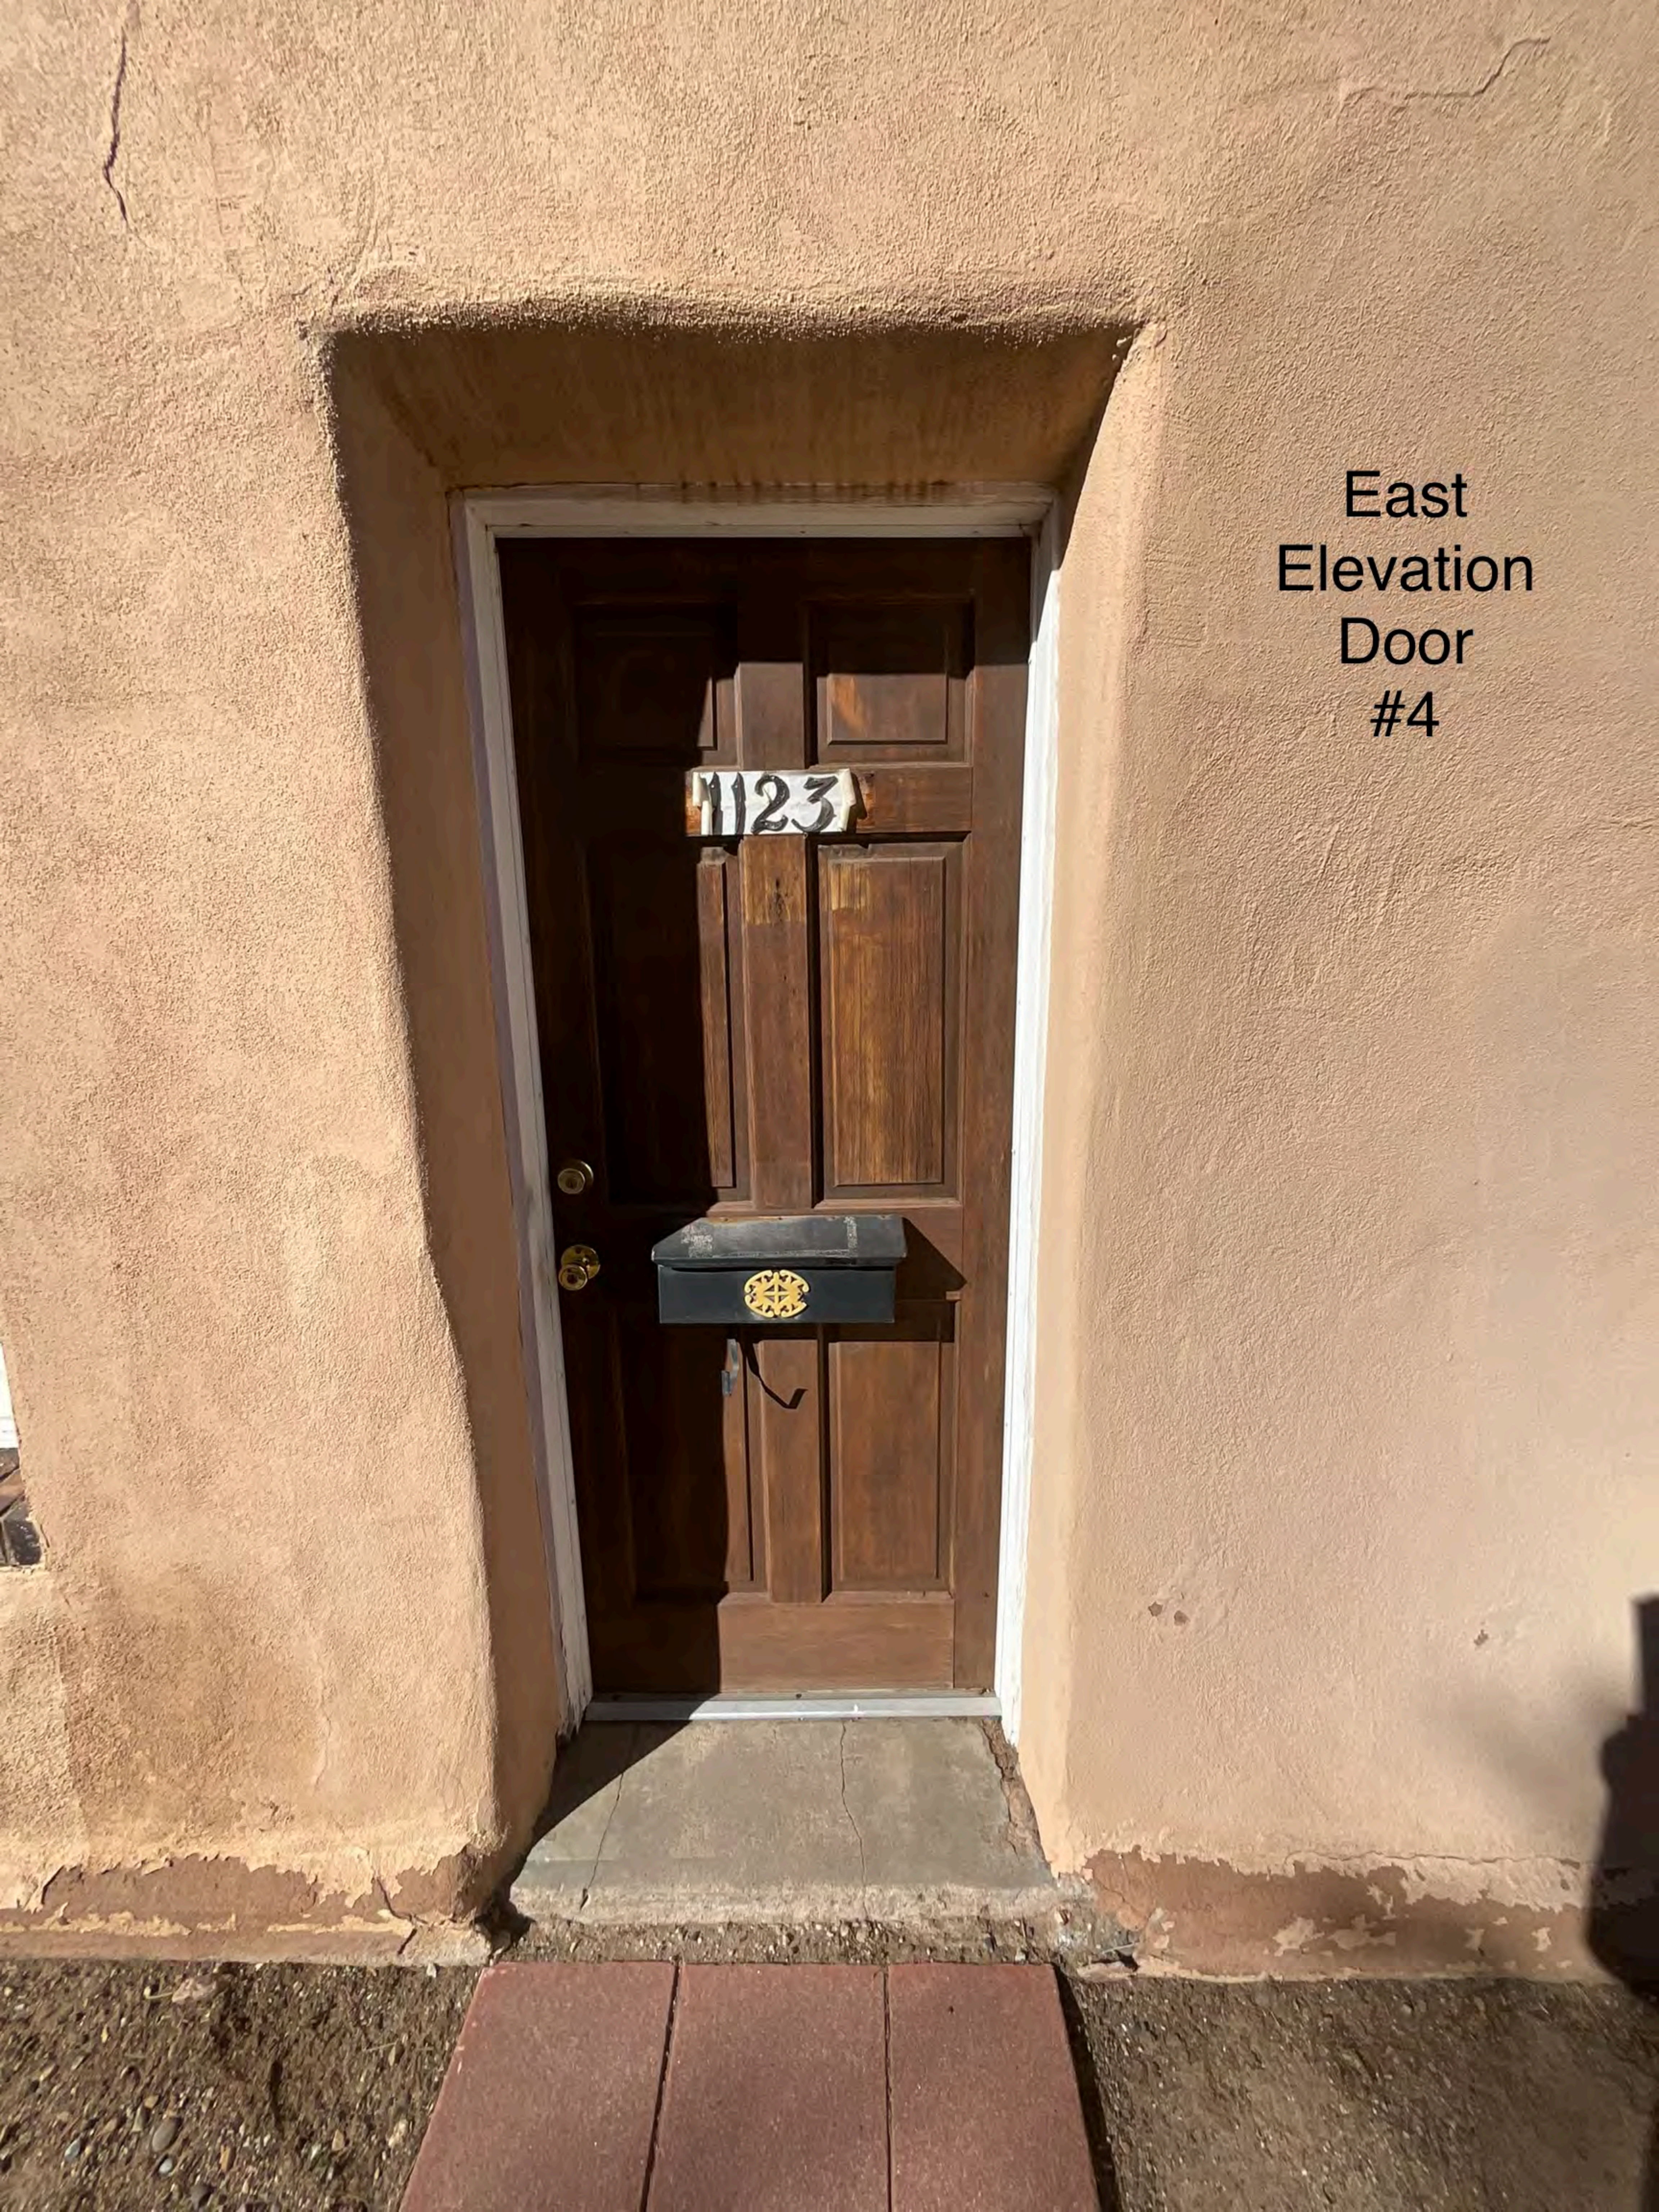
East
Elevation
Window
H

LABEL	WINDOW & DOOR DESCRIPTION	CONDITION & INTEGRITY CODE	HISTORIC/NON-HISTORIC – AGE
<u>EAST</u>			
DR #3	32" x 80" LH INSWING DOOR 3W5H	F	NON-HISTORIC – FIR “SIMPSON” DOOR (1996)
F	20" x 50" DOUBLE HUNG 1/1 OBSCURE	F	NON-HISTORIC – SASHES REPLACED EARLY 1980’s PER GLASS, NON-DIVIDED LITES
G	28" x 56" DOUBLE HUNG 3W1H/1-LT	F	HISTORIC
DR #4	32" x 80" RH INSWING DOOR 6-PANEL	F	NON-HISTORIC – FIR “SIMPSON” DOOR (1996)
H	28" x 56" DOUBLE HUNG 3W1H/1-LT	F	HISTORIC
I	28" x 56" DOUBLE HUNG 3W1H/1-LT	U	HISTORIC – AC UNIT HAS LEAKED/CONDENSATED CAUSING WATER DAMAGE IN THE WALL BELOW THE WINDOW, ROTTED BEYOND 40% WINDOW JAMB WILL NEED TO BE REMOVED TO REPAIR WALL, THE JAMB IS THE WINDOW BUCK AND WILL BE DESTROYED UPON REMOVAL

The windows and doors that are non-historic and unrestorable are to be replaced in “like and kind” to the windows of that era, wood divided lite (simulated or TDL), insulated Low-E glass (such as Kolbe or Weathershield manufactured). K-KRON would be a good alternative because of exterior low maintenance. K-KRON exterior has a 15-year warranty, whereas paint is approximately 3-5 years.
