MEMORANDUM

RE: 515 Paseo de Peralta

Subject: HDRB Design Review – 515 Paseo de Peralta

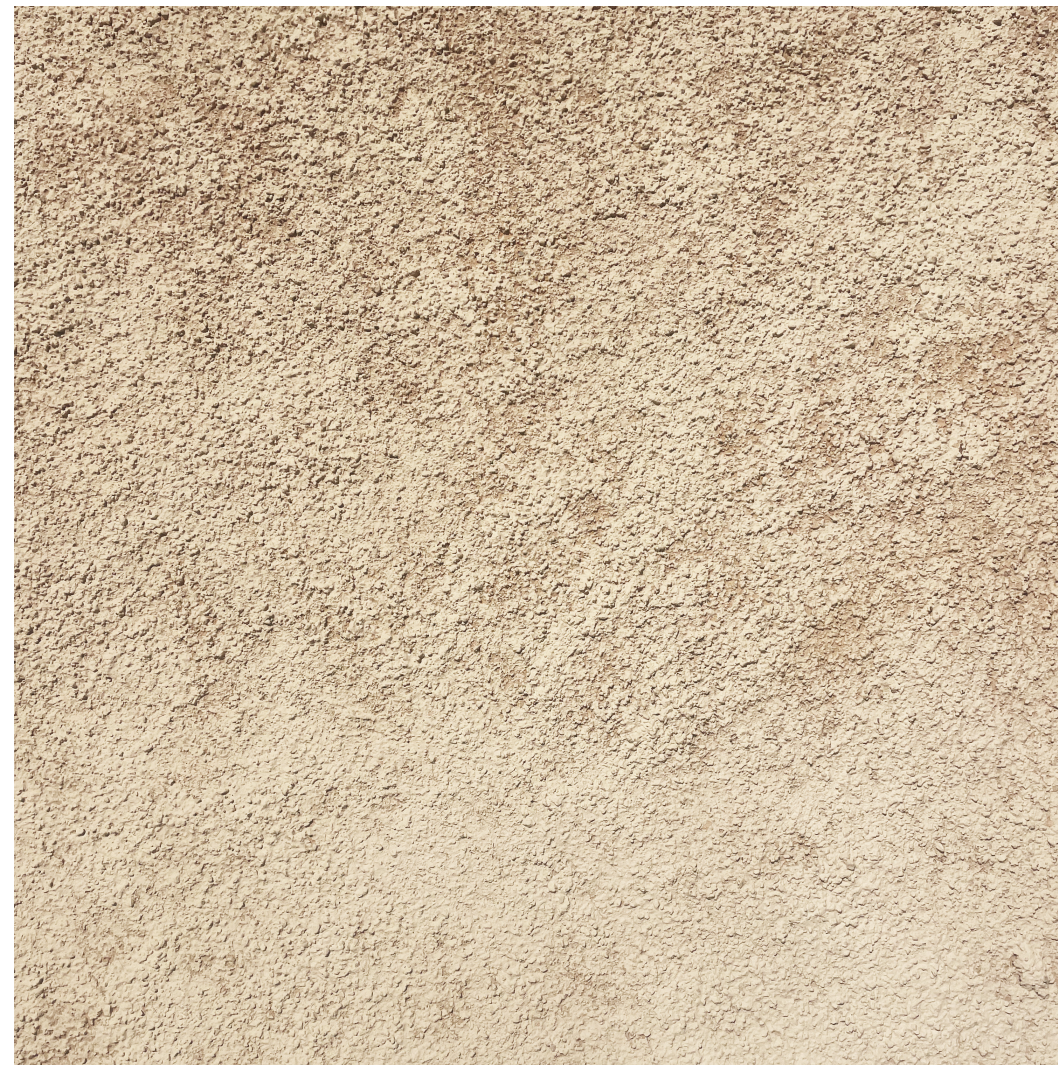
Historic House Existing Stucco Repair

Custom color similar to El Rey Sandalwood
Pebble-dashed texture to match existing

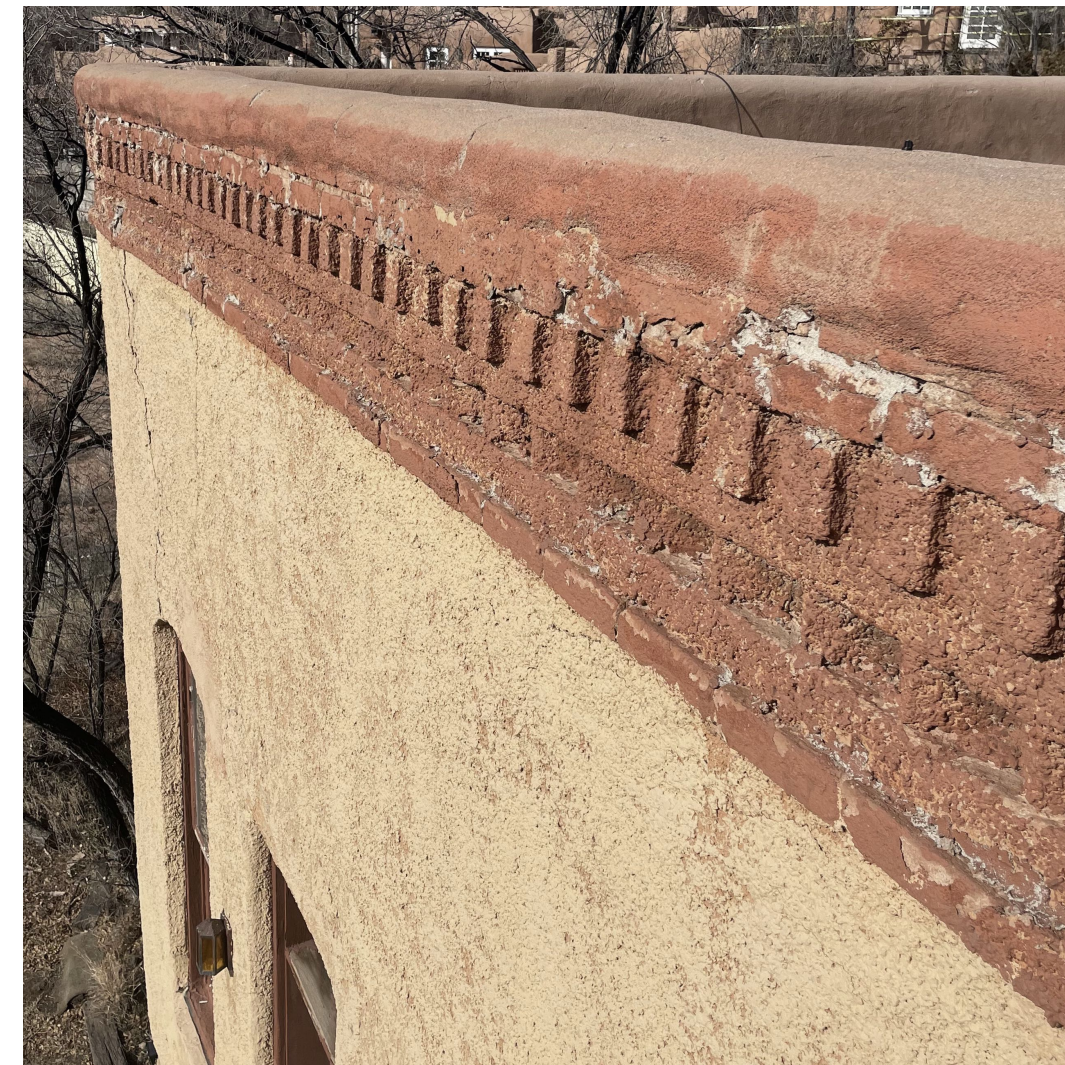
Historic House Existing Coping Repair

Custom color similar to LaHabra X-63149 Hatteras
Matching existing red brick where exposed

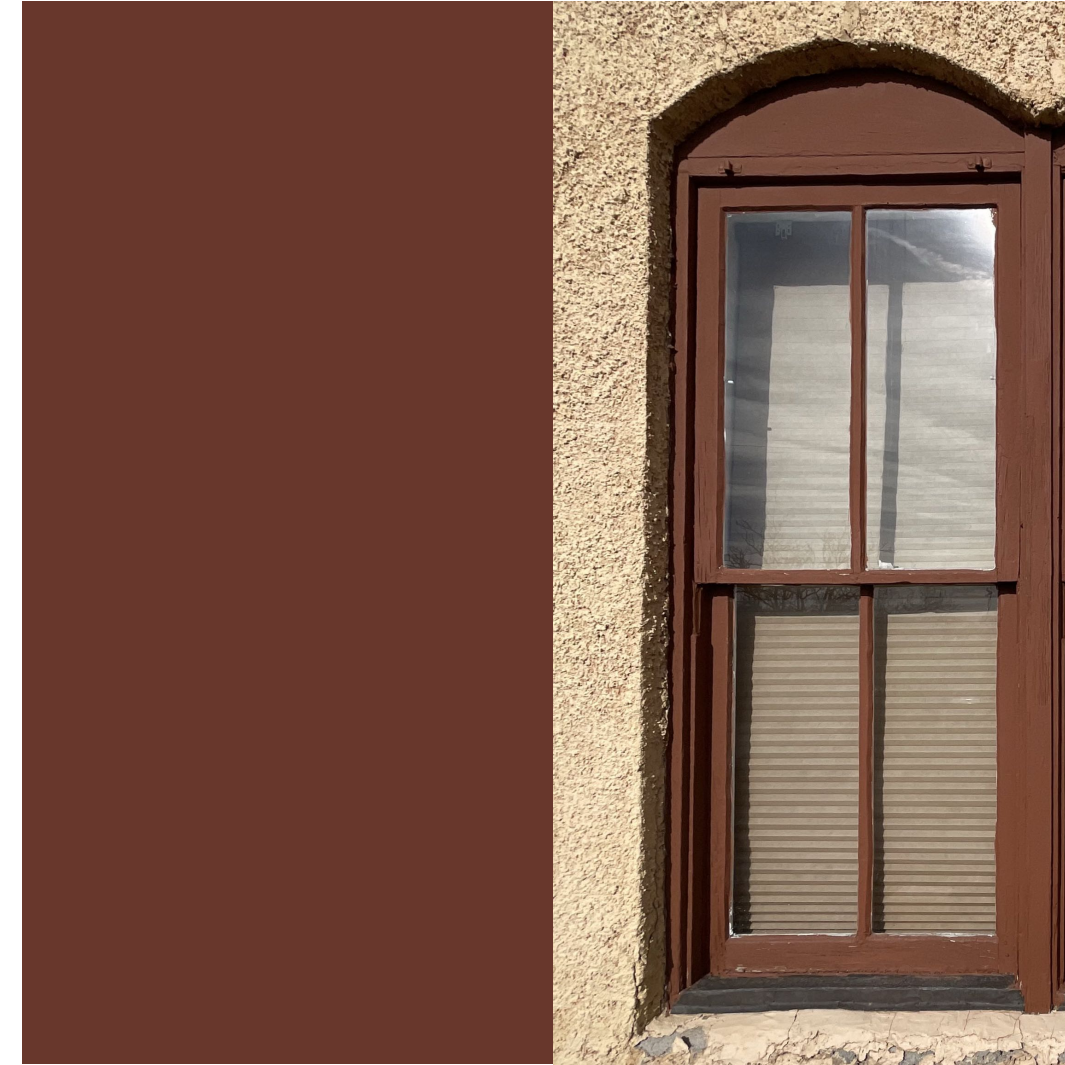
Historic House Windows

Repair or Replace in Kind
Kolbe Traditional Divided-lite Wood Windows
K-Kron II Exterior Finish in Nutmeg

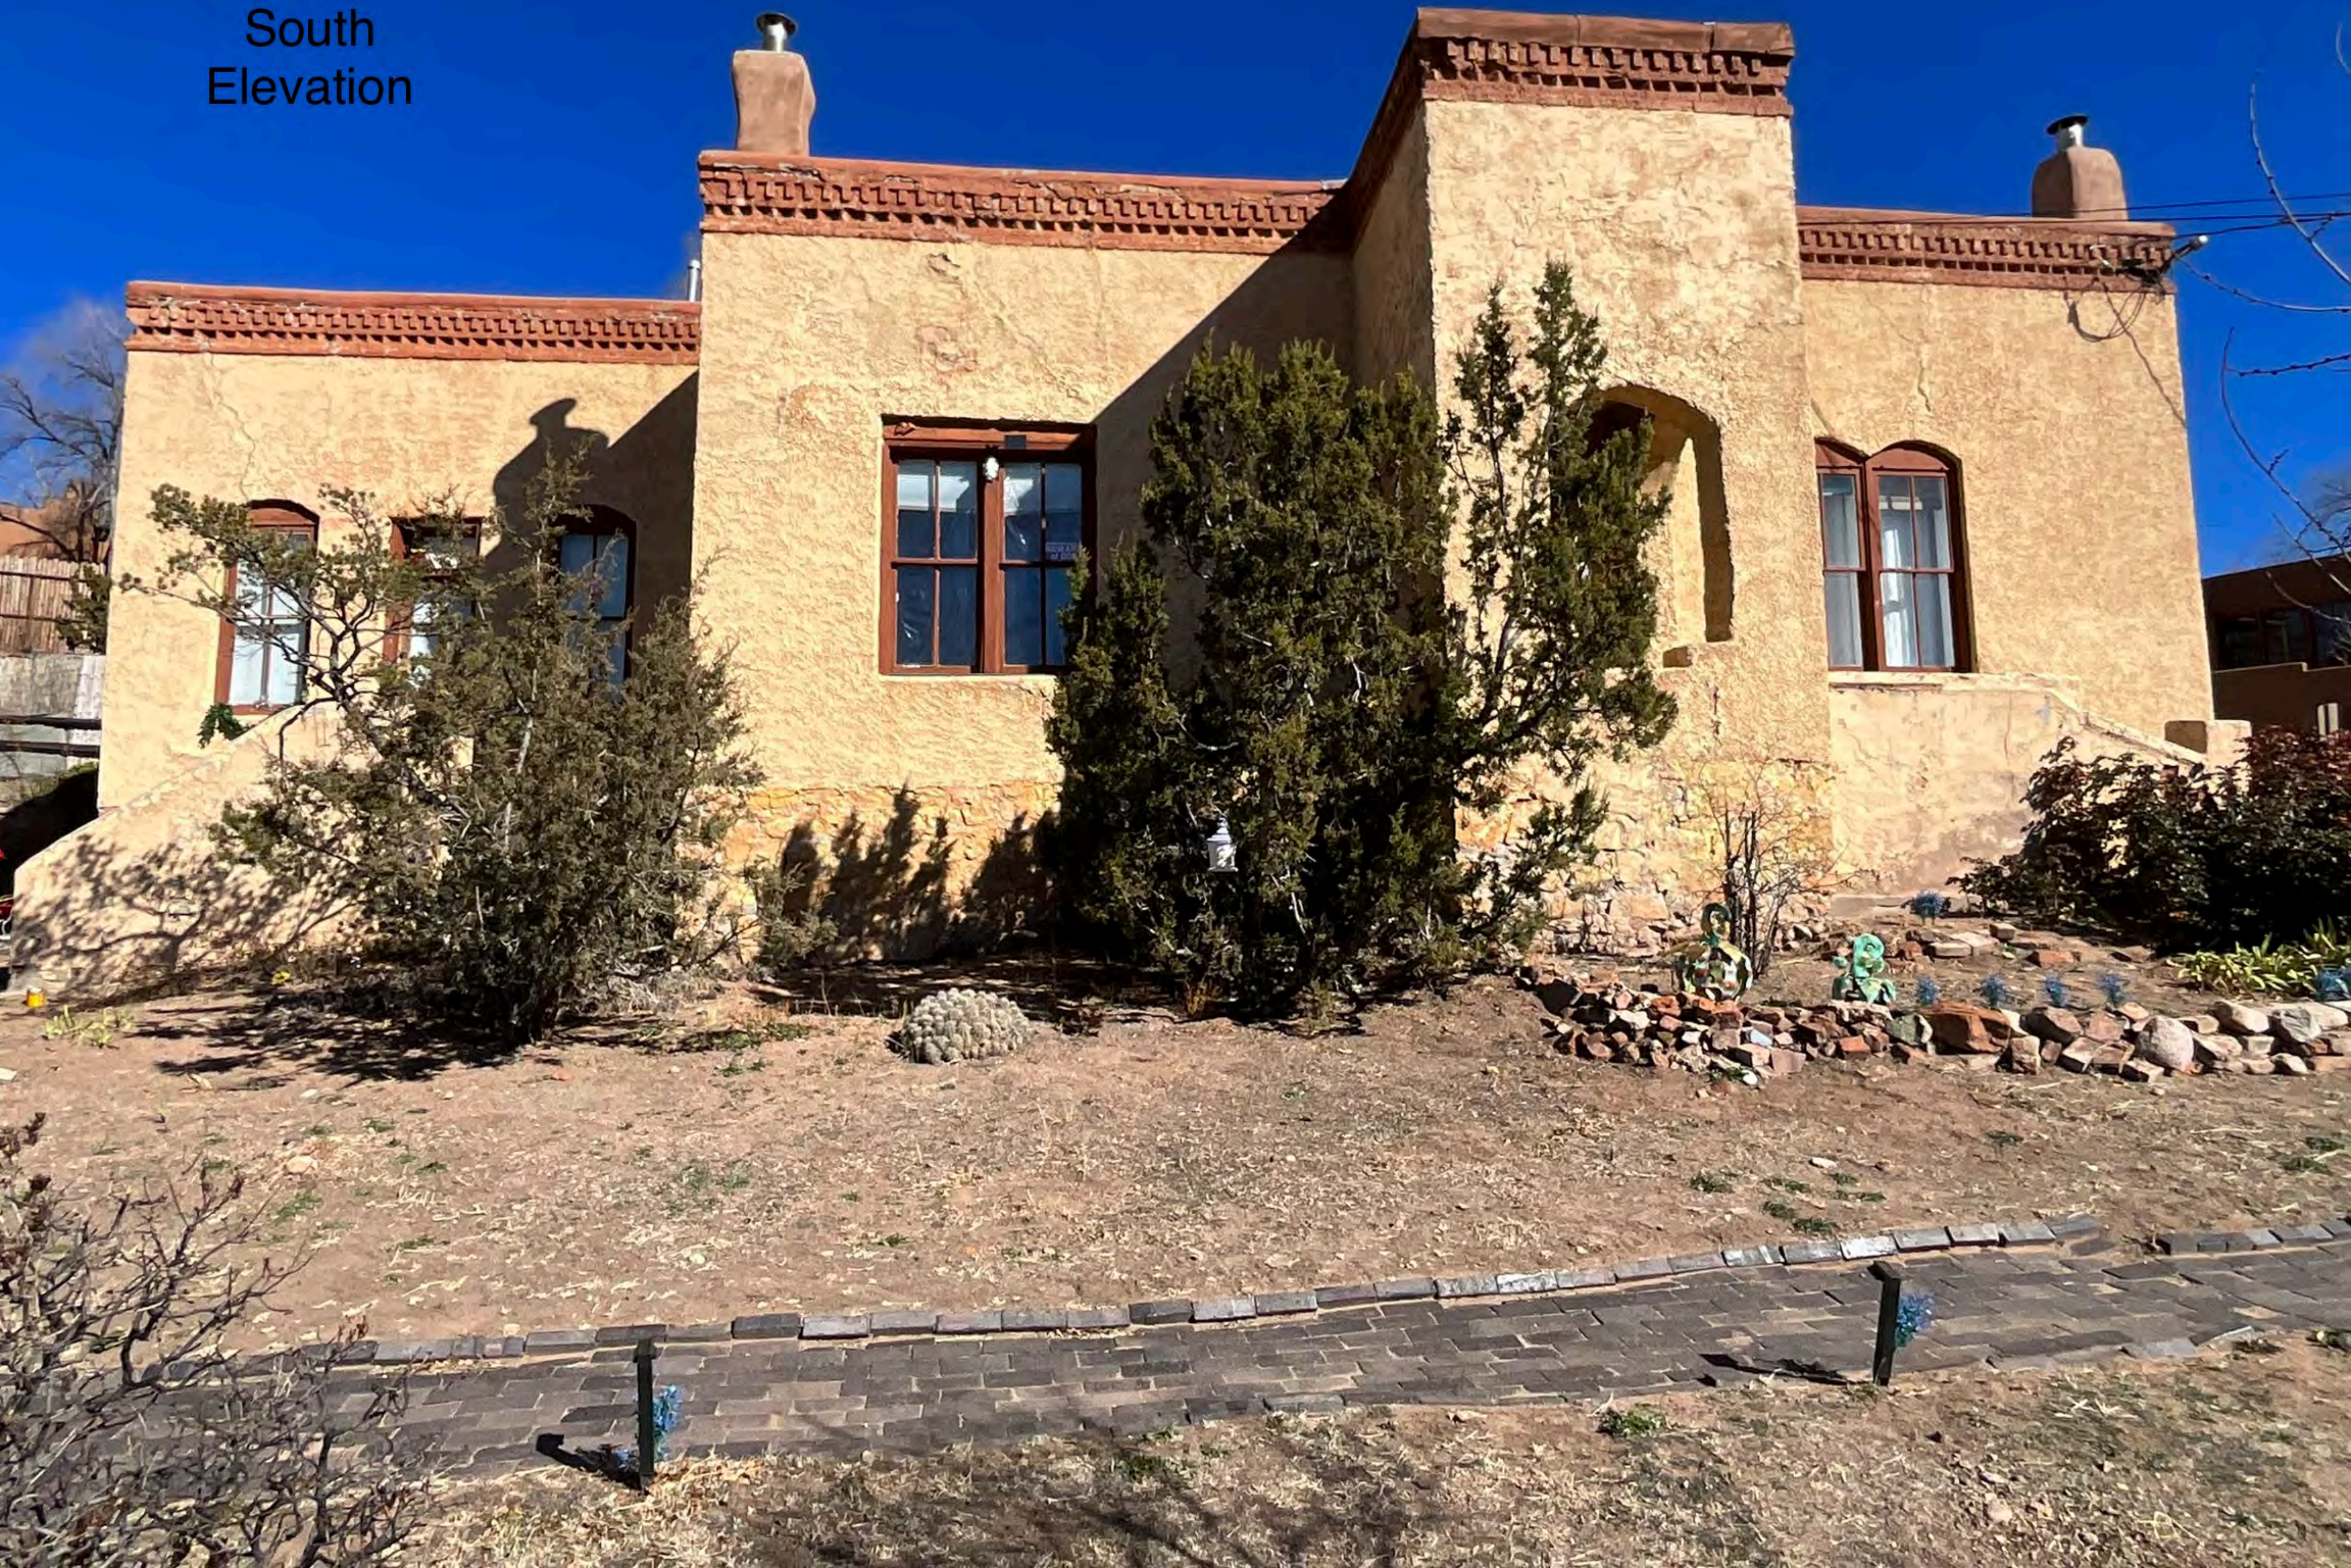
East Elevation
Window
A

LABEL	WINDOW & DOOR DESCRIPTION	CONDITION & INTEGRITY CODE	HISTORIC/NON-HISTORIC - AGE
A	32" x 73" (+/-) DOUBLE HUNG 2W1H/2W1H 1 1/8" TDL EXTERIOR ARCH TOP CASING	F	HISTORIC
B	27 1/2" x 34" (+/-) HOPPER 7/8" TDL	F	HISTORIC - DIFFERENT ERA THAN THE DOUBLE HUNG, SMALLER DIVIDED LITE BAR WITH NO EXTERIOR SILL
C	32" x 73" (+/-) DOUBLE HUNG 2W1H/2W1H 1 1/8" TDL EXTERIOR ARCH TOP CASING	F	HISTORIC
D	32" x 73" - 2 (+/-) TWIN DOUBLE HUNG 2W1H/2W1H 1 1/8" TDL EXTERIOR ARCH TOP CASING	U	HISTORIC - NON-RESTORABLE SILLS, THEY COMPLETELY ROTTED SHOWING DETERIORATION & DAMAGE TO THE WALL. THE PROCESS OF REMOVING THE WINDOW WILL COMPLETELY DESTROY THE UNIT BECAUSE THE WINDOW JAMB/FRAME IS THE BUCK/SUPPORT TO THE OPENING
DR #1	32 1/2" x 80 1/2" (+/-) LH INSWING 2-ARCH GLASS/2-PANEL DOOR	S	NON-HISTORIC - NON-PUTTY GLAZED, MACHINED BEAD WITH SHAPER, AIR NAILED WOOD GLAZING BEAD SIMPSON DOOR (1992)
E	32" x 73" - 2 (+/-) TWIN DOUBLE HUNG 2W1H/2W1H 1 1/8" TDL EXTERIOR FLAT TOP CASING	U	HISTORIC - SILLS COMPLETELY MISSING, THEY COMPLETELY ROTTED SHOWING DETERIORATION & DAMAGE TO THE WALL. THE PROCESS OF REMOVING THE WINDOW WILL COMPLETELY DESTROY THE UNIT BECAUSE THE WINDOW JAMB/FRAME IS THE BUCK/SUPPORT TO THE OPENING

It would be my recommendation that the replacement windows be in “like and kind”, all wood exterior and interior, true or simulated divided light with insulated glass (such as Kolbe millwork). The exterior finish should be K-Kron factory paint (with a 20 year warranty), to preserve the wood or a primed field painted finish (with a 1 year warranty).

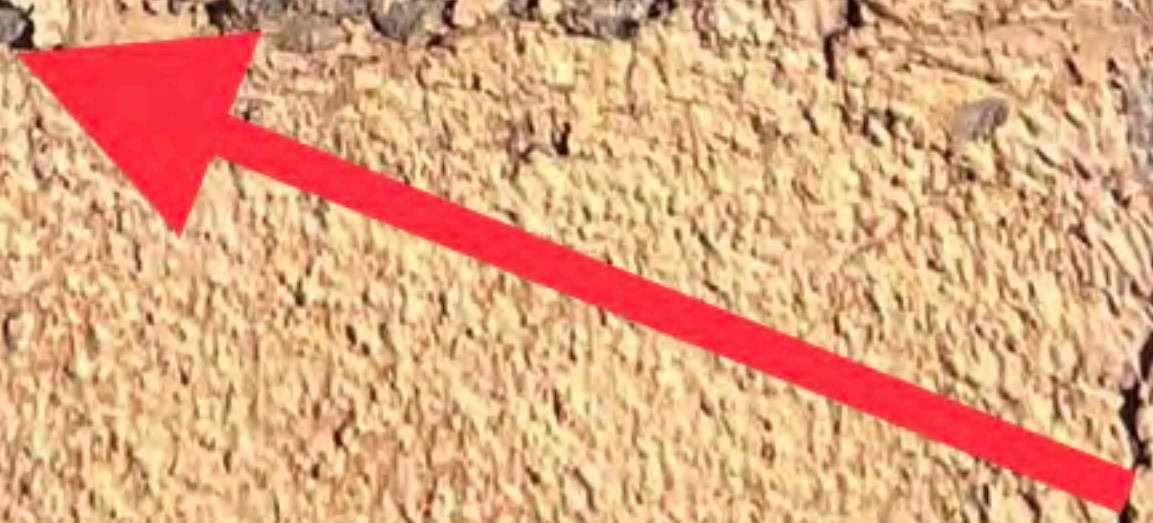
Wall
damage
from rotted
sills allowing
water to leak
into the

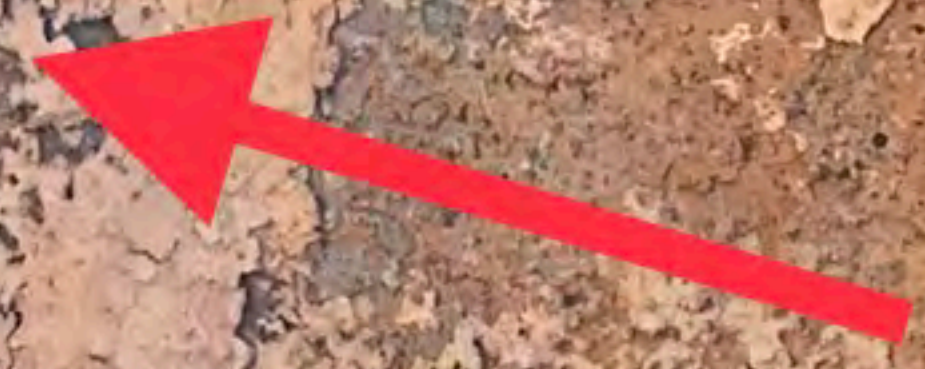
Water penetration
at sill into the wall
because of sill rot

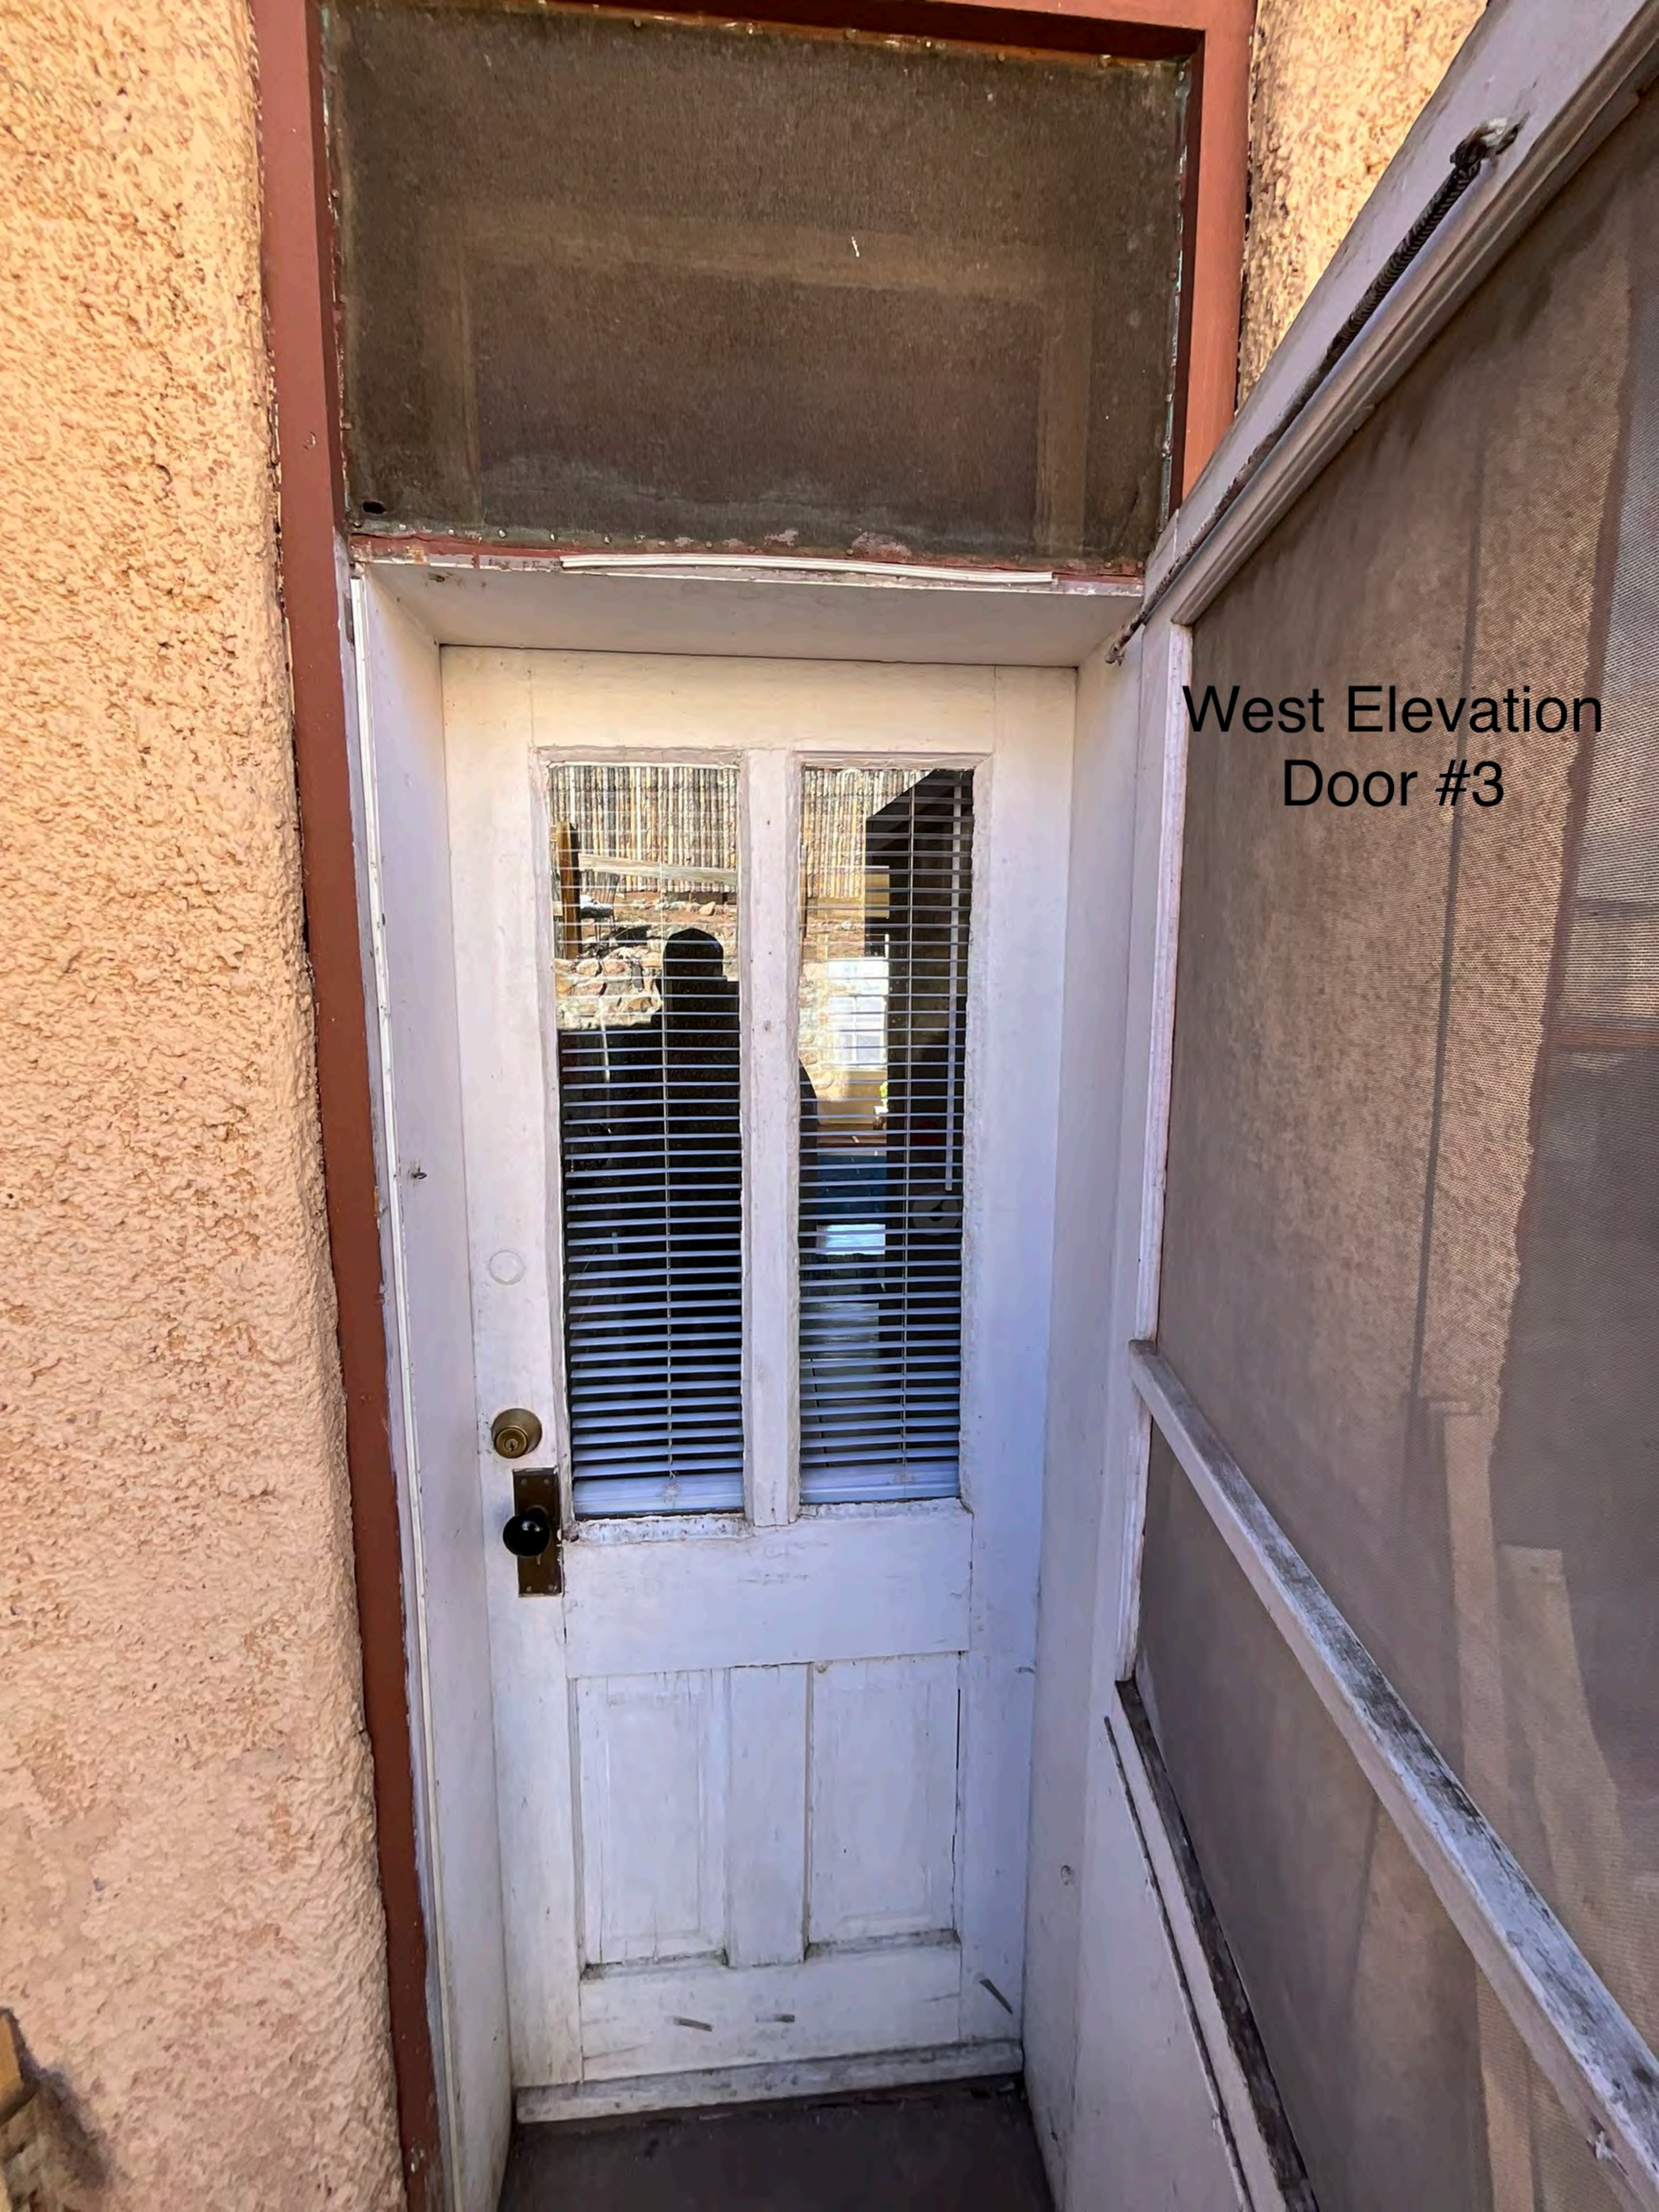
North Elevation
Window
J

LABEL	WINDOW & DOOR DESCRIPTION	CONDITION & INTEGRITY CODE	HISTORIC/NON-HISTORIC - AGE
	N/A #1, N/A #2, N/A #3, N/A #4 & N/A #5 - NOT APPLICABLE		
DR #3	29" x 78" (+/-) LH INSWING 4-LT 2W2H /2-PANEL DOOR WITH 20" (+/-) TRANSOM 2W1H ALL WOOD	F	HISTORIC
J	32" x 73" (+/-) DOUBLE HUNG 2W1H/2W1H ARCH TOP CASINGS	F	HISTORIC NON-HISTORIC - EXTERIOR CASINGS REPLACED IN THE 1990's
K	32" x 54" (+/-) FIXED/HOPPER 1-LT 2W1H BOTH OBSCURE GLAZING ALL WOOD	F	NON-HISTORIC - THE OPENING ONLY HAS A TOP SASH OF THE DOUBLE HUNG FASTENED TO THE FRAME AND STOPPED IN A PIECE OF GLASS FOR TRANSOM THE WINDOW OPENING WAS ORIGINALLY A DOUBLE HUNG (32" x 73") HOWEVER THE OPENING WAS FILLED IN TO MAKE A SHORTER BATHROOM WINDOW (SEE ATTACHED PHOTO)

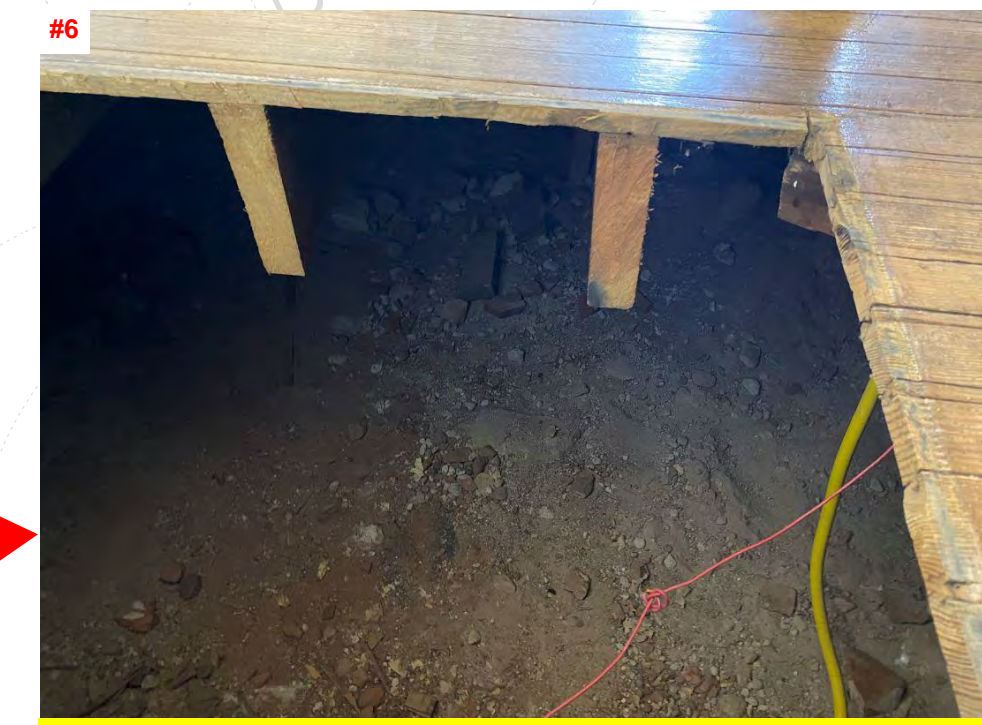
- Floor joists that have been cut to accommodate out of service floor heaters were noted to occur in two locations in the main structure. The alterations should be corrected with adequately sized floor joist girders and headers.

#6 2x8 FLOOR JOISTS CUT AT OUT-OF-SERVICE GAS FLOOR HEATERS

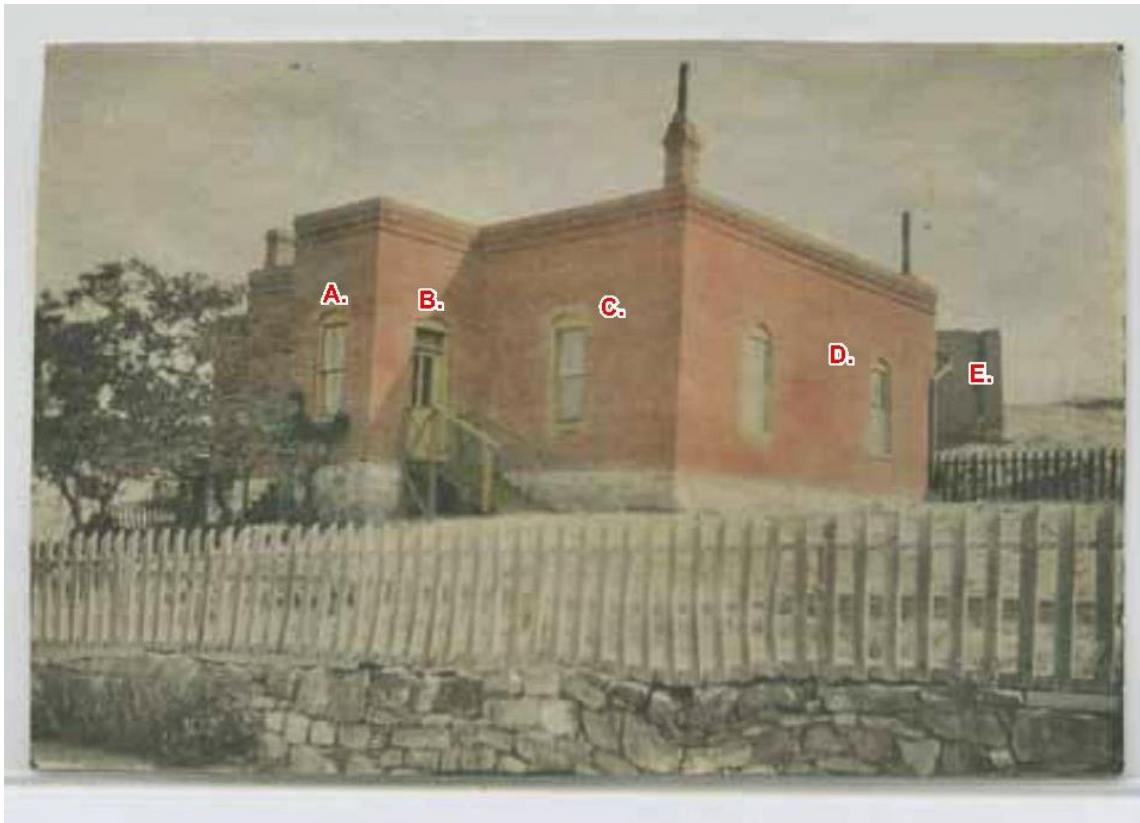
Figure 3: “Adobe home on Hillside Street, Santa Fe, New Mexico,” H. H. Dorman, ca. 1915, Negative Number 010516. Courtesy of Palace of the Governors Photo Archives, New Mexico History Museum.

Note: A. Window removed; B. door and wood stairs removed; C. window added; D. window added; E. building demolished.

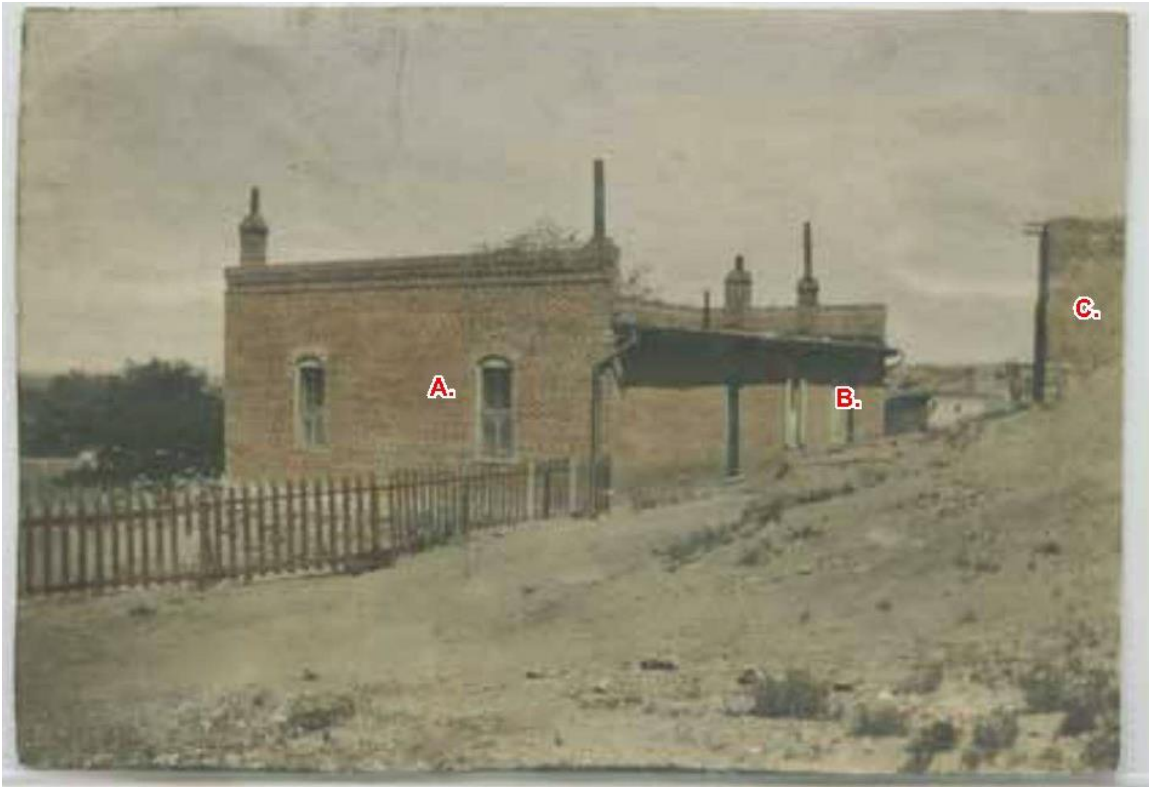
Figure 4: “Adobe home on Hillside Street, Santa Fe, New Mexico,” H. H. Dorman, ca. 1915, Negative Number 010517. Courtesy of Palace of the Governors Photo Archives, New Mexico History Museum.

Note: A. Window added; B. door removed with addition; C. building demolished.

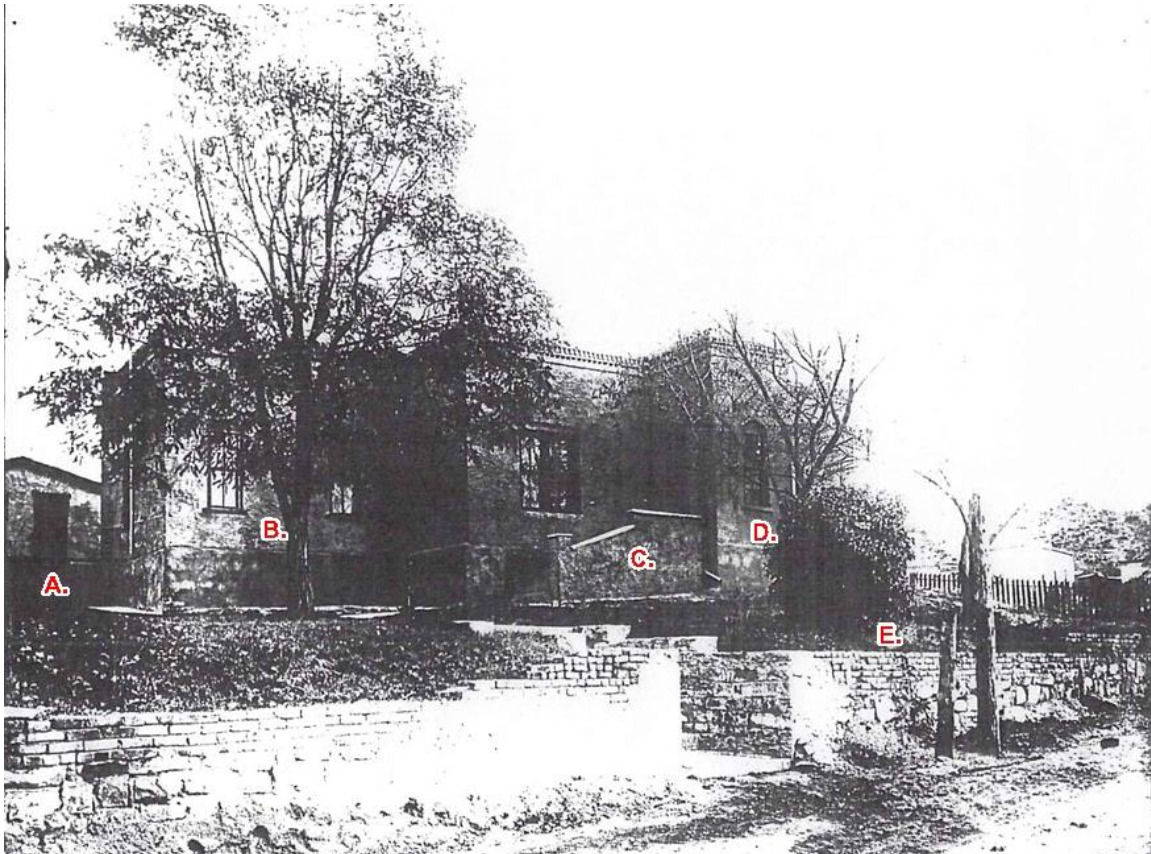
Figure 5: “House of Paseo de Peralta (formerly Hillside Avenue), ca. 1910-15, Negative Number 51631. Courtesy of Palace of the Governors Photo Archives, New Mexico History Museum.

Note: A. Shed in existence; B. stairway and door added; C. stairway removed; D. window removed; E. shorter wall topped with bricks.

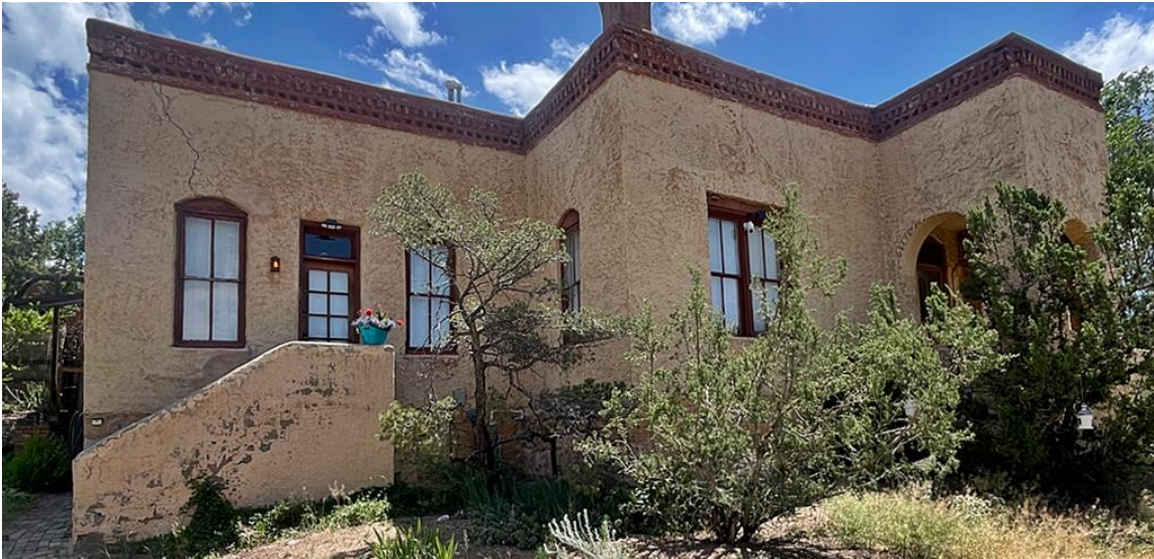
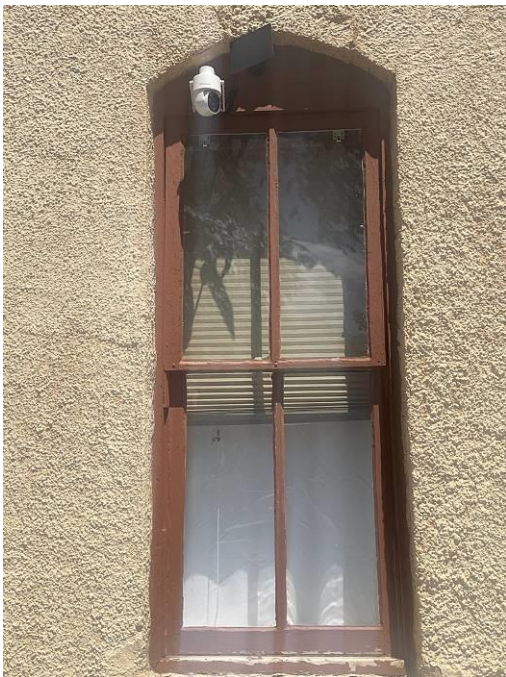
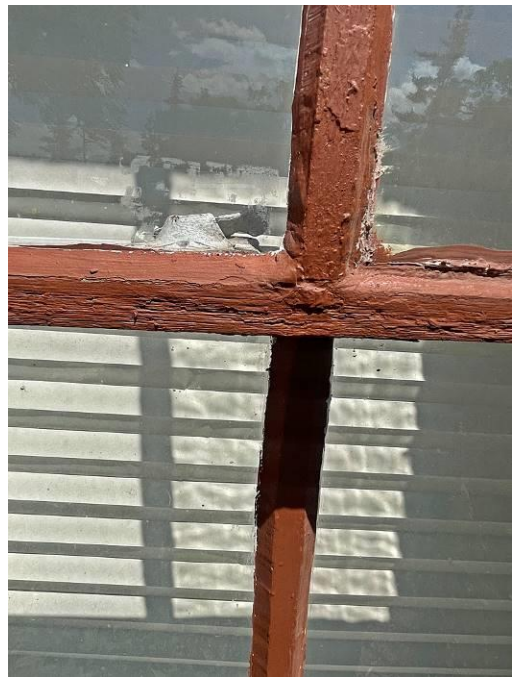
However, based on their appearance, the existing sash may be later, cost-conscious replacements. Although there is moderate paint buildup, the wood elements lack the characteristic “alligatoring” associated with lead-based finishes from the 19th century. The glazing putty is minimal, missing, or obscured by overpainting, and the glass panes appear flat and uniform, lacking the wavy surface typical of earlier cylinder glass.²

Moving east, the façade projects about 10 feet and contains a pair of 2/2 wood sash windows separated by a mullion (Photo 4). Distinct from the other openings, these windows are topped with a flat arched header. Below them, an exposed section of the foundation indicates the former location of stairs that once led to the front entry.

Photo 4: West half of south elevation. Camera facing up and northeast. Typical window (left) and muntin pattern (right).

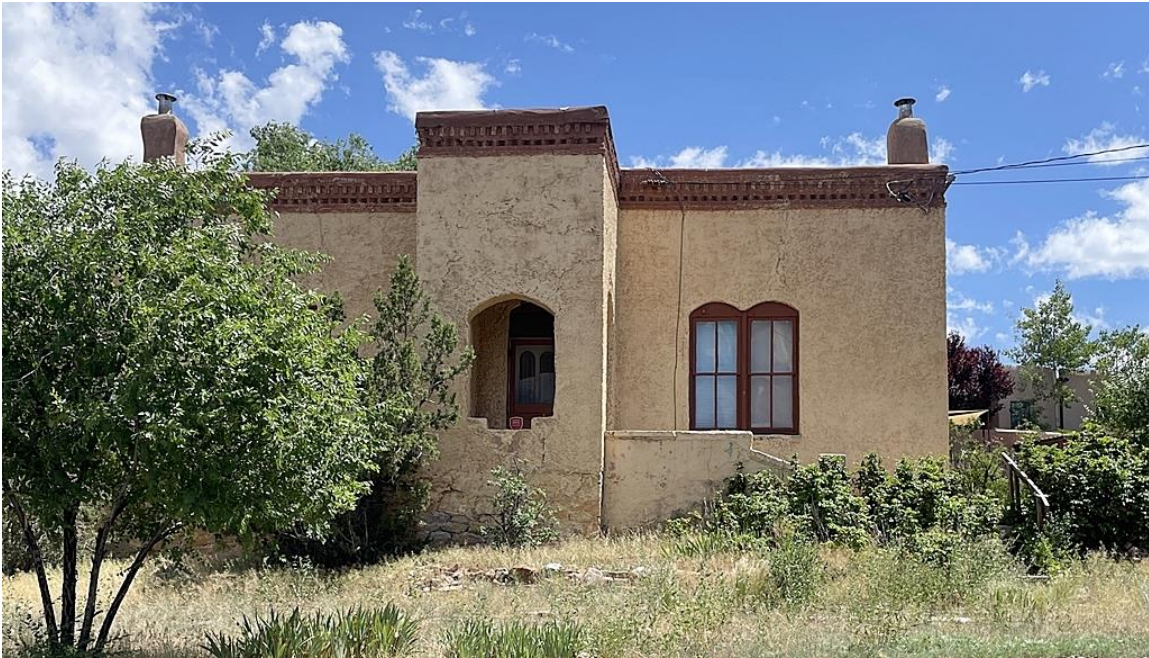
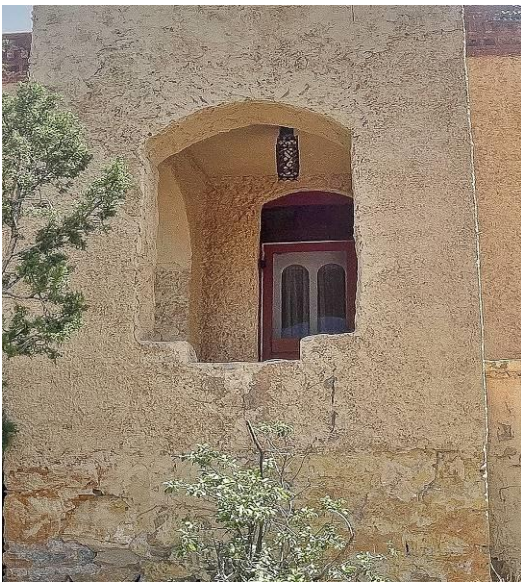
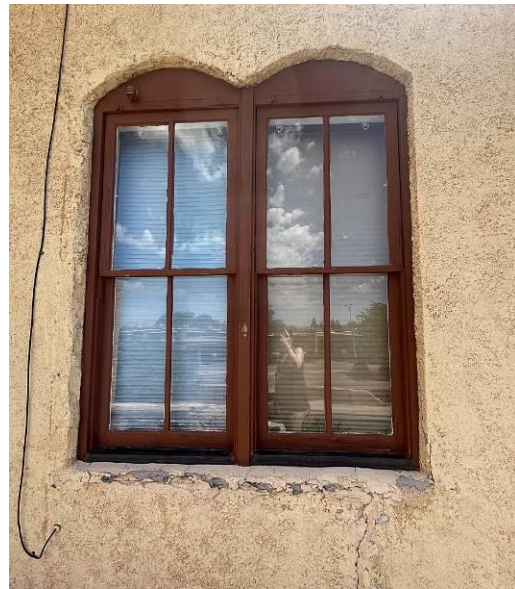
The façade projects approximately nine feet at what was originally the primary entry elevation. Early photographs indicate that this section was once fenestrated with doors on the east and west sides and a segmental-arched window on the south elevation (Figs. 3 & 5). These openings were later removed to create a small open porch exhibiting a modest Moorish influence, most evident in the modified keyhole-shaped opening on the south side, which replaced the original segmental-arched window (Photo 5). The east side of the porch is accessed by a set of concrete steps that replaced an earlier wooden staircase. Entry to the house is through a wood door with arched lights.

Photo 5: Entry façade and east half of south elevation. Camera facing up and northeast. Entry porch (left) and altered windows (right).

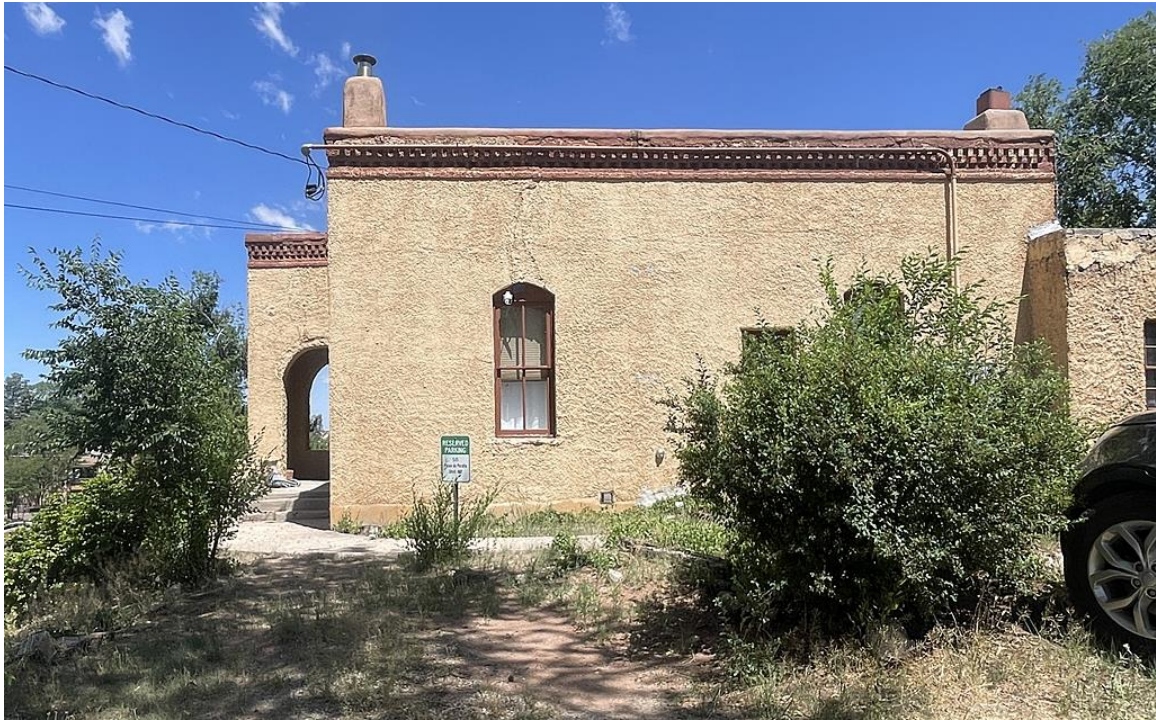
The east elevation, which faces the driveway, extends nearly 60 feet and includes the original house, a garage added before 1930, and a later rock structure which replaced the original garage (Photos 6-9). The historic portion repeats the fenestration of the street façade, with two tall 2/2 wood sash windows set beneath segmental arches (Photo 6). South of the second window is a small opening containing a four-light hopper window, which does not appear in early photographs of the house (Fig. 5).

Photo 6: East elevation of the original building. Camera facing northwest.

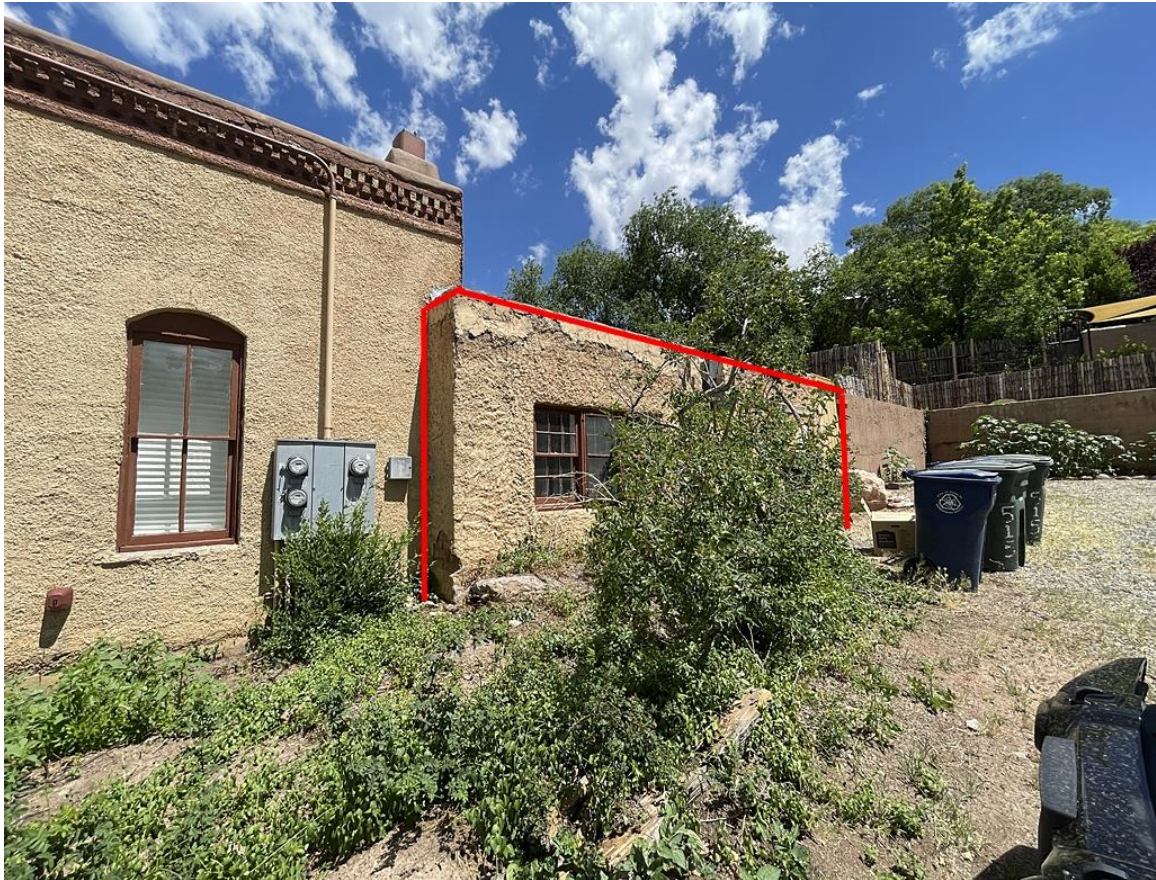
Projecting approximately three feet from the façade is a structure identified as a garage on the 1930 Sanborn Fire Insurance Map (Fig. 6). Constructed of stone and set at a lower elevation, it features a grouping of three 6/6 wood sash windows, some of which are missing muntins (Photos 7 & 8). This section of the elevation appears to be in deteriorated condition.

Photo 7: East elevation oblique. Two garage additions highlighted. Camera facing north.

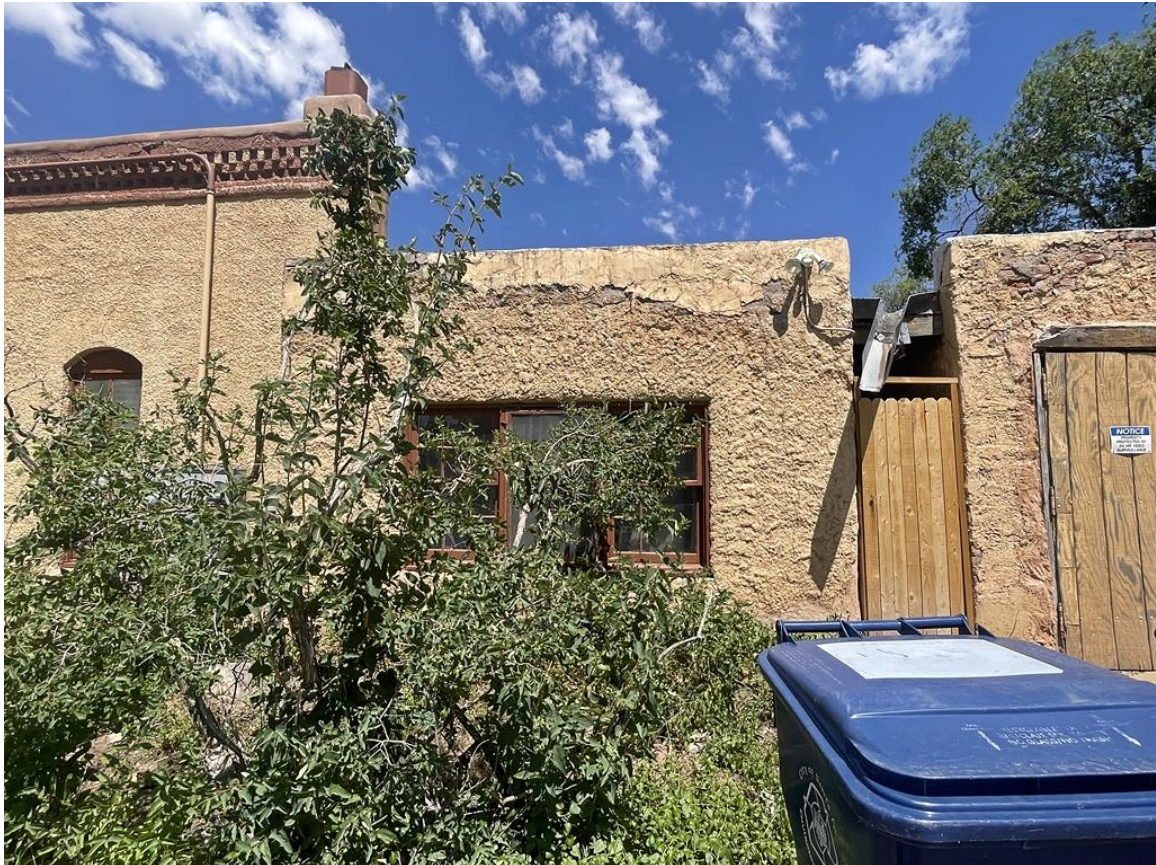
Photo 8: East elevation. Original garage at center. Camera facing northwest.
