MEMORANDUM

RE: 515 Paseo de Peralta

Subject: HDRB Design Review – 515 Paseo de Peralta

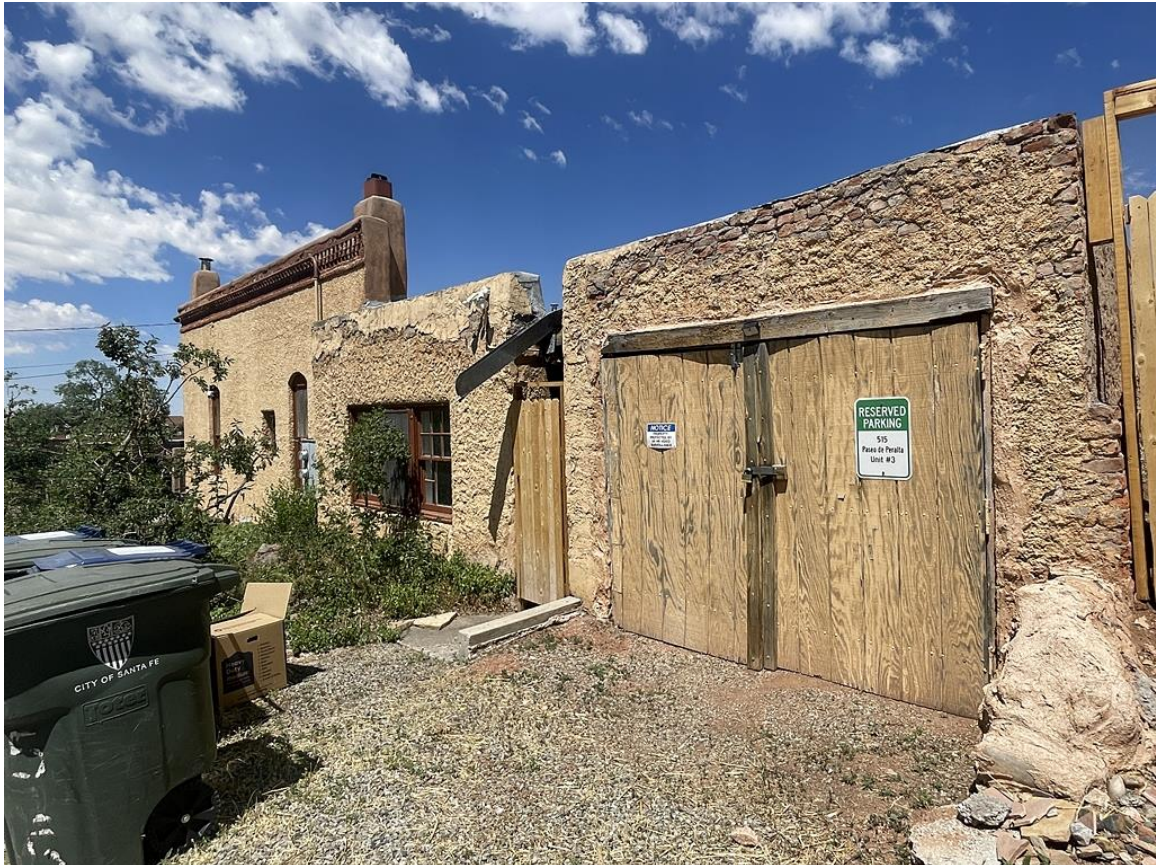
Separated from it by a narrow walkway is the final element of the south elevation: a one-bay stone garage partially built into the hillside (Photos 9 & 10). It is accessed through a pair of non-historic outswing doors constructed of vertical wood boards. Based on the 1943 drawing, this second garage was already in place by that time. It is also in poor condition.

Photo 9: East elevation oblique. Later garage at right. Camera facing southwest.

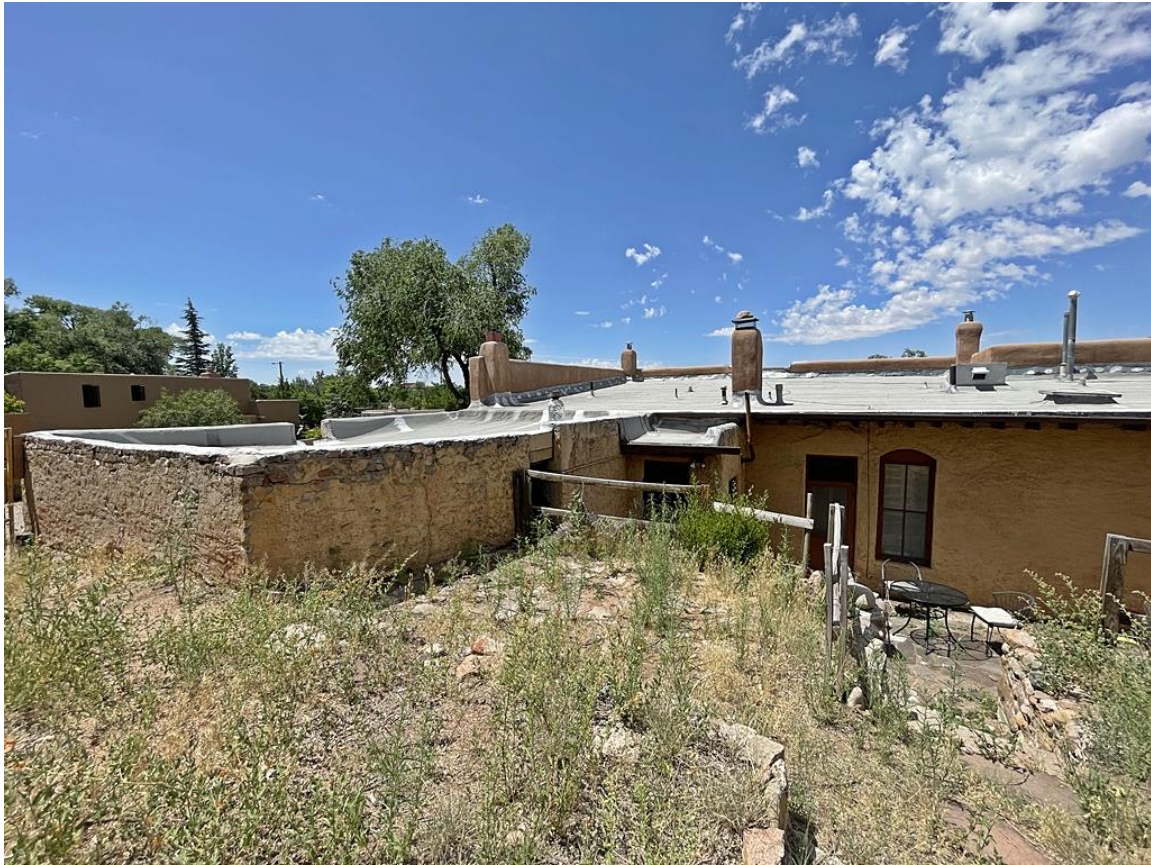
units are exposed here, including plumbing vents, ductwork, and chimneys (Photos 10 & 11).

Photo 10: Combined garages. North and west elevations. Camera facing southeast.

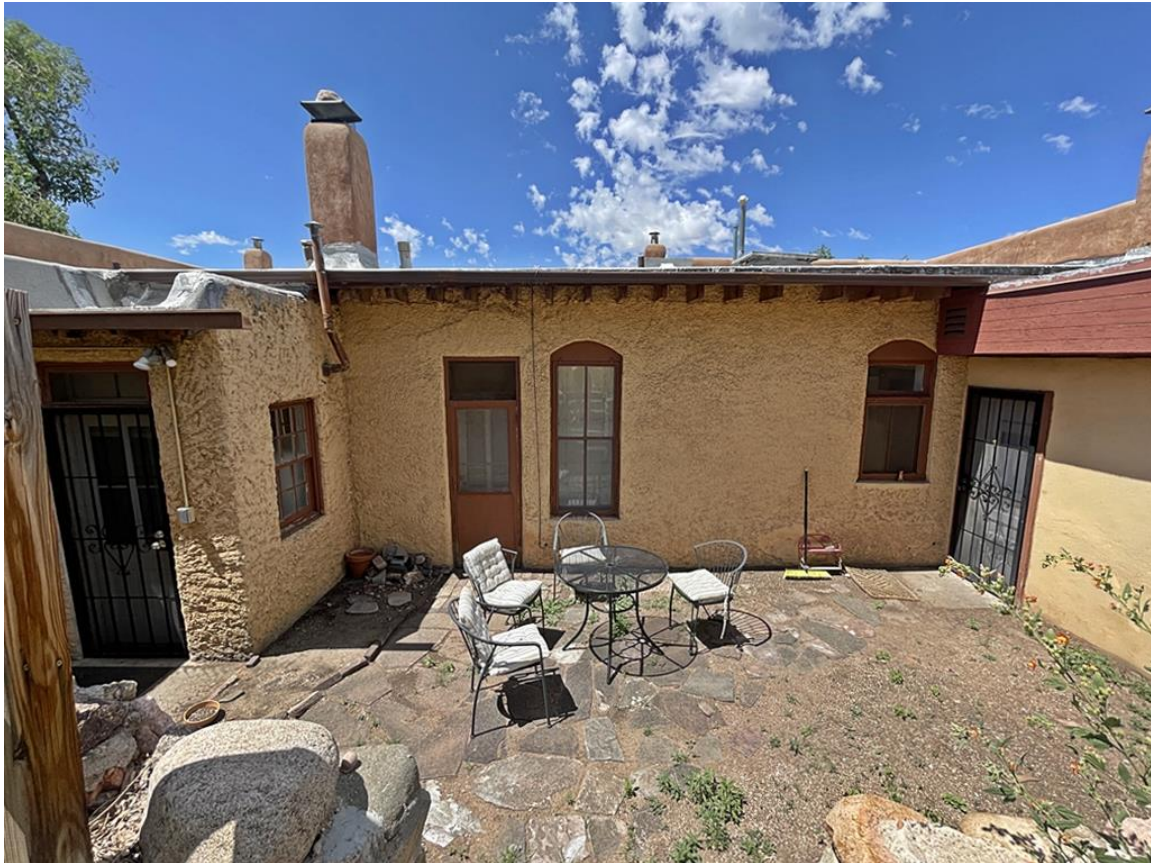
The central portion includes a double-light wood door with transom, protected by a wood screen door. To the west are two older wood sash windows (one converted to a hopper) with segmental-arched heads. Projecting from the east is the original garage, fenestrated on the north with a four-light and wood panel entry door with a transom, and on the west a single 6/6 wood sash window (Photos 11 & 12).

At the far west end is a small addition of uncertain origin (Photos 11 & 12). Based on Sanborn maps and aerial photographs, it was appended to the building sometime between 1948 and 1958 (Fig. 8). However, its exterior detailing appears more modern, characterized by a smoother stucco finish, pronounced fascia, and a sliding aluminum window. It is possible that the current structure replaced an earlier addition. The courtyard-facing door is a half-light over wood panel unit of indeterminate age.

Photo 11: North elevation. Original garage (left); bedroom addition (right). Camera facing southeast.

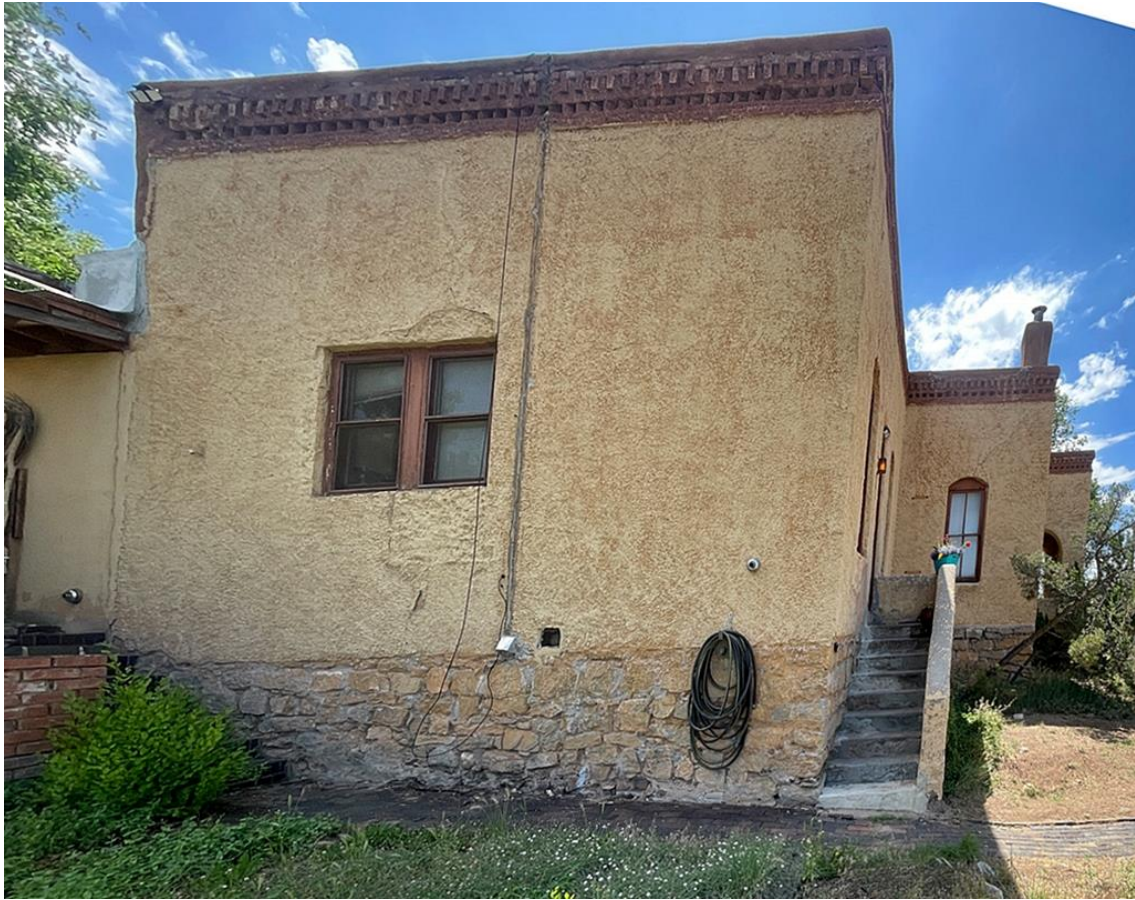
The older portion of the building contains two 1/1 wood hung-sash windows separated by a mullion (Photo 13). Ghosting visible in the surrounding stucco suggests this was originally a single vertical opening with a segmental-arched window. The adjoining addition contains a single sliding aluminum window (Photo 14).

Photo 13: West elevation of original building. 1940s staircase on the right. Camera facing northeast.

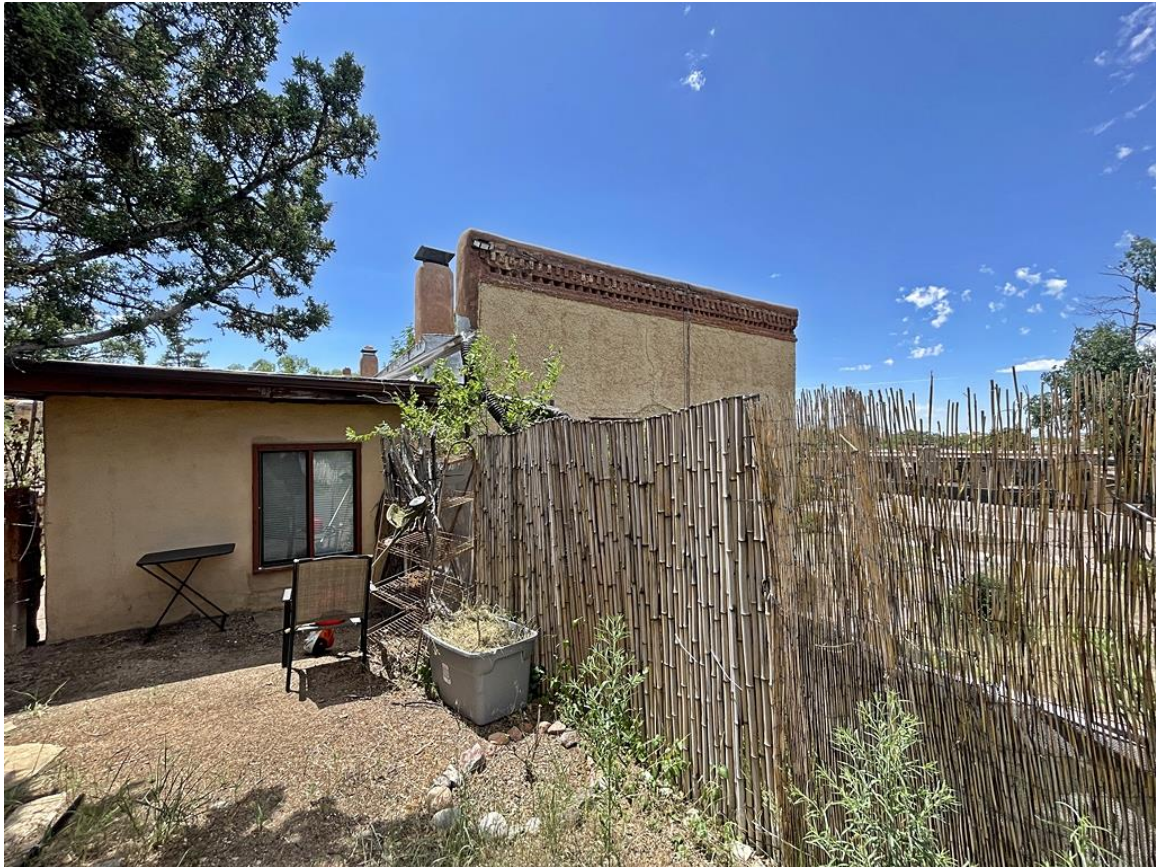
Photo 14: West elevation of bedroom addition. Camera facing southeast.

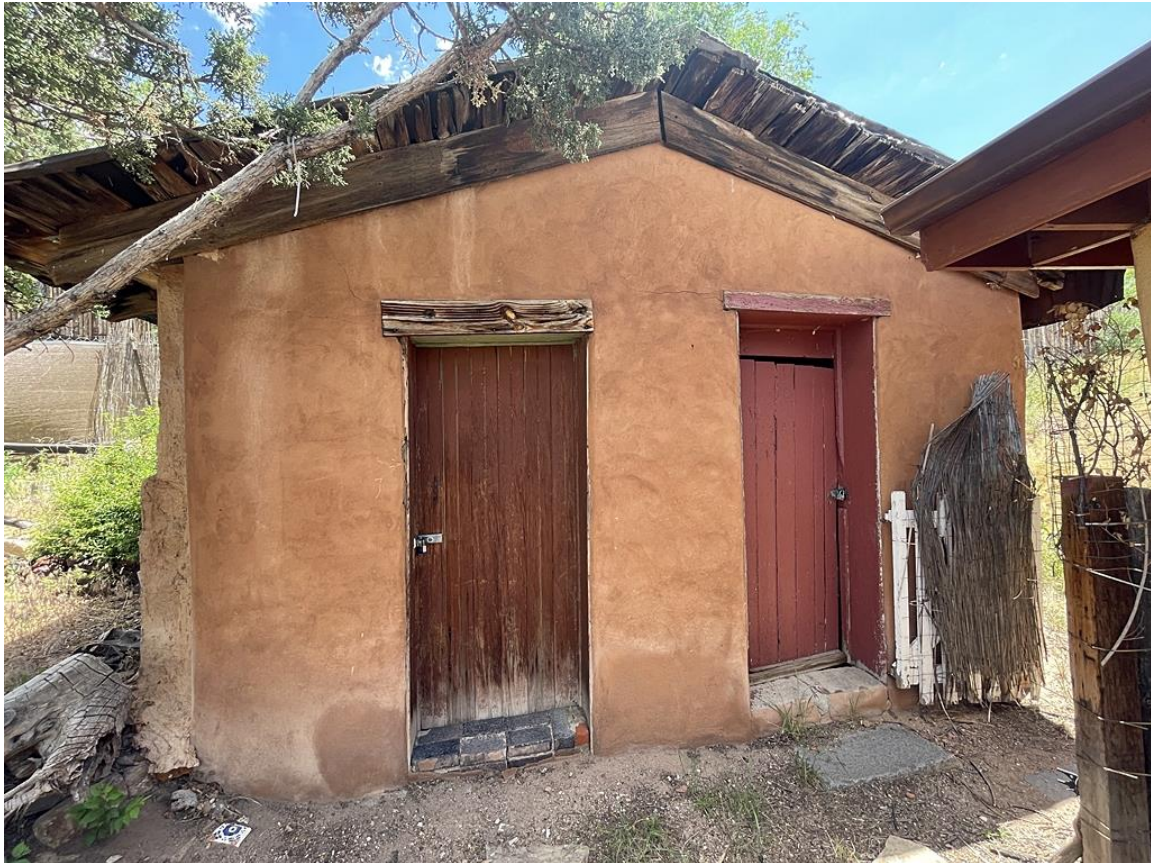
The approximately 195-square-foot shed is located on what was originally Lot 4, north of the alley that once divided the two properties. Constructed in part of adobe, the structure appears on the 1912 King's Map as a stable (Fig. 2). It is topped with a medium-pitched gable roof clad in weathered boards, over which corrugated metal—now painted black—has been applied (Photo 15). The front (south) elevation is finished with smooth stucco, while the side elevations exhibit much rougher texture (Photo 16).

The north elevation is set into the hillside and incorporates a mix of brick and rubblestone construction. Entry is through the south elevation via a pair of wood plank pedestrian doors (Photo 16).

Photo 16: Shed. South elevation. Camera facing northeast.

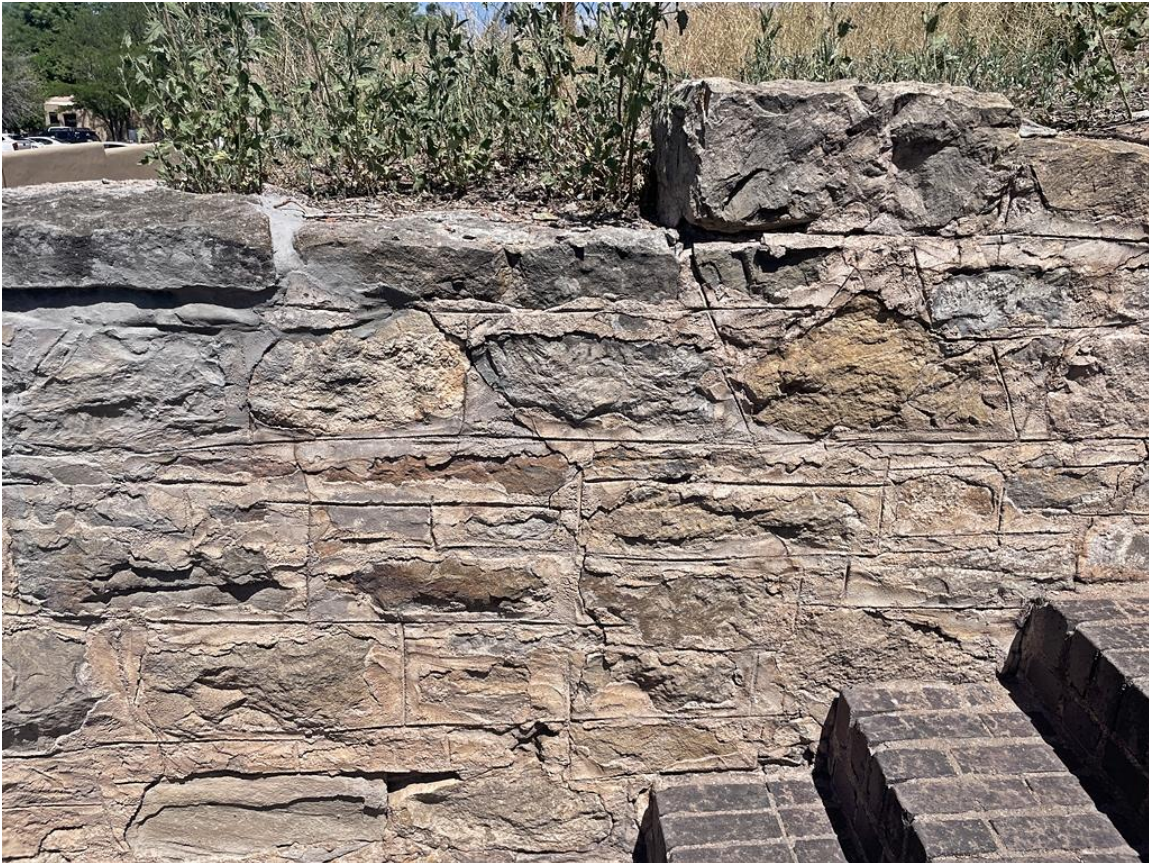
The wall is constructed primarily of locally sourced, undressed stone laid in irregular courses with occasional fragments of limestone. The uppermost courses appear to have been added at a later date. A circa 1915 photograph indicates that brick was originally used for the upper course (Fig. 5). A 70-inch-wide opening near the center forms a stairway lined with dark bricks likely fabricated by prisoners at the New Mexico State Penitentiary (Photos 3, 18 & 19).

Photo 18: Masonry stairway wall of street entry. Camera facing southwest.
