Historic Cultural Properties Inventory (HCPI) Base Form (FORM 1)

Date of Form: August 8, 2025 – Revised

1. Name of property: Antonio & Margarita Chavez House/ Karen Parfitt Hughes Second Home	2. Location: 532 Calle Corvo Downtown and Eastside Historic District Santa Fe	3. Local Reference Number: Santa Fe ID: H-638 4. County: Santa Fe Parcel # 10470528

8. Name of Project: HDRB Status Evaluation		
9. Lat/Long: 35.6806349,-105.9331281		
10. Photo Information: Giulia Caporuscio, photographer. Photo 1: View of east elevation, facing northwest.

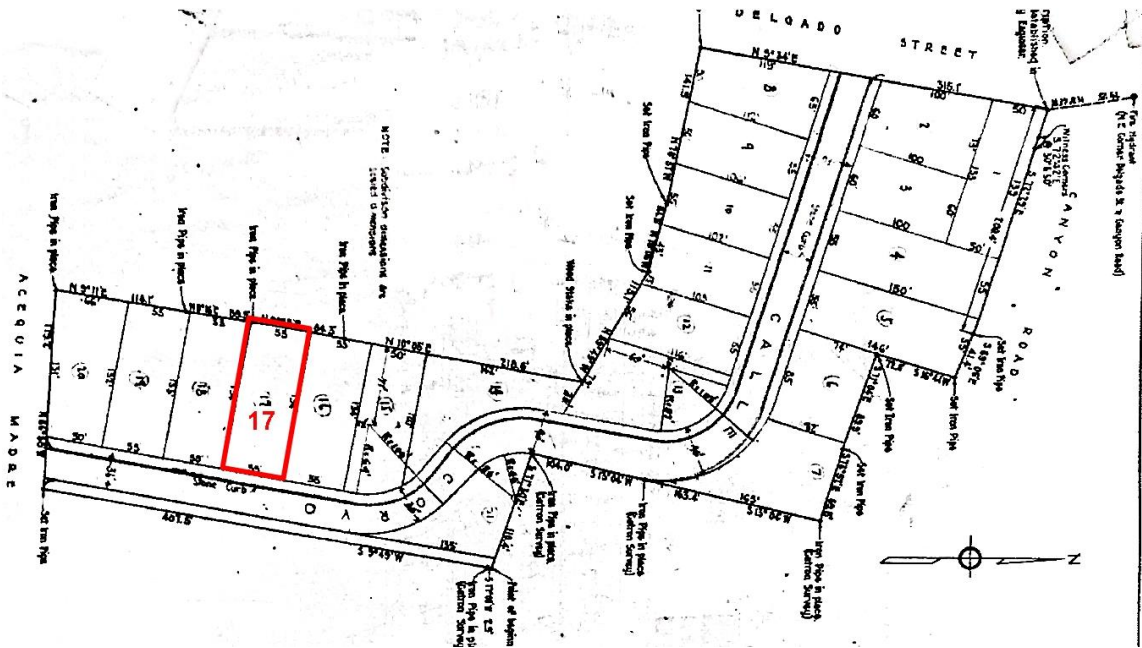
In 1937, he created the first Hughes Subdivision, consisting of 20 lots laid out along a gently curving road between Delgado Street and Acequia Madre—then known as East Manhattan Street. Following a contemporary trend of using picturesque Spanish names for new streets, Hughes named the road *Calle Corvo*, loosely translated as “curving” or “bent street.” The subdivision was replatted the following year as the Second Hughes Addition (Fig. 1).

Figure 1: Hughes Second Addition, 1938. Floyd Haak. Subject lot highlighted.

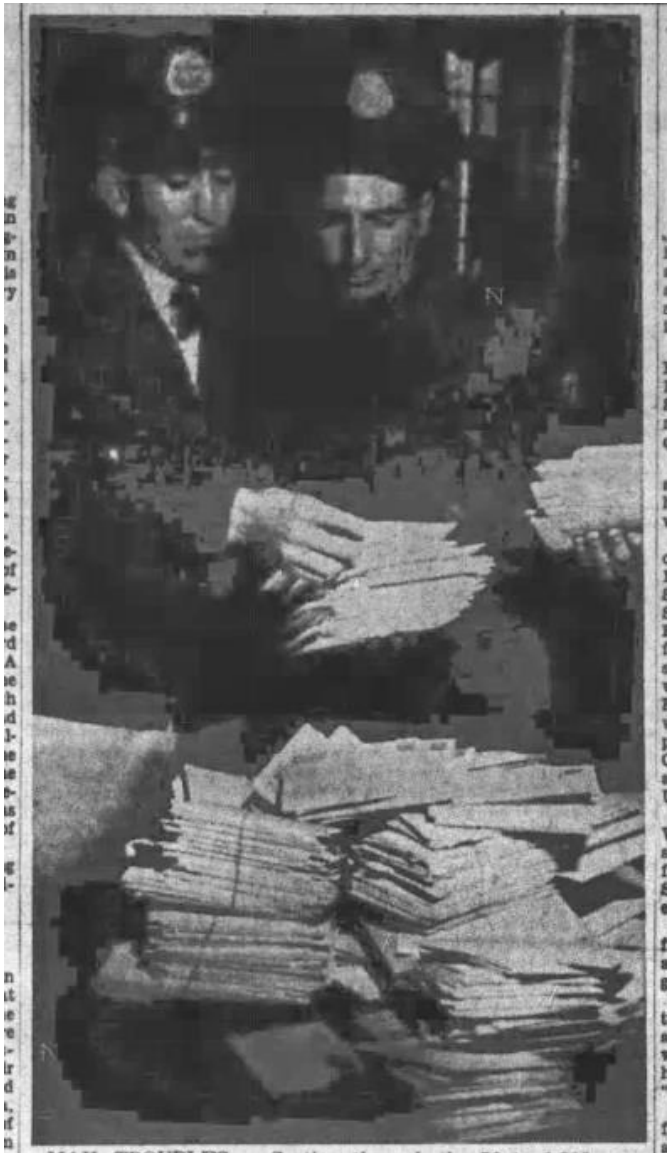
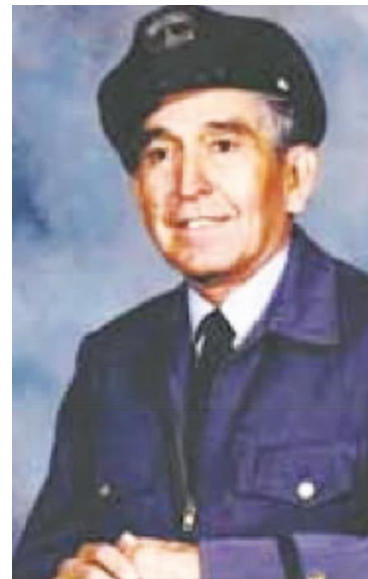
Following a brief stint as a fireman, Tony secured a position with the U.S. Postal Service as a mail carrier—a job he would hold for 38 years.¹¹ A 1953 photograph shows him sorting mail with a coworker (Fig. 3), corresponding with the first year Tony and Margie were listed in the city directory at the Calle Corvo address. They would go on to raise three daughters in the home.

Figure 3: 1953 photograph of Tony Chavez, Jr. (left) alongside retirement-era portrait (right). Both courtesy of the *Santa Fe New Mexican*.

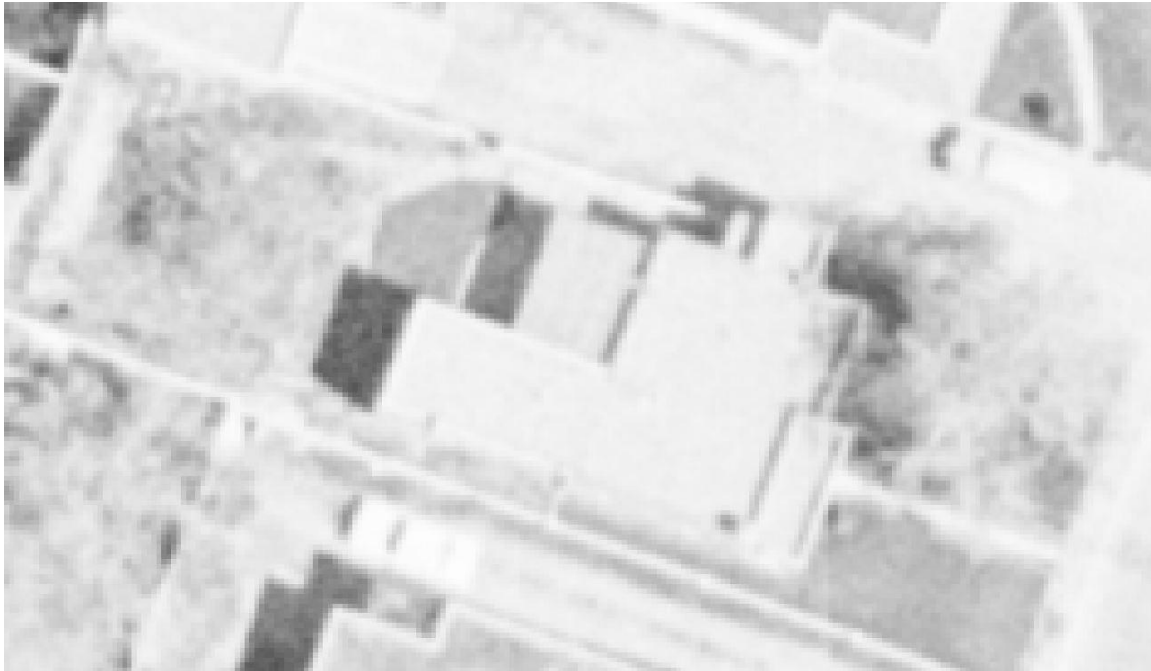
Beyond this is a primary bedroom addition, constructed—based on aerial photographs—between 1958 and 1966 (Figs. 4 & 5). This rectangular volume projects approximately 13 feet and features privacy-oriented fenestration: high-set horizontal windows and a vertical aluminum sliding unit placed in the short west-facing wall (Photo 11).

The dwelling, originally a two-bedroom house, is visible in a 1958 aerial photograph (Fig. 4). It shows a compact rectangular home with a full-width front porch, approached by a concrete walkway. As the family grew, a rear addition was constructed, likely in the early 1960s; it appears in aerial imagery by 1966 (Fig. 5).

Figure 5: June 6, 1966, aerial photograph. Note presence of primary bedroom addition, roofed patio, and canopy over laundry room entry.

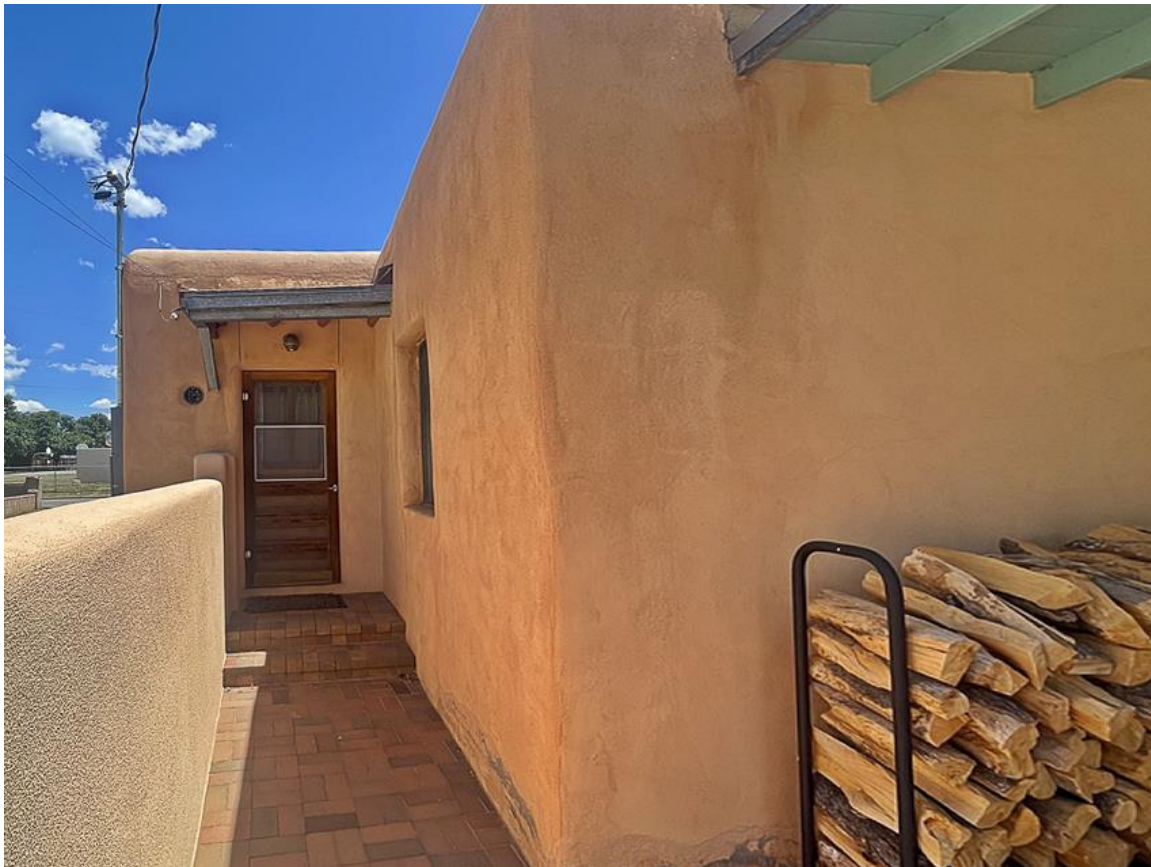
The north elevation, which faces the shared driveway, begins at the east end with the projecting volume of the laundry room (Photo 7). Around the corner, on the west-facing wall of this volume, is a secondary entry providing access to the laundry area (Photo 8). This door is a half-light wood panel unit that appears to be of an earlier vintage.

Photo 8: West elevation. Laundry room. Camera facing east.

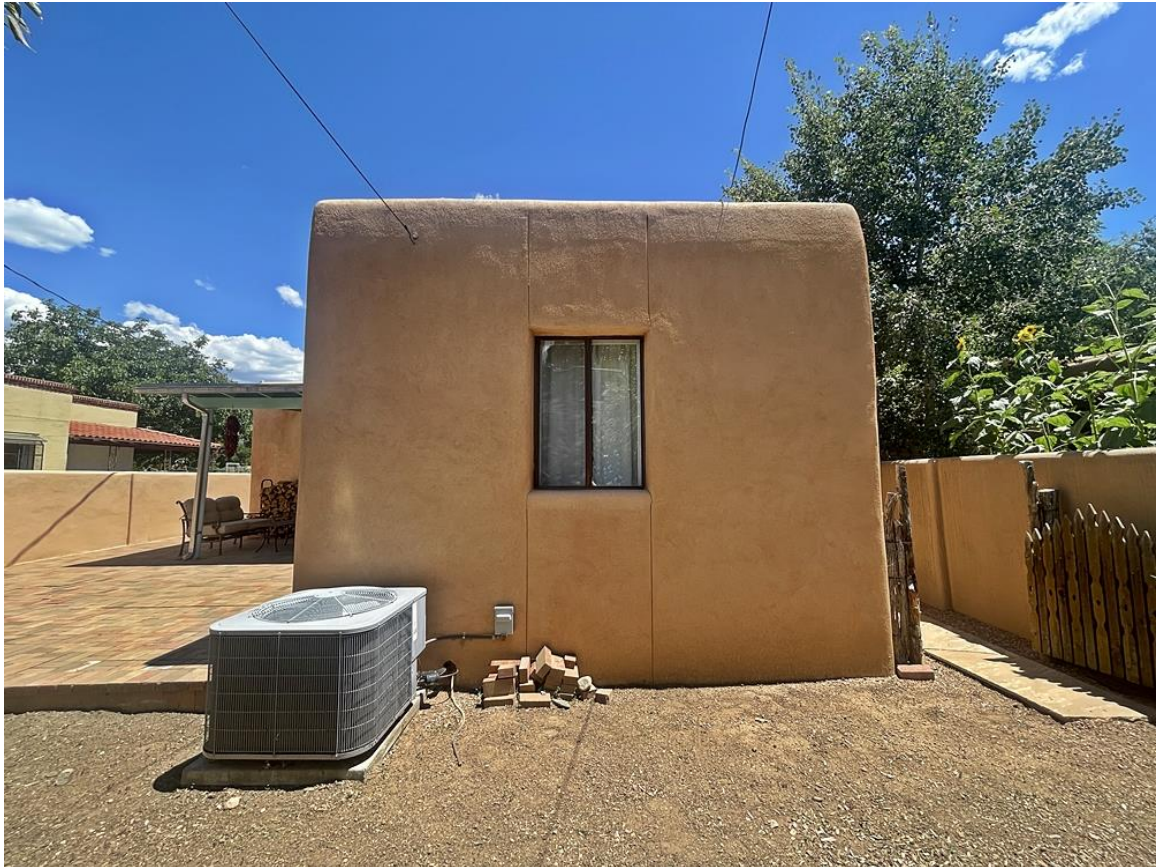
Photo 11: West elevation. Primary bedroom addition. Camera facing east.

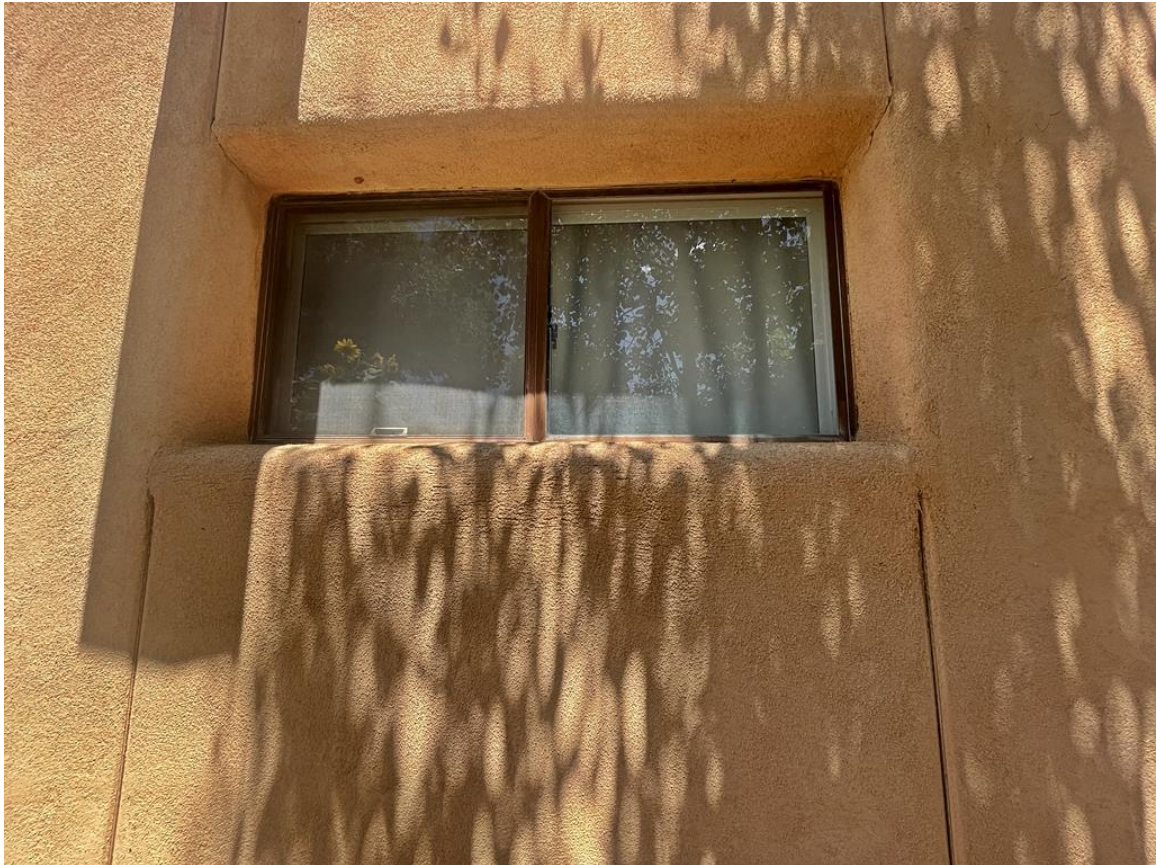
The south elevation sits close to the property line (Photo 12). It includes the south wall of the primary bedroom addition, which is marked by a single high-set privacy window (Photo 13). The remainder of the elevation belongs to the original volume and is fenestrated with two vertical openings, each fitted with sliding aluminum units (Photo 14).

Photo 13: South elevation. Privacy window at primary bedroom addition. Camera facing north.
