**HISTORIC DESIGN REVIEW BOARD
PROPOSAL FOR
329 OTERO ST.
SANTA FE, NM 87501**

Re: 329 Otero Street, Santa Fe, NM 87501 – Mike & Christine Foster - Request for HDRB Approval to replace Casita Windows/Doors + Stucco Patching

Martinez Design Group
Foster Residence 329 Otero St. Santa Fe, New Mexico 87501 Project Number Date 02/13/2025

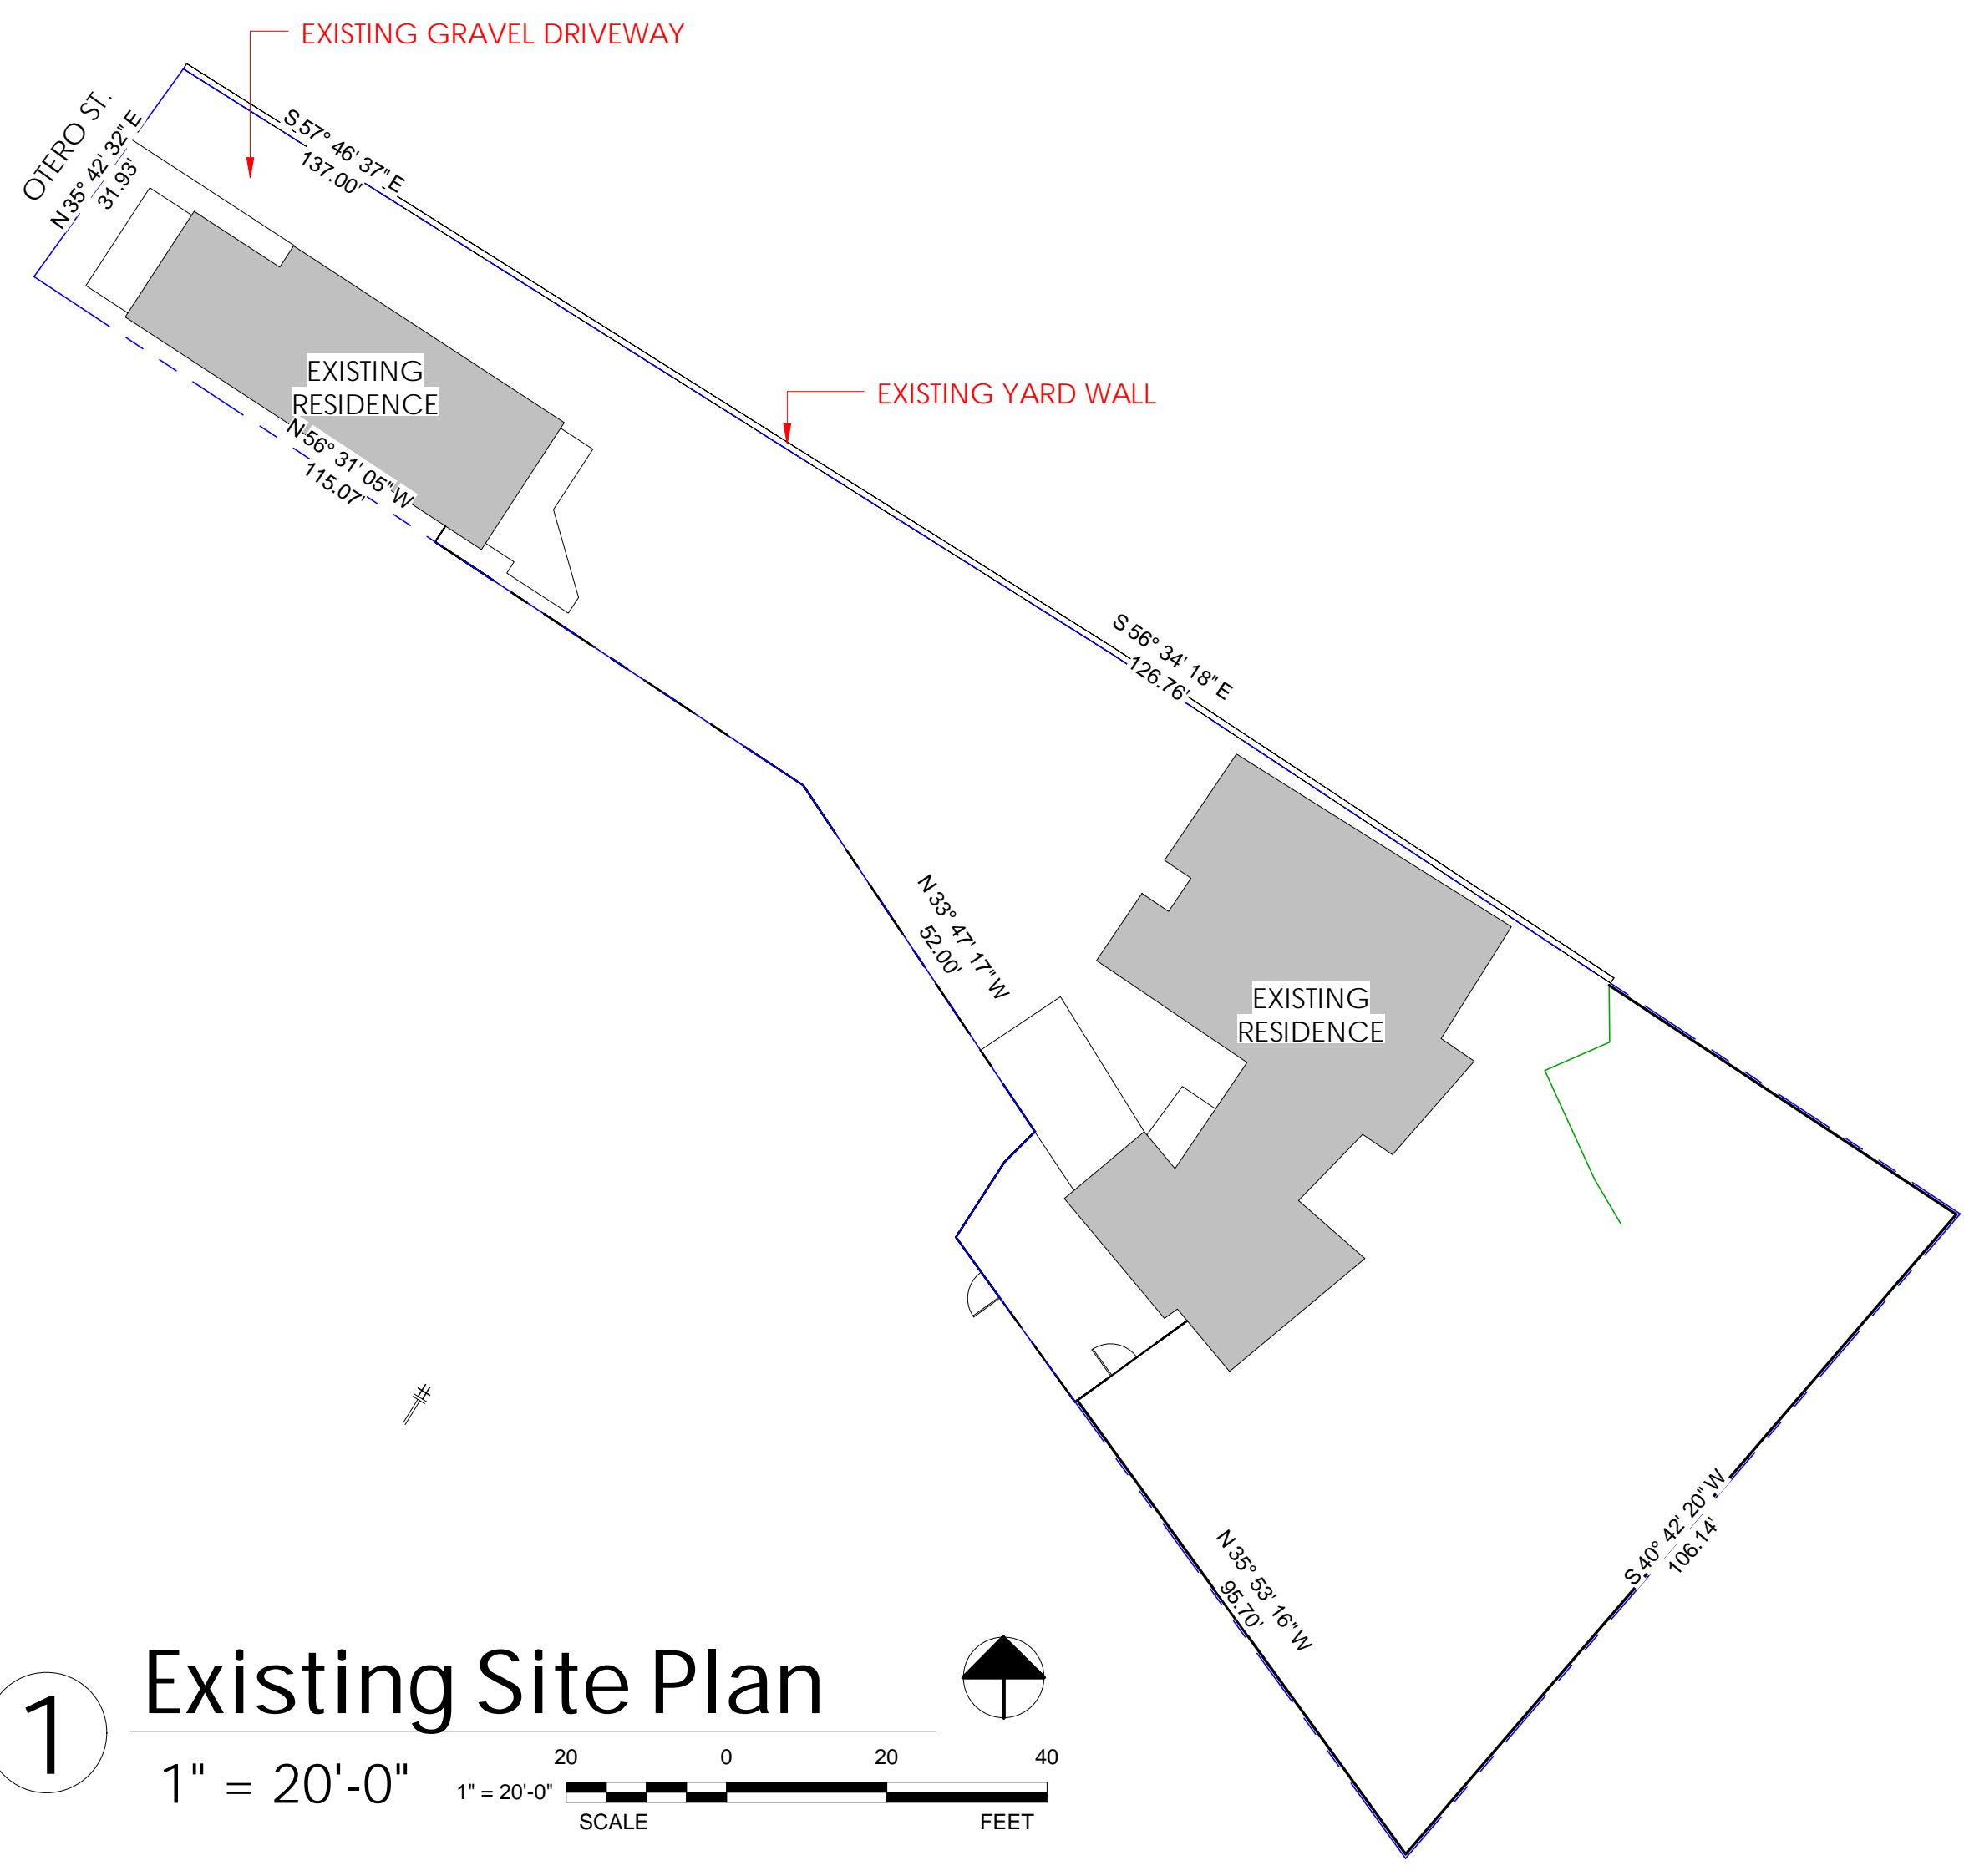
A0.1	SITE PLAN
Scale	1" = 20'-0"

GENERAL NOTE:
 -NO PROPOSED CHANGES
 -GATE APPROVED ADMINISTRATIVELY, SEPARATE BUILDING PERMIT.

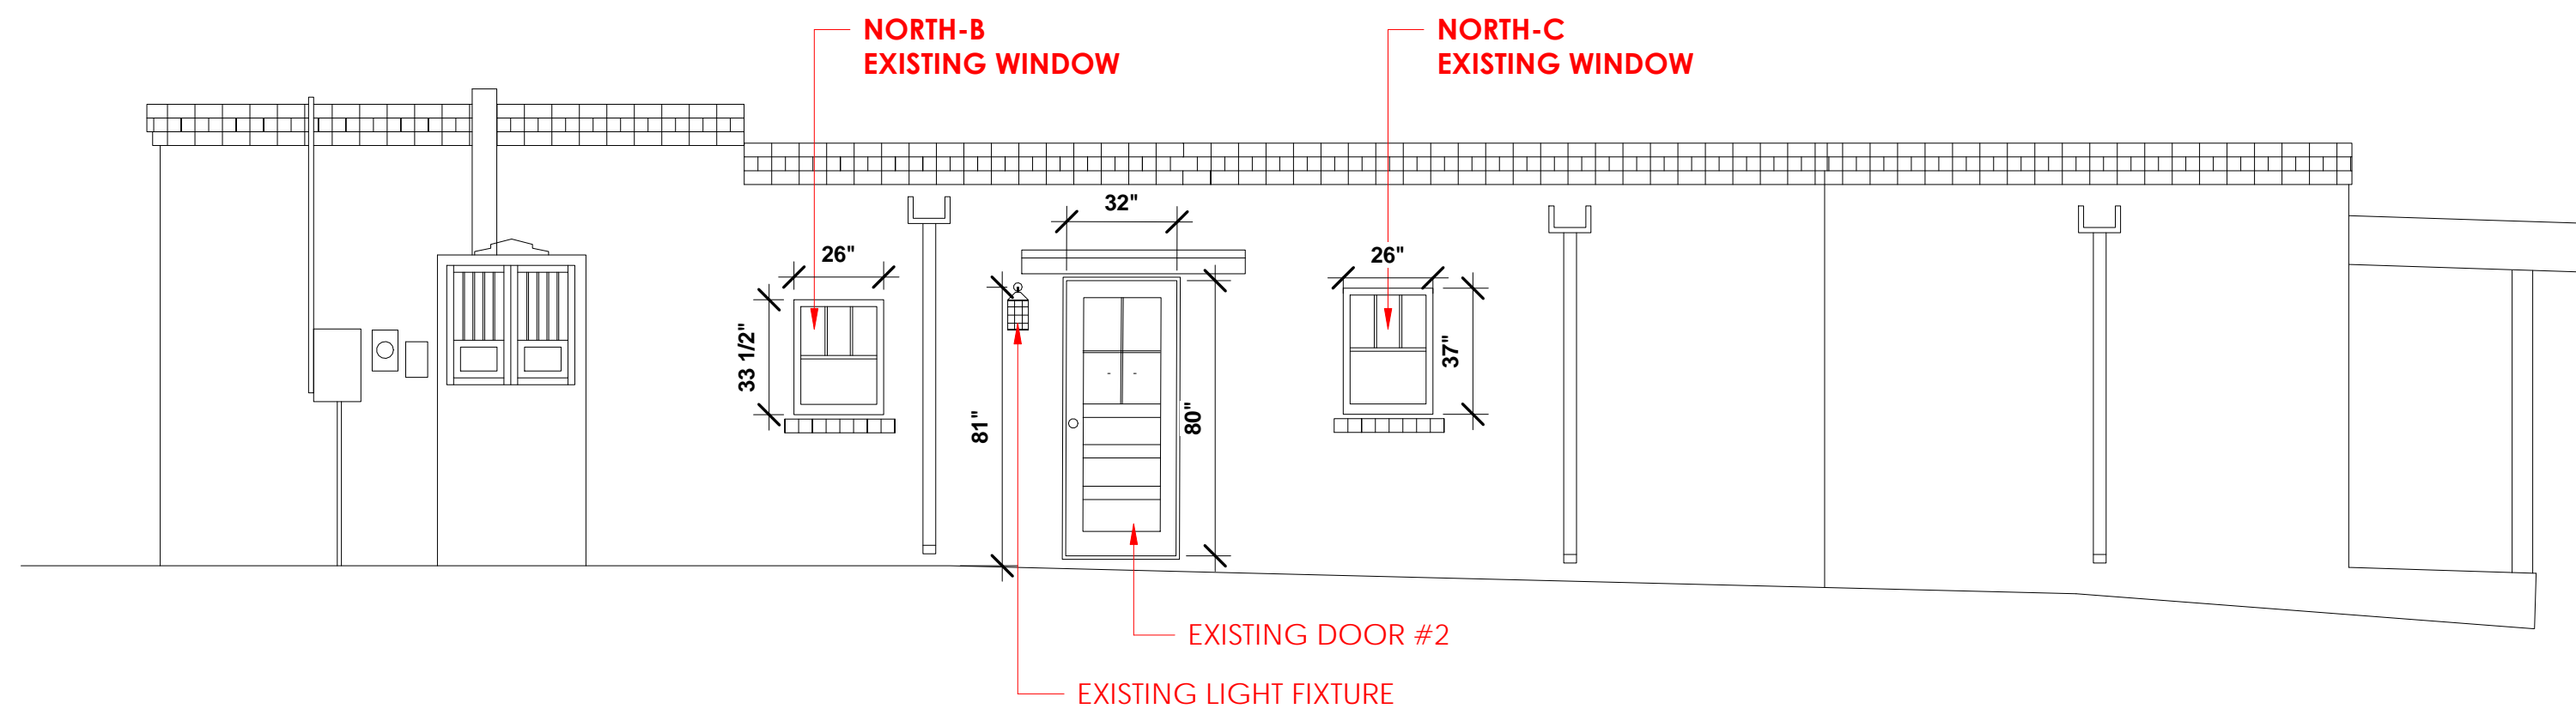
1 Existing North Elevation
 1/4" = 1'-0"
 SCALE FEET

NOTE:
 WINDOW/DOOR LABELS MATCH RPA & ASSOCIATES HISTORIC WINDOW + DOOR ASSESSMENT.

A Window/Door Historic Assessment from Ra Patterson, RPA & Associates identifies all three doors and three of nine windows as non-historic with the remaining six windows as having a historic date of manufacture. His rating system for the state of preservation is premium, satisfactory, fair, and unsatisfactory. In his opinion, all three non-historic doors are in satisfactory condition; the two historic windows on the west, street-facing elevation are in satisfactory condition; while the one historic window on the north elevation and the three historic windows on the south elevation are in fair condition.

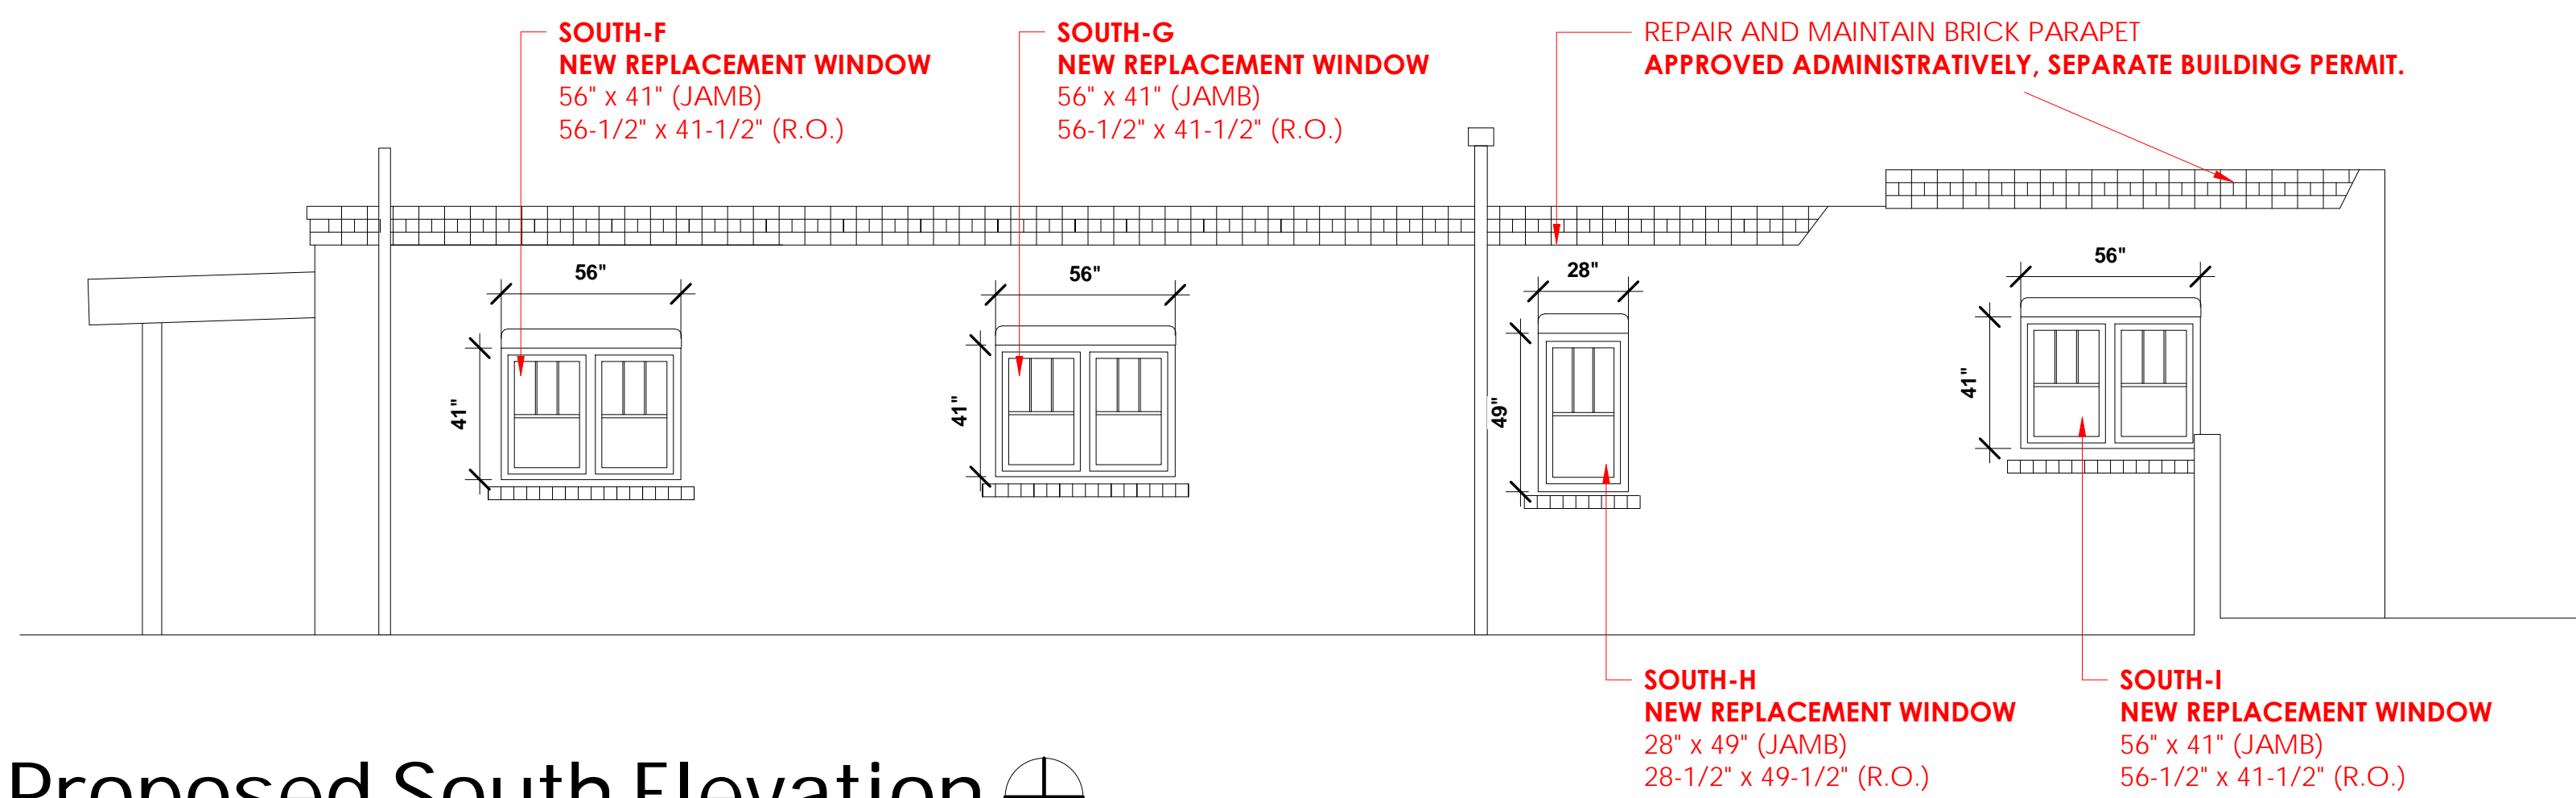
2 Proposed South Elevation

- WINDOWS + DOORS TO BE REPLACED TO MATCH EXISTING ARCHITECTURAL STYLE. SEE ATTACHED WINDOW REPLACEMENT AGREEMENT QUOTE.
- WINDOW + DOOR COLOR TO MATCH PROVIDED COLOR SAMPLES
- STUCCO PATCHING AROUND WINDOWS + DOORS AND OTHER AREAS REQUIRING REPAIR TO MATCH EXISTING COLOR AND TEXTURE
- REPLACE EXTERIOR LIGHT FIXTURES AT EACH ENTRY DOORWAY. SEE ATTACHED CUT-SHEETS. LIGHT FIXTURES ARE TO BE REPLACED AT EXISTING LOCATIONS AND HEIGHTS

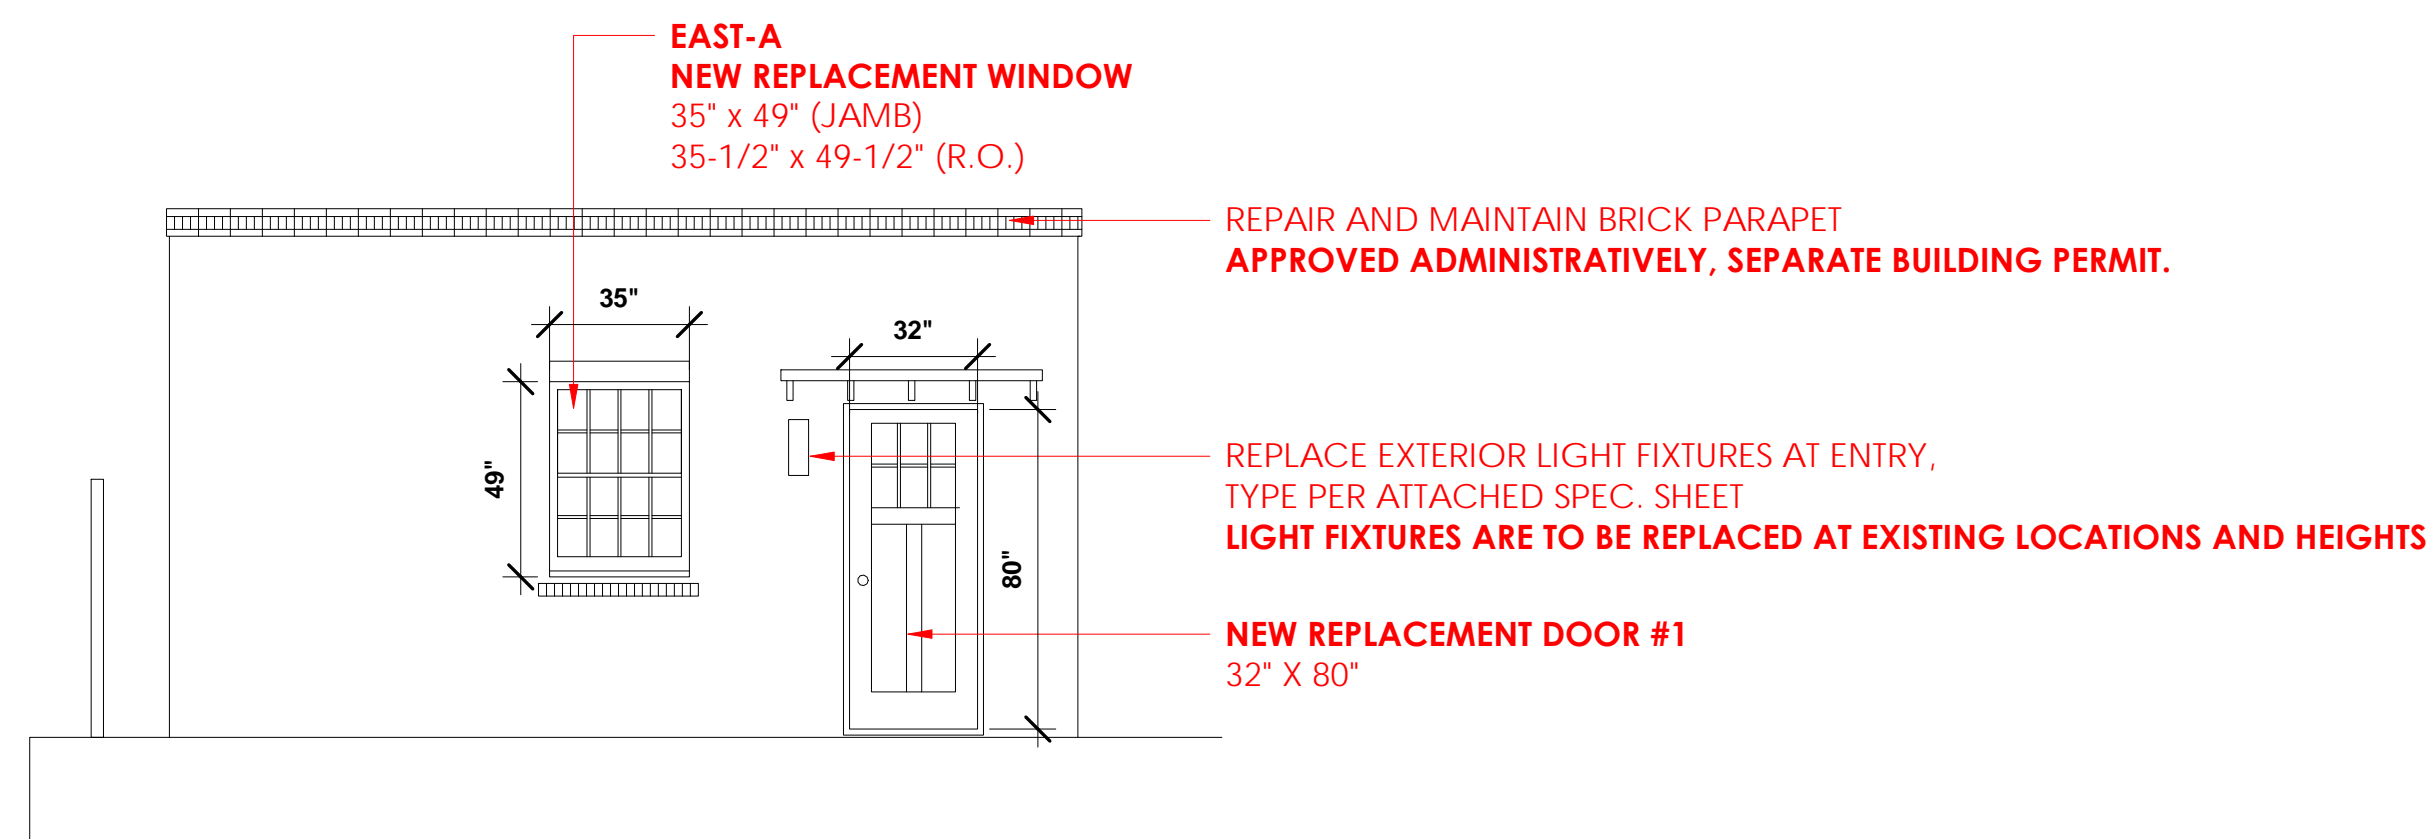
2 Proposed East Elevation

- WINDOWS + DOORS TO BE REPLACED TO MATCH EXISTING ARCHITECTURAL STYLE. SEE ATTACHED WINDOW REPLACEMENT AGREEMENT QUOTE.
- WINDOW + DOOR COLOR TO MATCH PROVIDED COLOR SAMPLES
- STUCCO PATCHING AROUND WINDOWS + DOORS AND OTHER AREAS REQUIRING REPAIR TO MATCH EXISTING COLOR AND TEXTURE
- REPLACE EXTERIOR LIGHT FIXTURES AT EACH ENTRY DOORWAY. SEE ATTACHED CUT-SHEETS. LIGHT FIXTURES ARE TO BE REPLACED AT EXISTING LOCATIONS AND HEIGHTS

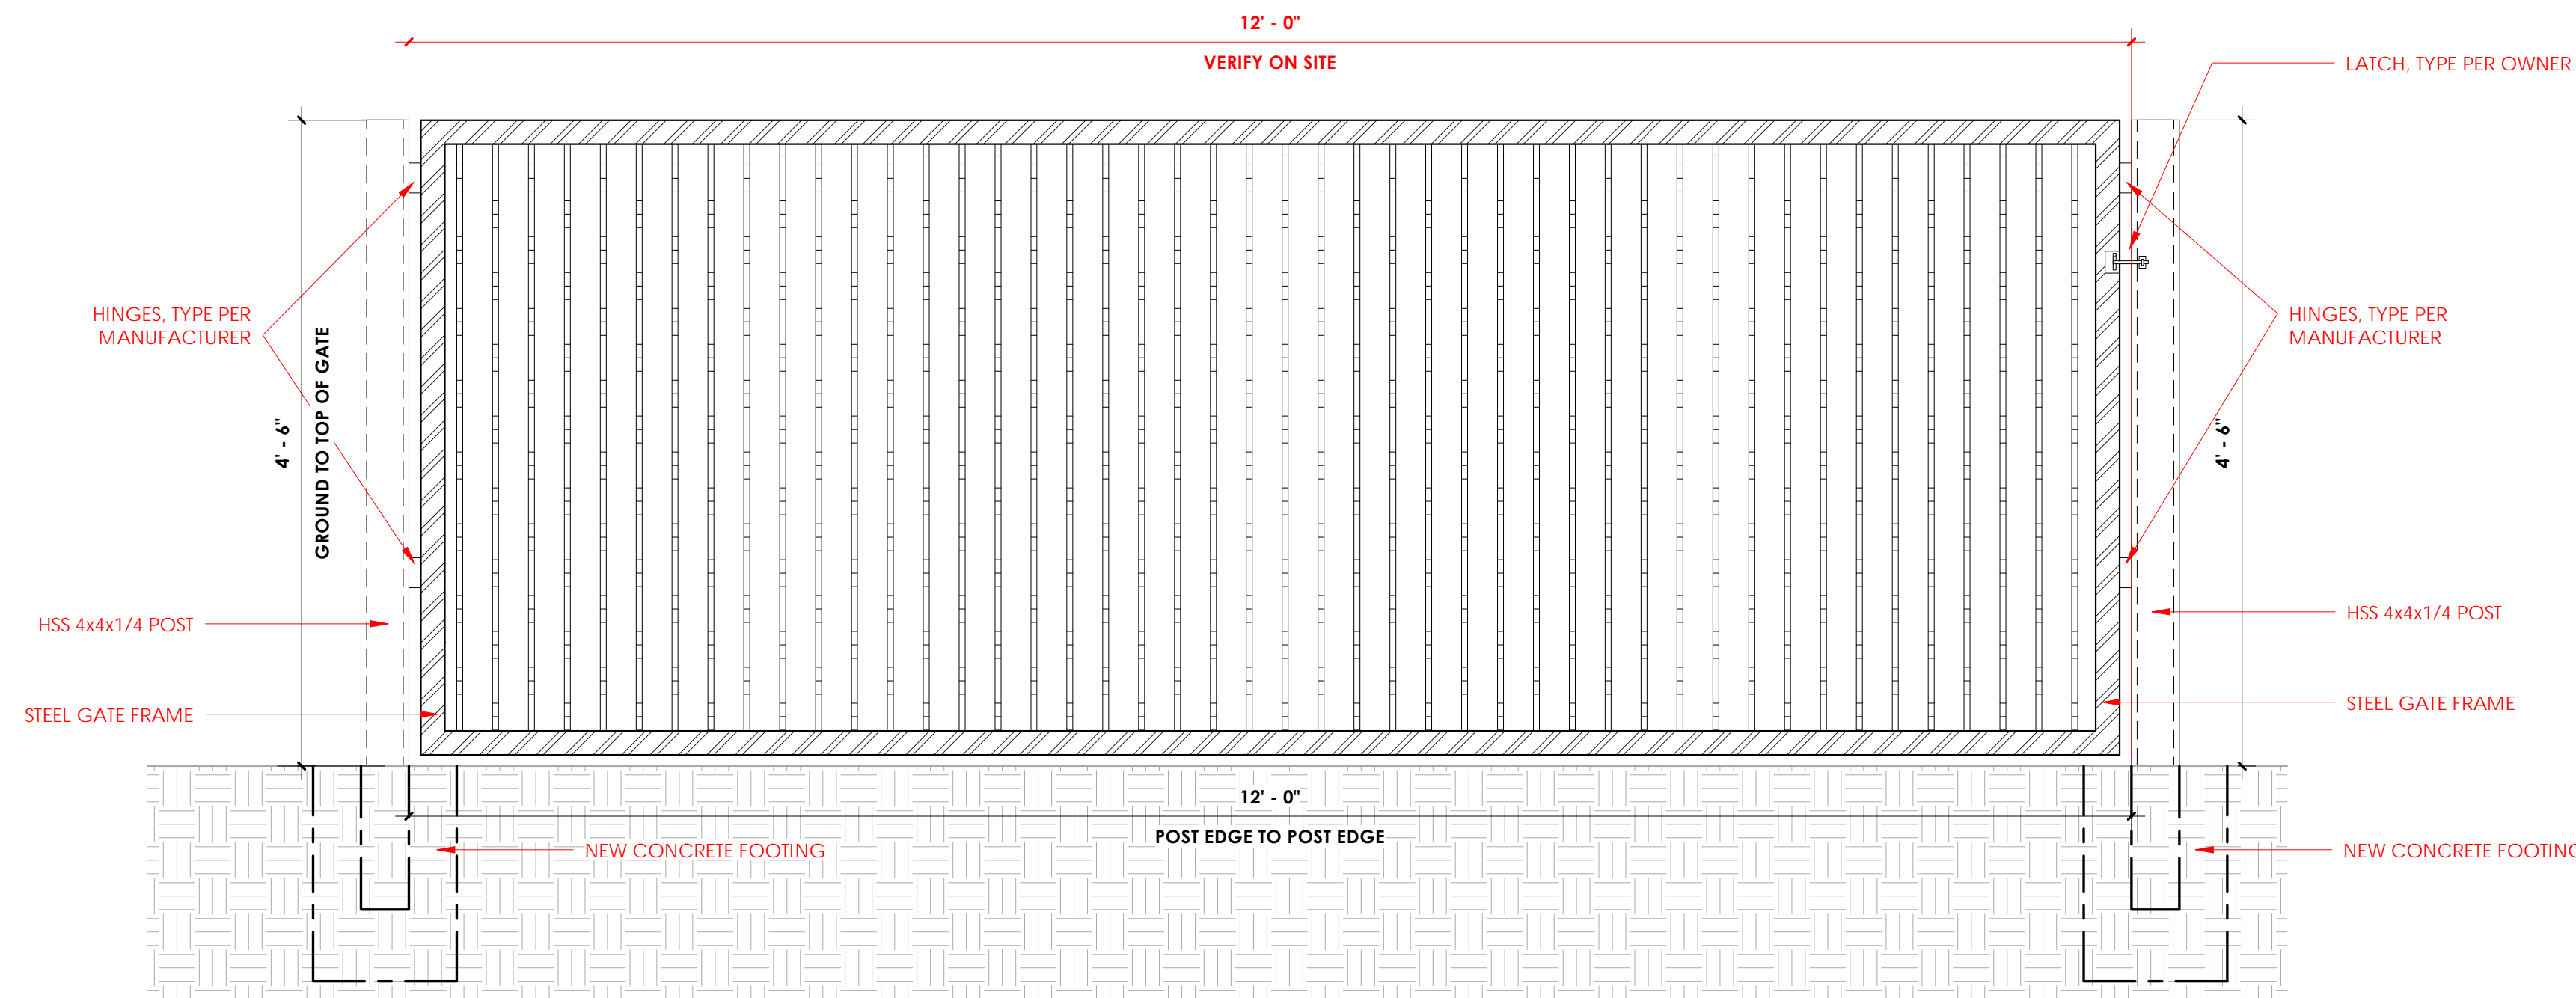
1 Gate Elevation

The installation of security gates across a fire apparatus access road shall be approved by the fire chief. Where security gates are installed, they shall have an approved means of emergency operation. The security gates and the emergency operation shall be maintained operational at all times. Electric gate operators, where provided, shall be listed in accordance with UL 325. Gates intended for automatic operation shall be designed, constructed and installed to comply with the requirements of ASTM F 2200

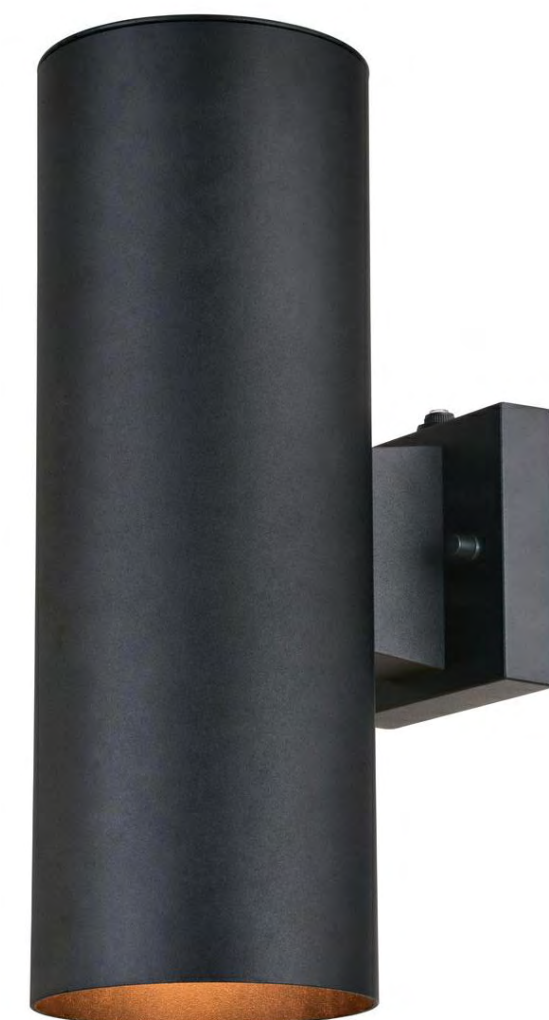
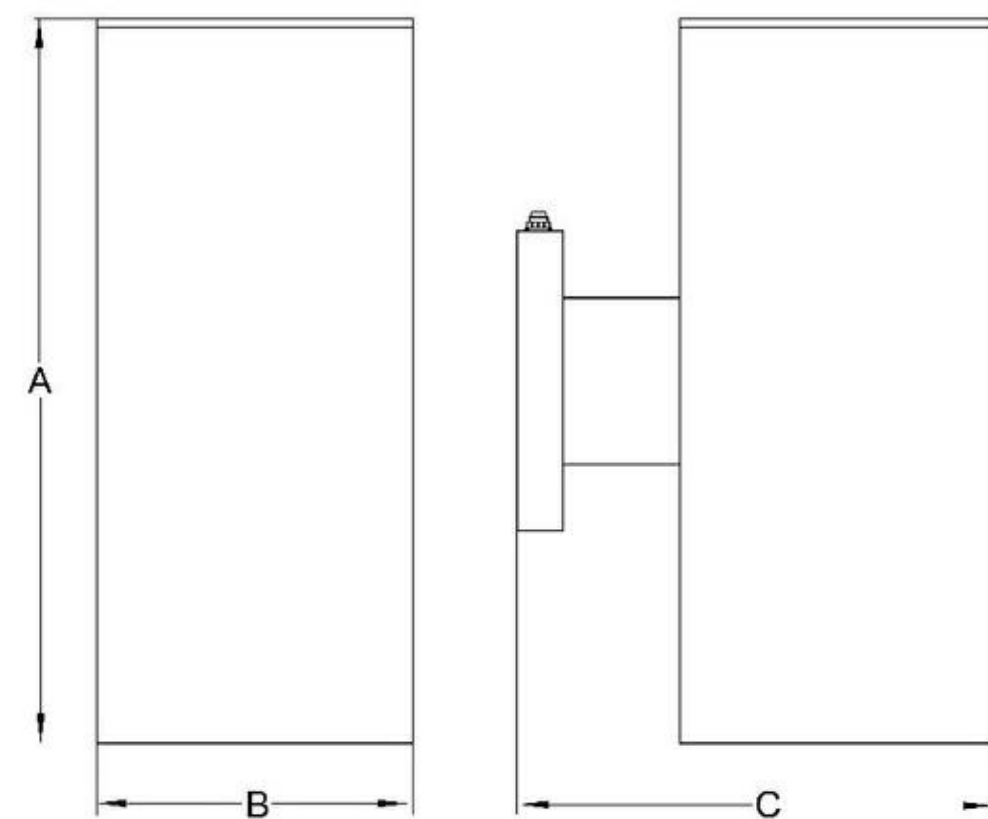
A: 14-1/4"
B: 5"
C: 7-1/2"

MANUFACTURER: VAXCEL
MODEL: # T0653 Chiasso 2 Light 14.25-in.H Dusk to Dawn Outdoor Wall Light
COLOR: Textured Black

GENERAL NOTE:
 LIGHT FIXTURES ARE TO BE REPLACED AT EXISTING LOCATIONS AND HEIGHTS.
 HEIGHT ELEVATION VARIES FROM 75'-81", PER ELEVATIONS.

Finish: Textured Black	Finish Color: Black
Dimmable: Yes	Style: Contemporary
Rating: Wet	Width Range: 0.00-6
Backplate Width: 4.25	Shade Material: Aluminum
ETL: 7	Backplate Height: 4.25
Outdoor Listed: Yes	Qty of Bulbs: 2
Motion Sensor: No	Photo Cell: Yes

Item Height: 14.25	Item Width: 5
Item Weight: 2.75	Item Depth: 7.5
Shade Name: Textured Black Metal Shade	Keywords: illumination ultra bright dark bronze matte installation home décor led brass rustic custom light fixture adjustable energy efficient outdoor deck patio water resistant walkway path way circular lamp
Shade Height: 14.25	Shade Width: 5
Wire Length: 6	Backplate Depth: 2.5
Edison Bulb Requir: NO	Power Source: Hardwired
Bulb Included: No	LED Compatible: Yes
Bulb Base: E26 Medium	Type of Bulb: LED Compatible
Max Wattage per Bulb: 60	Bulb Shape: A19
Safety Rating CA: C ETL	Safety Rating USA: ETL
Title 20: NA	Dark Sky: NO
Warranty: 5 Year Limited Warranty	Energy Star: NO
Mounting: Wall Mount	Open Bottom: Yes
	Light Direction: Up and Down (at same time)

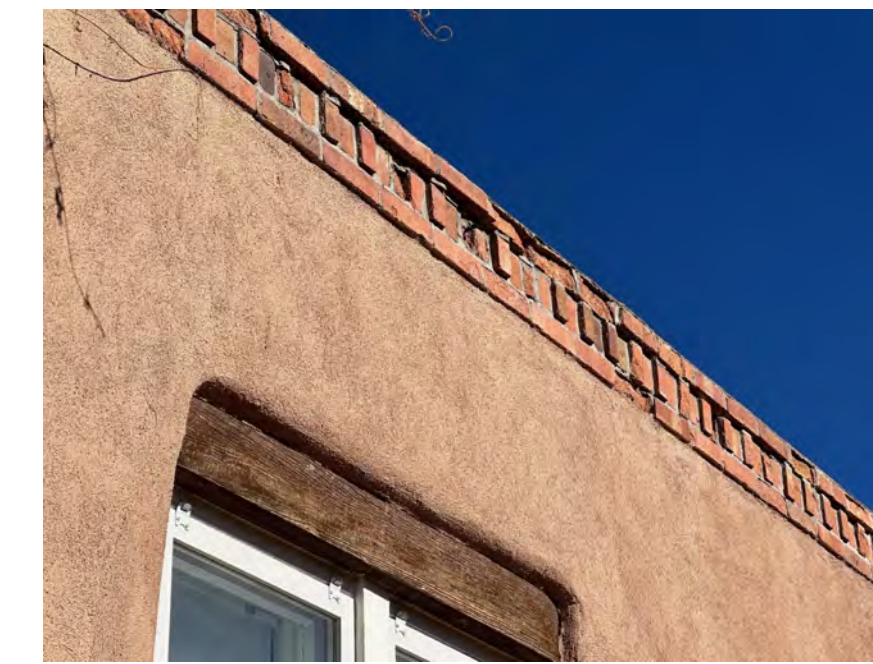
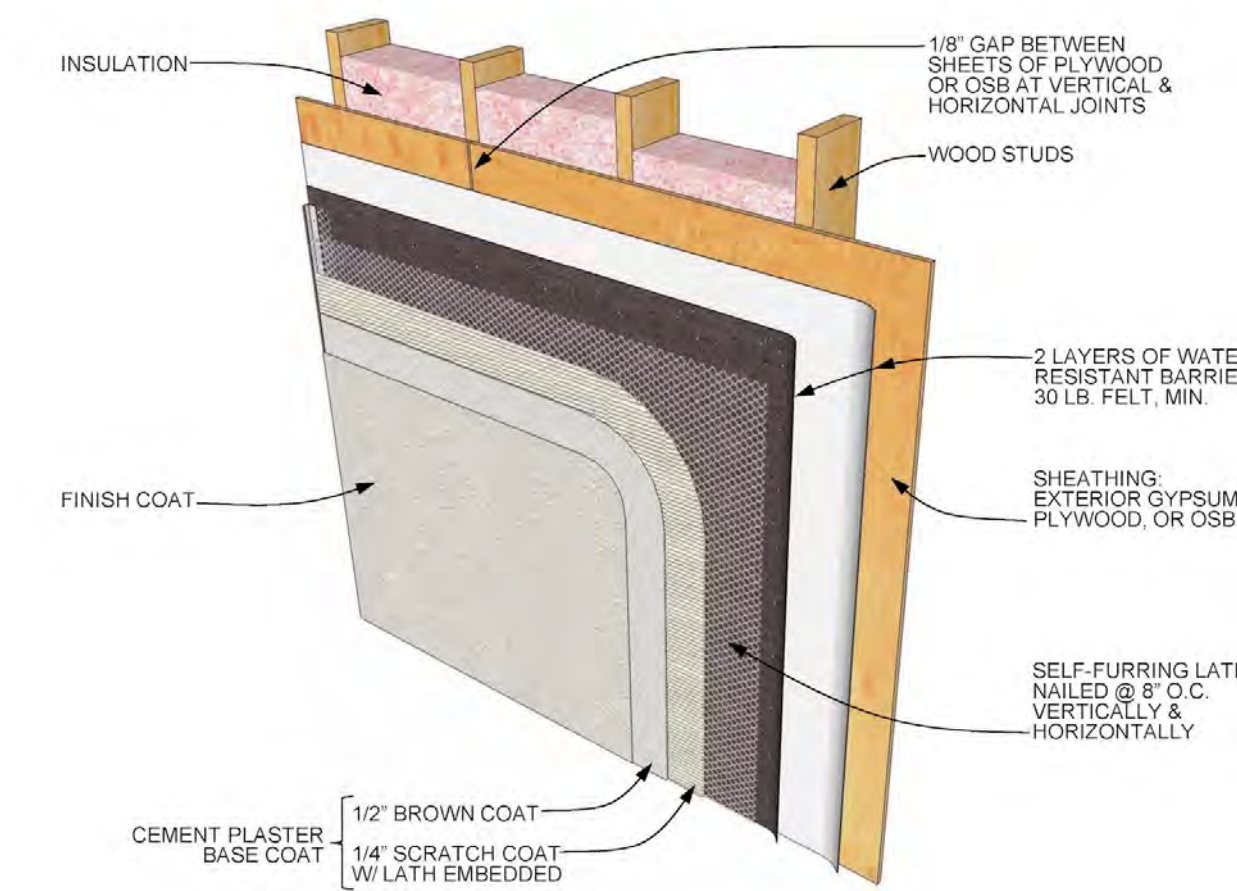
3 Stucco NOT TO SCALE

NOTES:
 -STUCCO COLOR: LA HABRA MOCHA (COLOR 338)
 -SPECIAL COLOR MATCHING MAY BE REQUIRED TO MATCH EXISTING.
 -STUCCO TO BE TRADITIONAL 3 COAT STUCCO
 *REPAIR AND MAINTAIN BRICK PARAPET APPROVED ADMINISTRATIVELY, SEPARATE BUILDING PERMIT.
