Historic Cultural Properties Inventory (HCPI) Base Form (FORM 1)

For HPD Office use only: HCPI No. _____ District No. _____ NRHP _____ SRCP _____ Criteria <u> </u> A <u> </u> B <u> </u> C <u> </u> D		
1. Name of property: Rosina Chavez House	2. Location: 423 A West San Francisco Street Downtown and Eastside Historic District Santa Fe	3. Local Reference Number: Santa Fe ID: N/A 4. County: Santa Fe Parcel # 10468150

19. Site Plan: Portion of 1995 survey plat. Courtesy of Rick Chatroop.

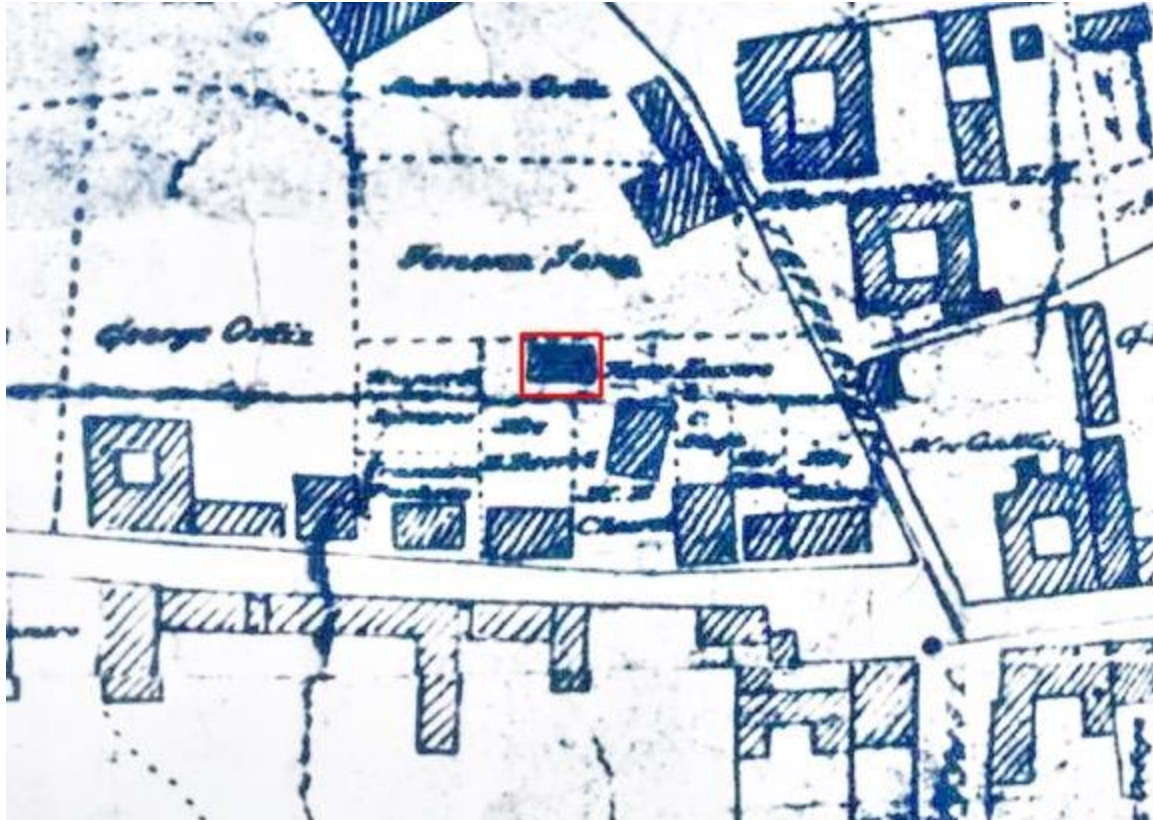
Figure 2: Hugo Hartmann, "Map of the City of Santa Fe, N.M.," 1884. Highlighted building may be the subject structure.

In 1884, a German-born engineer, Hugo Hartmann, sketched a rectangular building at the back of a long lot fronting Jefferson Street (Fig. 2). The name of the owner of the lot holding the house is hard to decipher but could be Jesus Lucero. The owner's name is immaterial, as the lot and its owner would change following the arrival of the Denver & Rio Grande Railroad three years later.

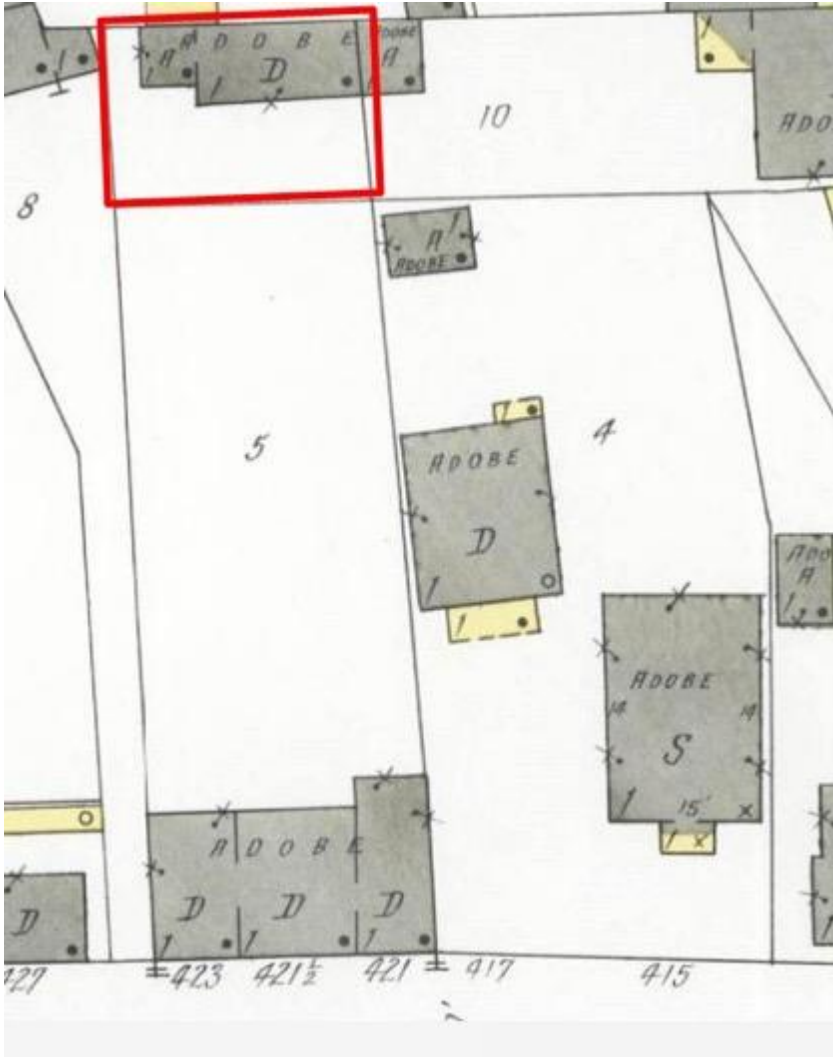
Figure 4: 1930 Sanborn Fire Insurance map. Subject property highlighted. The property was owned by Refugio Chavez during this period.

A Sanborn Fire Insurance map published in the same year as the census displayed the house but did not provide an address (Figs. 3 & 4). Based on the street addresses indicated on the map, the house would be presumably identified as "425," as this number is absent.

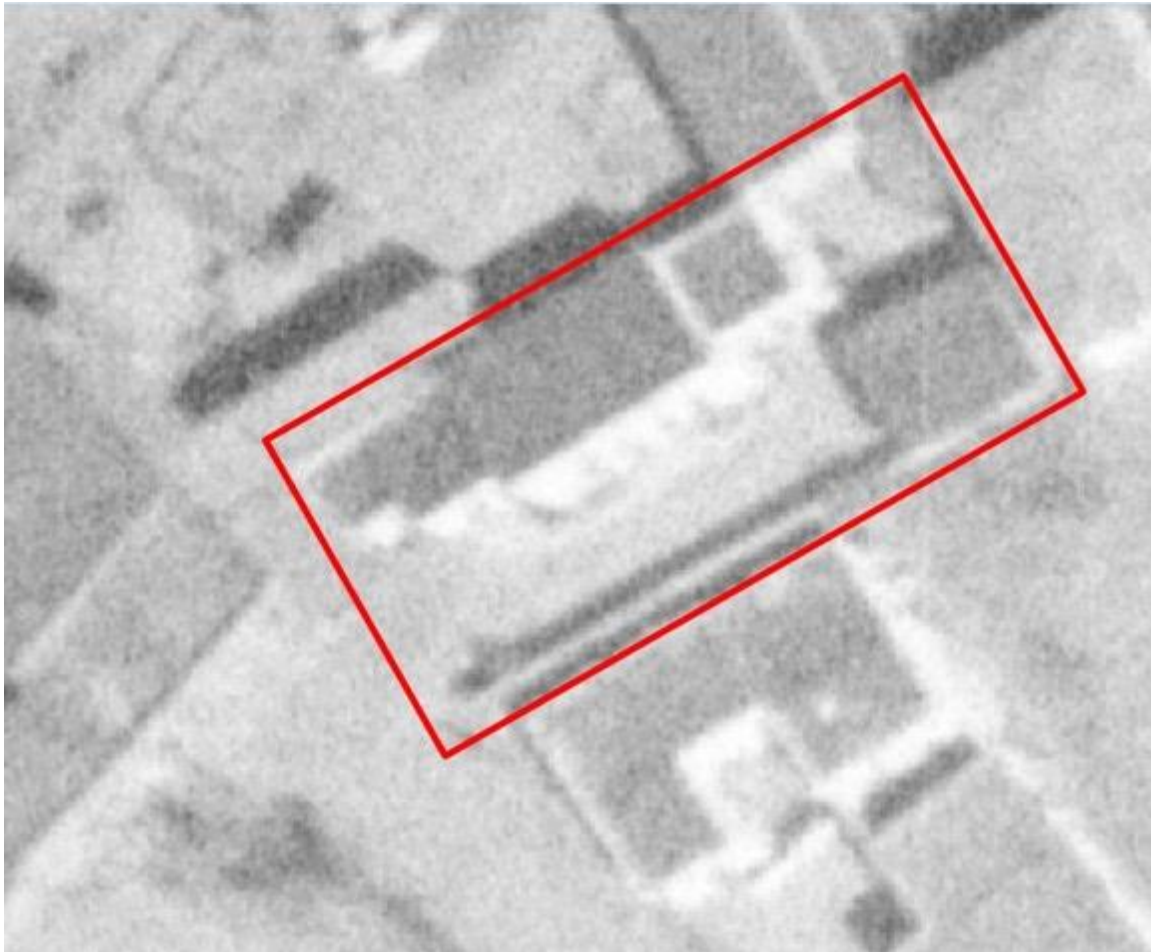
Figure 8: November 10, 1958, aerial photograph.
The current building footprint appears to be in place by this time.

An aerial from 1958 captures the house during this period (Fig. 8). By this time, the property boundary had extended eastward into the lot where the abutting garage once stood. This structure had been demolished and replaced by a small addition set back from the core block (Room 4). The west end of the house had received a small volume — the space now containing the bathroom (Room 1). In the southeast corner sat a separate building, now the garage.

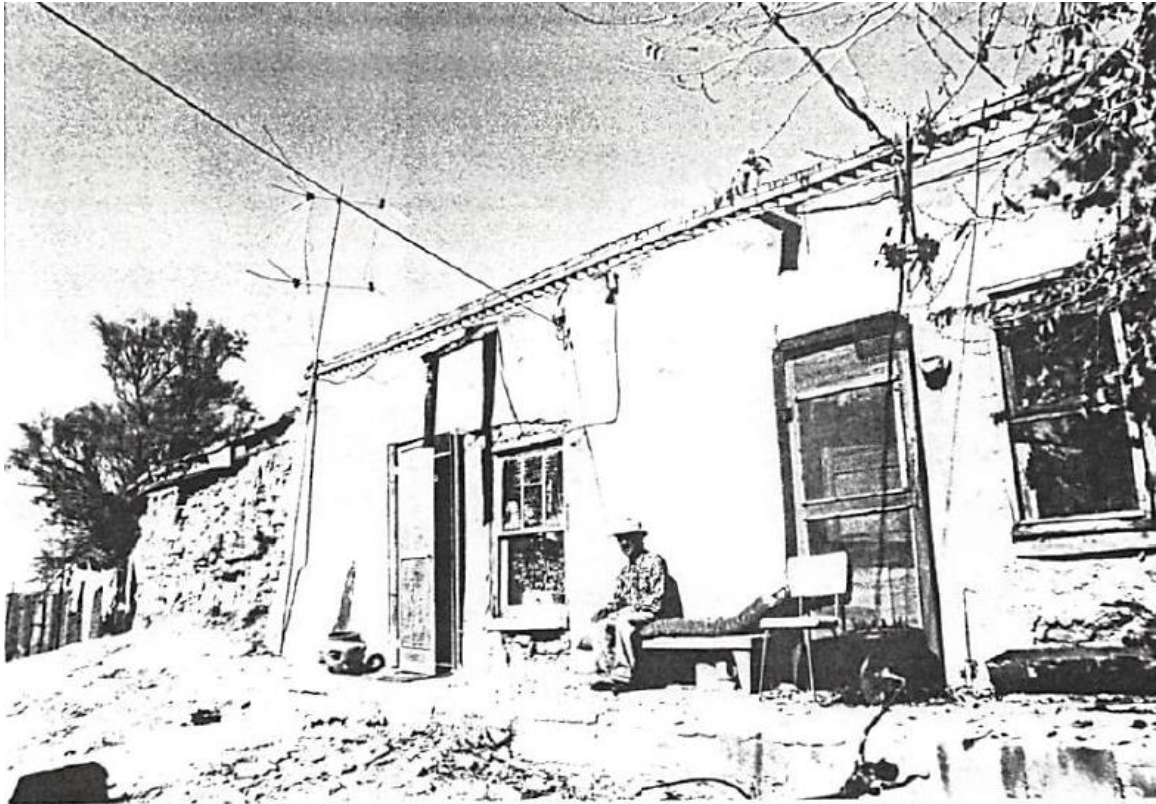
Figure 10: Copy of photograph of what has been described as the original Trinidad Chavez House. Courtesy of NMCRIS.

form and door and window pattern typical of that period (Fig. 10), it seems fitting to designate the south elevation of this section (Room 4) as the primary façade.

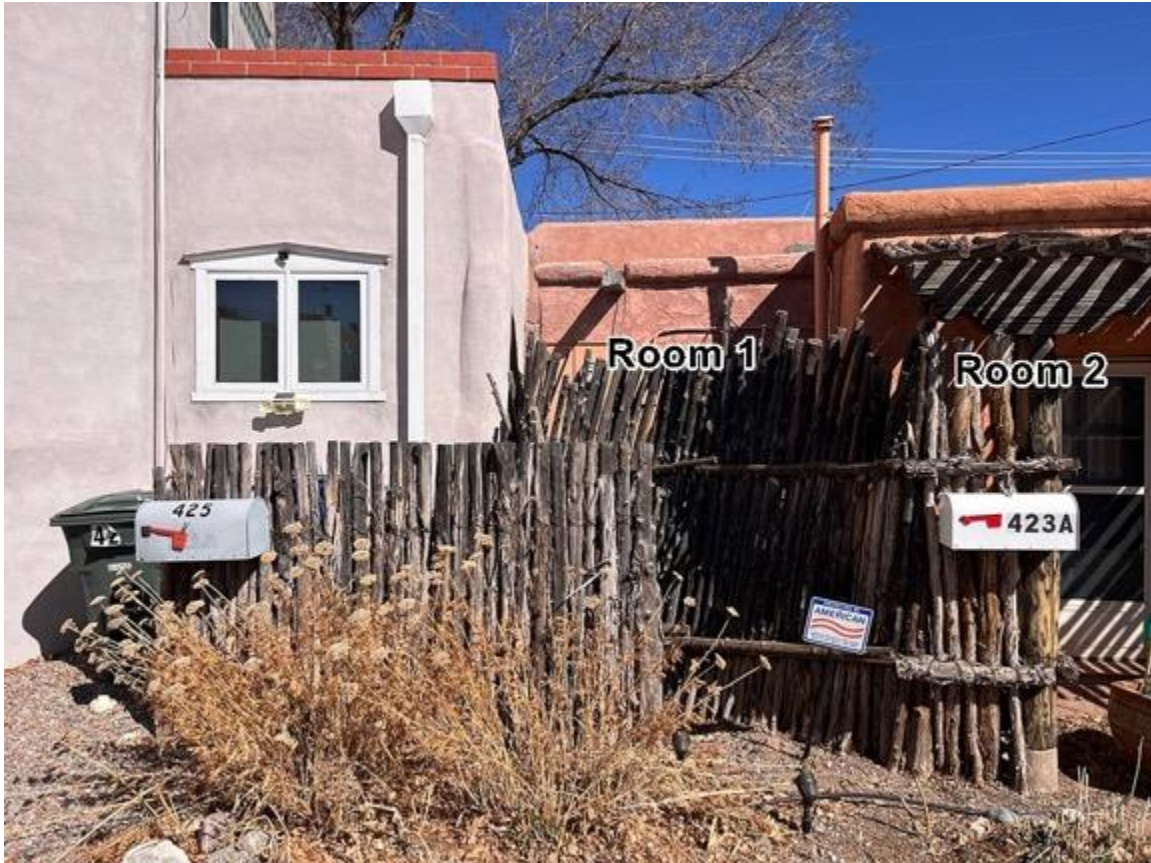
Photo 6: West end of subject building, holding Rooms 1 and 2. White building to the left, replaced the Trinidad Chavez House. Camera facing north.

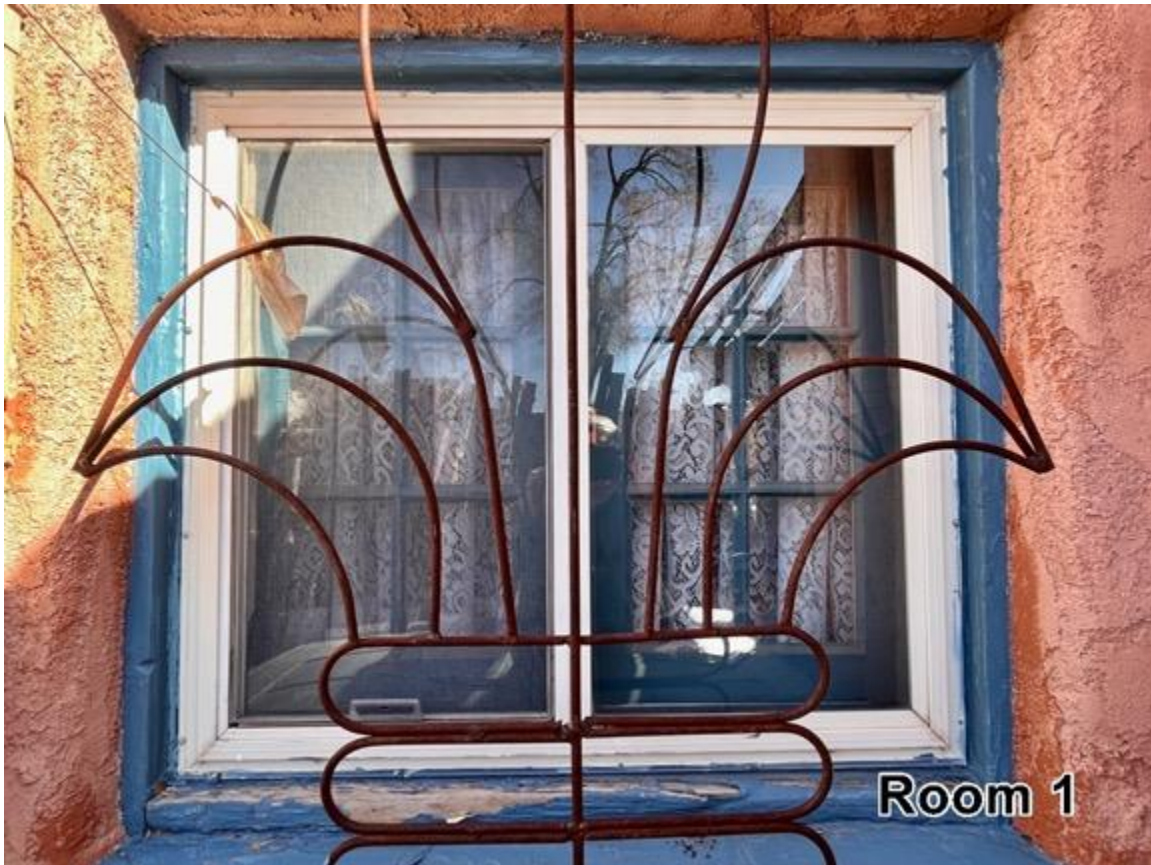
Photo 8: Room 1. Window. Camera facing north.

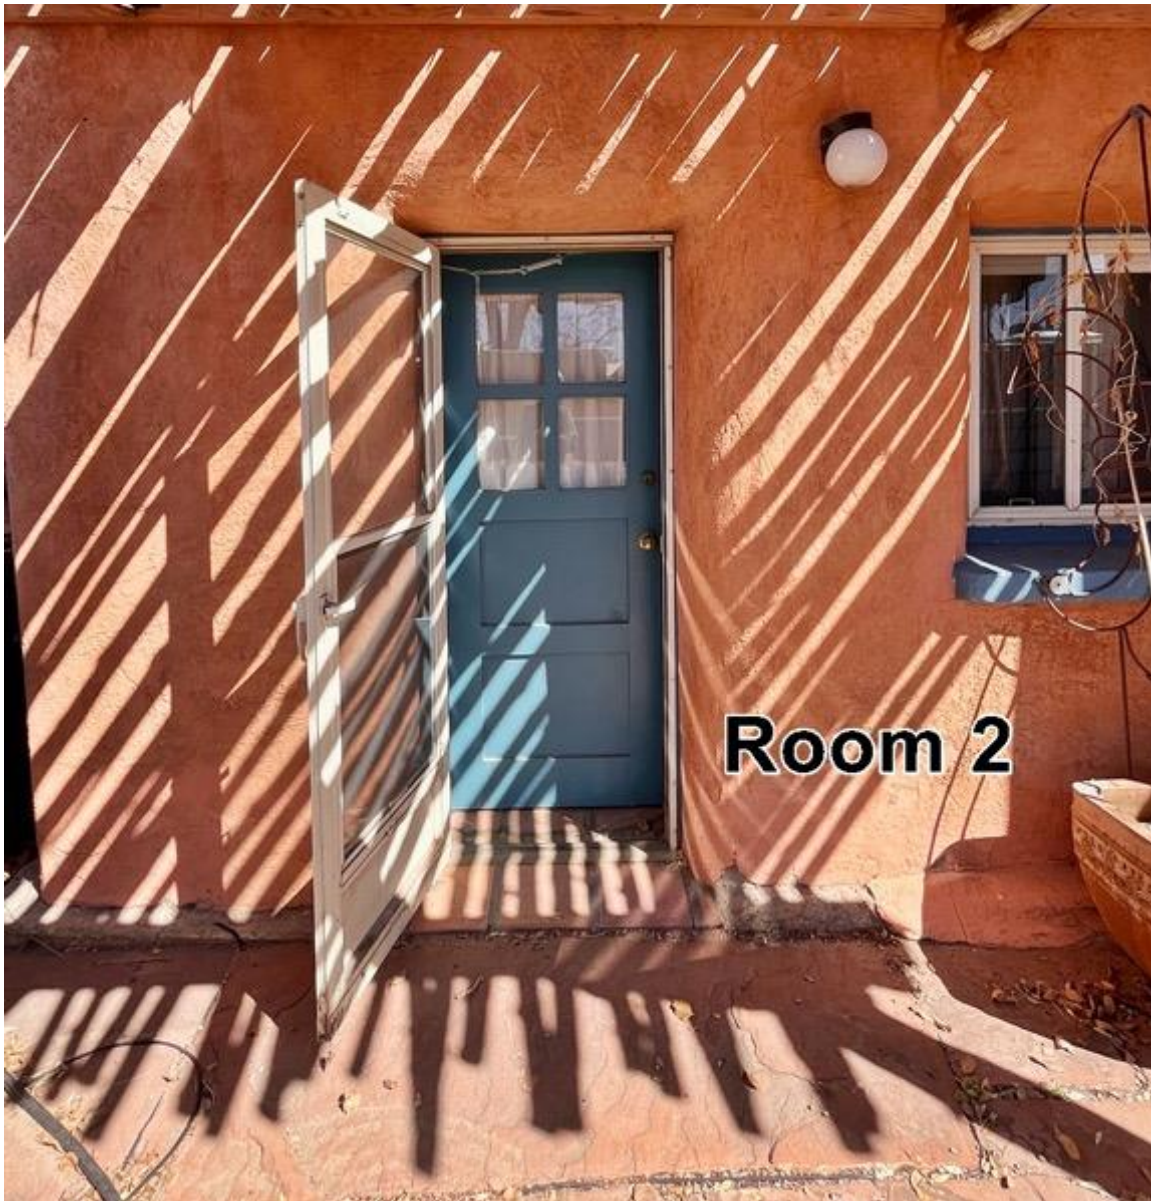
Photo 11: Room 2. Door and window. Camera facing north.

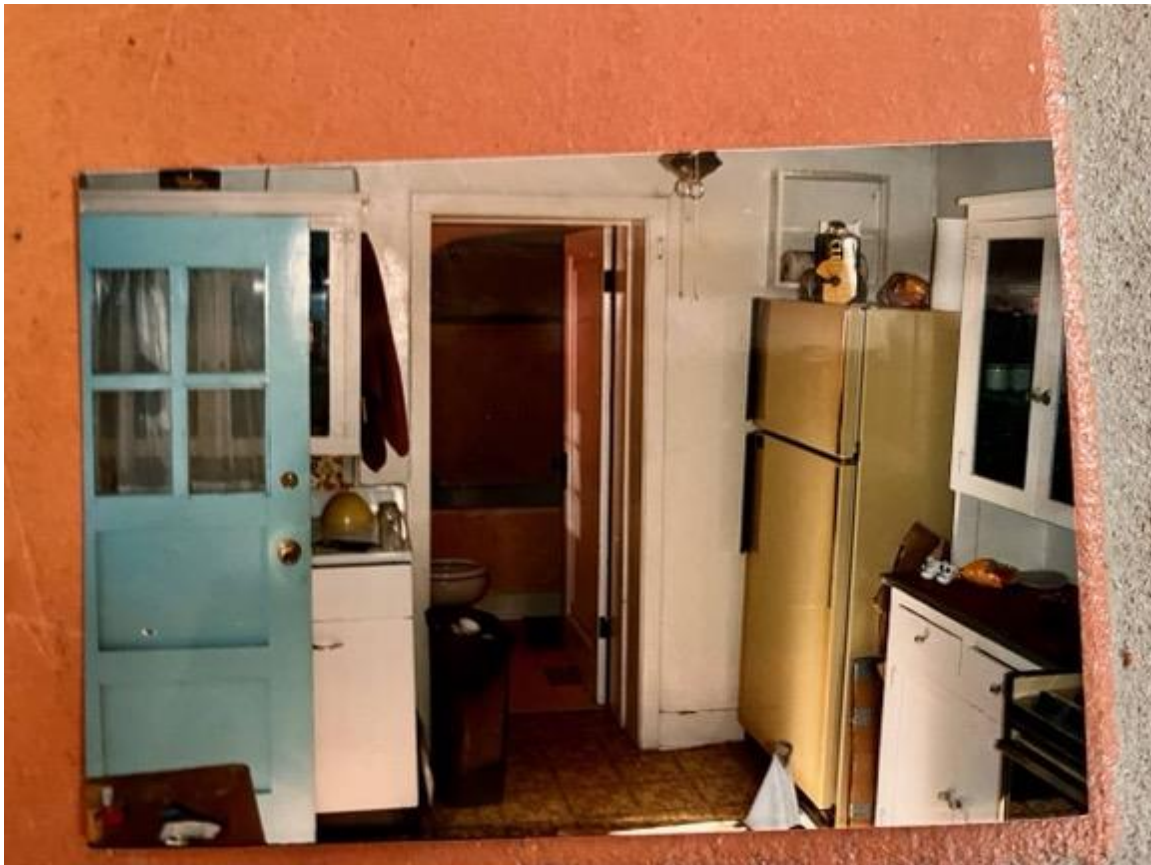
**Photo 12: Room 2. 1990s renovation photograph. Camera facing west.
 Courtesy of Heidi Cost.**

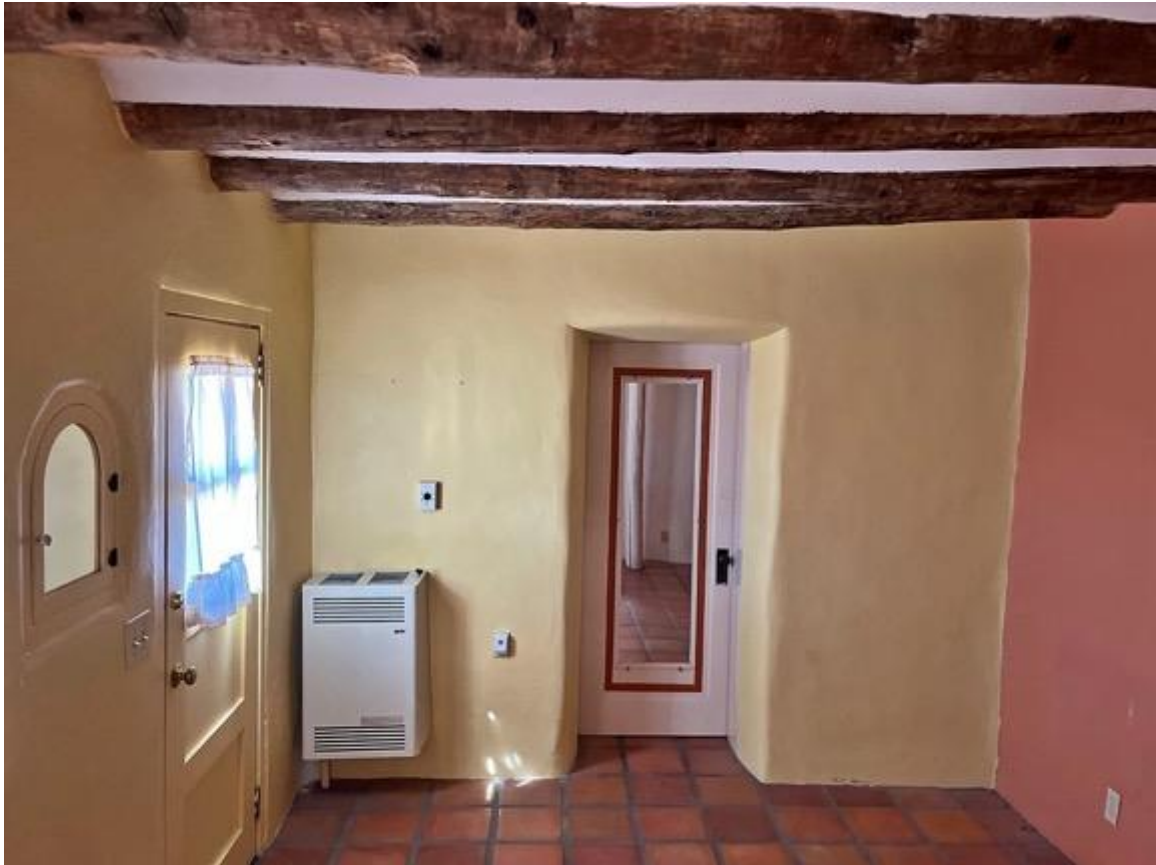
Photo 13: Room 2. Interior. Camera facing west.

The next room to the east historically served as a kitchen during the Rosina Chavez period. This approximately 114-square-foot room is constructed of adobe and is depicted on the 1930 Sanborn Fire Insurance map, the first map to cover the area, as a small garage (Fig. 5). Its exterior features a doorway with an older four-light over two-panel wood door (Photo 11), which is visible in one of the pre-renovation photos when the space was still used as a kitchen (Photo 12). Adjacent to the east is a set of non-original wood casement windows with single lights. The room has clay tile flooring (Photo 13); its viga ceiling has plaster coving between the beams, which was likely added during renovation (Photo 14).

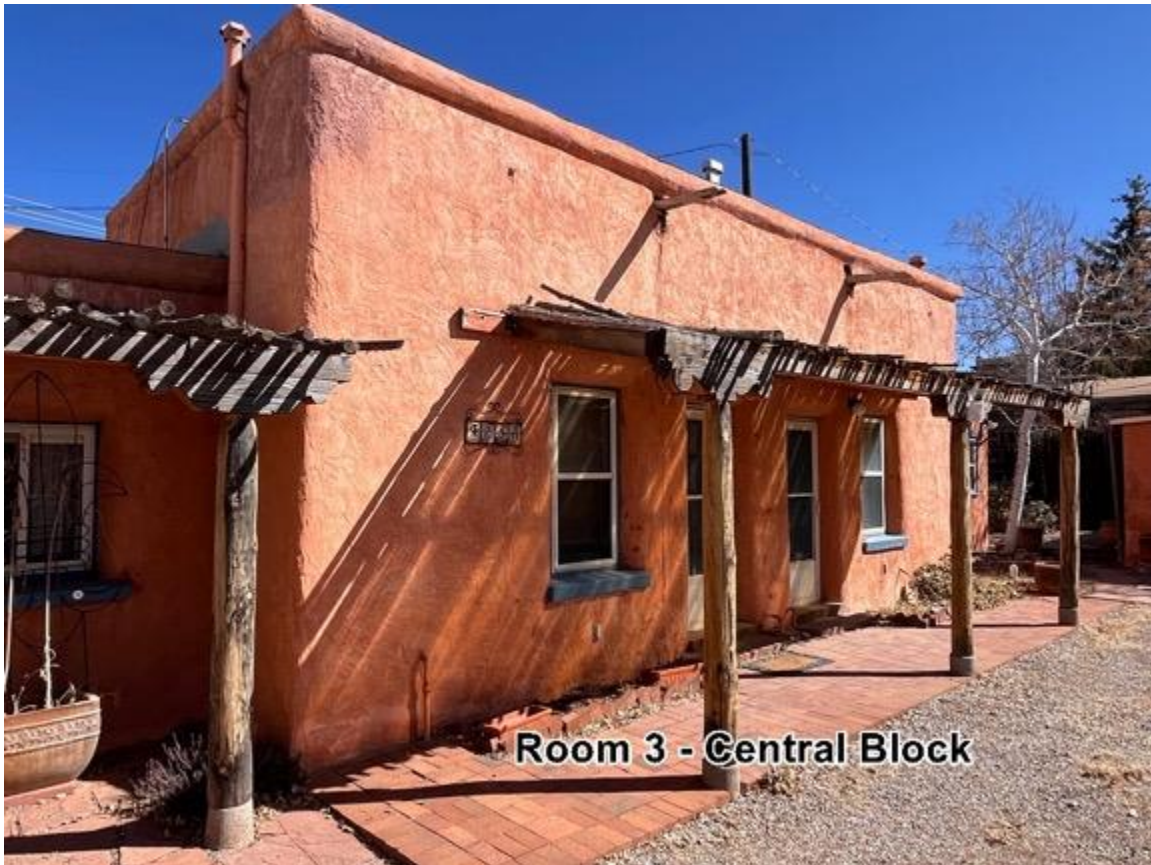
Photo 15: Room 3 (Central Block). Camera facing northeast.

Projecting out approximately 4' from the kitchen, the central block is the building's oldest and most significant piece (Photo 15). It presents a strong example of late 19th and early 20th-century vernacular construction with its tall profile, adjacent doors, and what may be brick coping under built-up stucco. Its construction is of traditional adobe brick covered with multiple layers of stucco, suggesting an older vintage (Photo 16).

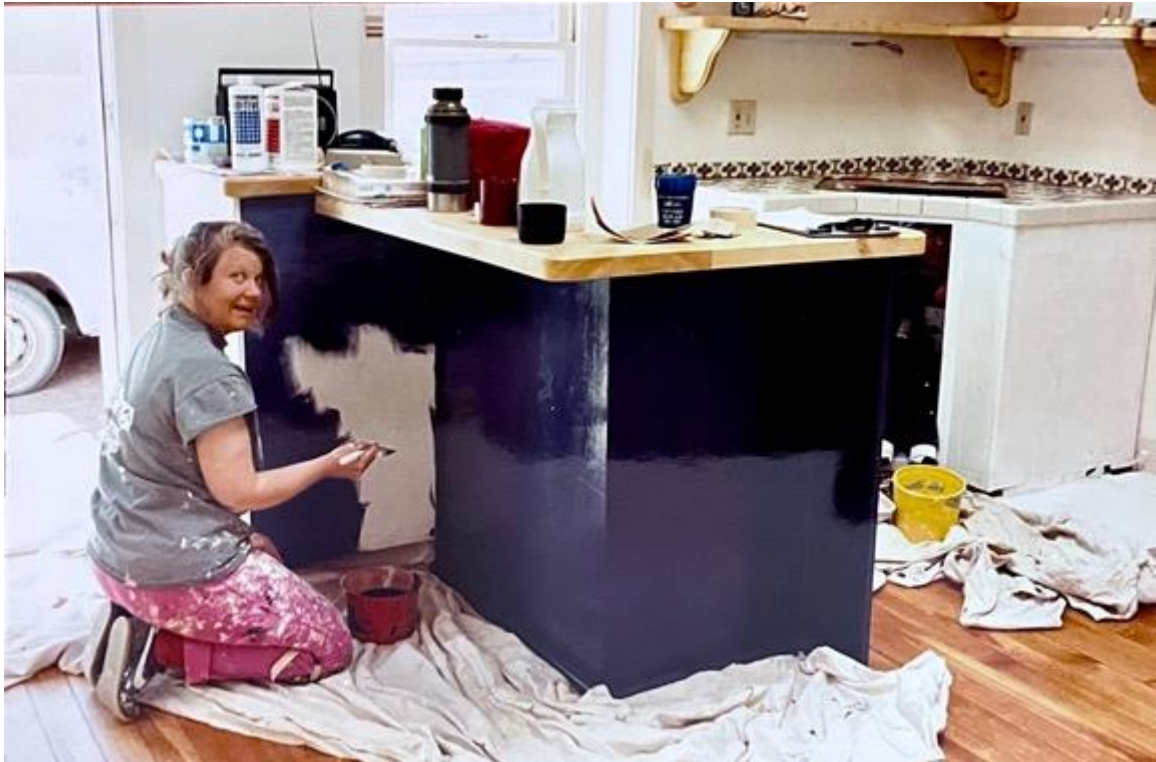
Photo 20: Room 3. Installation of kitchen at southwest corner. Camera facing southwest. Courtesy of Heidi Cost.

two rooms, the central block’s interior was opened during the renovation to create a combined kitchen and living area (Photo 20).

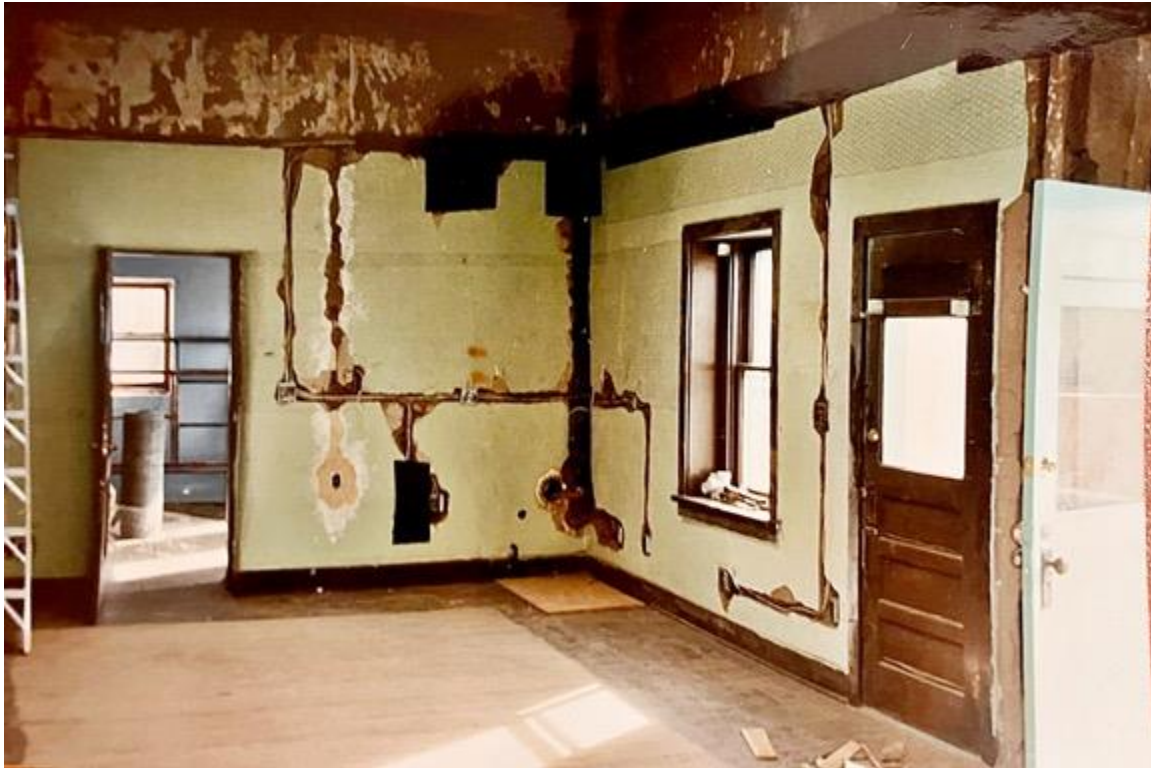
Photo 21: Room 3. 1990s renovation photograph. Camera facing southeast. Note conduit cuts in the adobe walls, removal of ceiling, and older window and door. Courtesy of Heidi Cost.

The renovation included removing the interior dividing wall and ceiling (Photo 21). The vigas and rough-sawn boards were painted white, and skylights were added to the roof, resulting in a light, airy, and anachronistic sala-like space (Photo 22). The flooring consists of 3½” wood strips that change color at the point where the core was divided into two rooms (Photo 23).

Photographs from this period show Rosina's old house undergoing significant renovations. The ceiling of the central room was removed, exposing the vigas, and the adobe walls were cut to accommodate new electrical conduit. A room that had previously served as the kitchen was converted into a bedroom. Older doors and windows were replaced with new ones, and a rustic ramada was installed across the façade of the main block.

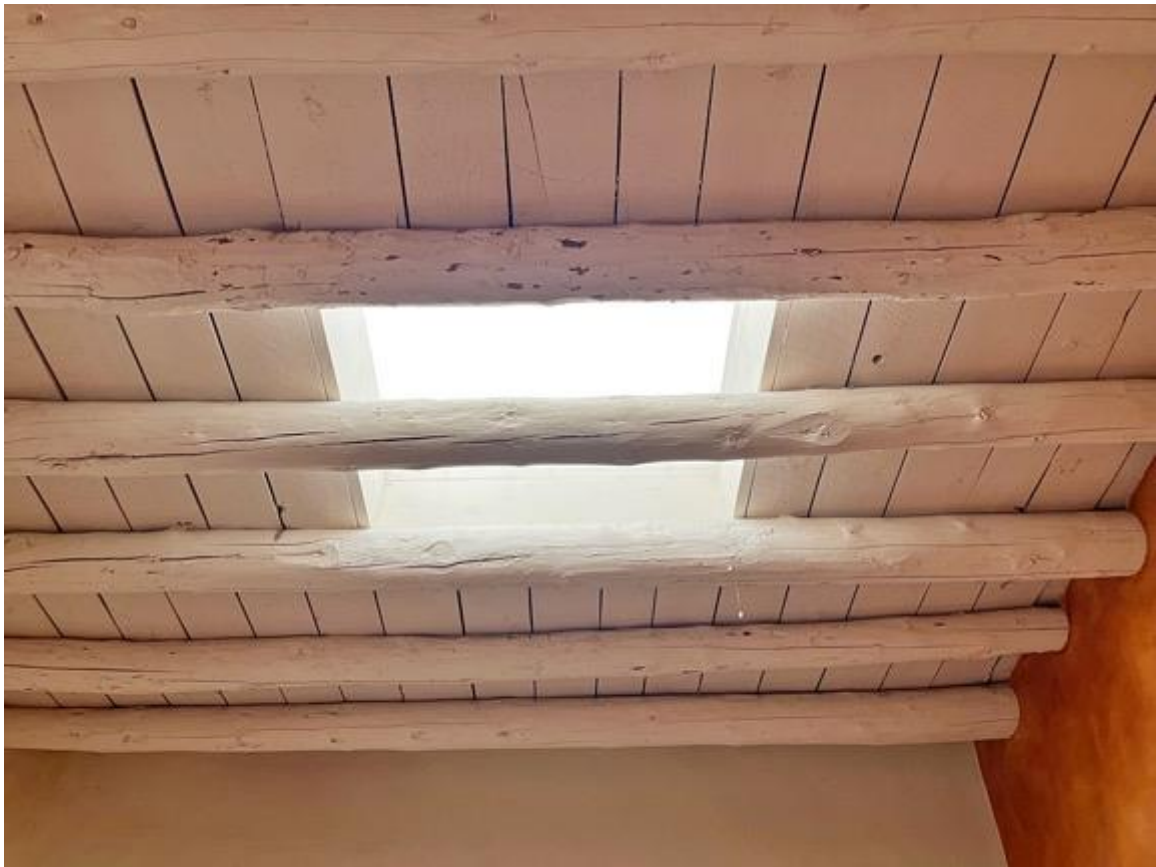
Photo 22: Room 3. Interior ceiling.

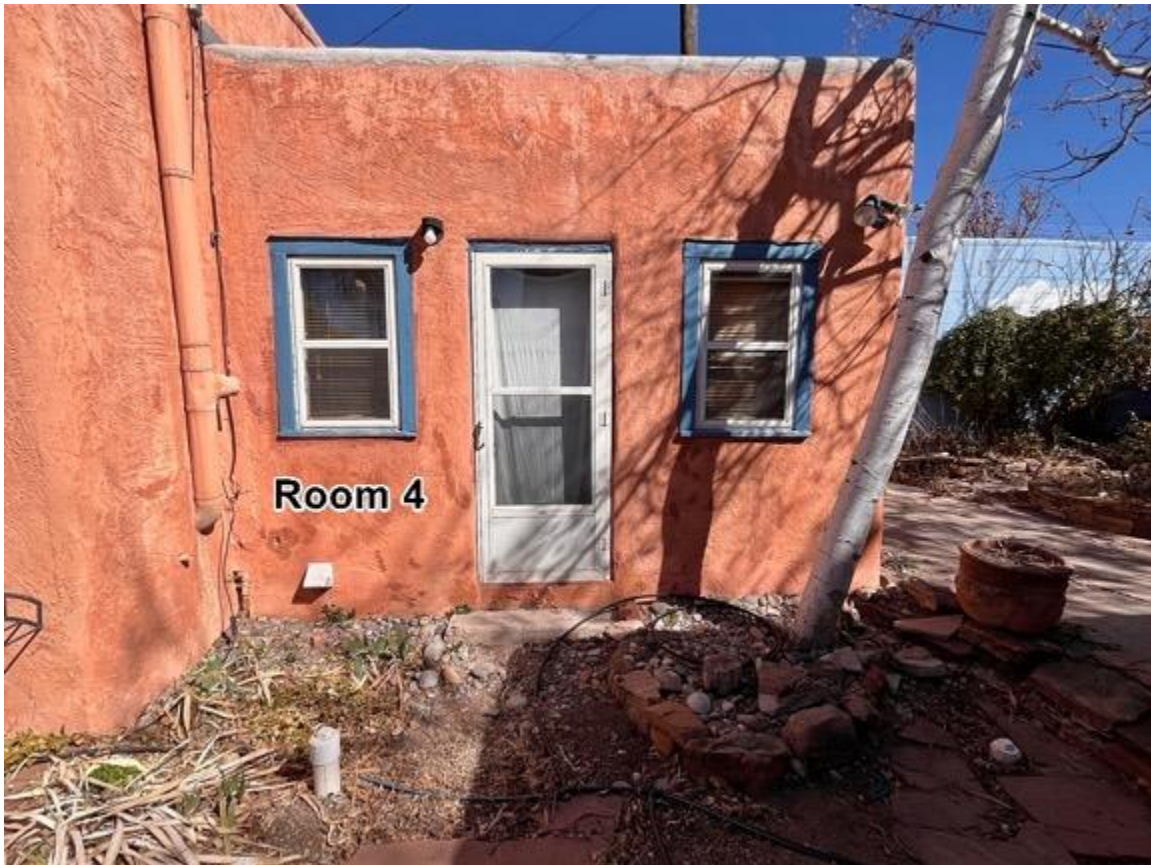
Photo 24: Room 4. Camera facing north.

The last room is set back 40” from the core block and has a lower roof height (Photo 24). Constructed after 1948, the volume appears to be made of concrete blocks. The entrance to the outside is through an older four-light, three-panel wood door, which is flanked by 1/1 vinyl sash windows (Photos 24 & 25).

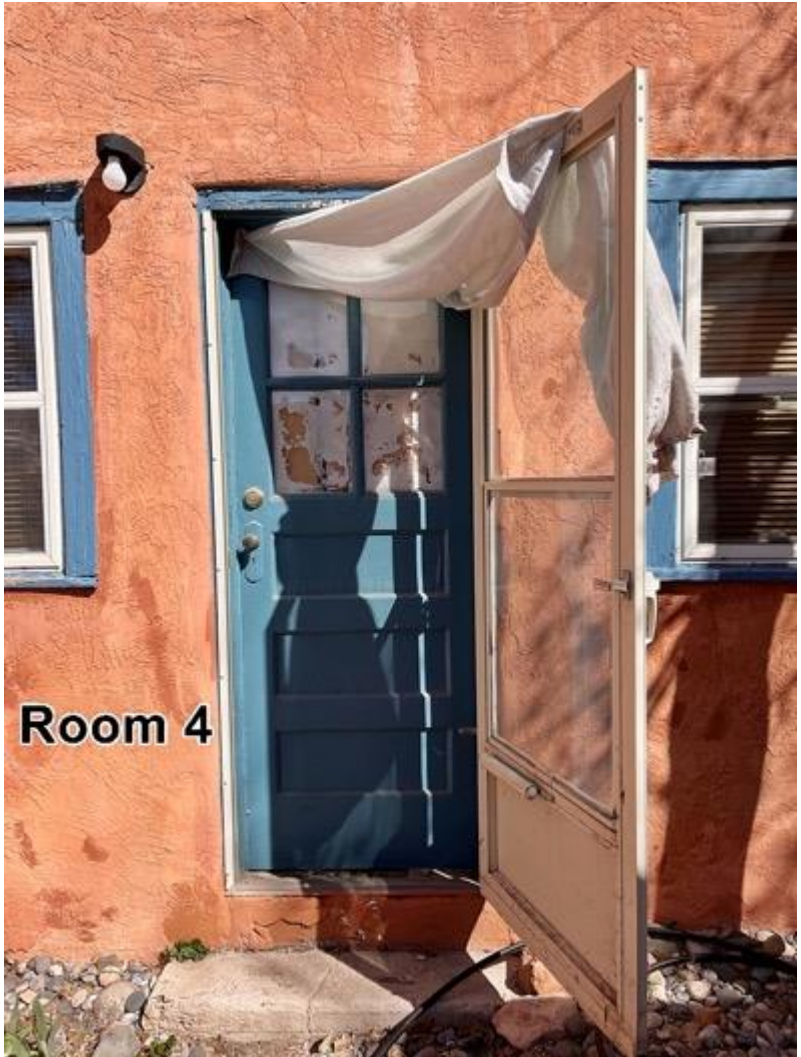
Photo 25: Room 4. Door. Camera facing north.

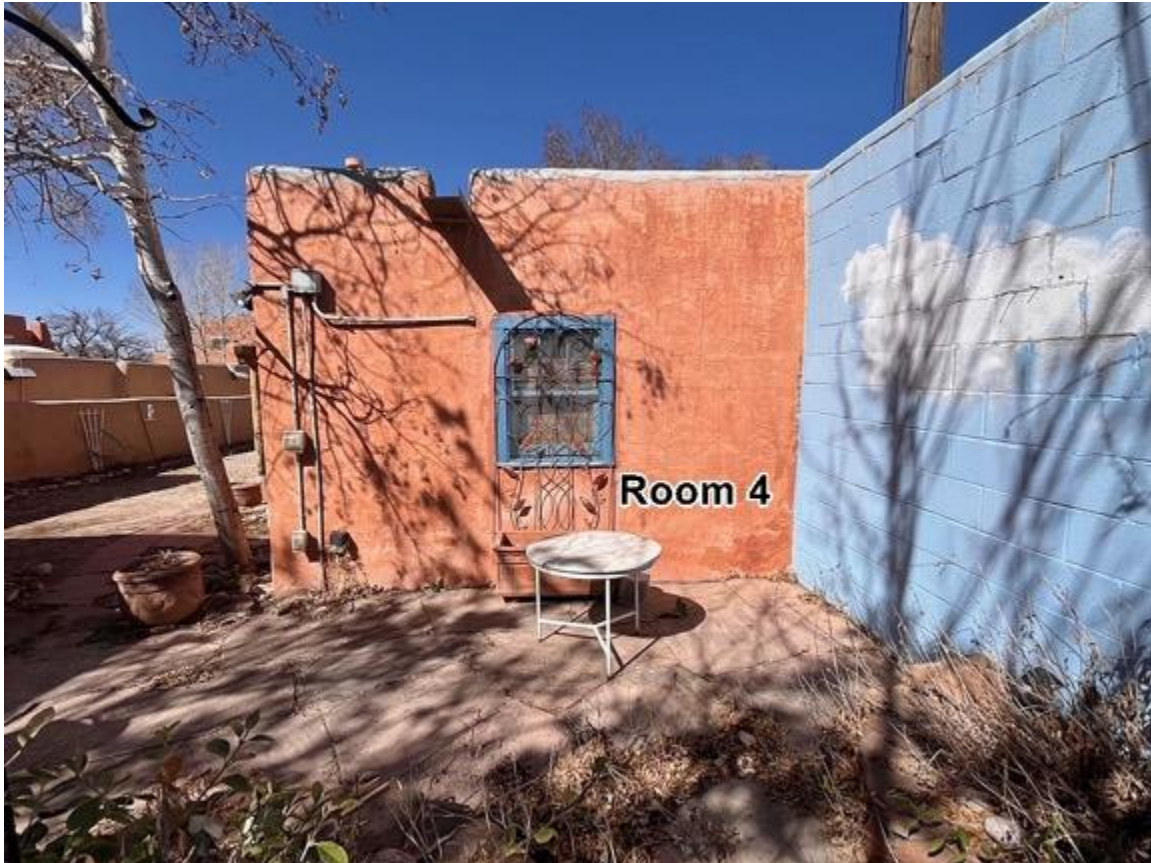
Photo 26: Room 4. East elevation. Camera facing west.

An additional opening on the east elevation contains a 3/1 wood-hung sash window (Photo 26). Both this window and the units on the south elevation are flush with the wall, indicating non-adobe block construction. Its single room measures approximately 114 square feet and has wide board flooring (Photo 27). The southeast corner of the room is occupied by a corner bathroom addition which takes up a significant portion of the space.

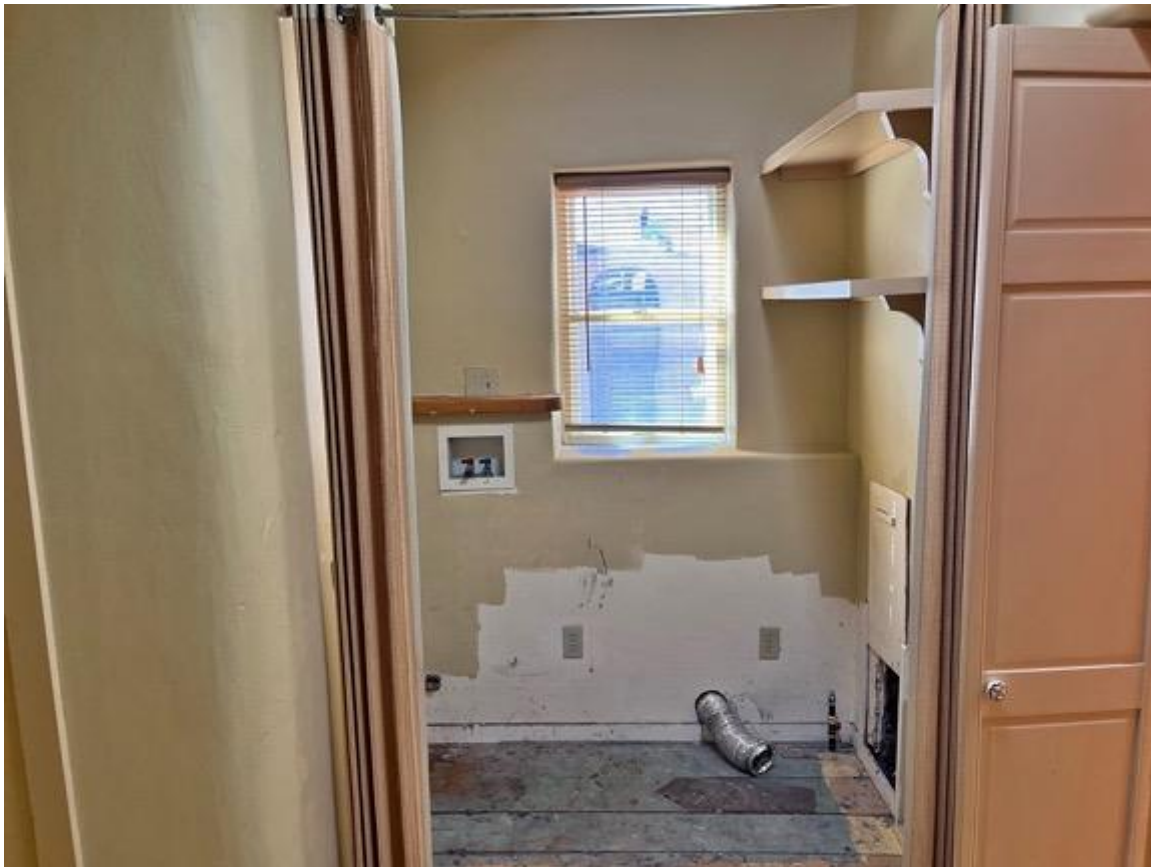
Photo 27: Room 4. Interior, frame bathroom enclosure. Camera facing south.

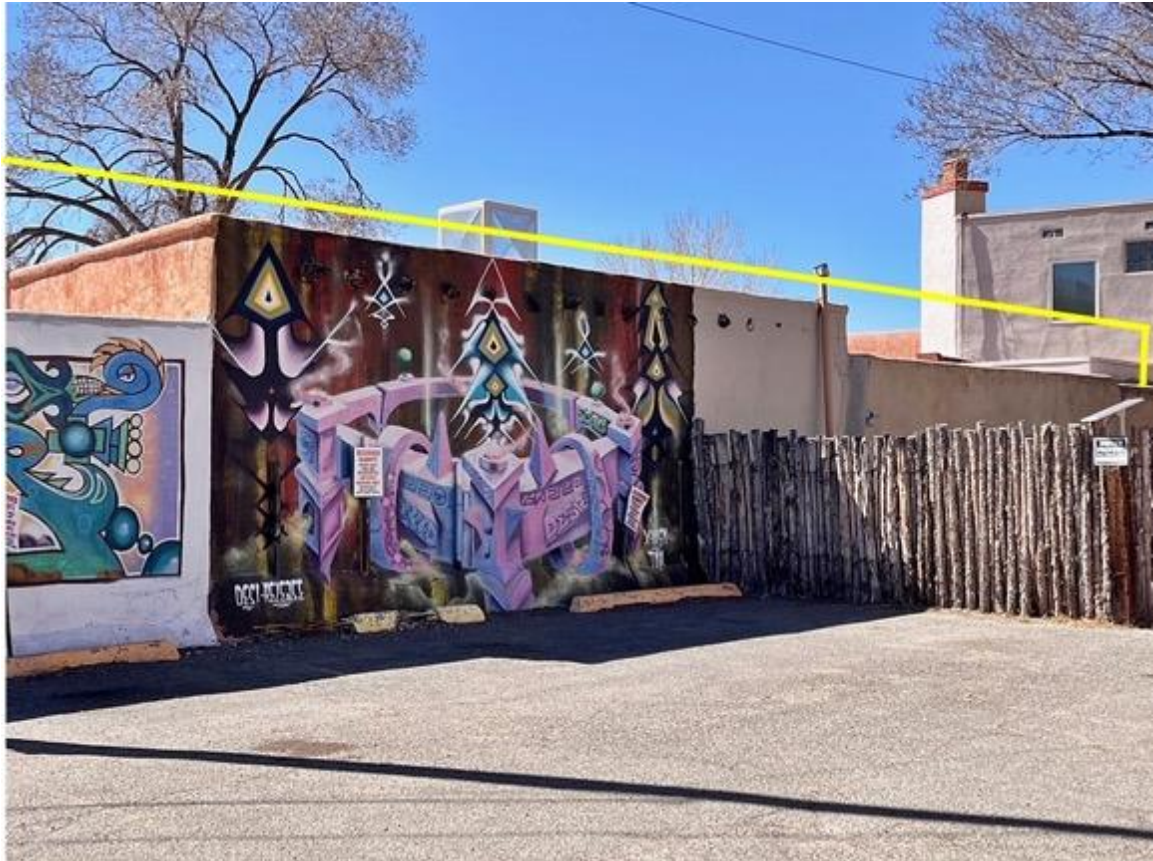
Photo 28: Subject building. North elevation at North Guadalupe Street parking lot. Camera facing southwest.

The back side of the building faces a parking lot associated with North Guadalupe Street (Photo 28). None of the rooms have openings on this façade. The exterior walls of Rooms 3 and 4 are covered with murals (Photos 28 & 29). The remaining elevation is a solid painted wall facing a private residence (Photo 30).

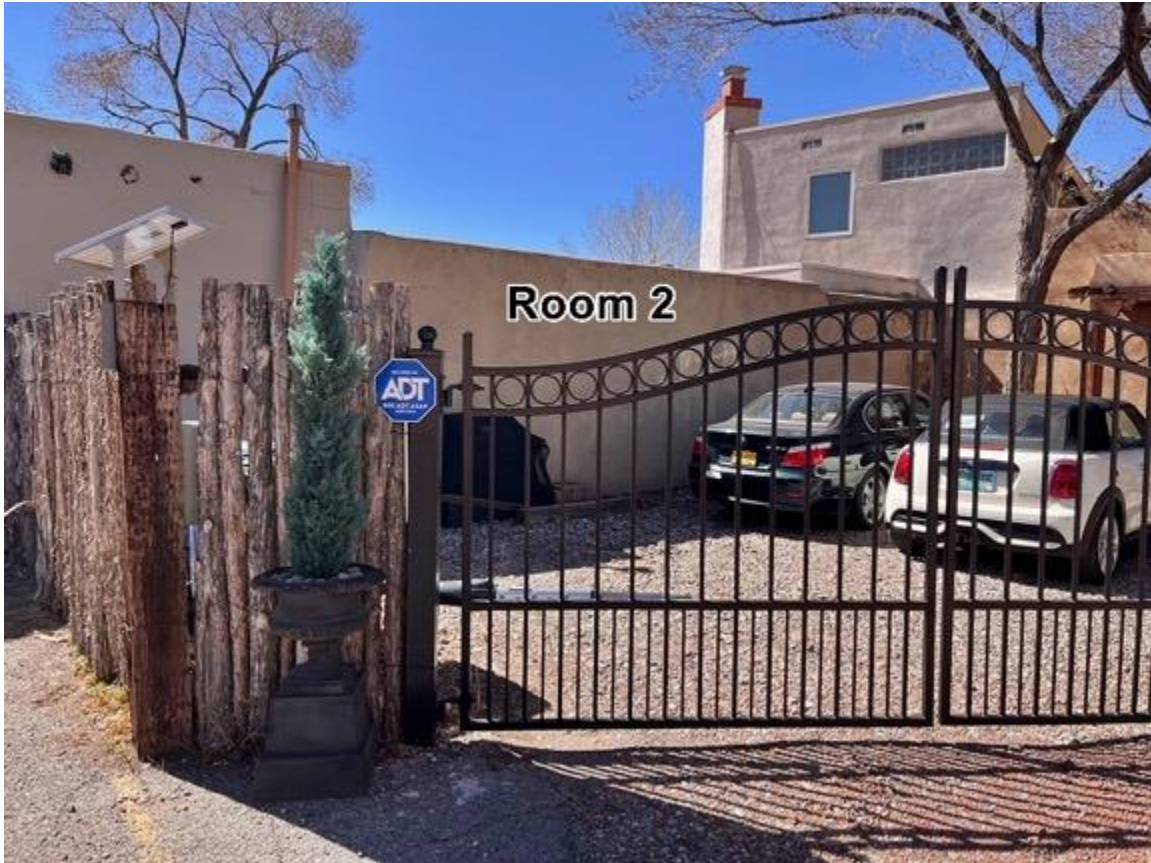
Photo 30: Room 2. North elevation. Camera facing southwest.

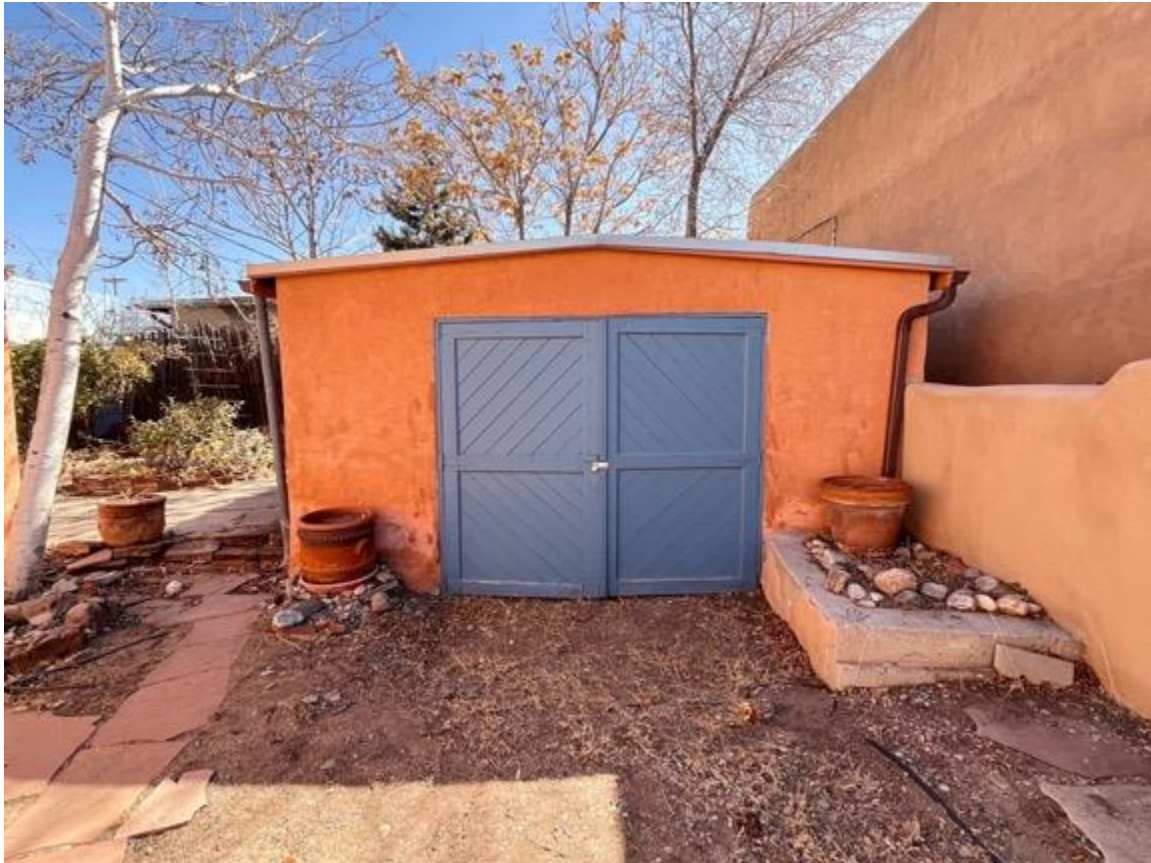
Photo 31: Garage. West elevation. Camera facing east.

Squeezed into the southeast corner of the property is a garage that, based on Sanborn maps, was erected after 1948 (Photo 31). It faces west with a low-pitch gable roof and is partially dug into the ground. It has two 48 ½” wide, outward-swinging, screw-

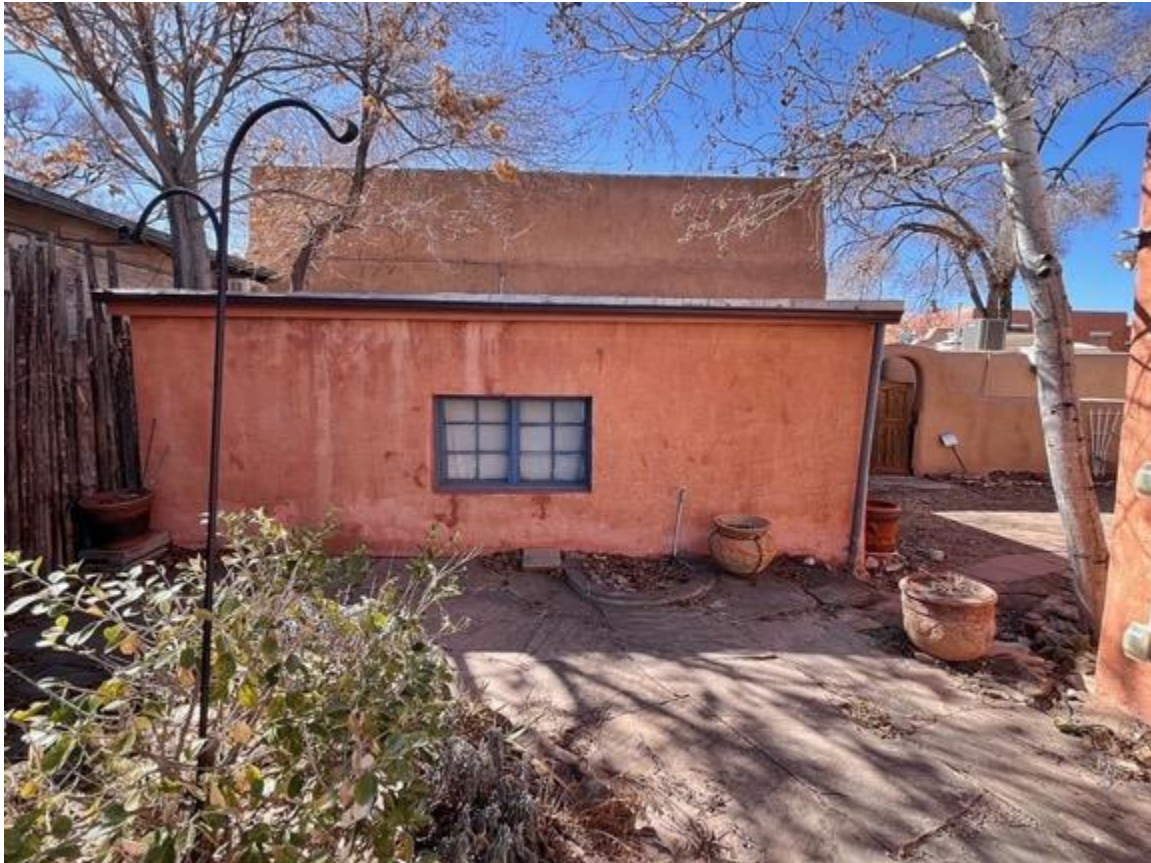
Photo 32: Garage. North elevation. Camera facing south.

assembled wood doors at the front. There are two 6-light sash windows separated by a mullion on the north elevation (Photos 32 & 33).
