Historic Cultural Properties Inventory (HCPI) Base Form (FORM 1)

For HPD Office use only: HCPI No. _____ District No. _____ NRHP _____ SRCP _____ Criteria <u> </u> A <u> </u> B <u> </u> C <u> </u> D		
1. Name of property: Rosina Chavez House	2. Location: 423 A West San Francisco Street Downtown and Eastside Historic District Santa Fe	3. Local Reference Number: Santa Fe ID: N/A 4. County: Santa Fe Parcel # 10468150

19. Site Plan: Portion of 1995 survey plat. Courtesy of Rick Chatroop.

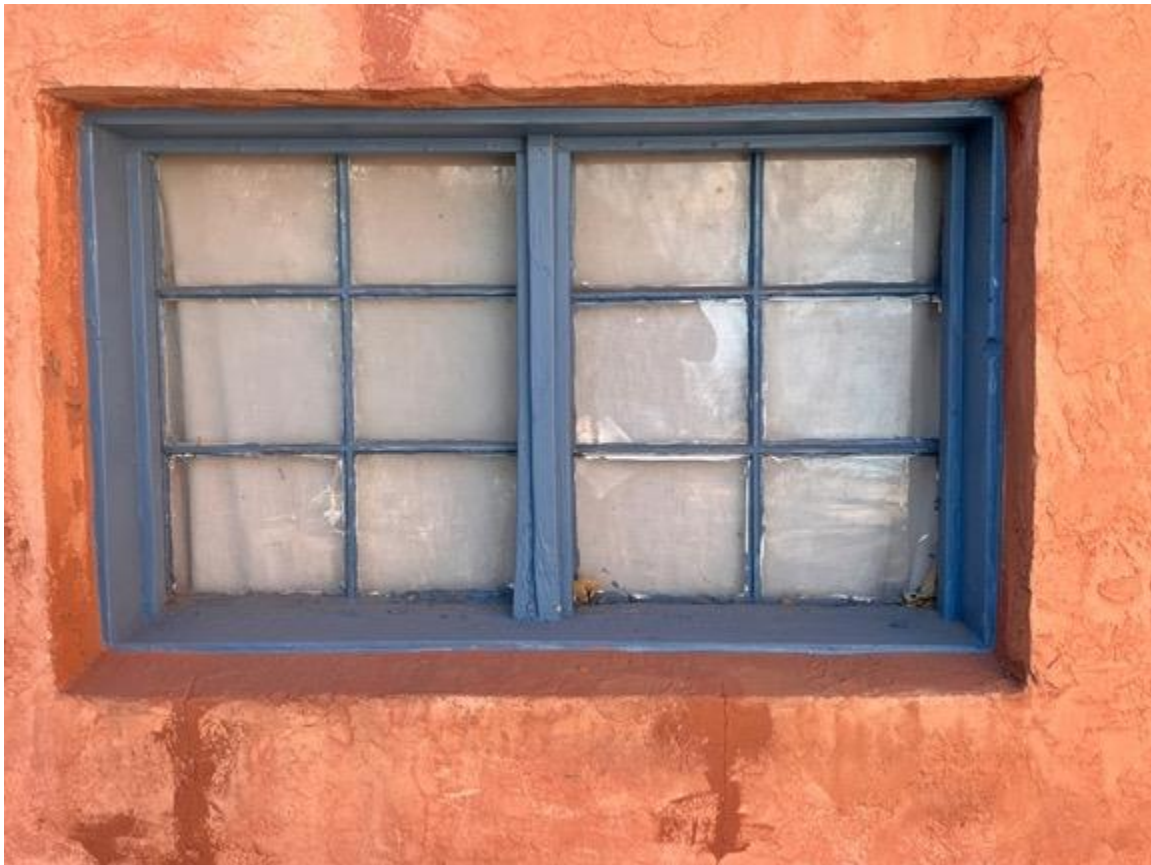
Photo 33: Garage. North elevation. Window. Camera facing south.

assembled wood doors at the front. There are two 6-light sash windows separated by a mullion on the north elevation (Photos 32 & 33).
