A R C H A E O
architects

Historic Review

RE: 206 McKenzie St.

FOR CONSTRUCTION
206 McKenzie St. Santa Fe, NM 87501

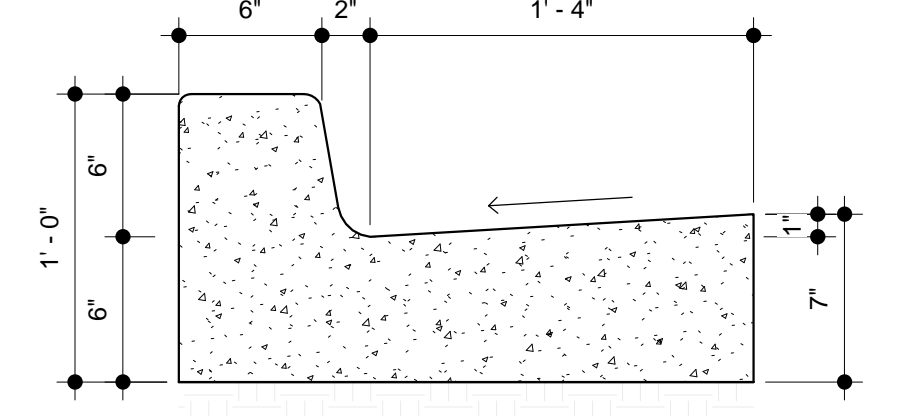
2 CURB AND GUTTER
1 1/2" = 1'-0"

- FOR CONCRETE CURB AND GUTTER CONSTRUCT TRANSVERSE JOINTS AS FOLLOWS:
 - TOOLED CONTRACTION JOINTS AT 5' INTERVALS
 - 1/2" PRE-MOLDED BITUMINOUS EXPANSION JOINTS AT 30' INTERVALS UNLESS DIRECTLY ABUTTING THE SIDEWALK THEN 15' INTERVALS ARE REQUIRED
- DIMENSIONS AT ROUNDED CORNERS MEASURED TO INTERSECTION OF STRAIGHT LINES
- LIP OF GUTTER SHALL BE EVEN WITH THE ADJACENT ASPHALT, BUT IN NO CASE SHALL IT EXCEED 1/4".

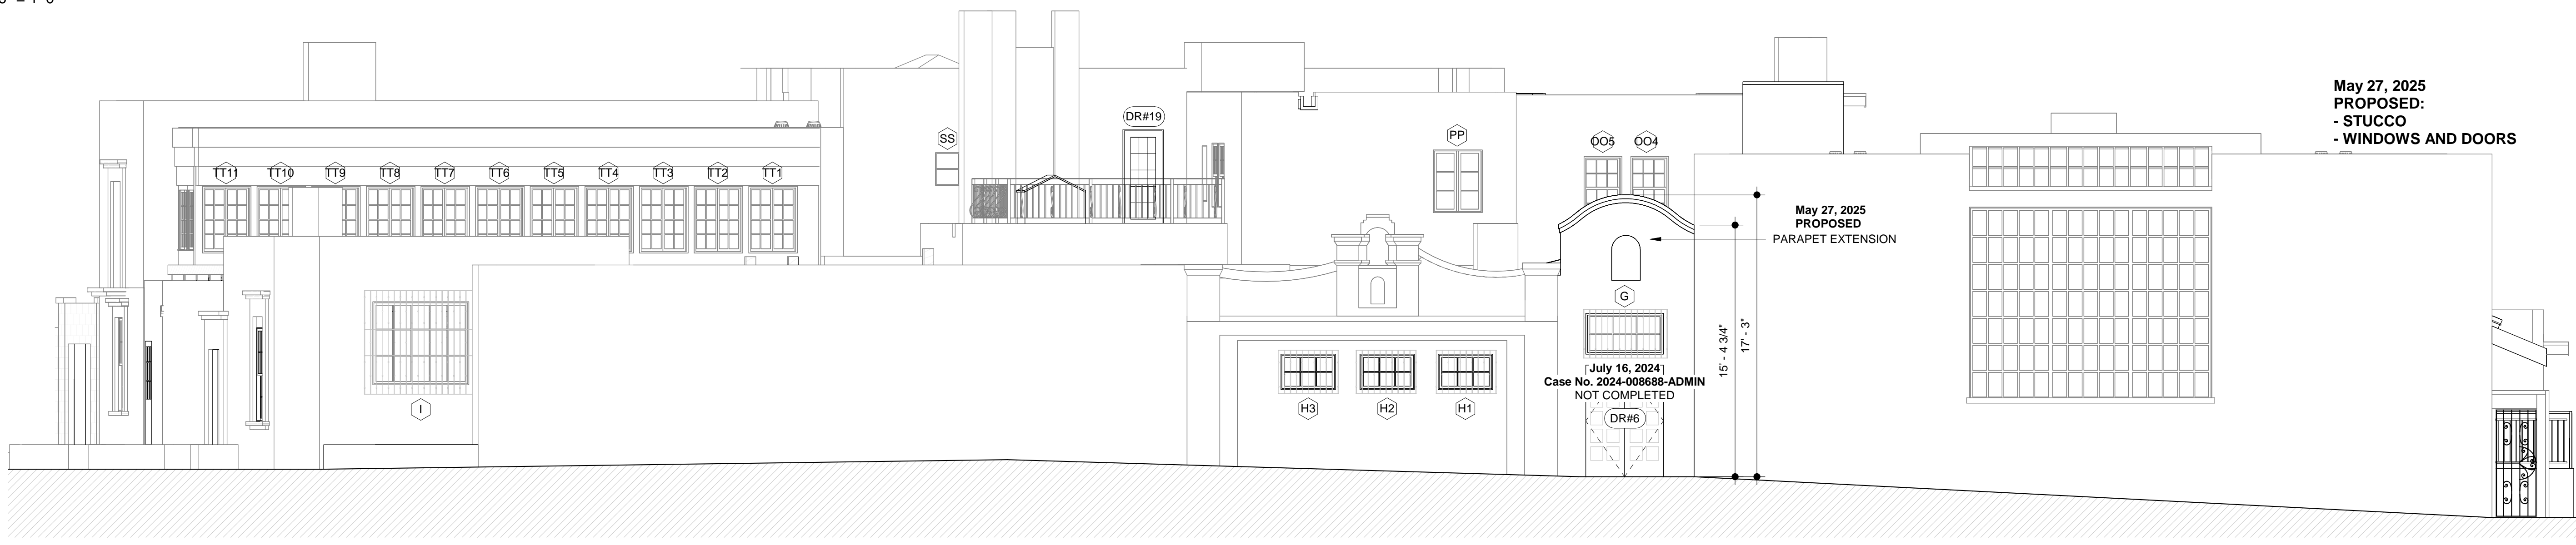
2 NORTH - NEW
3/16" = 1'-0"

May 27, 2025
PROPOSED:
- STUCCO
- WINDOWS & DOORS

We are asking for approval for the replacement of all the doors and windows throughout the building. The current doors and windows are in complete disrepair, missing in some places, and broken beyond repair in others. A majority of the doors and windows that had historic status have already been removed and replaced throughout the building's history. In addition, those that are still of historic status have been destroyed, rendered inoperable, or incorrectly sealed and flashed during the previous remodel. If an attempt were made to repair those that could be repaired, uncovering them would destroy their structural attachments to the building, thus rendering them unsalvageable.

The existing stucco is failing by delaminating from the structure of the building and needs to be replaced. The replacement stucco will be a three-coat cementitious system of the same white color that was previously applied. The color will be Parex, Colonial White, a sample of which is located at the jobsite.

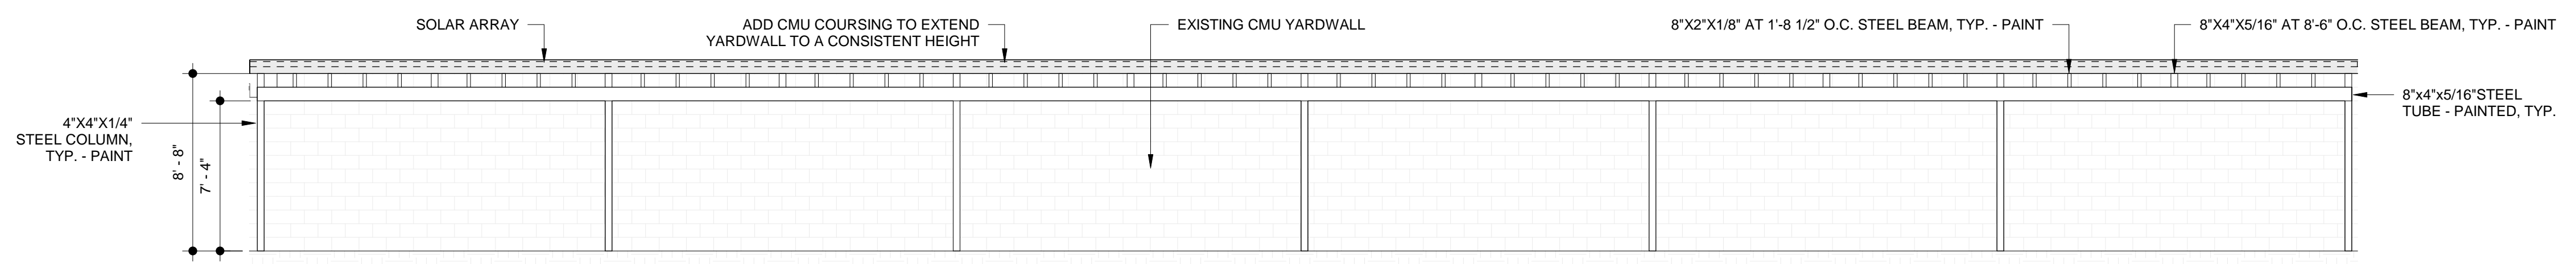
6 NEW CARPORT FRONT ELEVATION
3/16" = 1'-0"

May 27, 2025
PROPOSED:
STEEL CARPORT

New Carport to Replace Existing

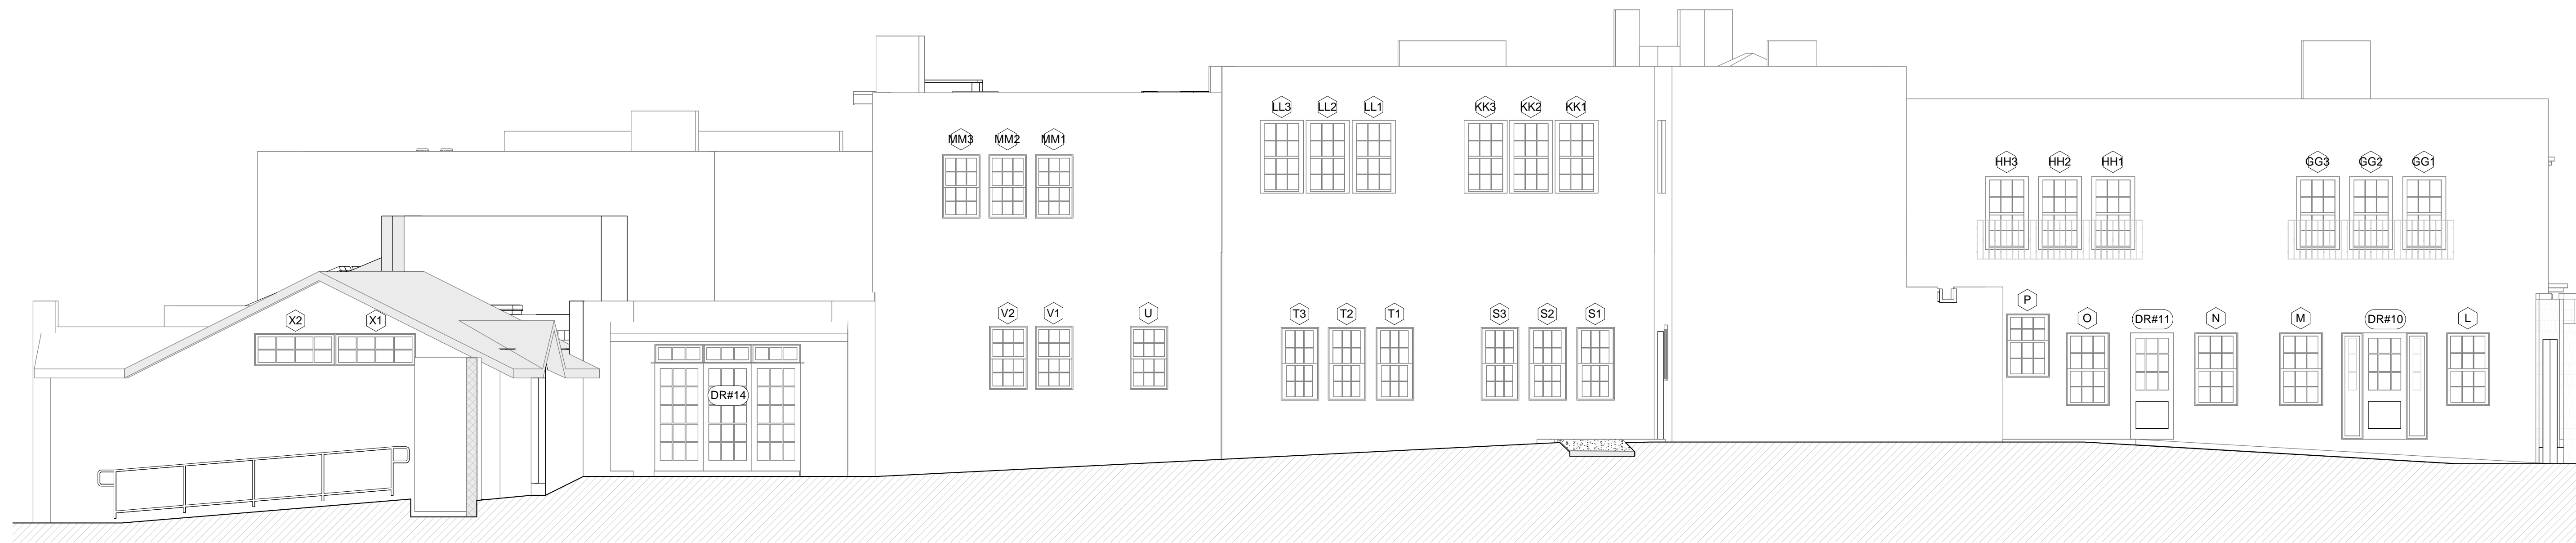
② SOUTH - NEW
3/16" = 1'-0"

May 27, 2025
PROPOSED:
- STUCCO
- WINDOWS & DOORS
