City of Santa Fe, New Mexico

memo

2025-010839-HDRB, 433 Calle La Paz, Downtown & Eastside Historic District, contributing, Martinez Architecture Studio, agent for John C. Gregory and Pamela S Austin Revocable Trusts, owners, requests primary façade designation of the main residence, a historic status review with primary facade(s) designation, if applicable, for a casita and a garage structure.

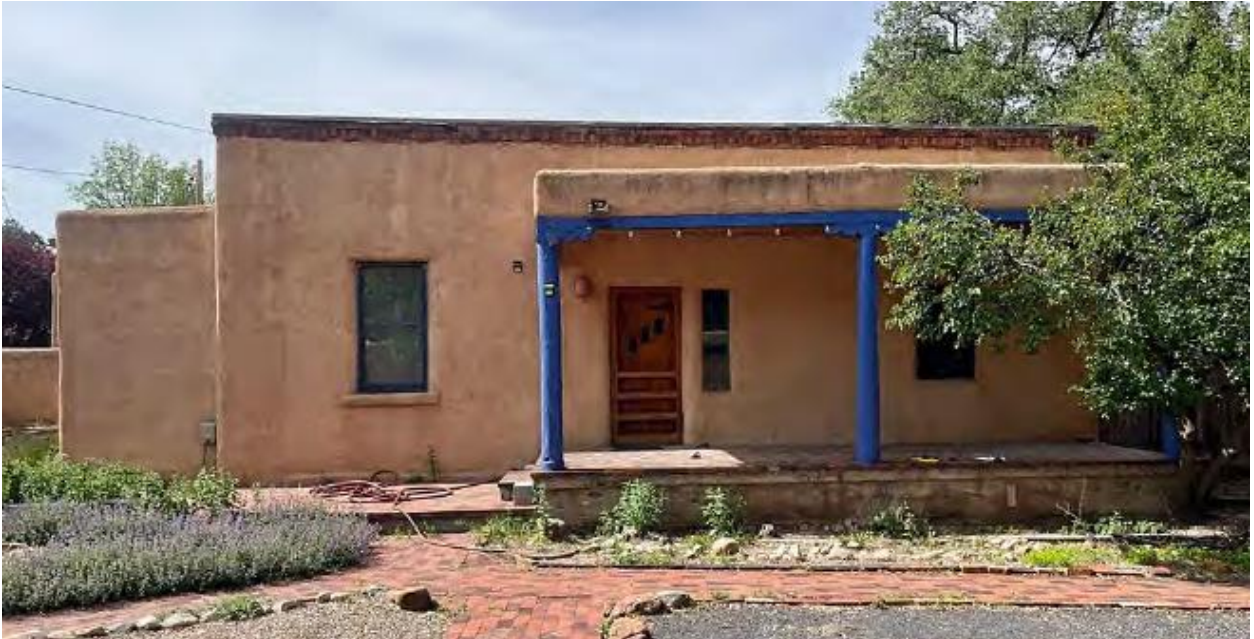
Figure 2: Main Residence

The 1,358 square foot single-family residence at 433 Calle la Paz is listed as contributing to the Downtown and Eastside Historic District. The original portion of the home was constructed in adobe sometime between 1912 and 1930, with four subsequent additions, all of which were constructed before 1970. The residence is a vernacular interpretation of Territorial Style with Pueblo Revival influence in the additions to the historic footprint. The roof heights vary, with most having a brick cornice, which was installed in 2001. The main entrance of the residence faces north and is covered by a portal that is off-center from the elevation due to one of the additions. The recent brick floor of the portal is several feet above ground level, and the roof is supported by wood posts set on concrete pier blocks. The residence retains its original fenestrations with mostly two-over-one wood windows, except one six-over-one wood-clad and one one-over-one vinyl window. The doors are wood, except for one metal door. The residence is stuccoed in cement stucco in “buckskin”. Character-defining elements of the main residence include the original core, original fenestration openings fitted with two-over-one wood windows, and the brick cornice.

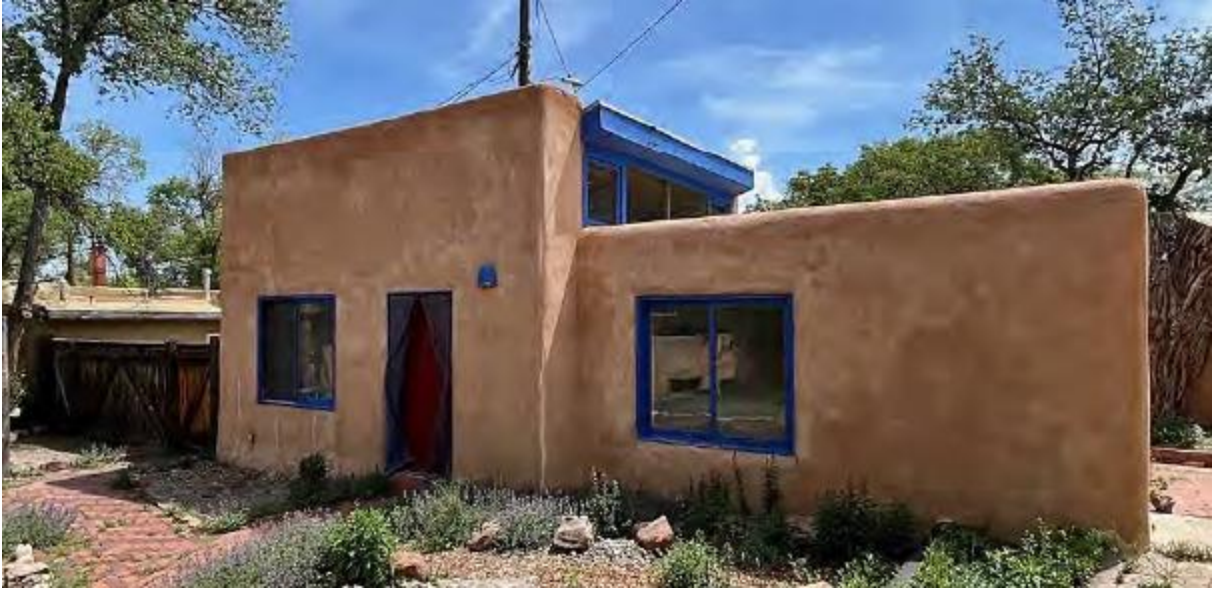
Figure 3: Casita

The 564 square foot casita is listed as non-contributing to the historic district. It was constructed in the early 1980s with frame construction that seems to encompass an older structure on its south end. The casita is a vernacular style with a passive solar design consisting of south-facing clerestory windows and interior brick floors. The main entrance faces west and has a metal panel door and sash windows. The south houses French doors and a sash window, and the upper level has the clerestory windows. The east façade contains wood windows, and the north façade has no openings. According to the window assessment, all windows are non-historic from 1987 to 2015.

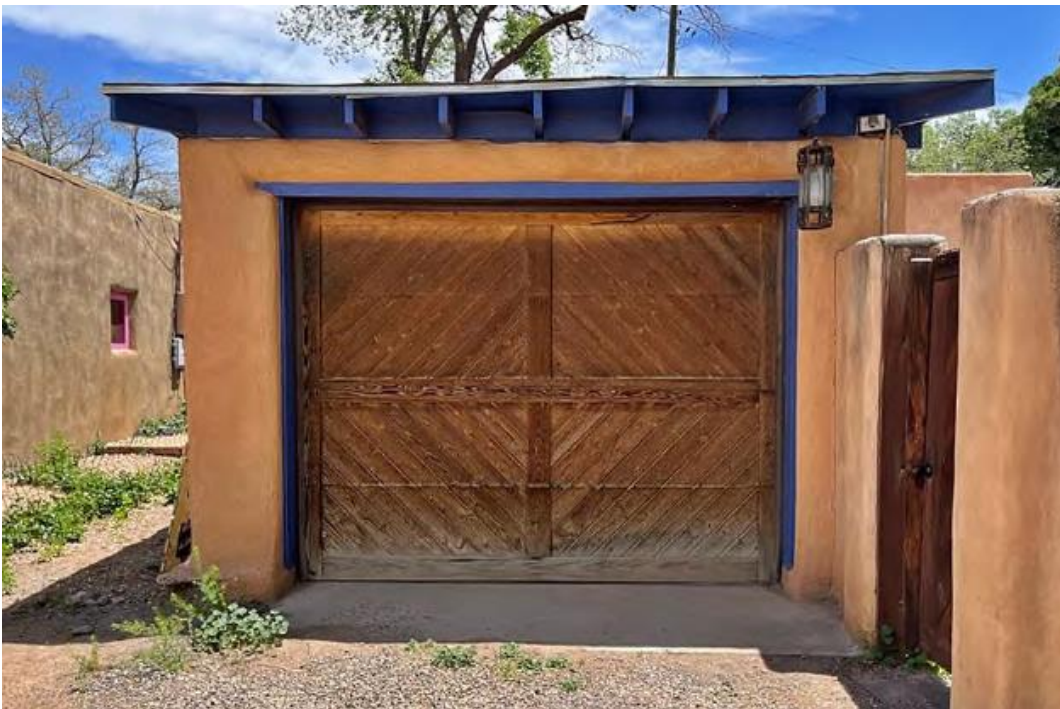
Figure 4: Garage

The 264 square foot west-facing garage was constructed before 1958 of hollow clay tile blocks in a Spanish Pueblo Revival style. The roof has been modified with a flat roof with plywood overhang. The vehicle door is a double chevron wood overhead door in a natural color with blue trim surround that matches the blue of the roof overhang. There is a metal light fixture to the south of the door. The south façade holds a non-original 1990 wood pedestrian door painted red, and an eight-lite sash window turned on its side. The window assessment shows this window as a non-historic 1987 window. The north façade has no openings. The garage is a good example of this type of construction and design.

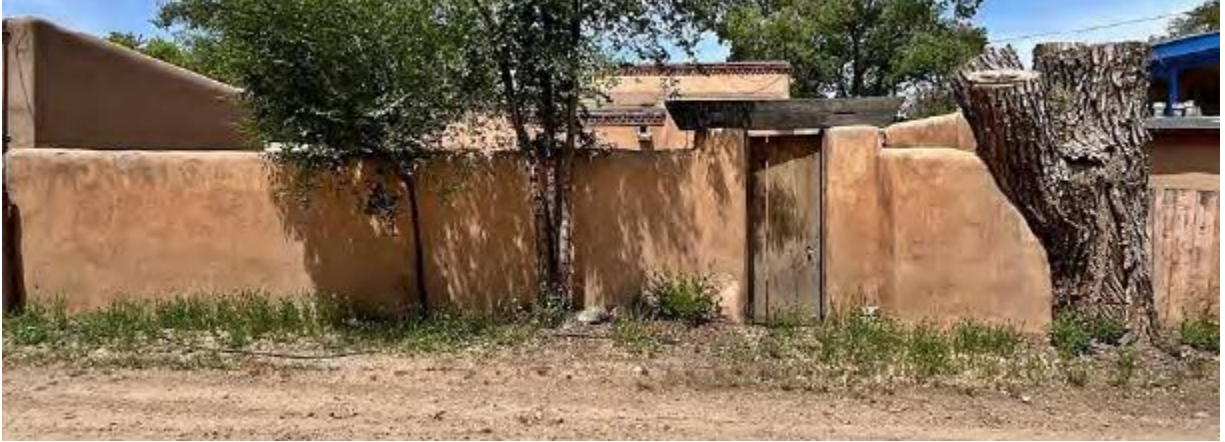
Figure 5: East Yard Wall

There are seventy-inch-tall yard walls along both Calle la Paz and Camino Manzano, which were constructed after 1983. In the 1983 survey photo, a much lower wall was in front of the residence, which was raised in height by 1991 as is illustrated in that survey photo. The west wall contains an arched gate opening that reaches ninety inches and holds a wooden gate. To the south is a seventy-two-inch wood plank fence. The yard wall on Camino Manzano starts at the south corner of the lot and runs to the edge of the guest house. Closer to the guest house is a wooden pedestrian gate topped with a header. At the south end of the guest house starts a seventy-two-inch plank fence that runs for about five to ten feet before ending in a wire fence that is damaged by the overgrown foliage that clings to it.
