PROJECT 2023-007680-HDRB. 128 Camino Santiago. Downtown & Eastside Historic District.

DESC: Contributing. John Padilla, agent for Onesimo Vigil, owner, proposes to construct 2,142 sq. ft. of additions to a height of 13'-0" where the maximum allowable is 13'-3" and yard walls to the maximum allowable height of 6'0". Exceptions are requested to 14-5.2 (D)(5)(a) for removal of historic doors and windows and 14-5.2(D)(2)(d) to exceed 50% of the historic footprint.

CASE NUMBER: 2023-007680--HDRB

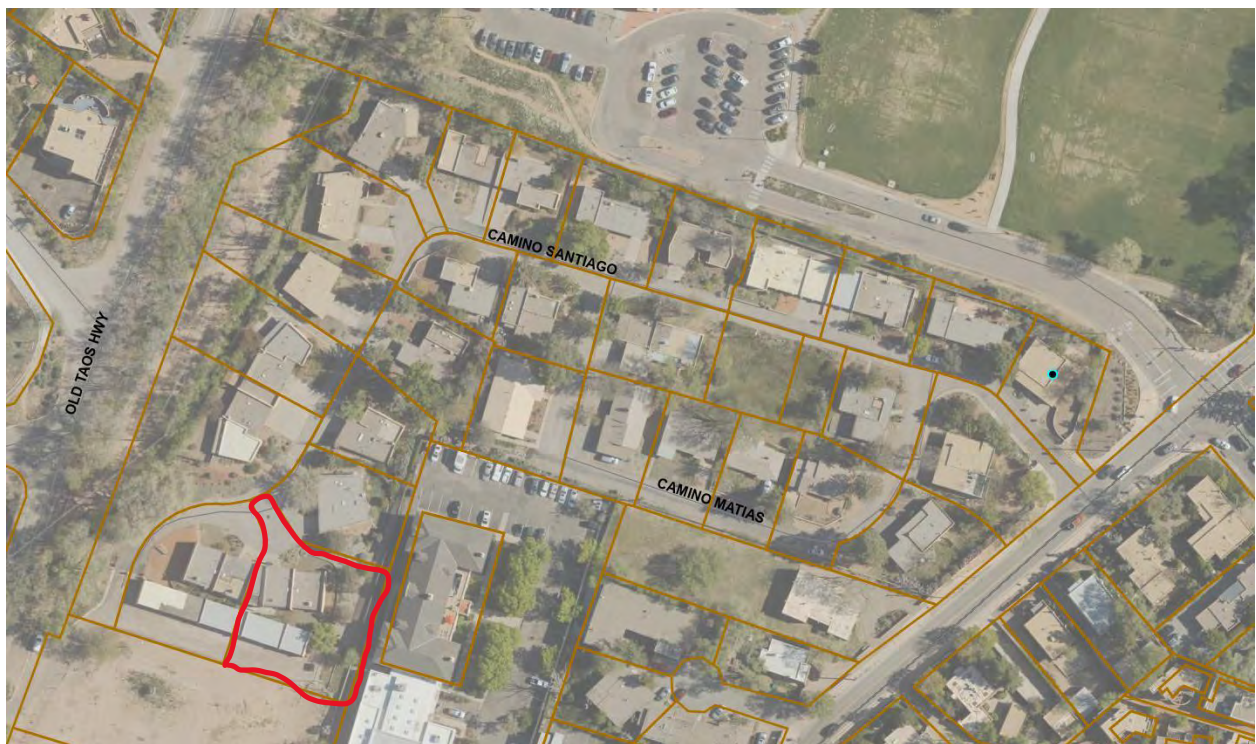
Figure 1. Plaza del Monte. 128 Camino Santiago is in the lower left corner of the property.

Highway on the west. The development has two roads, Camino Santiago and Camino Matias. While several structures predate the center, the communal living center was originally developed for retired members of the Presbyterian Church starting in the late 1950s until 1977. The earliest plans by Clark and Register are for the buildings on the eastern portion of the development and were Spanish-Pueblo Revival in style. However, when Philippe Register took over the project in the 1960s, his designs evolved into a contemporary flat-roof structure with the use of canales, viga-roof portales, and carport elements. In the mid-1960s Camino Santiago was extended and development of the western end of the development began. This is when Register chose to eliminate several freestanding houses on the plans and replace them with quad apartments. Once fully developed the compound consisted of 25 single family residences and 3 quad apartment structures. The apartments include the structures at 105, 125, and 126 Camino Santiago.

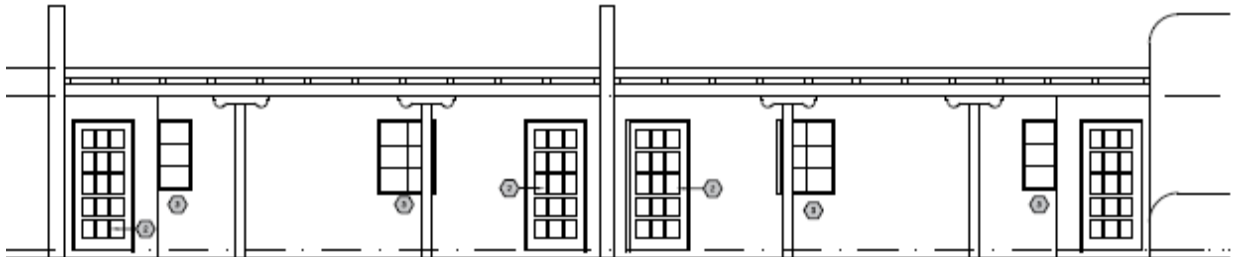
Existing:

Exception to Section 14-5.2(D)(5)(a): The applicant requests an exception to alter openings on a primary façade by infilling windows and doors.

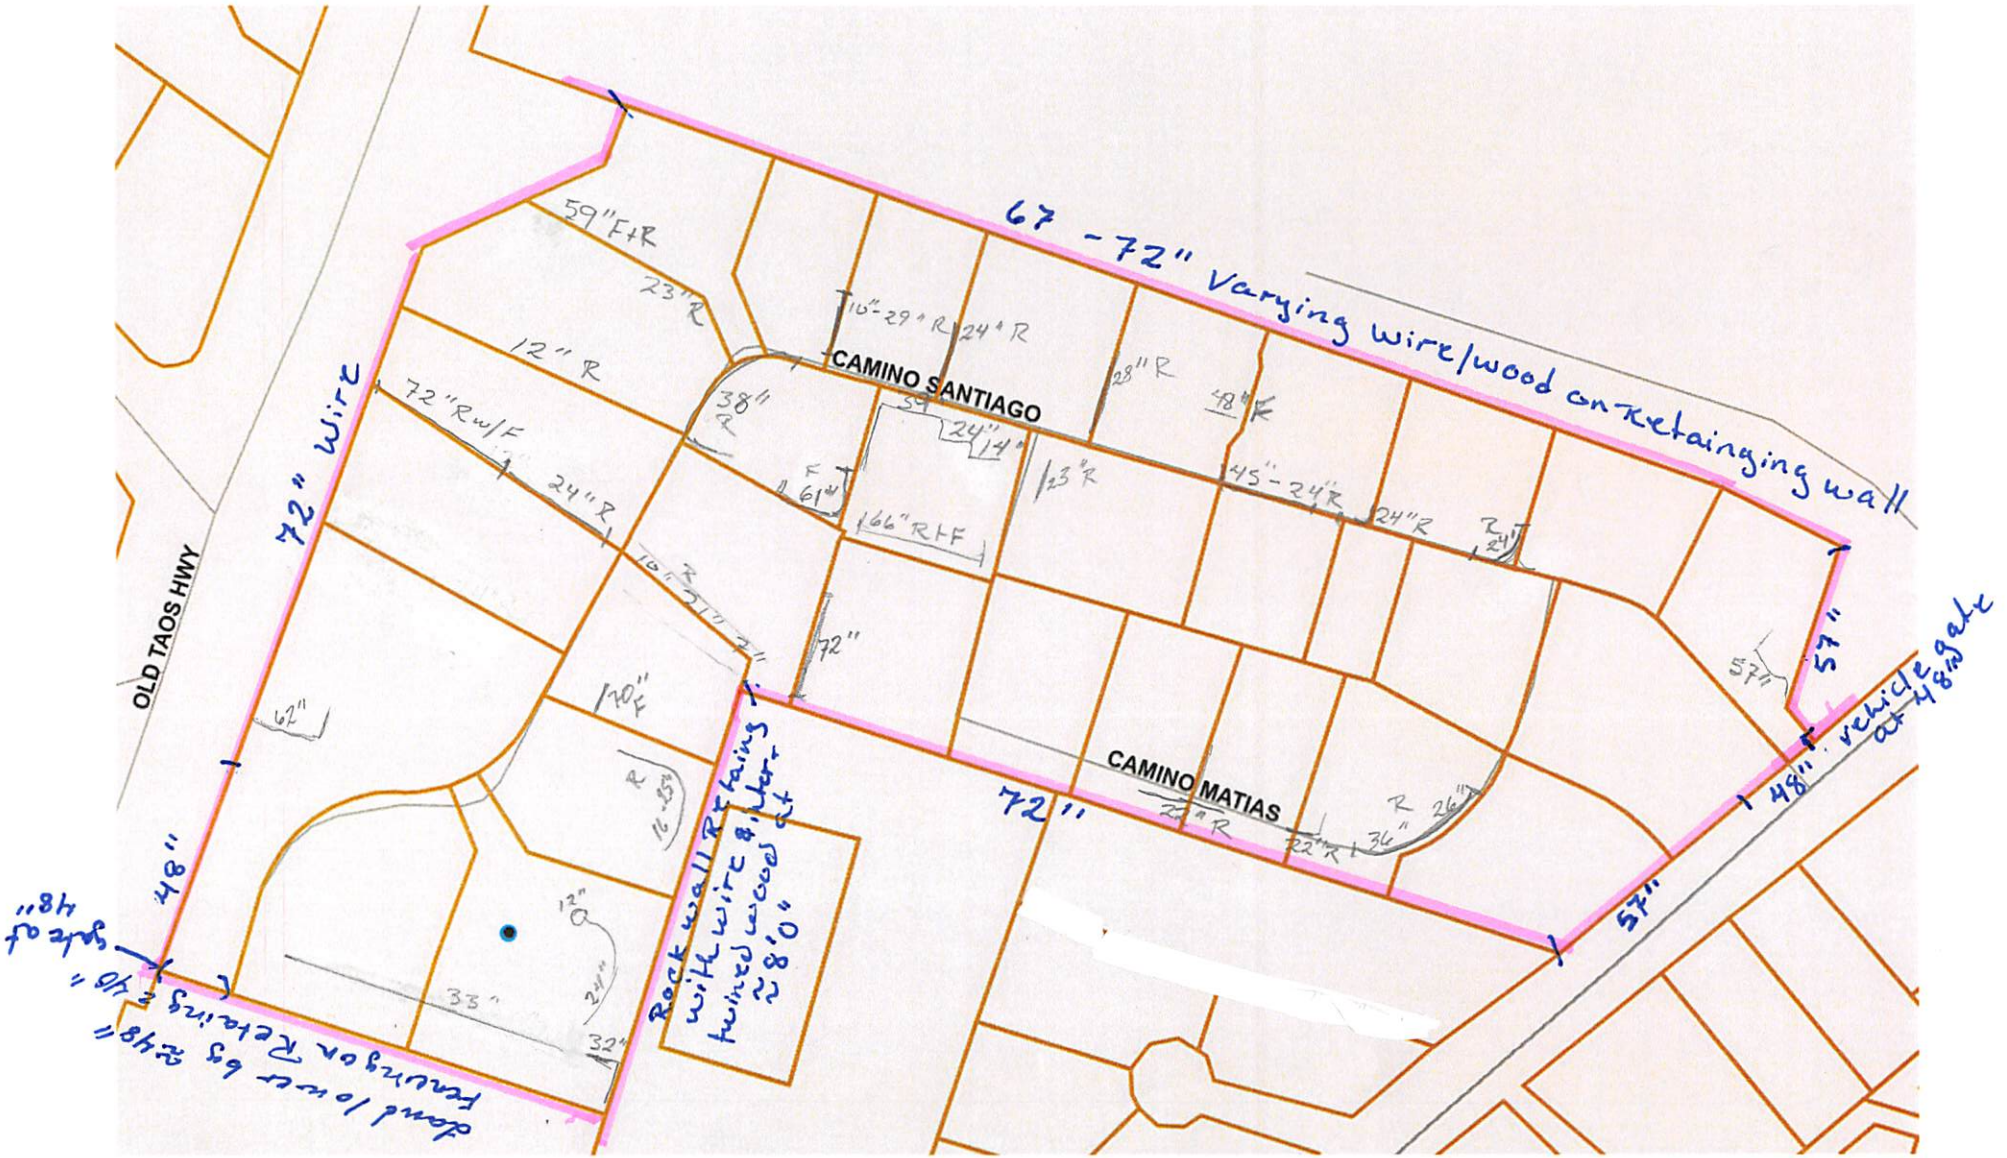
Plaza del Monte: — Perimeter Heights
 R = Retaining
 F = Fence

The Plaza del Monte landscape includes retaining walls, constructed of formed concrete or concrete and stone. The walls were built over several phases and the dates of construction are between 1950 and 1973. The walls were constructed to retain earth or to separate building pads. Few of them rise above grade but some of the lots do have above-ground property line walls which are constructed of stucco-clad concrete masonry units. The retaining and property line walls appear to post-date the construction of their associated units. The retaining walls vary in height from 8” up to 38” though most are 20” in height. No property has front yard fencing. All fencing is a minimum of 10’ from the front property line. Those properties who have rear yard fencing the height is generally 5’-0”. Fences built on top of retaining walls or perimeter fences tend to be at 6’-0”. There are two sections of retaining wall with fencing that reaches 8’-0” between the compound and neighboring lots.

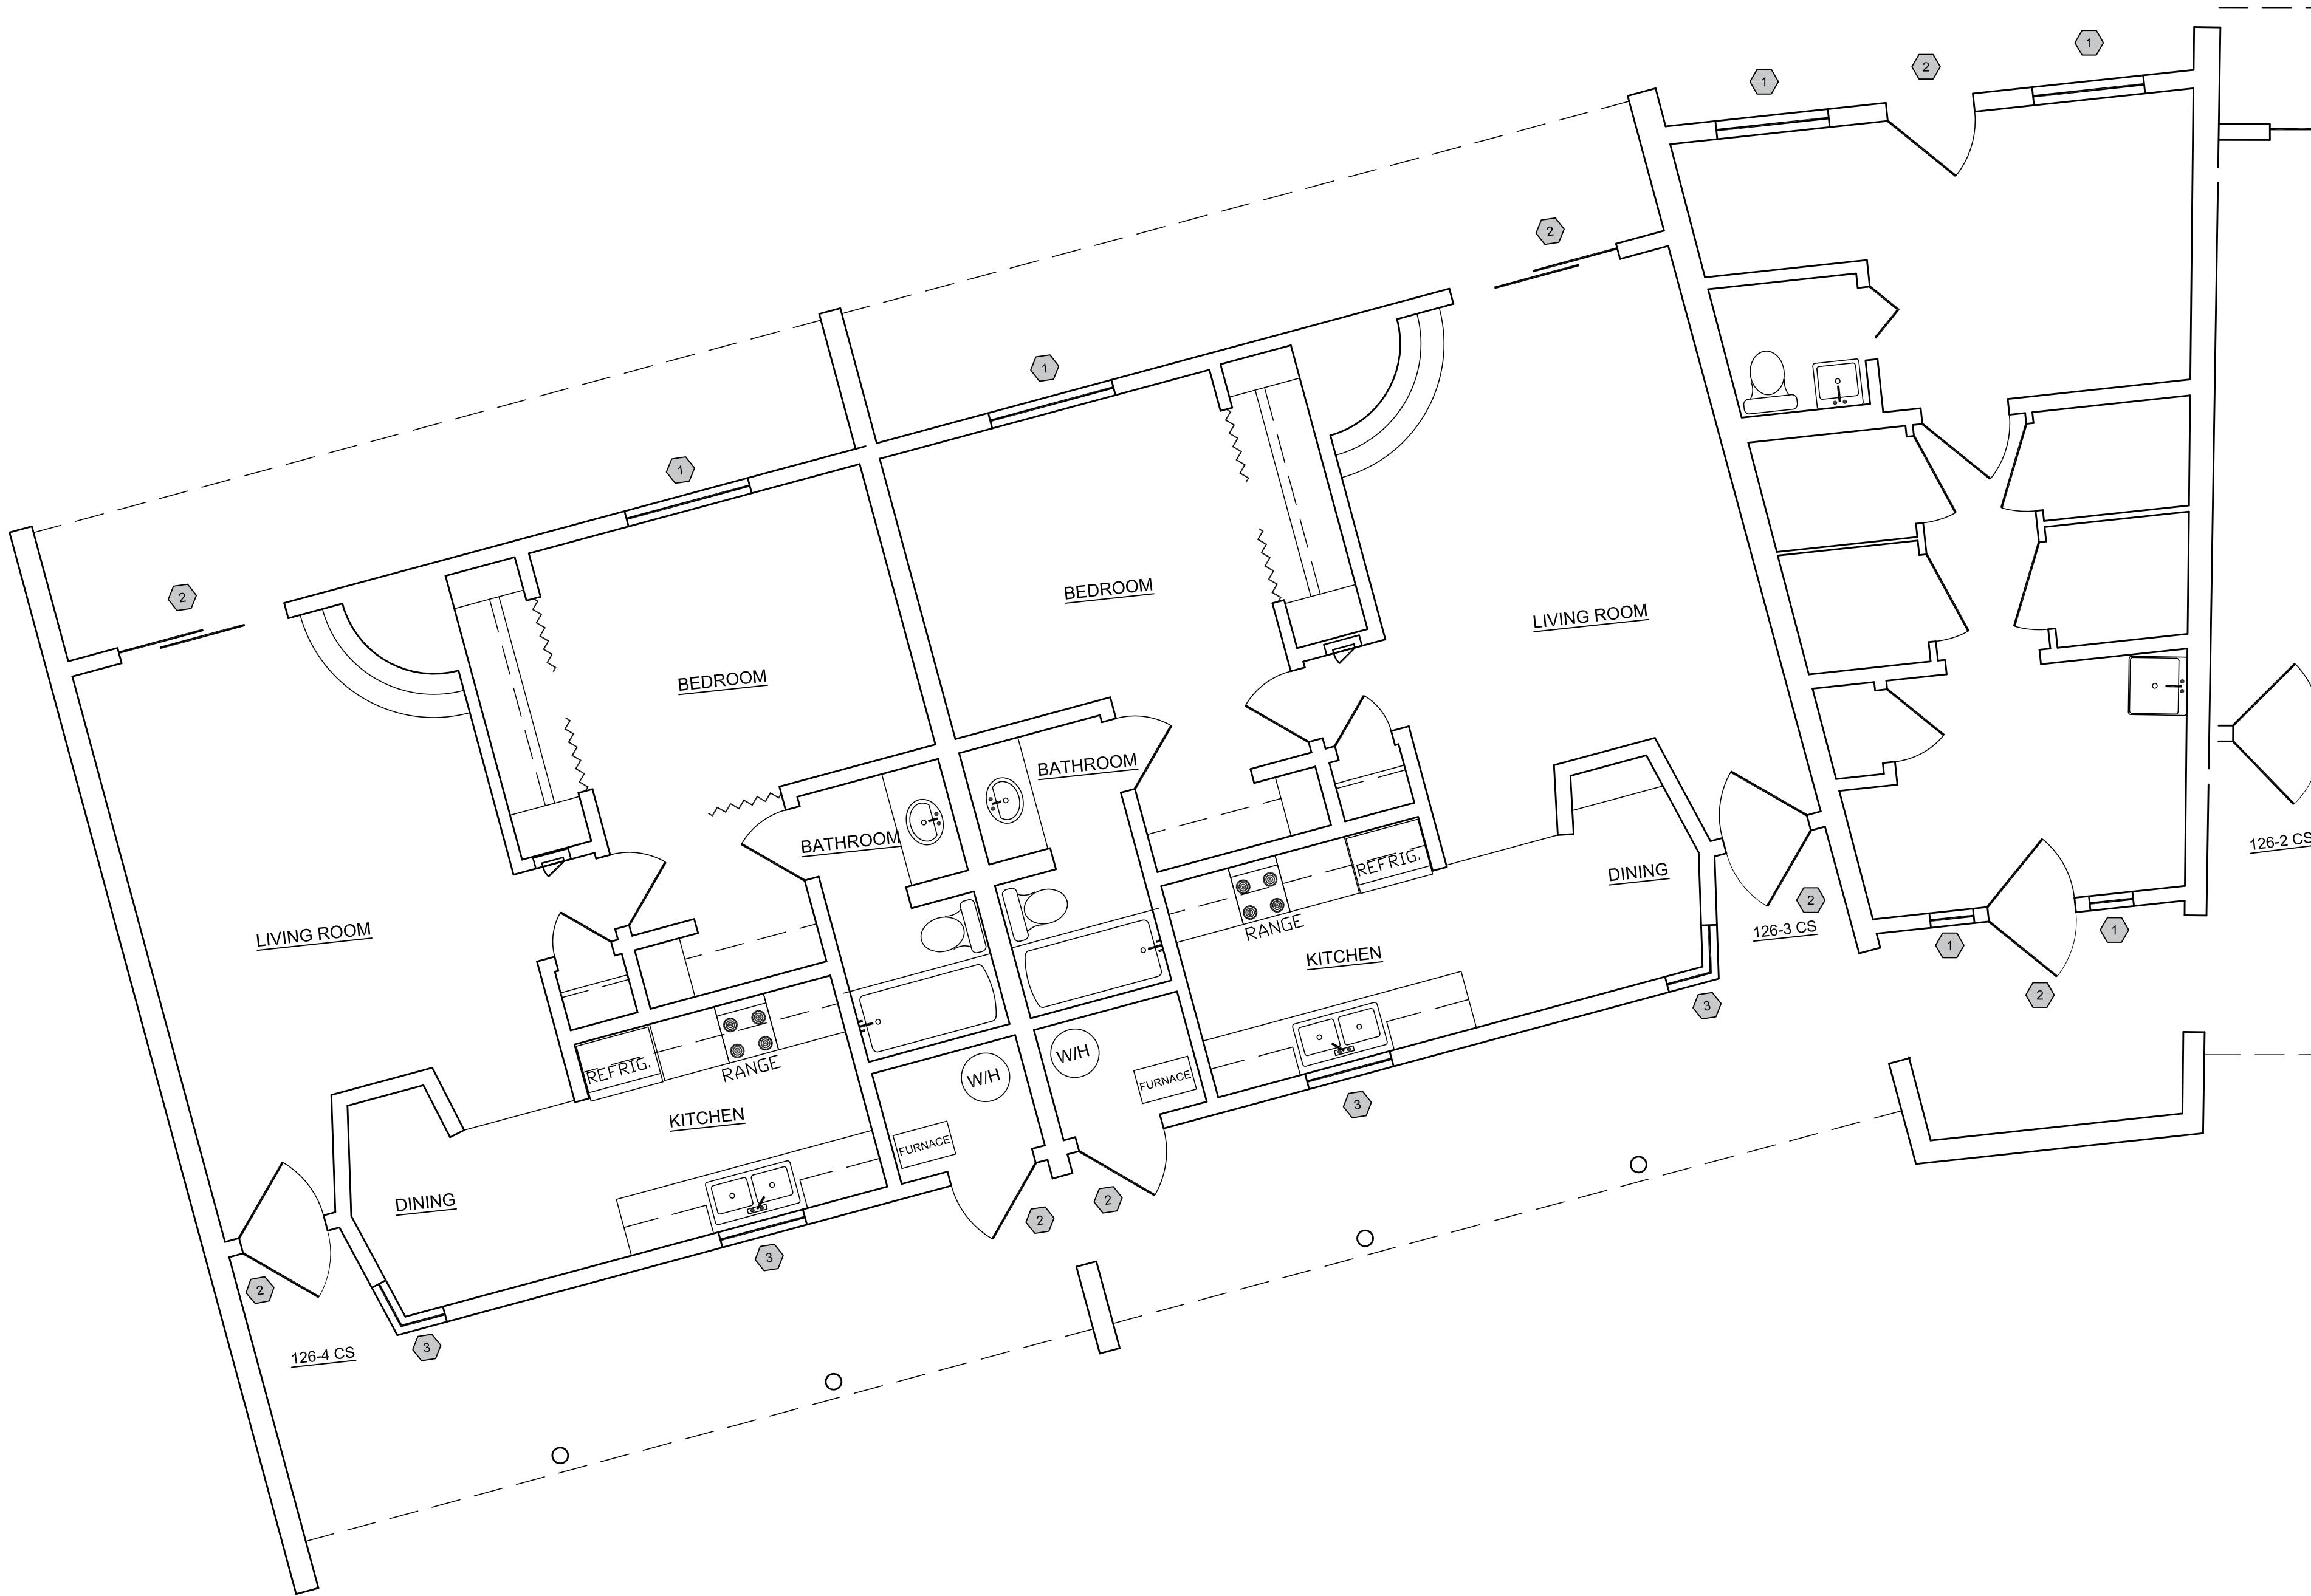
PROPOSED PLAN SHEET KEYED NOTES

1. EXISTING WINDOW TO BE REMOVED
2. EXISTING DOOR TO BE REMOVED
3. EXISTING WINDOW TO BE REMOVED AND REPLACED IN-KIND
4. EXISTING CARPORT TO BE REMOVED
5. EXISTING GARAGE TO BE REMOVED

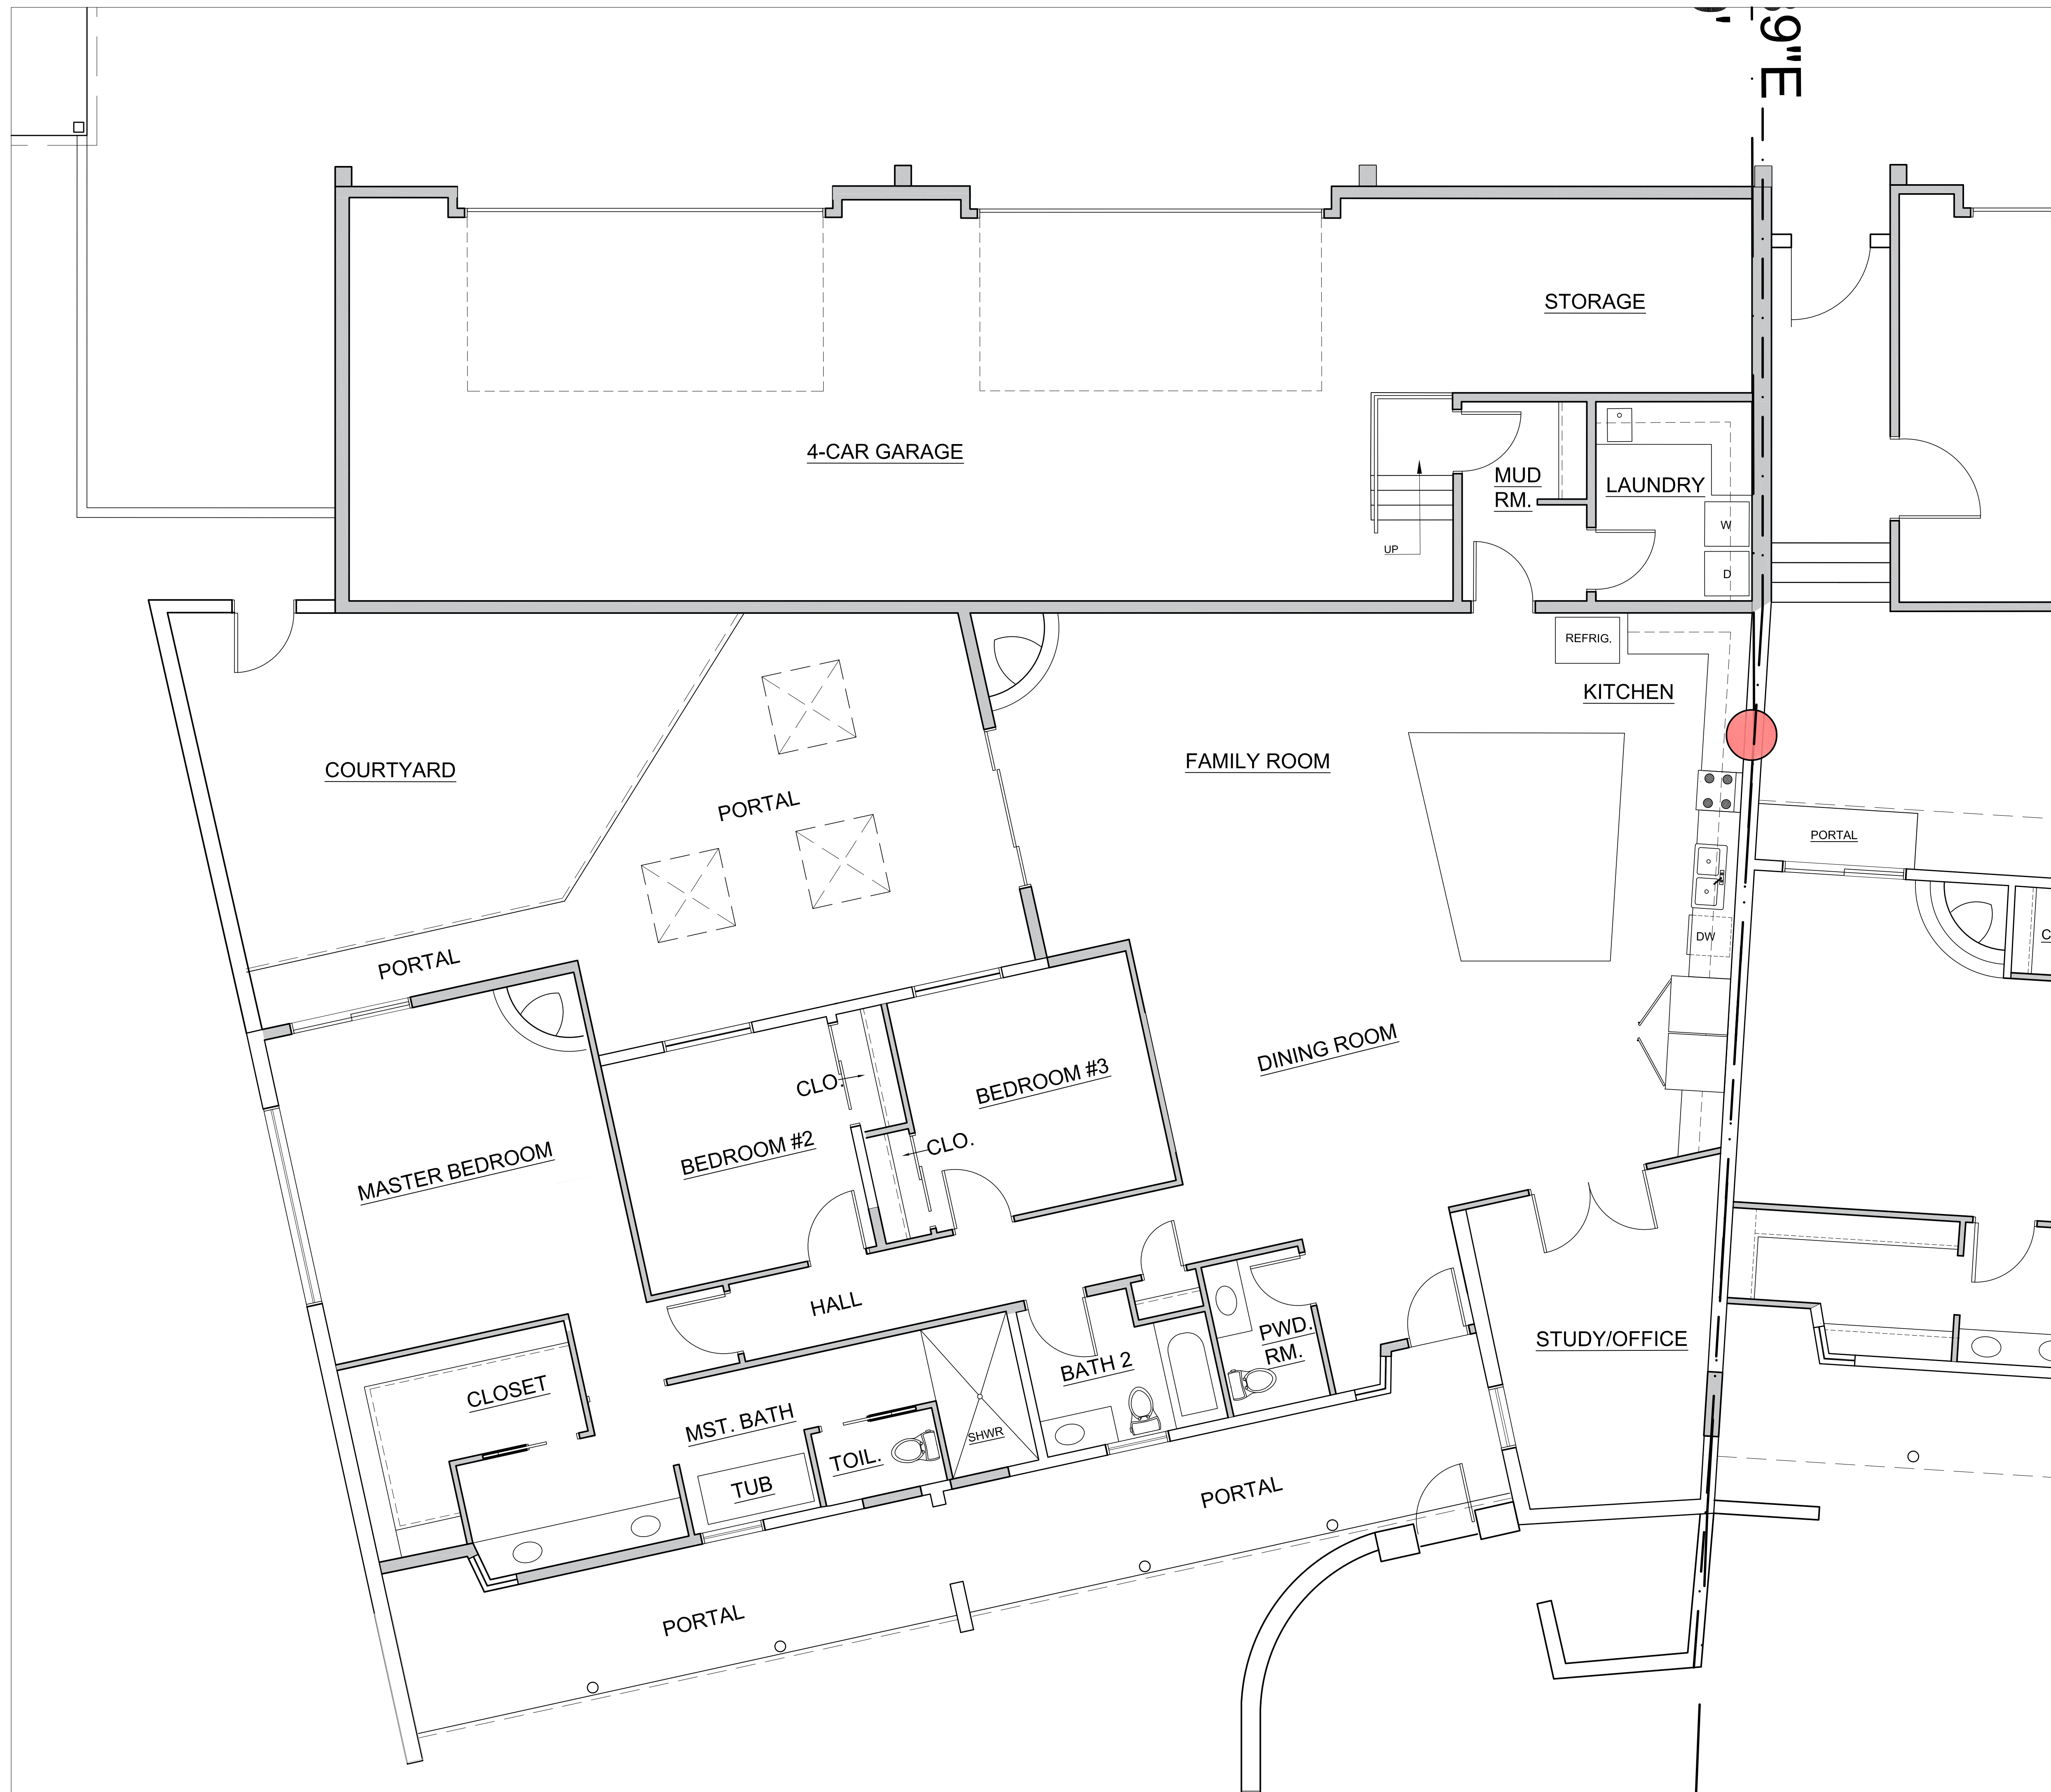
PROPOSED FLOOR PLAN

PROPOSED PLAN SHEET KEYED NOTES
 GENERAL:
 1.
