City of Santa Fe, New Mexico

memo

2024-009398-HDRB, 346 Hillside Ave., Downtown & Eastside Historic District, Contributing, Martinez Architecture Studio, agent for Martha Davis, owner, requests to alter a previous approval including removing a fireplace, changes to windows, doors, exterior stairs, patio, installing a water feature, HVAC, skylights, constructing fencing with pedestrian and vehicle gates to the maximum allowable height of 4'-11", and adding a standing seam metal roof. An exception is requested to 14-5.2(D)(6) for changing the roof material not in-kind.

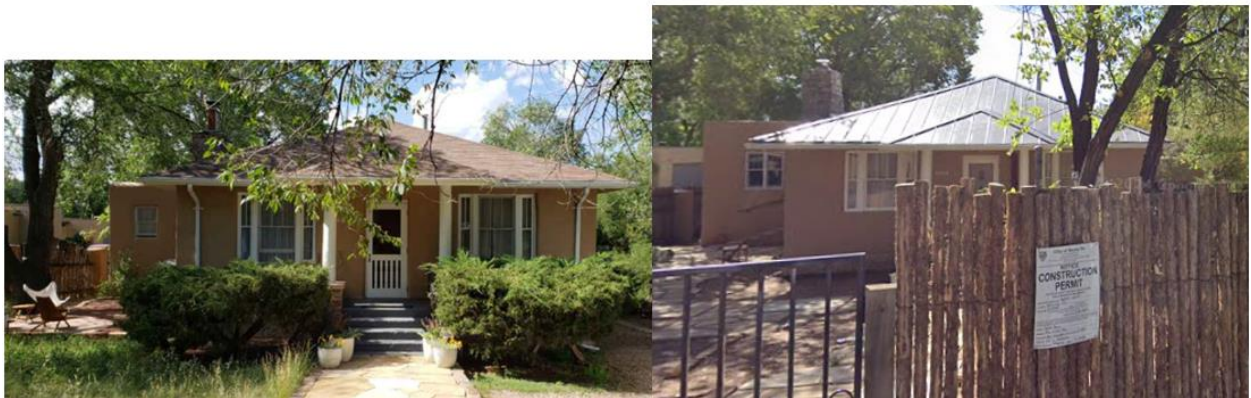
Figure 2: Pre (2022) and Post (2024) construction

The home was constructed around 1920 in a simplified craftsman bungalow style. The fenestration is symmetrical on the north elevation, with a front door flanked by large windows. The hipped roof had brick red asphalt shingles. The kitchen addition on the east elevation, constructed between 1948-1958, has a flat roof (see Figure 2).

In 2023, under case #2022-006237-HDRB the HDRB approved additions to the east and south elevations (non-primary), a portal on the south elevation and a deck and stone planters on the south elevation of the main residence. They further approved the removal of a portal on the south of the studio with an addition and portal to replace it. Later under case 2024-007809-ADMIN a roof mounted mini split system was added to the overall project.

During construction, the applicant made unauthorized changes to the board approved design (Case #2022-006237) and constructed items not previously considered or approved by the HDRB. On 10/25/2024 Historic Preservation inspectors issued a Stop Work Order (Red Tag) to the owner for the unauthorized alterations.

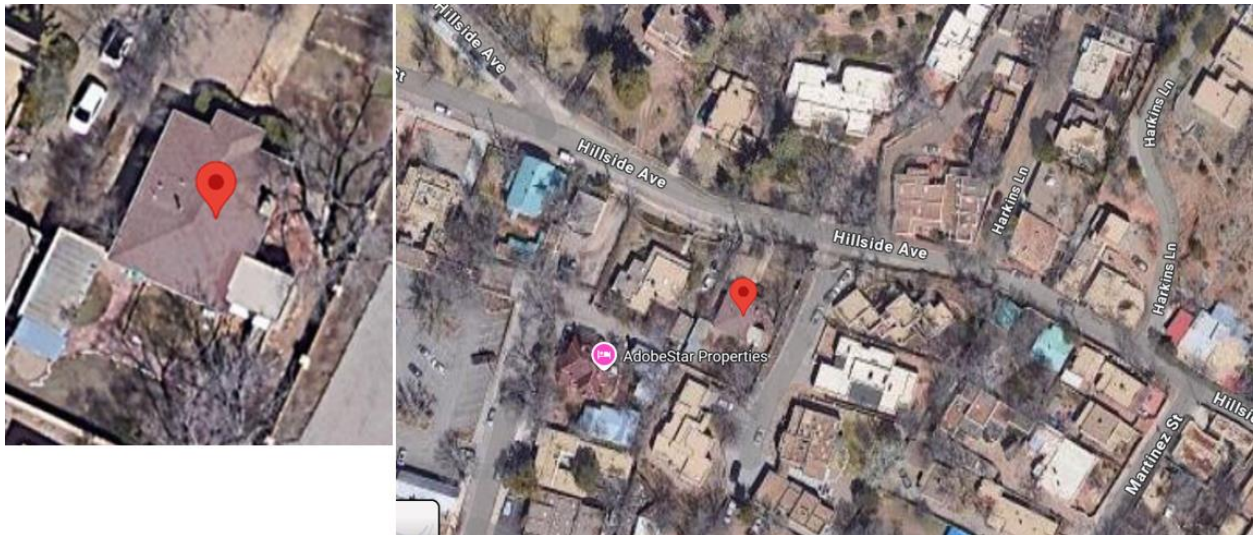
Figure 3: previous roof of structure and neighborhood roofs

Staff Response: Staff does not agree with this. While the roof shape and dimensions have not changed, the asphalt shingle roof was a reddish brown not a black in color and there is not a single black roof in the streetscape.

Changing the roof of the contributing structure further diverts from the character of the contributing building as there is no evidence that the roof material has ever been metal. The dark color of the metal roof is also not present on the streetscape. Therefore, staff recommends denial of the roofing material change for this contributing structure.
