City of Santa Fe, New Mexico

DATE: December 9, 2025
TO: Historic Districts Review Board Members
FROM: Heather Lamboy, Assistant Director, Planning & Land Use Department

2023-007596-HDRB. 406 Don Gaspar Ave. Downtown and Eastside Historic District. Contributing (office and garage buildings). Jennifer Jenkins, JenkinsGavin, Inc., agents for the State of New Mexico General Services Division, request demolition of the office building (previously a residence) and garage. Exceptions are requested to Sections 14-5.2(M)(3)(b), Contributing, Significant and Landmark Buildings for consideration of the loss of Historic Status, and 14-5.2(M)(4) Demolition of Historic and Landmark Structures within the State Capital Outlay Projects section of the code.

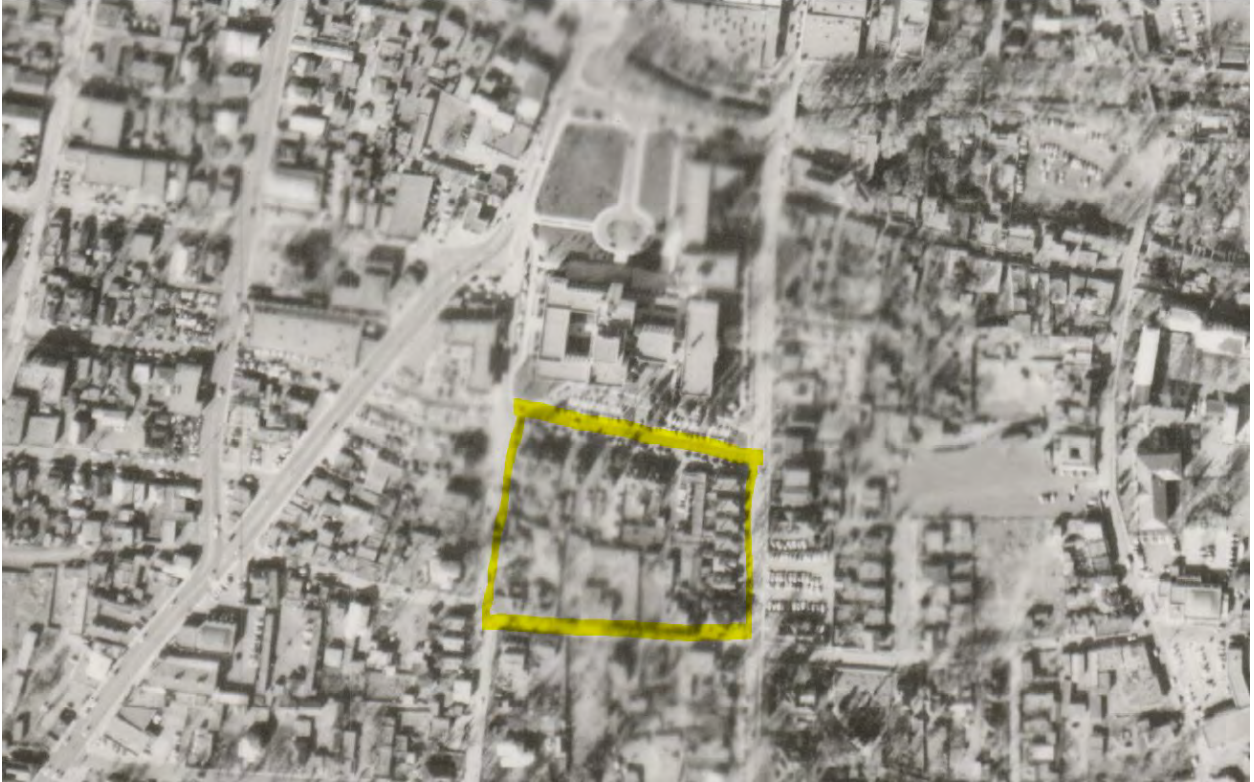
Figure 2 1957 Aerial

The aerial from 1957 illustrates how the State Capitol complex disrupted the neighborhood patterns of the Don Gaspar neighborhood, which started to develop to the north of the current Paseo de Peralta. One can see the development of a grid block pattern and detached single-family houses both within the block under consideration as well as across Don Gaspar at the site of the current Capitol building. The construction of the Paseo de Peralta divided this and adjacent bungalows from the Don Gaspar neighborhood.

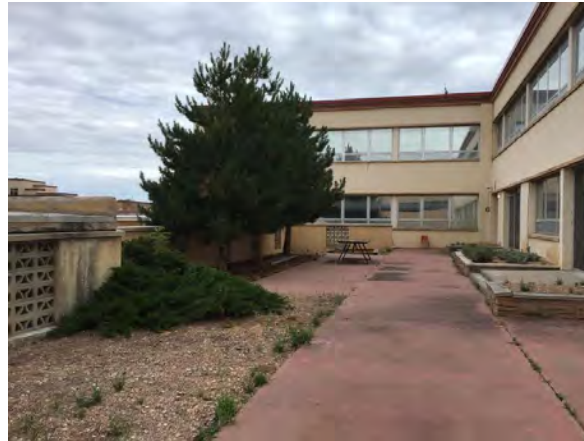
Project 01-001-00018.2004 · Site Improvements - Landscape

A landscaped and paved courtyard along the east side of the building is in poor condition.

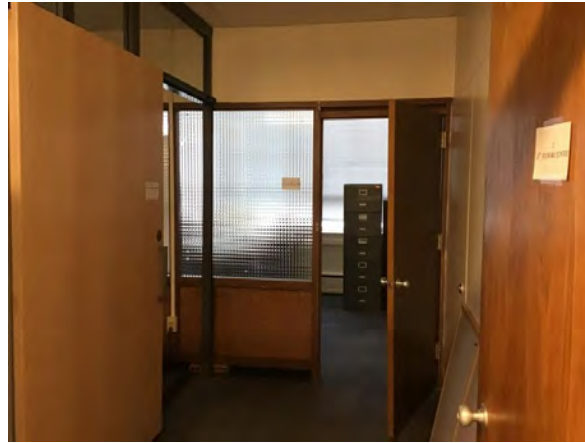
Project 01-001-00018.2008 · Interior Renovation

The building has a combination of traditional and open office spaces. Many of the first-floor offices are small and awkward due to the subdivision of larger areas into smaller individual offices. Various wall systems and finish materials create an incongruous hodgepodge of office spaces. The second floor is more cohesive regarding materials and finishes, but offices are small and cramped. Office furniture impedes clear pathways. The basement finishes are old and past their usable life span. The rooms in the basement are randomly furnished and finished.

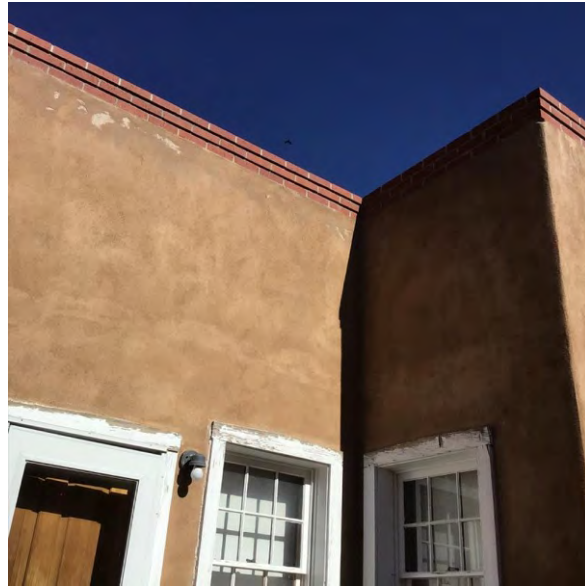
Project 01-001-00014.2003 · Exterior Building Improvements

The windows are single pane, broken, and painted shut. The stucco and paint are cracking and peeling. The building lacks exterior wall-mounted light fixtures.

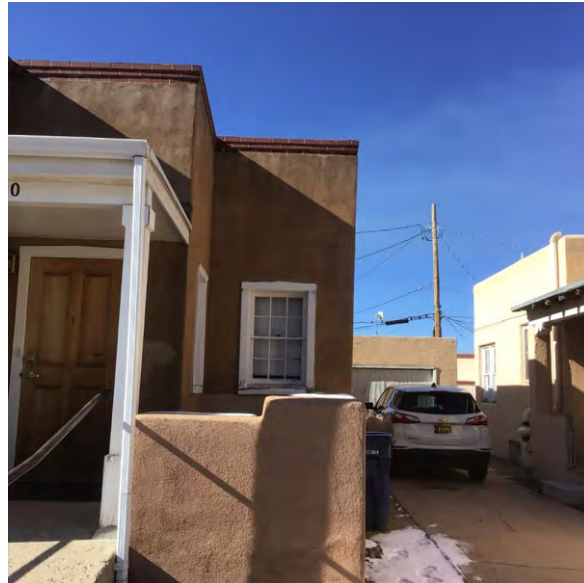
Project 01-001-00014.2004 · Security Upgrades

Facility: 410 Don Gaspar - Casita **IDNO:** 01-001-00014
Category: 4. **Type 1:** 05. **Type 2:** D06. **P/Class:** 3.

The building has no security alarm or surveillance system.

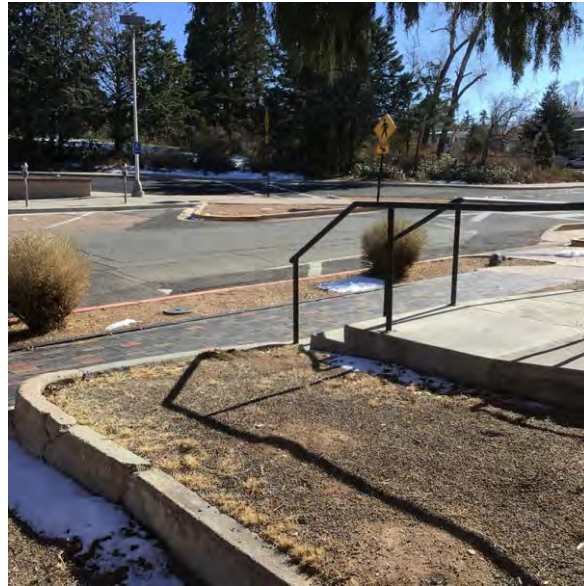
Project 01-001-00015.2002 · ADA Compliance: Site Work

Facility: 414 Don Gaspar - Casita **IDNO:** 01-001-00015
Category: 3. **Type 1:** 06. **Type 2:** A03.1. **P/Class:** 3.

The sidewalks are old, worn, weed-infested, and have settled, creating uneven walks that are not ADA compliant. The ramp at the building entrance is noncompliant. The ramp does not provide a 5' x 5' turn around space in two locations, handrails are noncompliant, and edge protection is absent.

Replace the sidewalks. Replace the ramp with an accessible ramp, including handrails. Replace the stairs, including handrails.

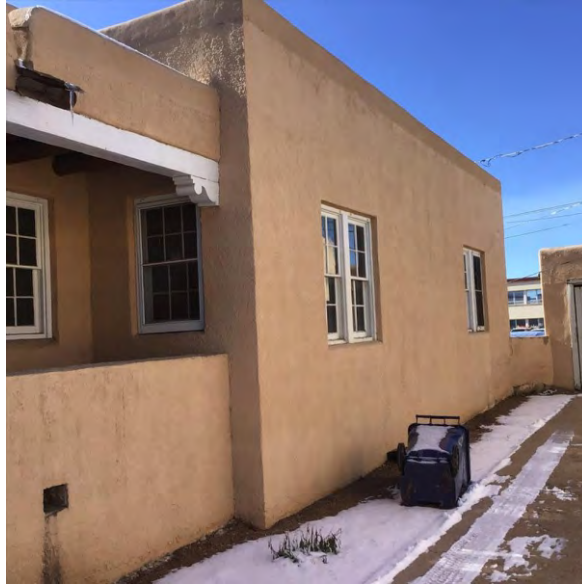
Project 01-001-00008.2001 · Exterior and Site Improvements

Facility: 414 Garage **IDNO:** 01-001-00008
Category: 4. **Type 1:** 05. **Type 2:** C02. **P/Class:** 3.

The garage door and the stucco on the garage are in poor condition. The concrete driveway is in poor condition.

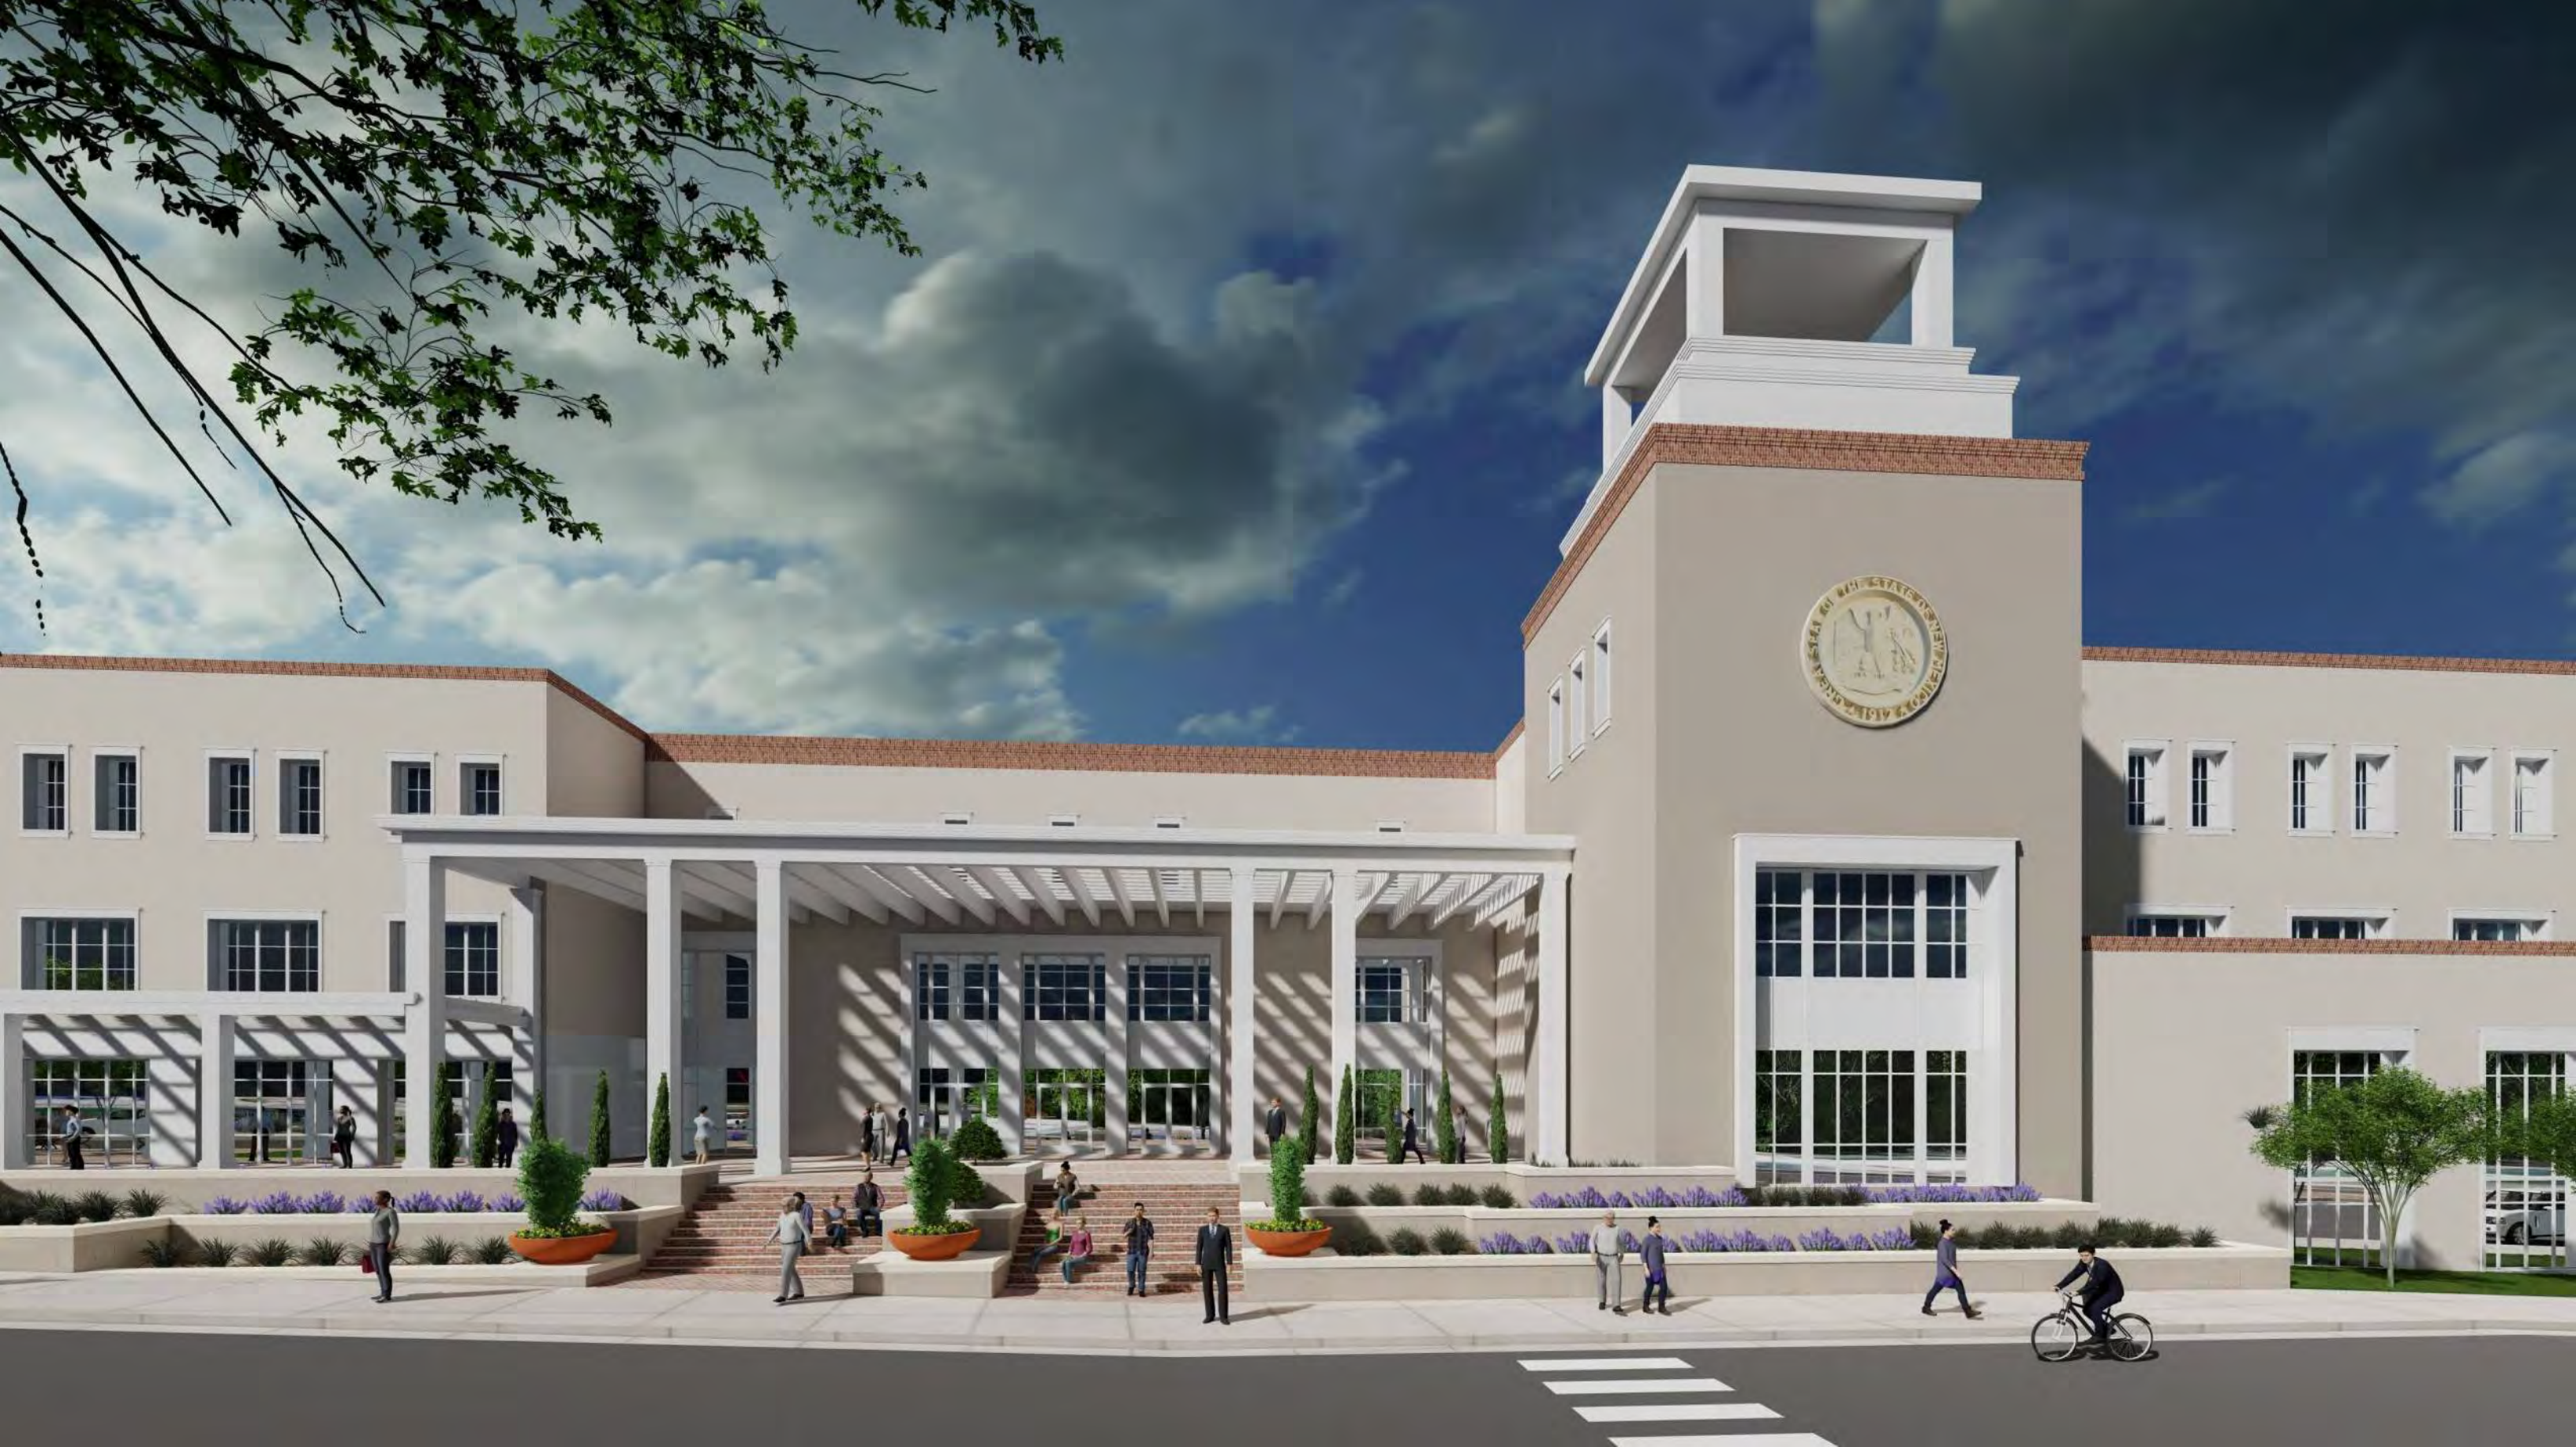
Main North Entry

STATE OF NEW MEXICO
Executive Office Building

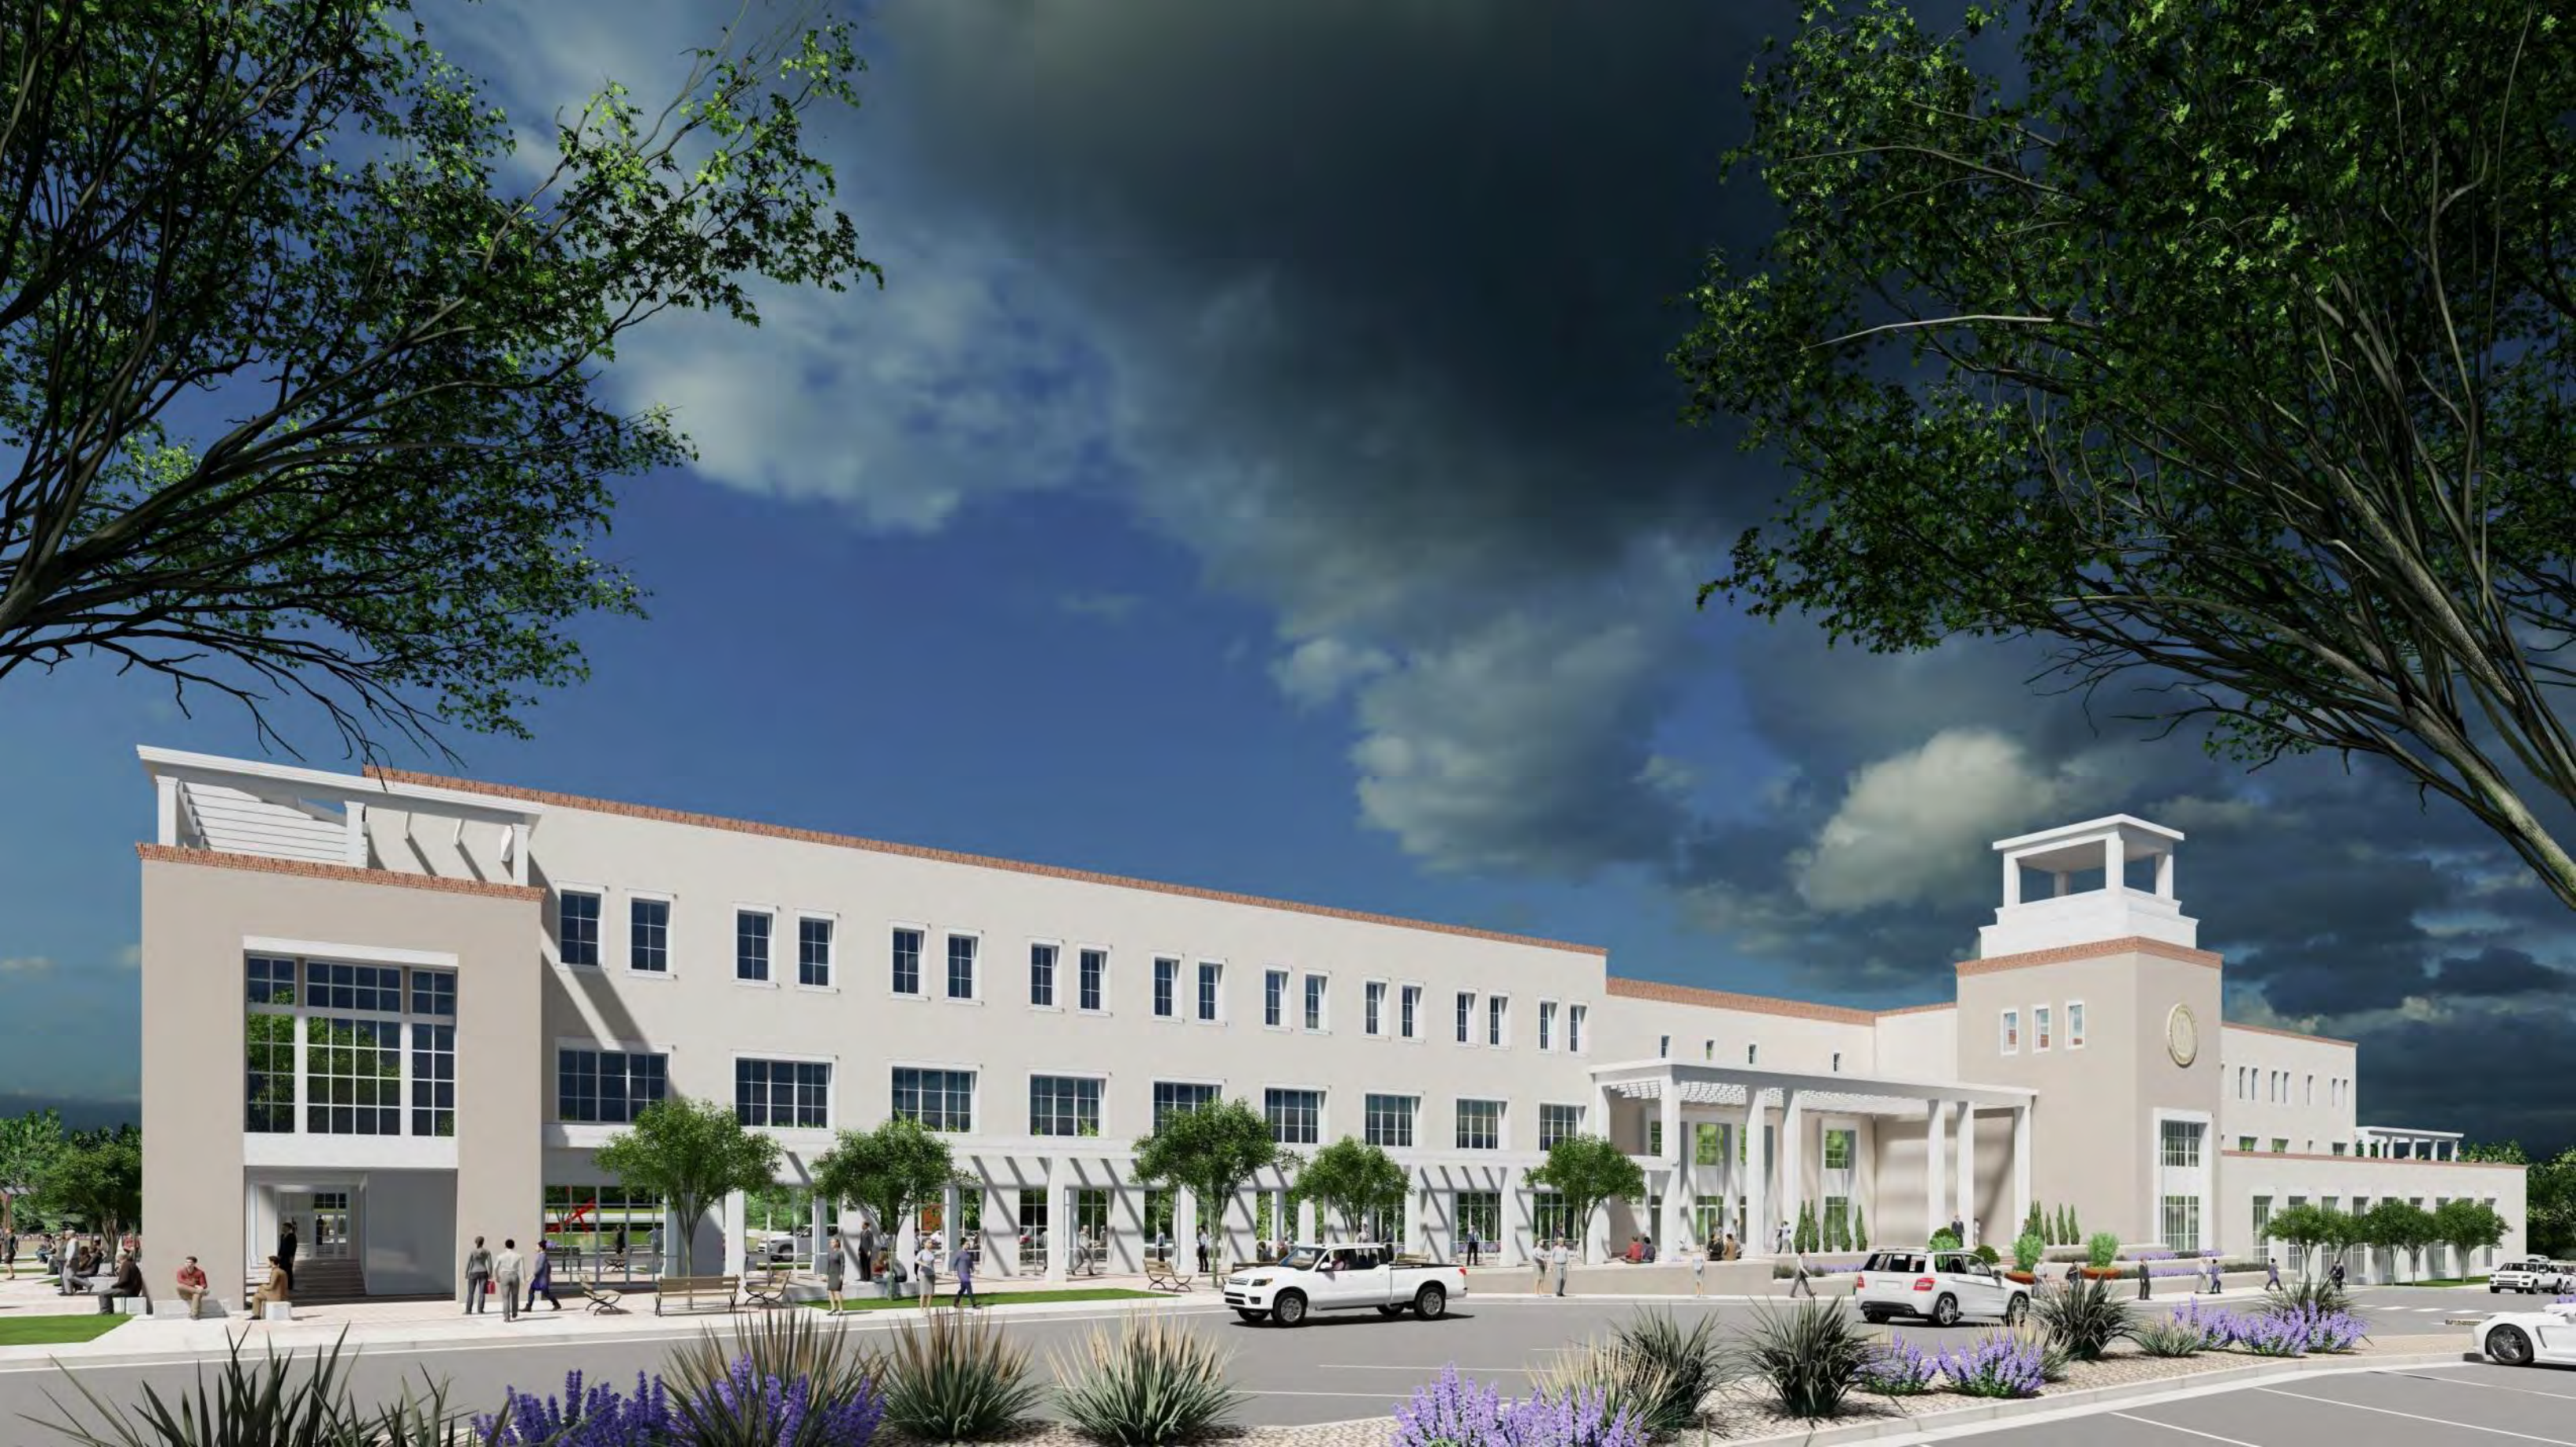
North Facade

STATE OF NEW MEXICO
Executive Office Building

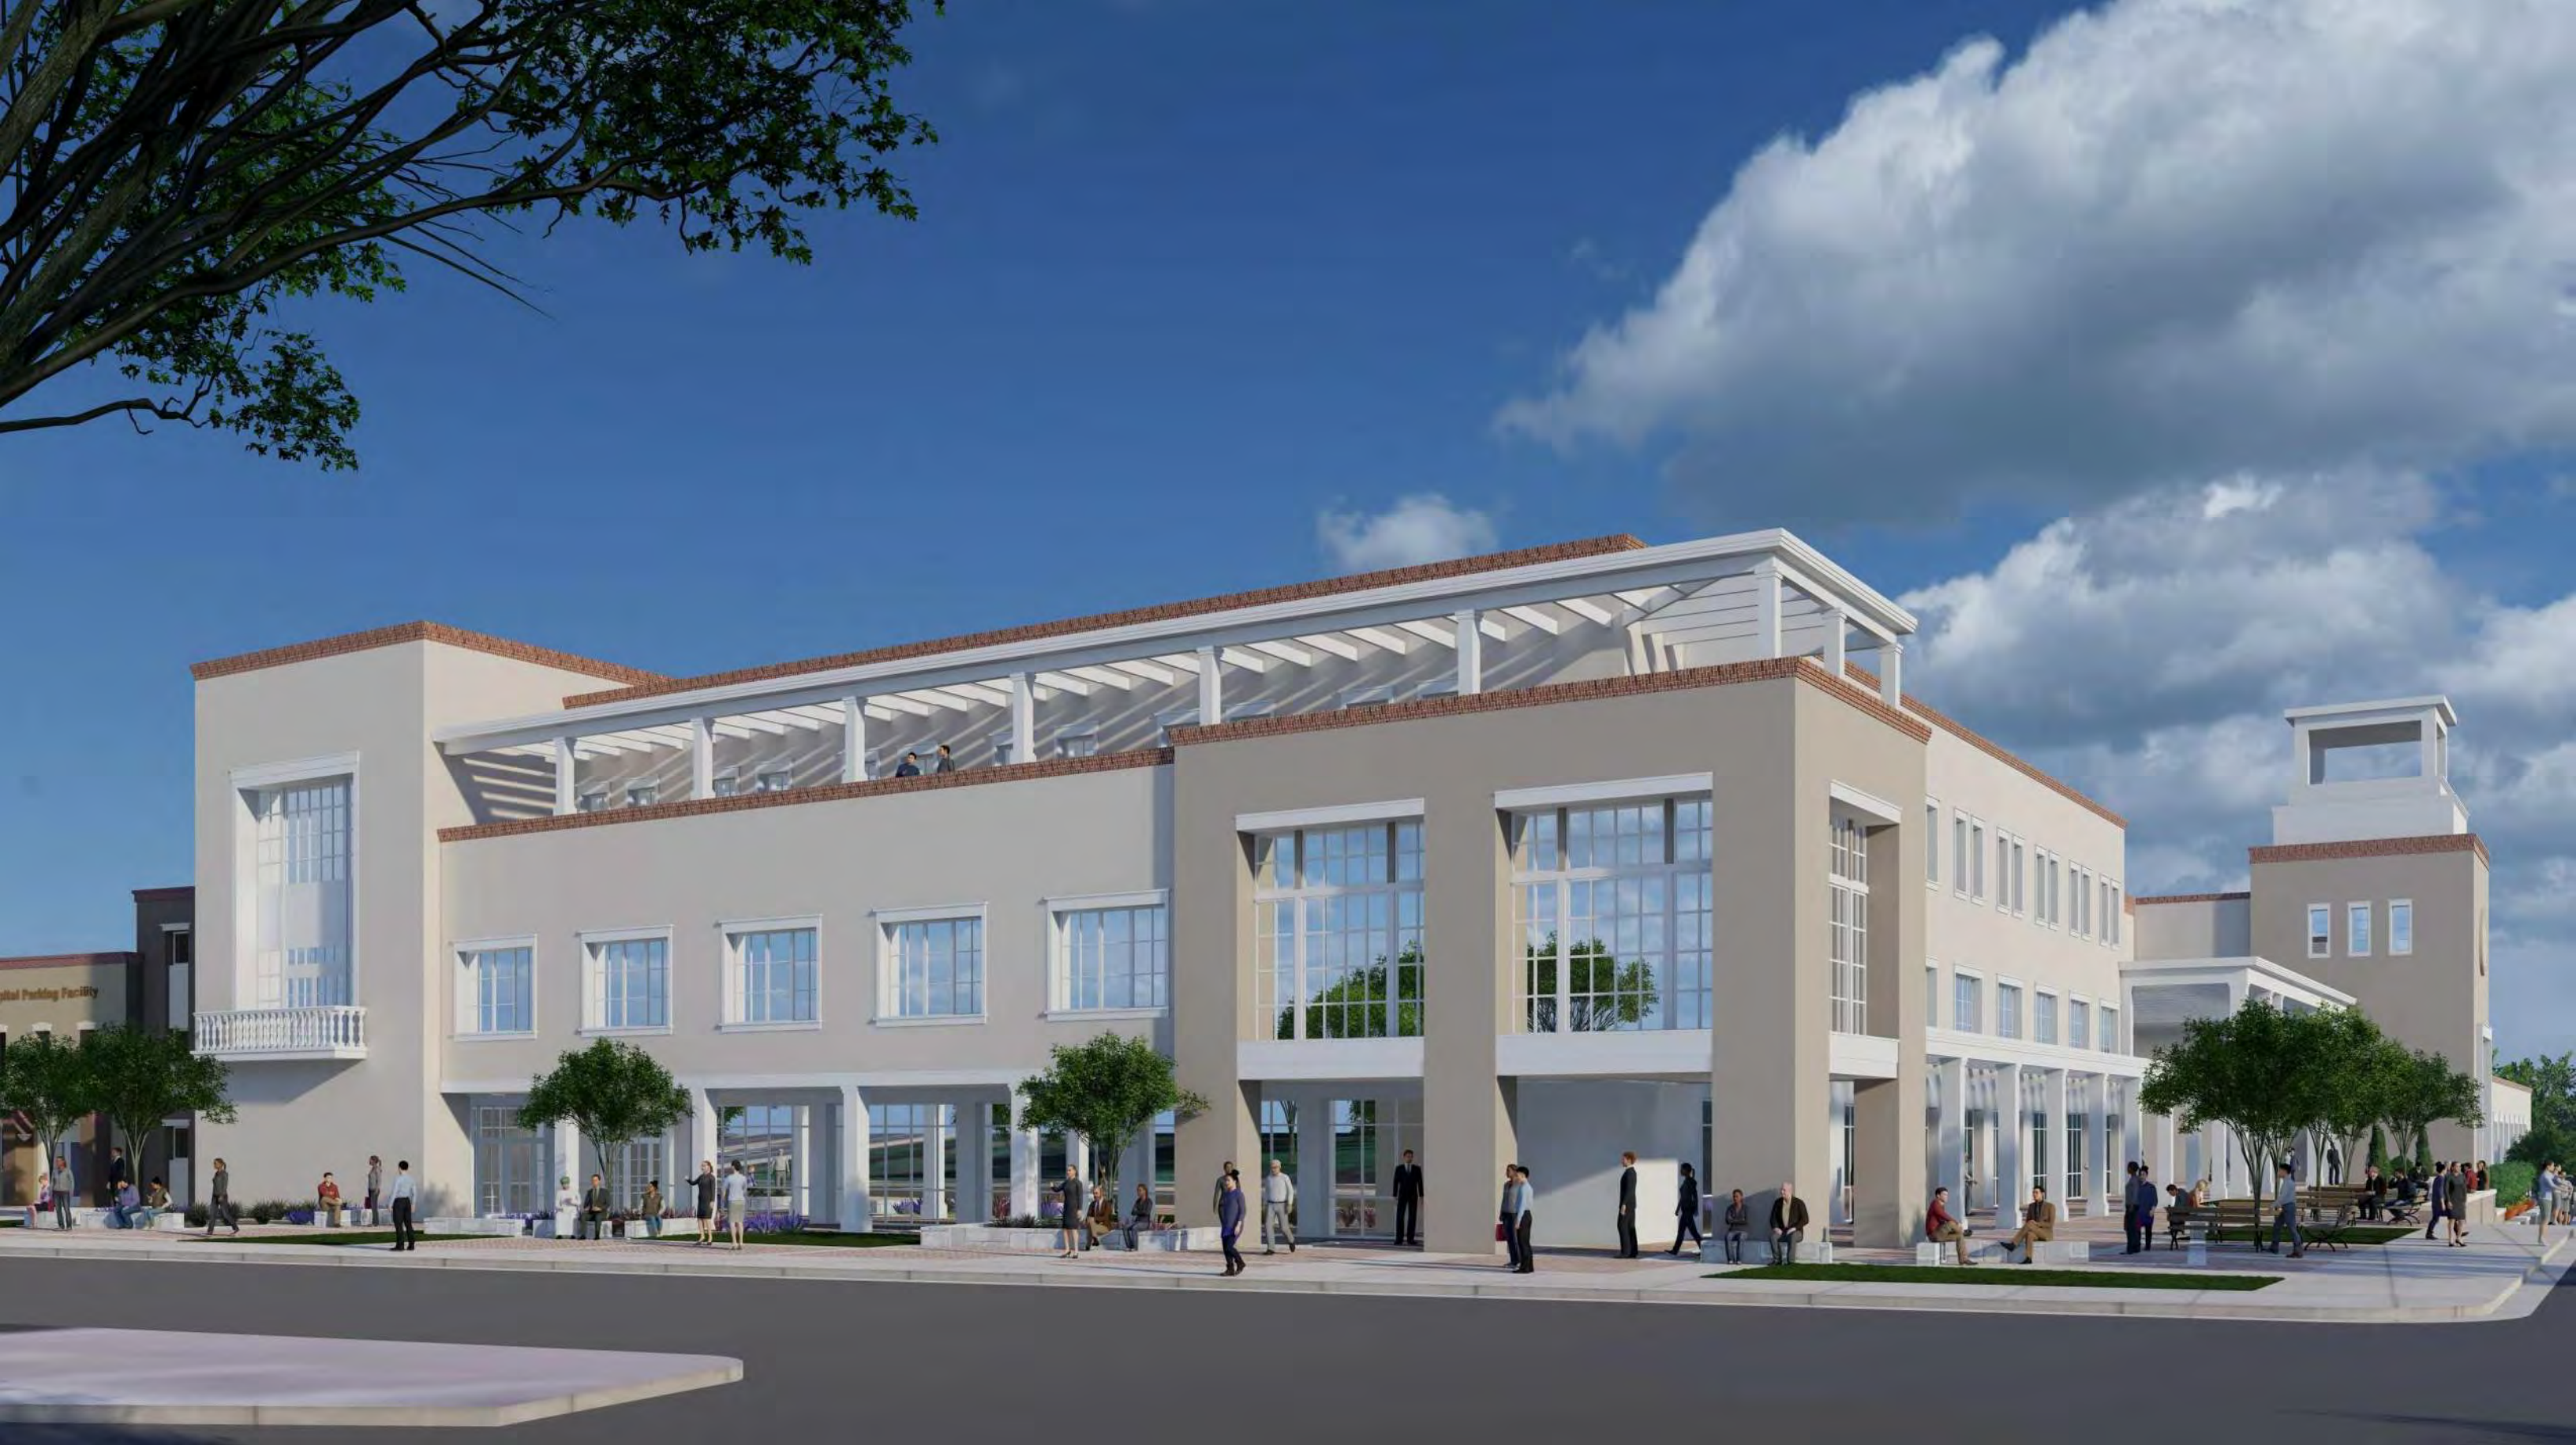
East Facade

STATE OF NEW MEXICO
Executive Office Building

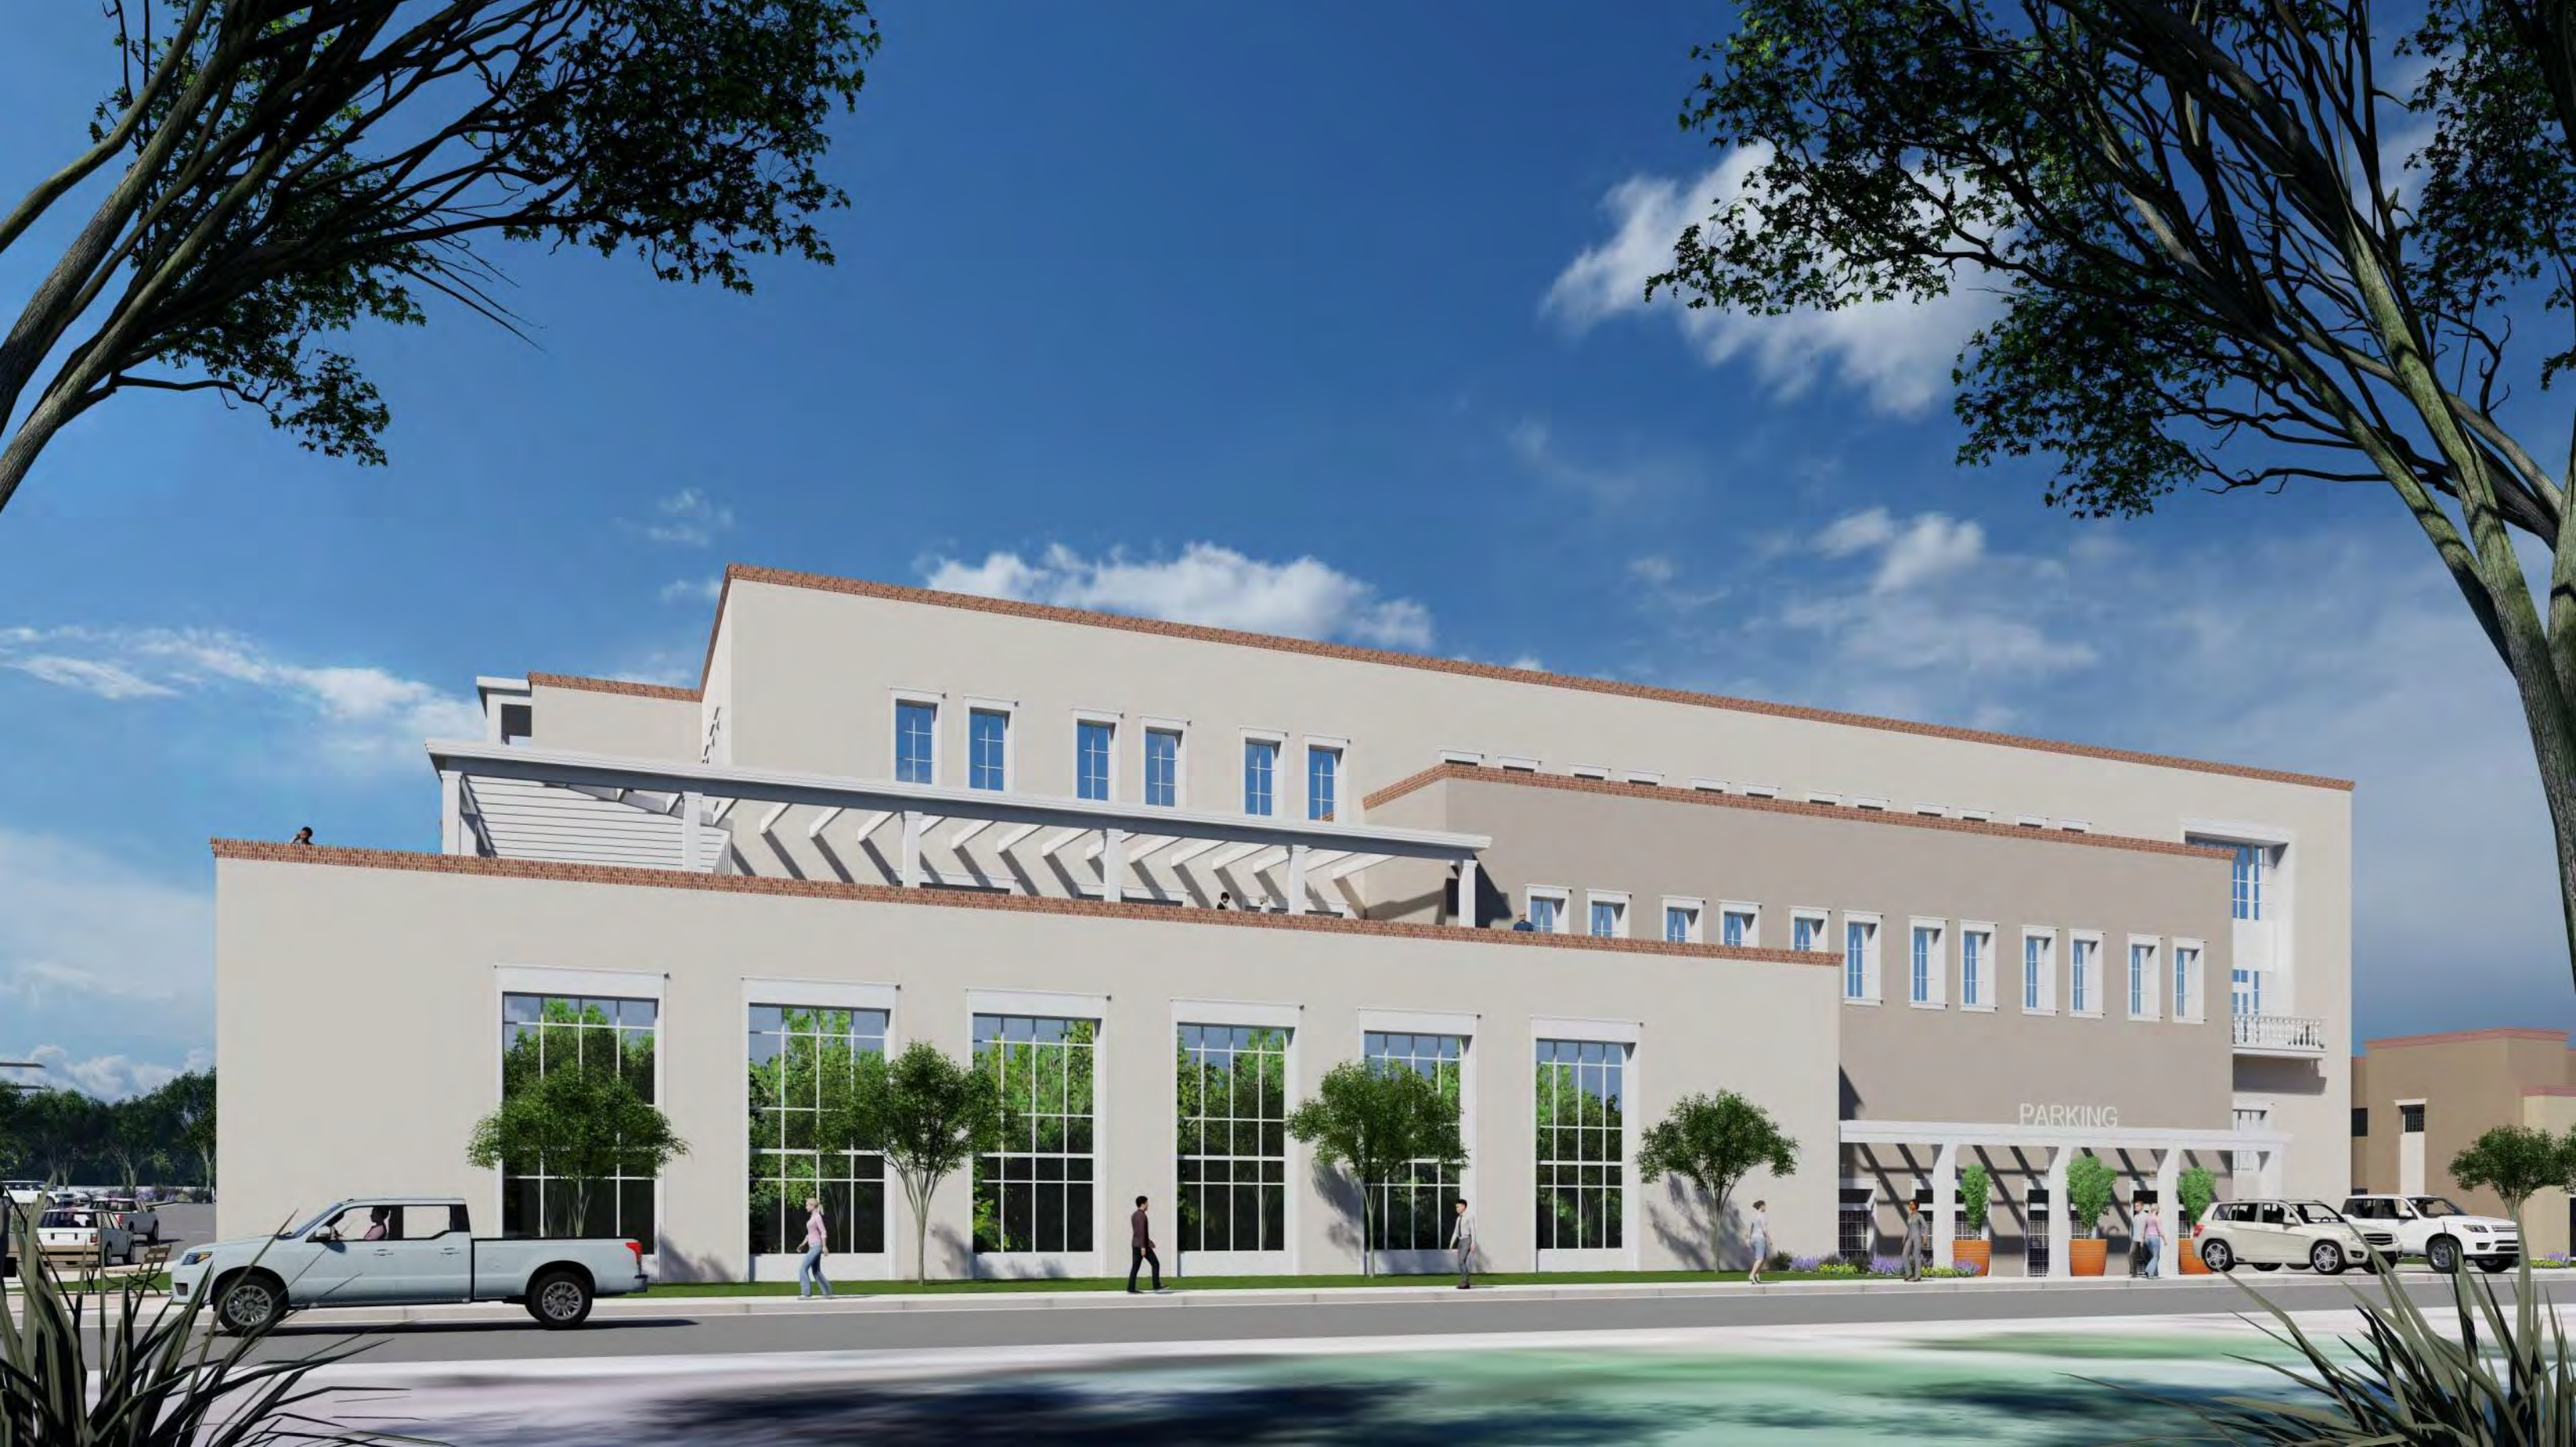
West Facade

STATE OF NEW MEXICO
Executive Office Building

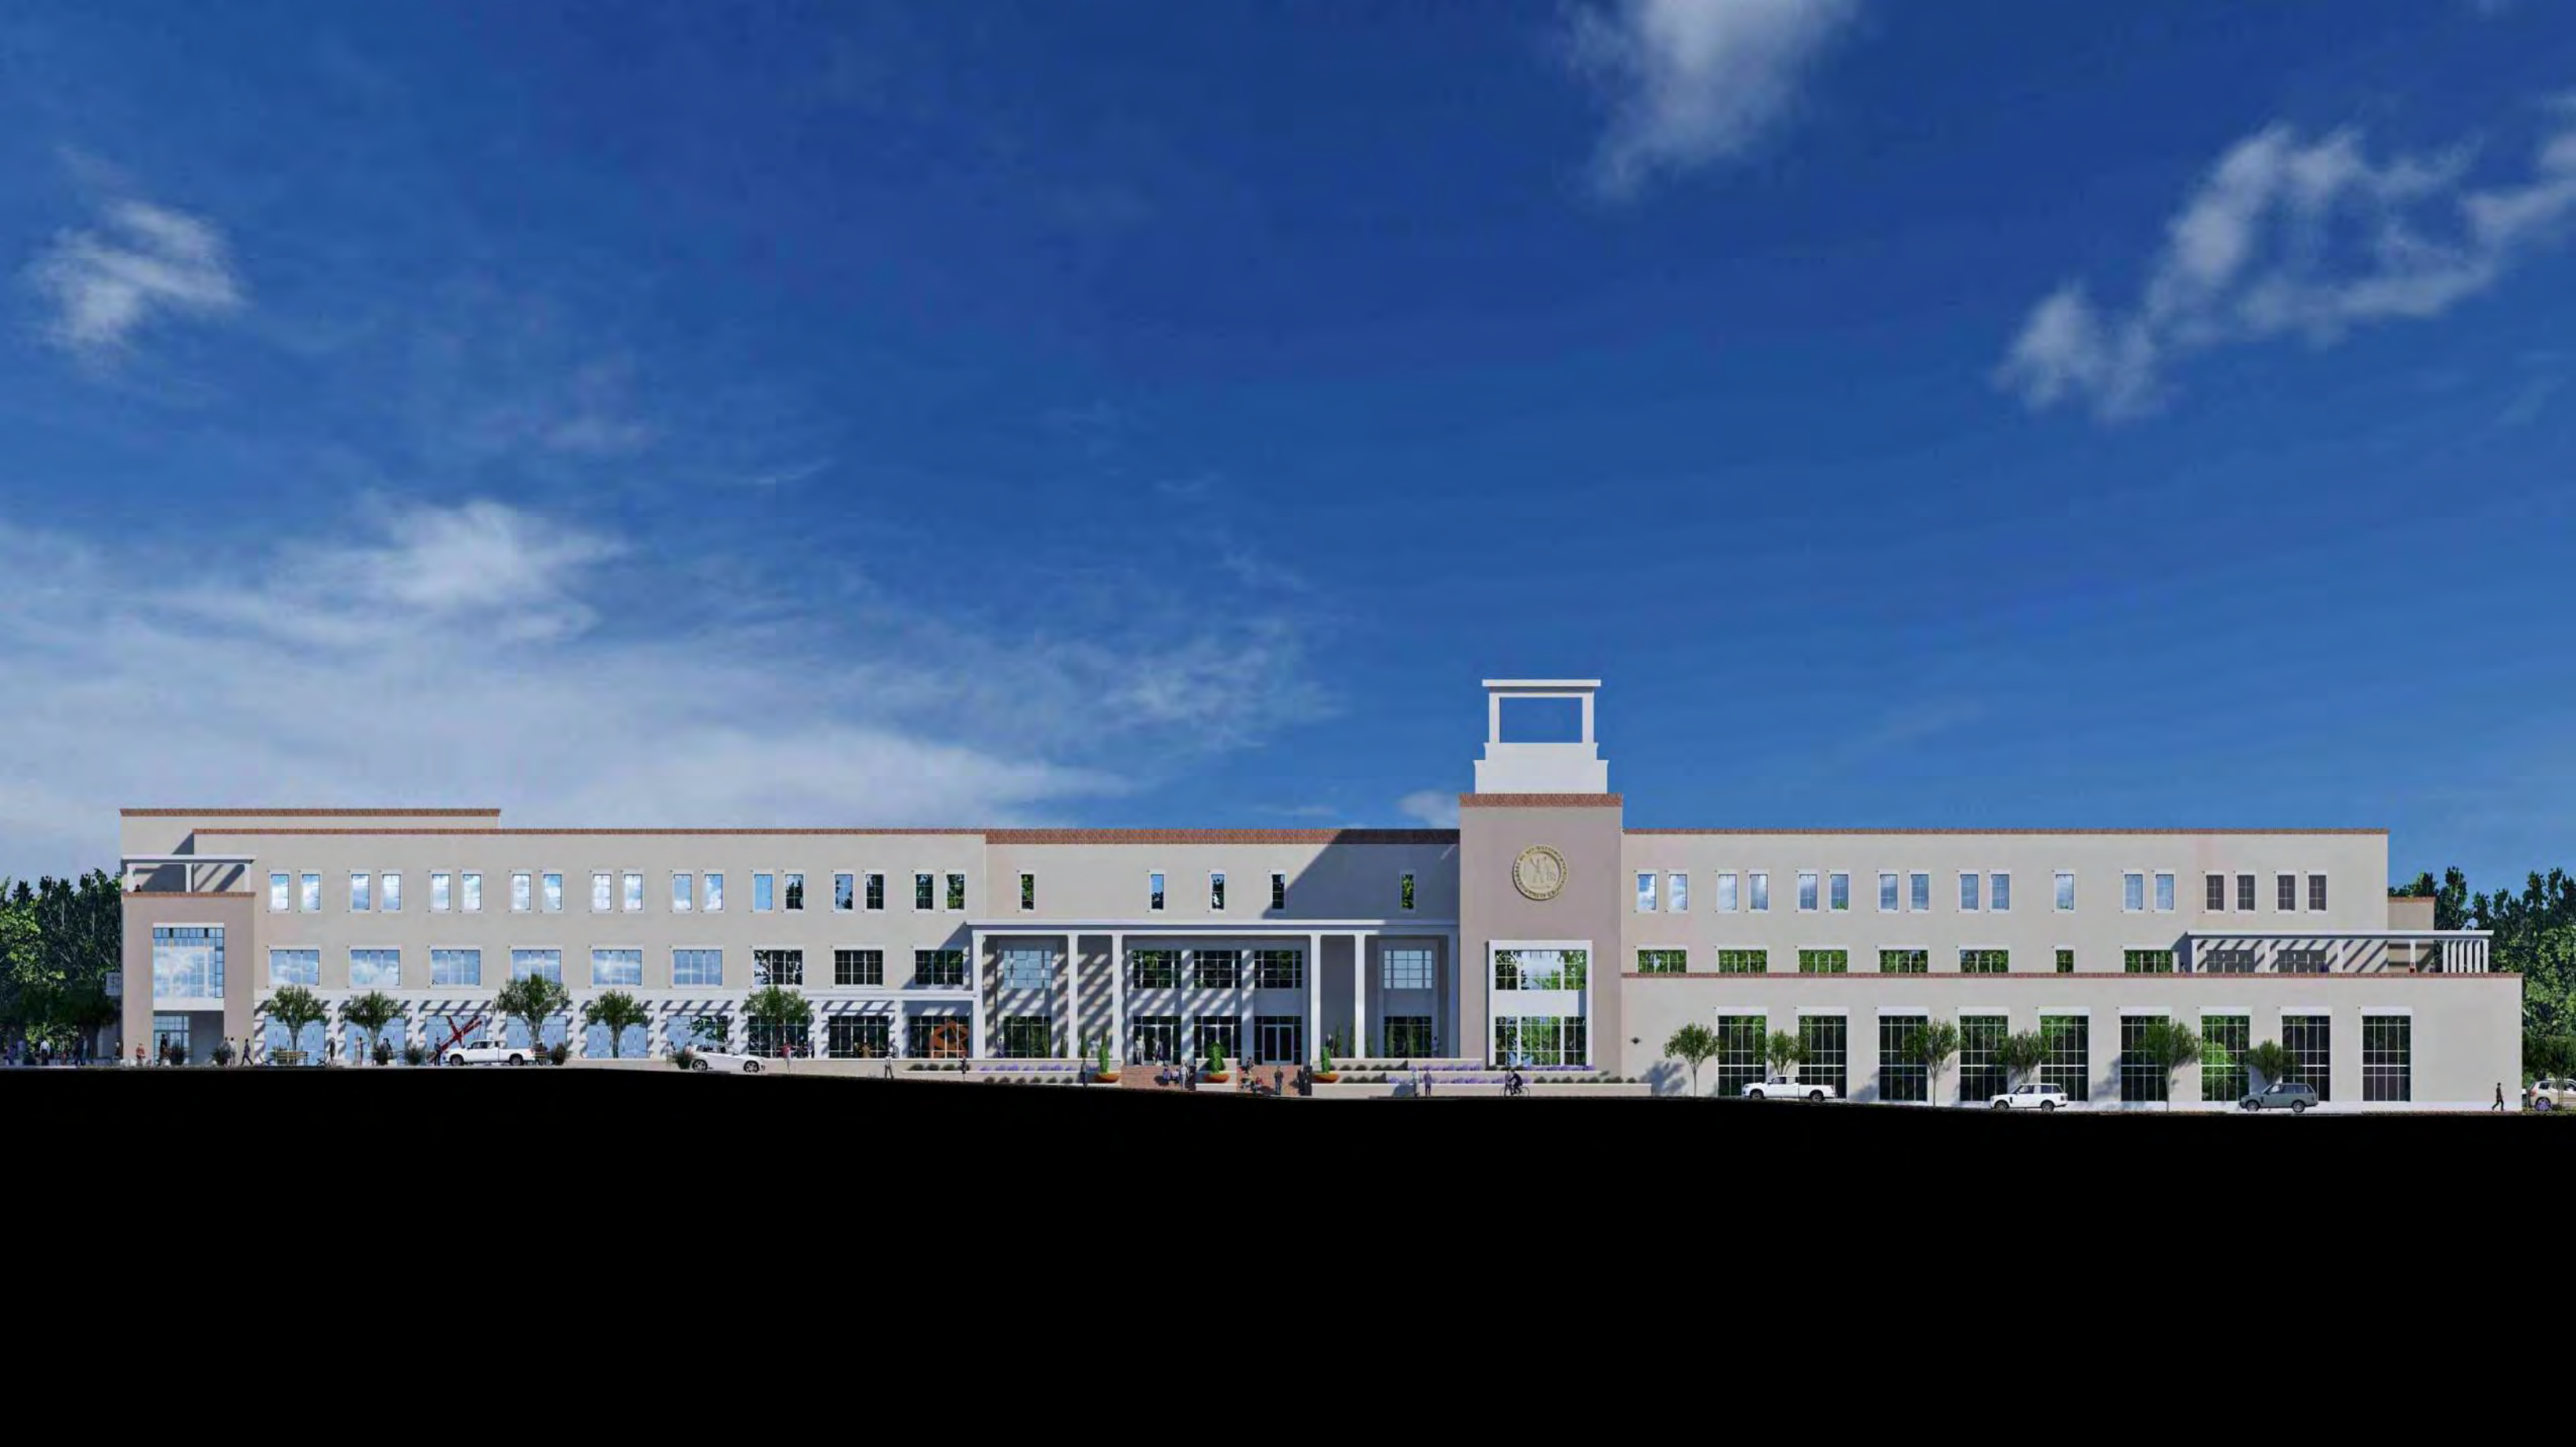
North Elevation

STATE OF NEW MEXICO
Executive Office Building
