City of Santa Fe, New Mexico

DATE: December 9, 2025
TO: Historic Districts Review Board Members
FROM: Heather Lamboy, Assistant Director, Planning & Land Use Department

2023-007596-HDRB. 406 Don Gaspar Ave. Downtown and Eastside Historic District. Contributing (office and garage buildings). Jennifer Jenkins, JenkinsGavin, Inc., agents for the State of New Mexico General Services Division, request demolition of the office building (previously a residence) and garage. Exceptions are requested to Sections 14-5.2(M)(3)(b), Contributing, Significant and Landmark Buildings for consideration of the loss of Historic Status, and 14-5.2(M)(4) Demolition of Historic and Landmark Structures within the State Capital Outlay Projects section of the code.

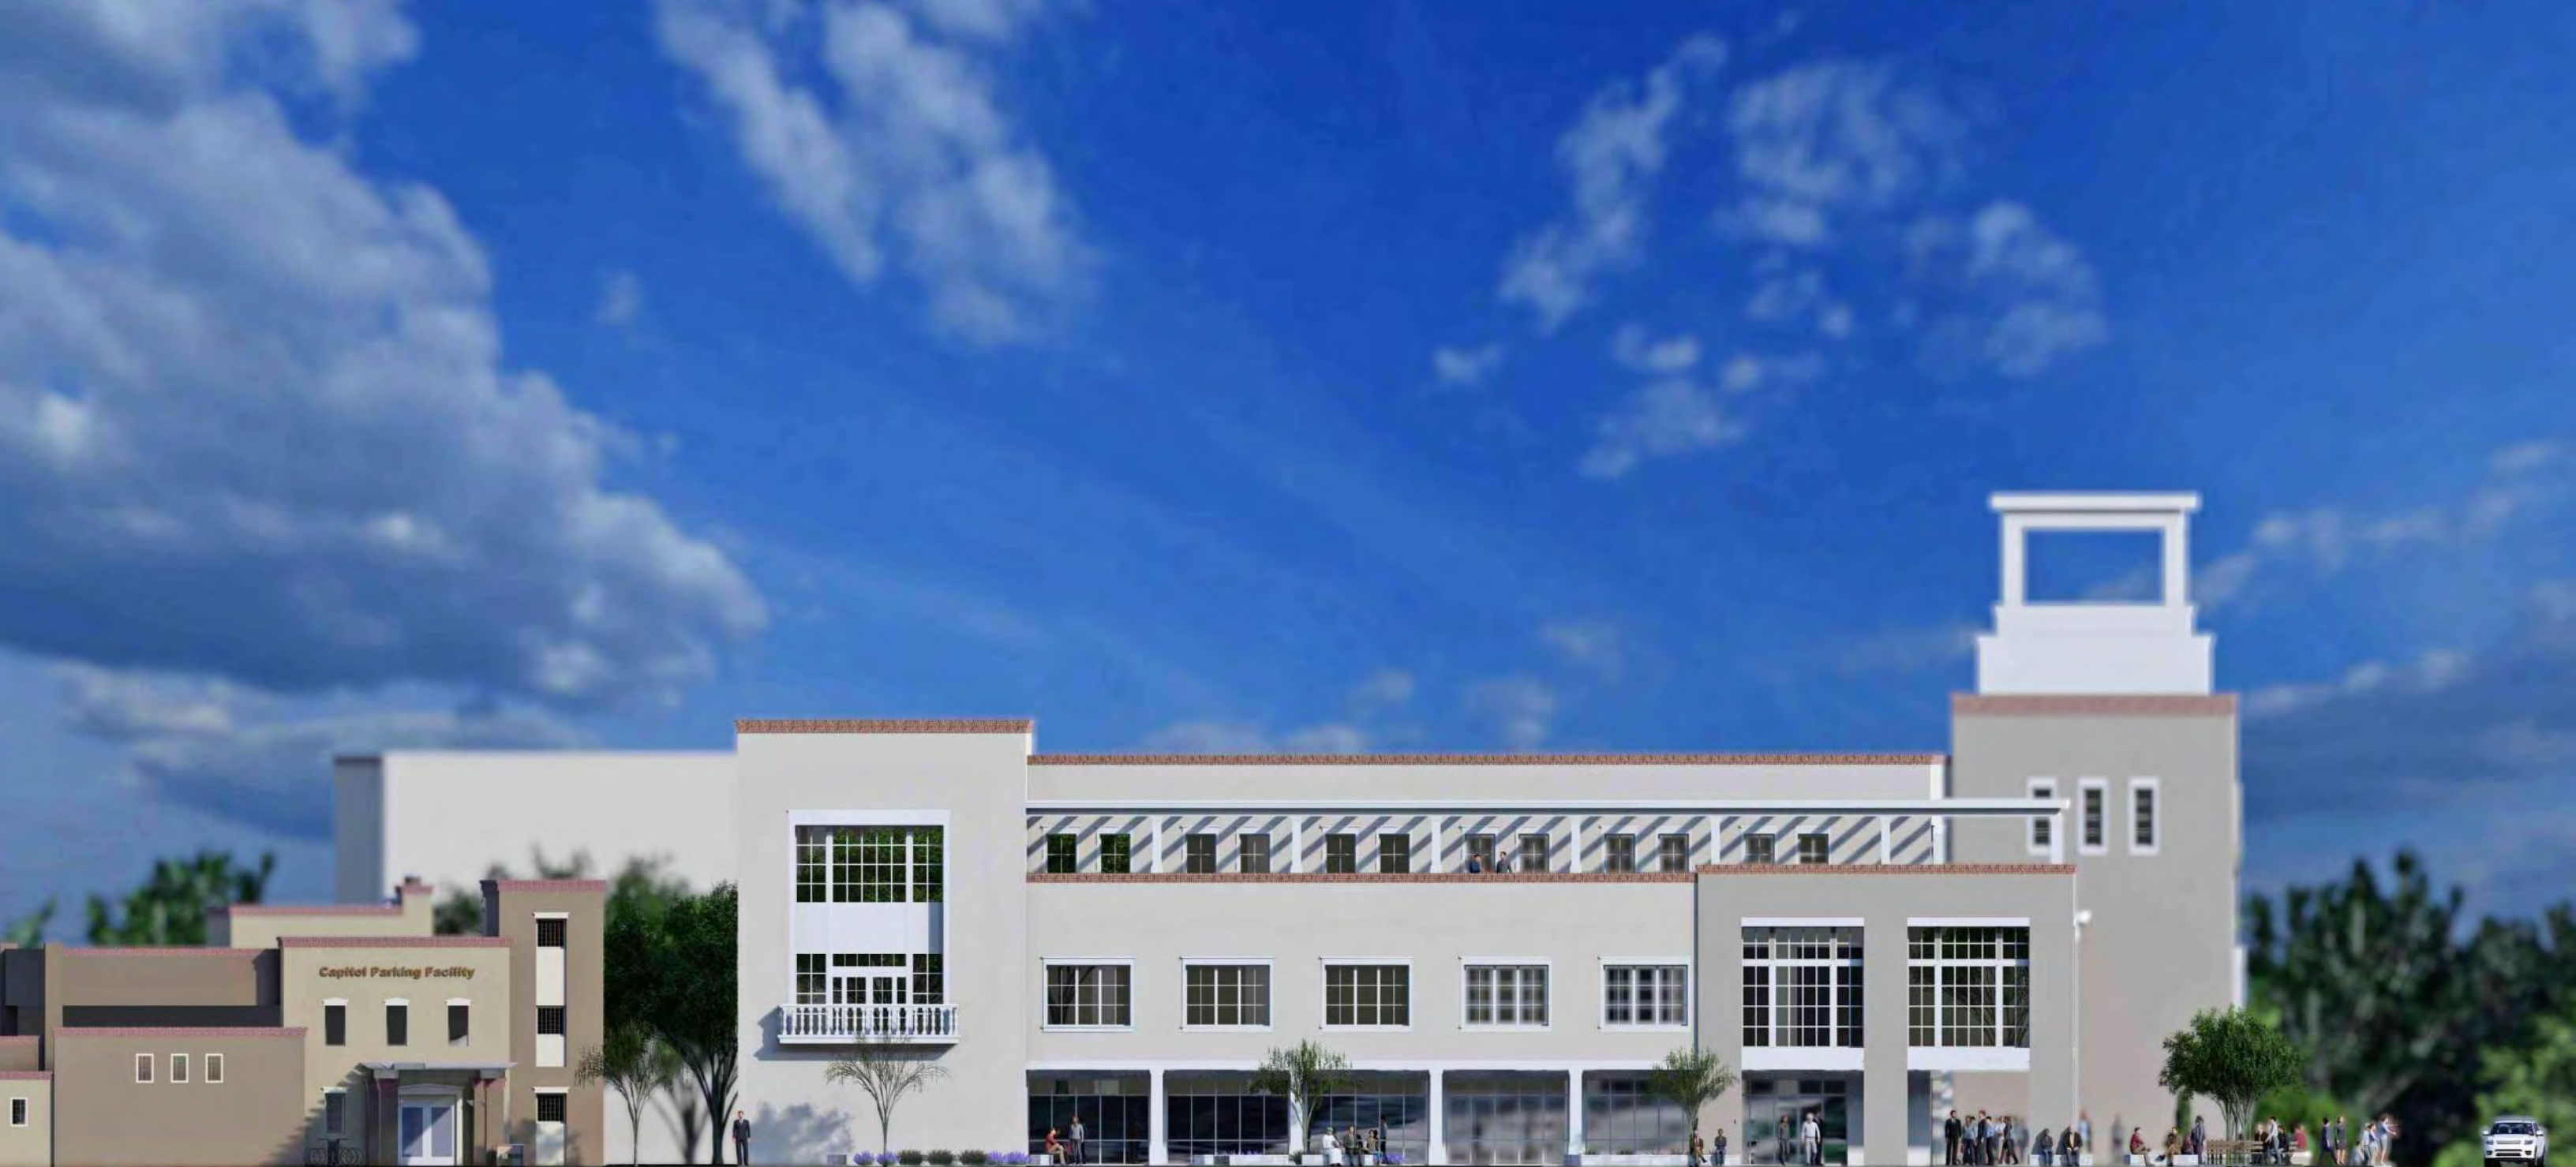
East Elevation

STATE OF NEW MEXICO
Executive Office Building

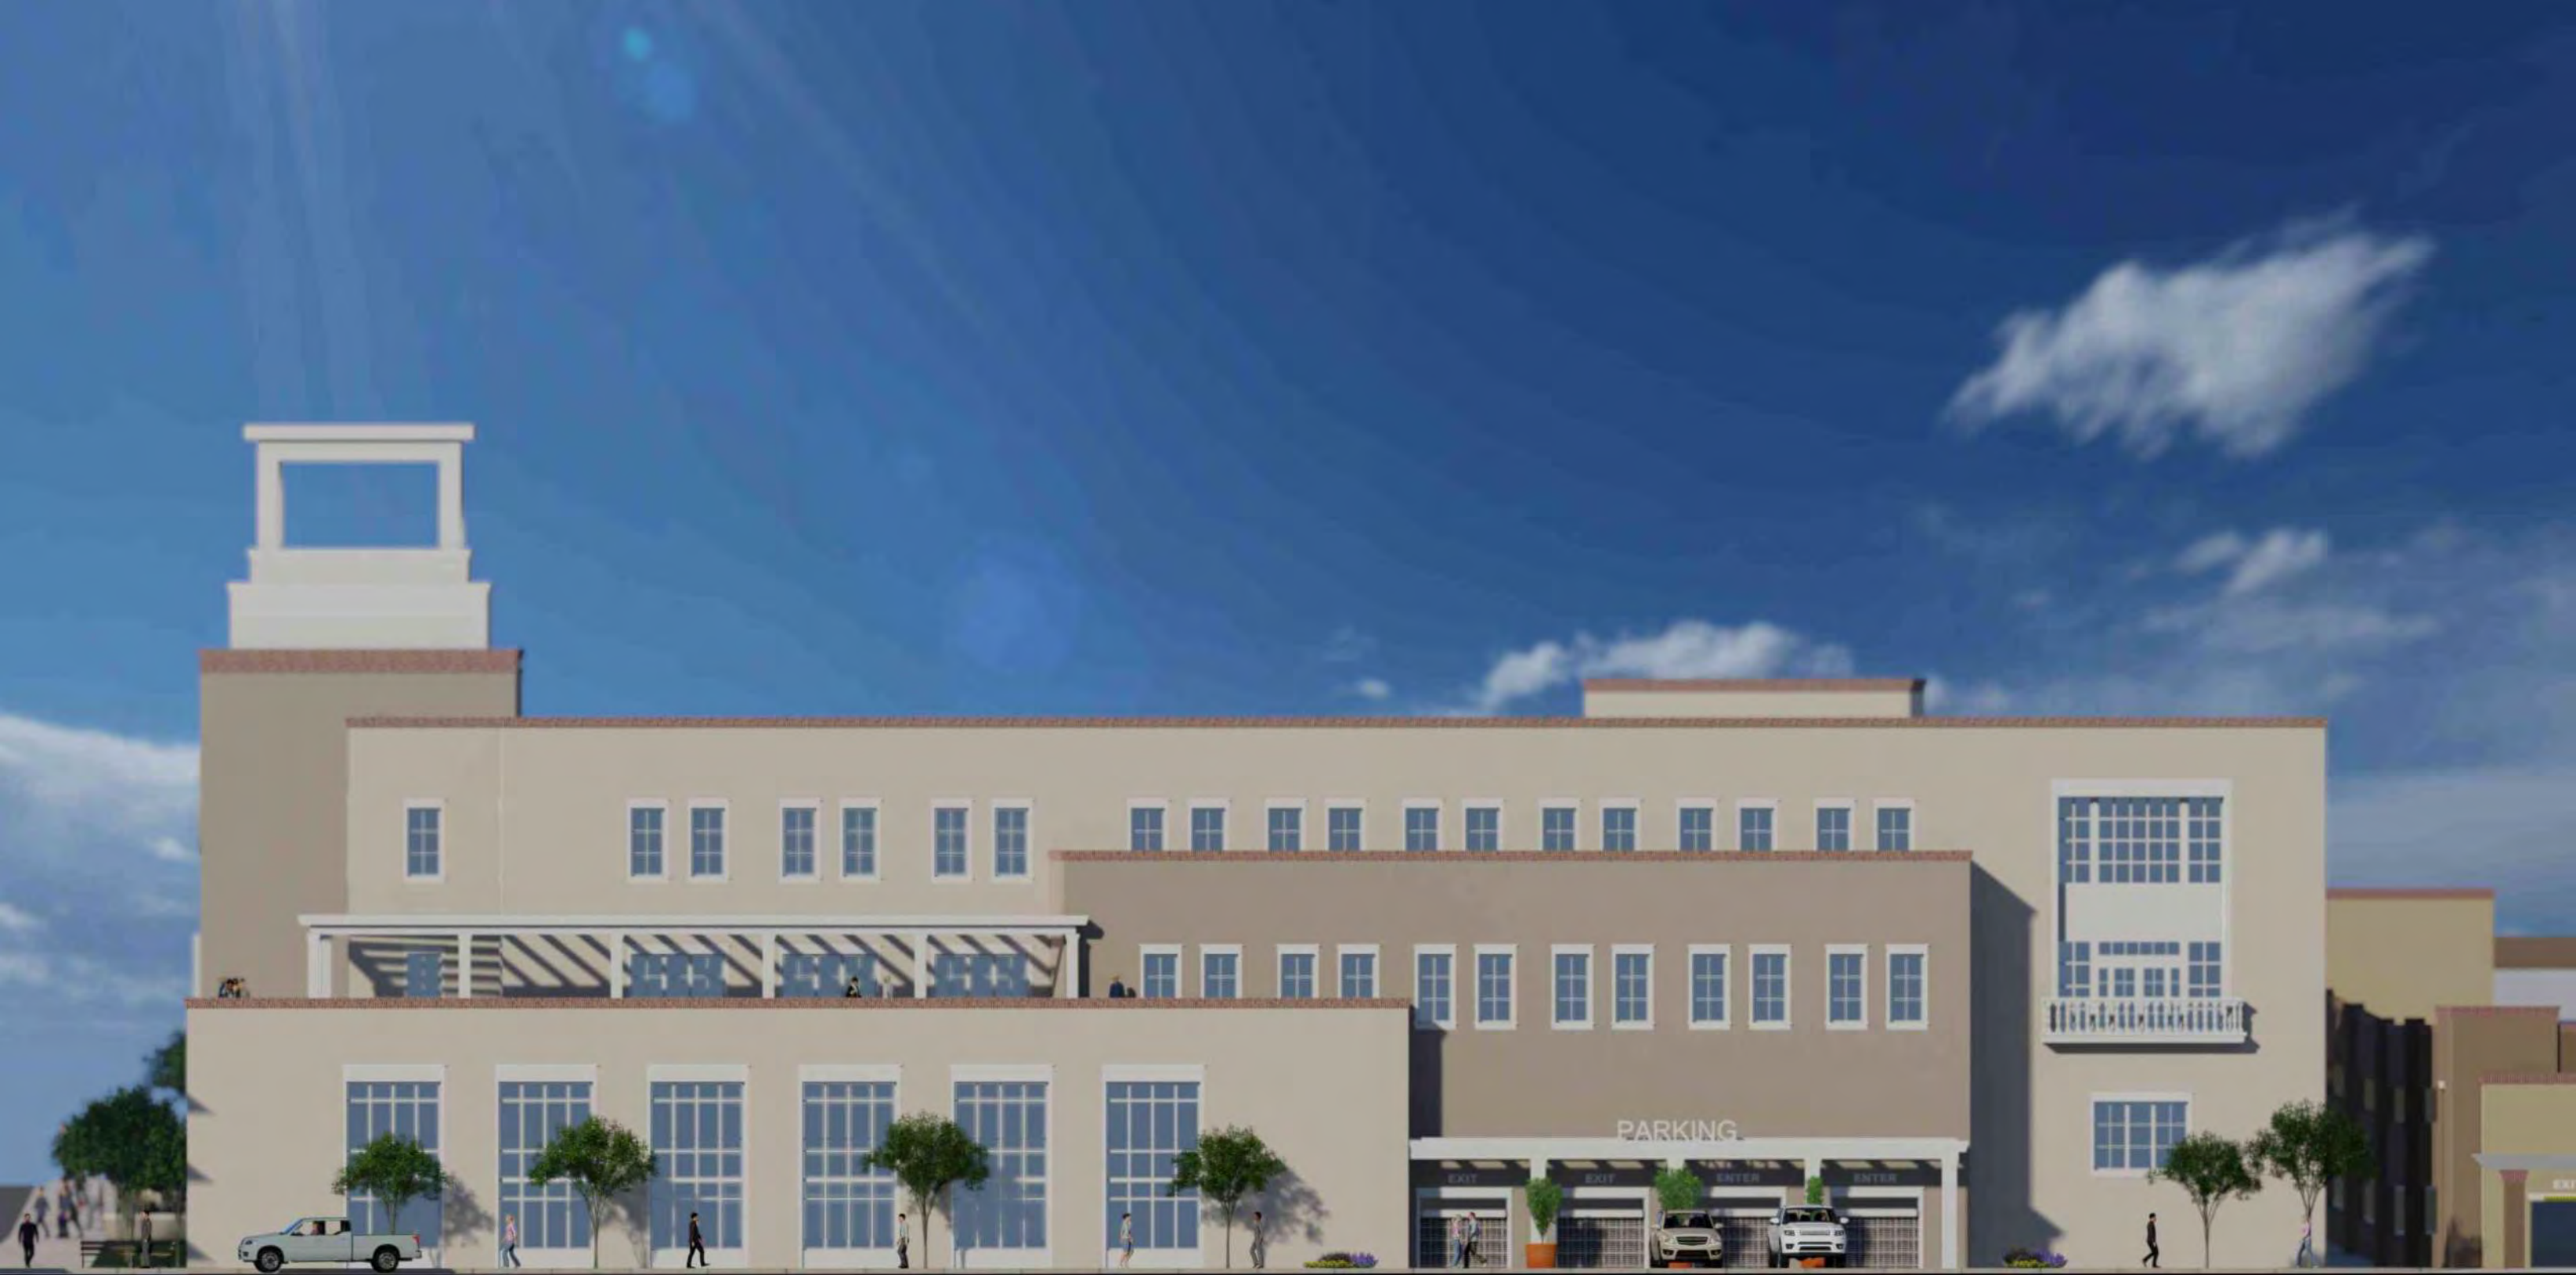
West Elevation

STATE OF NEW MEXICO
Executive Office Building
