City of Santa Fe, New Mexico

memo

2023-007598-HDRB. 414 Don Gaspar Ave. Downtown and Eastside Historic District. Contributing. Jennifer Jenkins, JenkinsGavin, Inc., agents for the State of New Mexico General Services Division, request demolition of the office building (previously a residence). Exceptions are requested to Sections 14-5.2(M)(3)(b), Contributing, Significant and Landmark Buildings for consideration of the loss of Historic Status, and 14-5.2(M)(4) Demolition of Historic and Landmark Structures within the State Capital Outlay Projects section of the code.

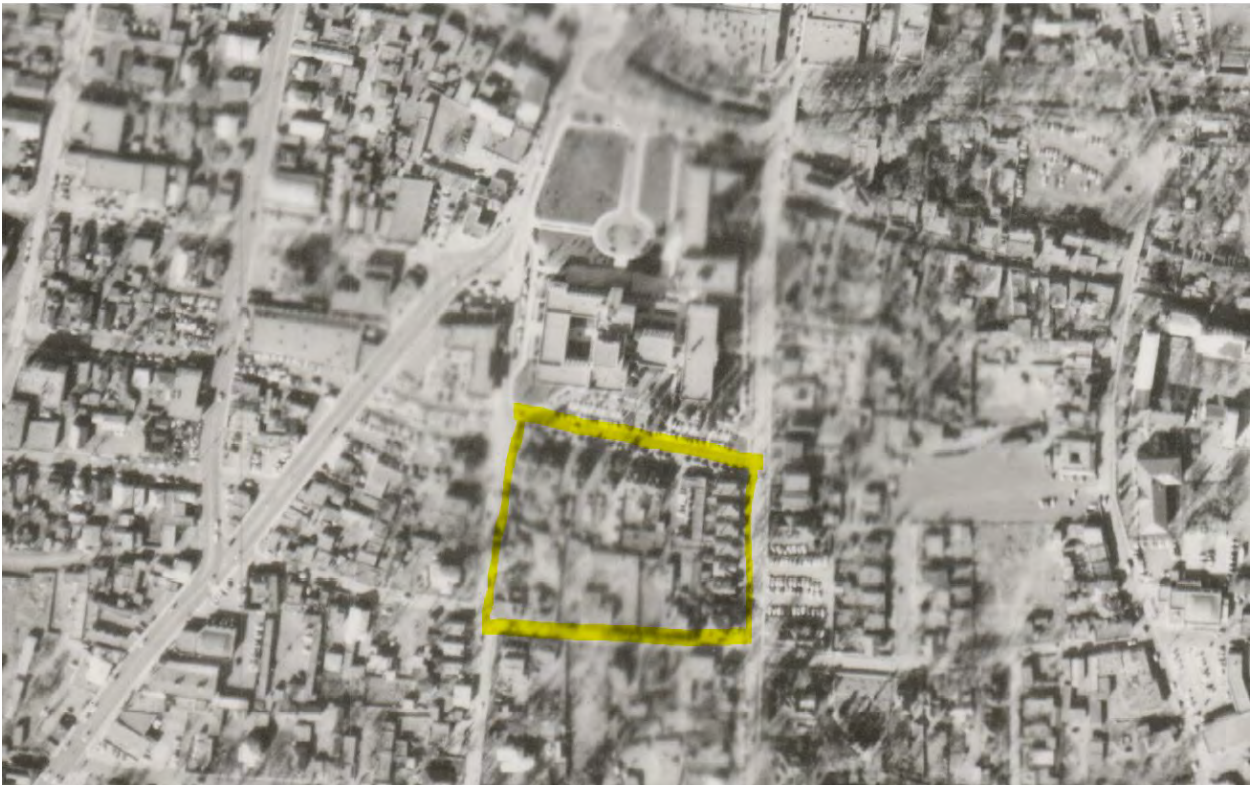
Figure 2 1957 Aerial

The aerial from 1957 illustrates how the State Capitol complex disrupted the neighborhood patterns of the Don Gaspar neighborhood, which started to develop to the north of the current Paseo de Peralta. One can see the development of a grid block pattern and detached single-family houses both within the block under consideration as well as across Don Gaspar at the site of the current Capitol building. The construction of the Paseo de Peralta divided this and adjacent bungalows from the Don Gaspar neighborhood.

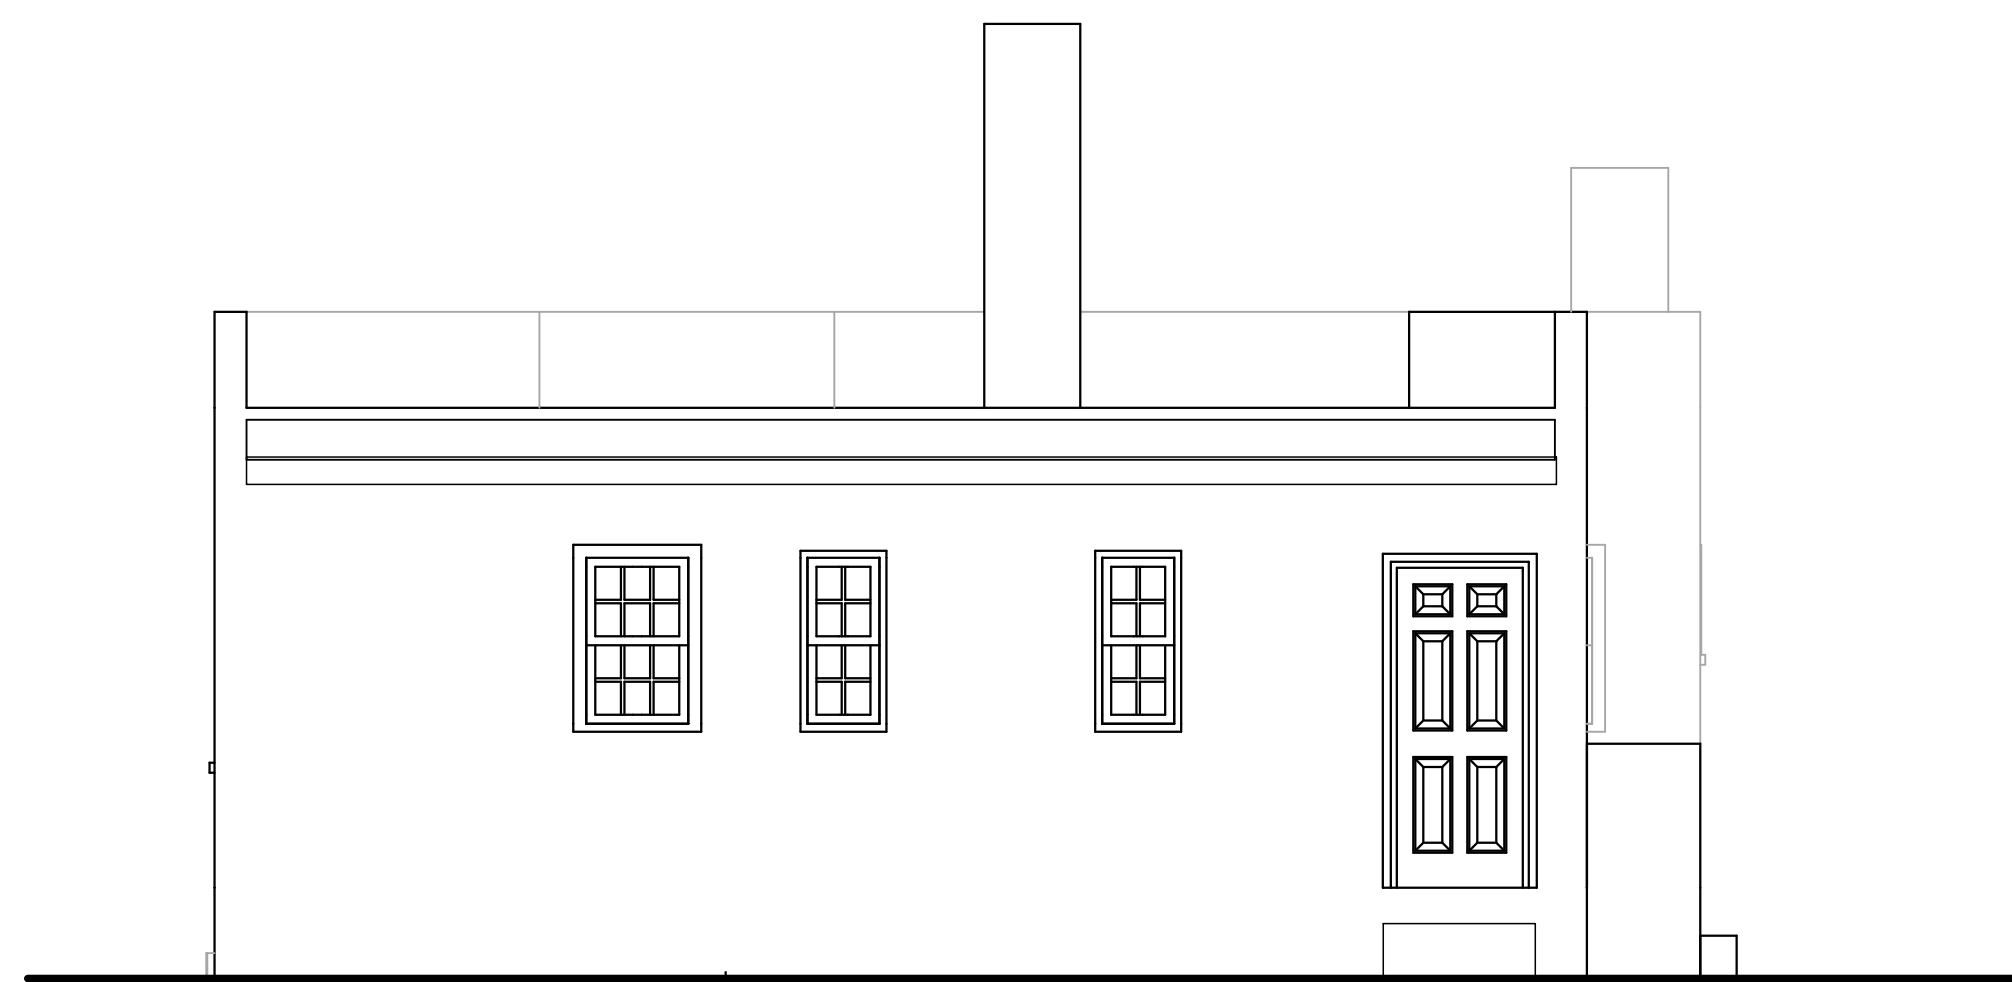
4 WEST ELEVATION
SCALE: 1/4" = 1'-0"

Ms. Lamboy said staff's opinion is that the elevations facing S. Capitol Street, north, should be considered as primary. The courtyard was an important feature as outlined in the drawings. Staff recommends the west elevation be considered primary. For the yard wall abutting the parking area, staff recommends designation as primary as it is a stylistic modernist movement design.

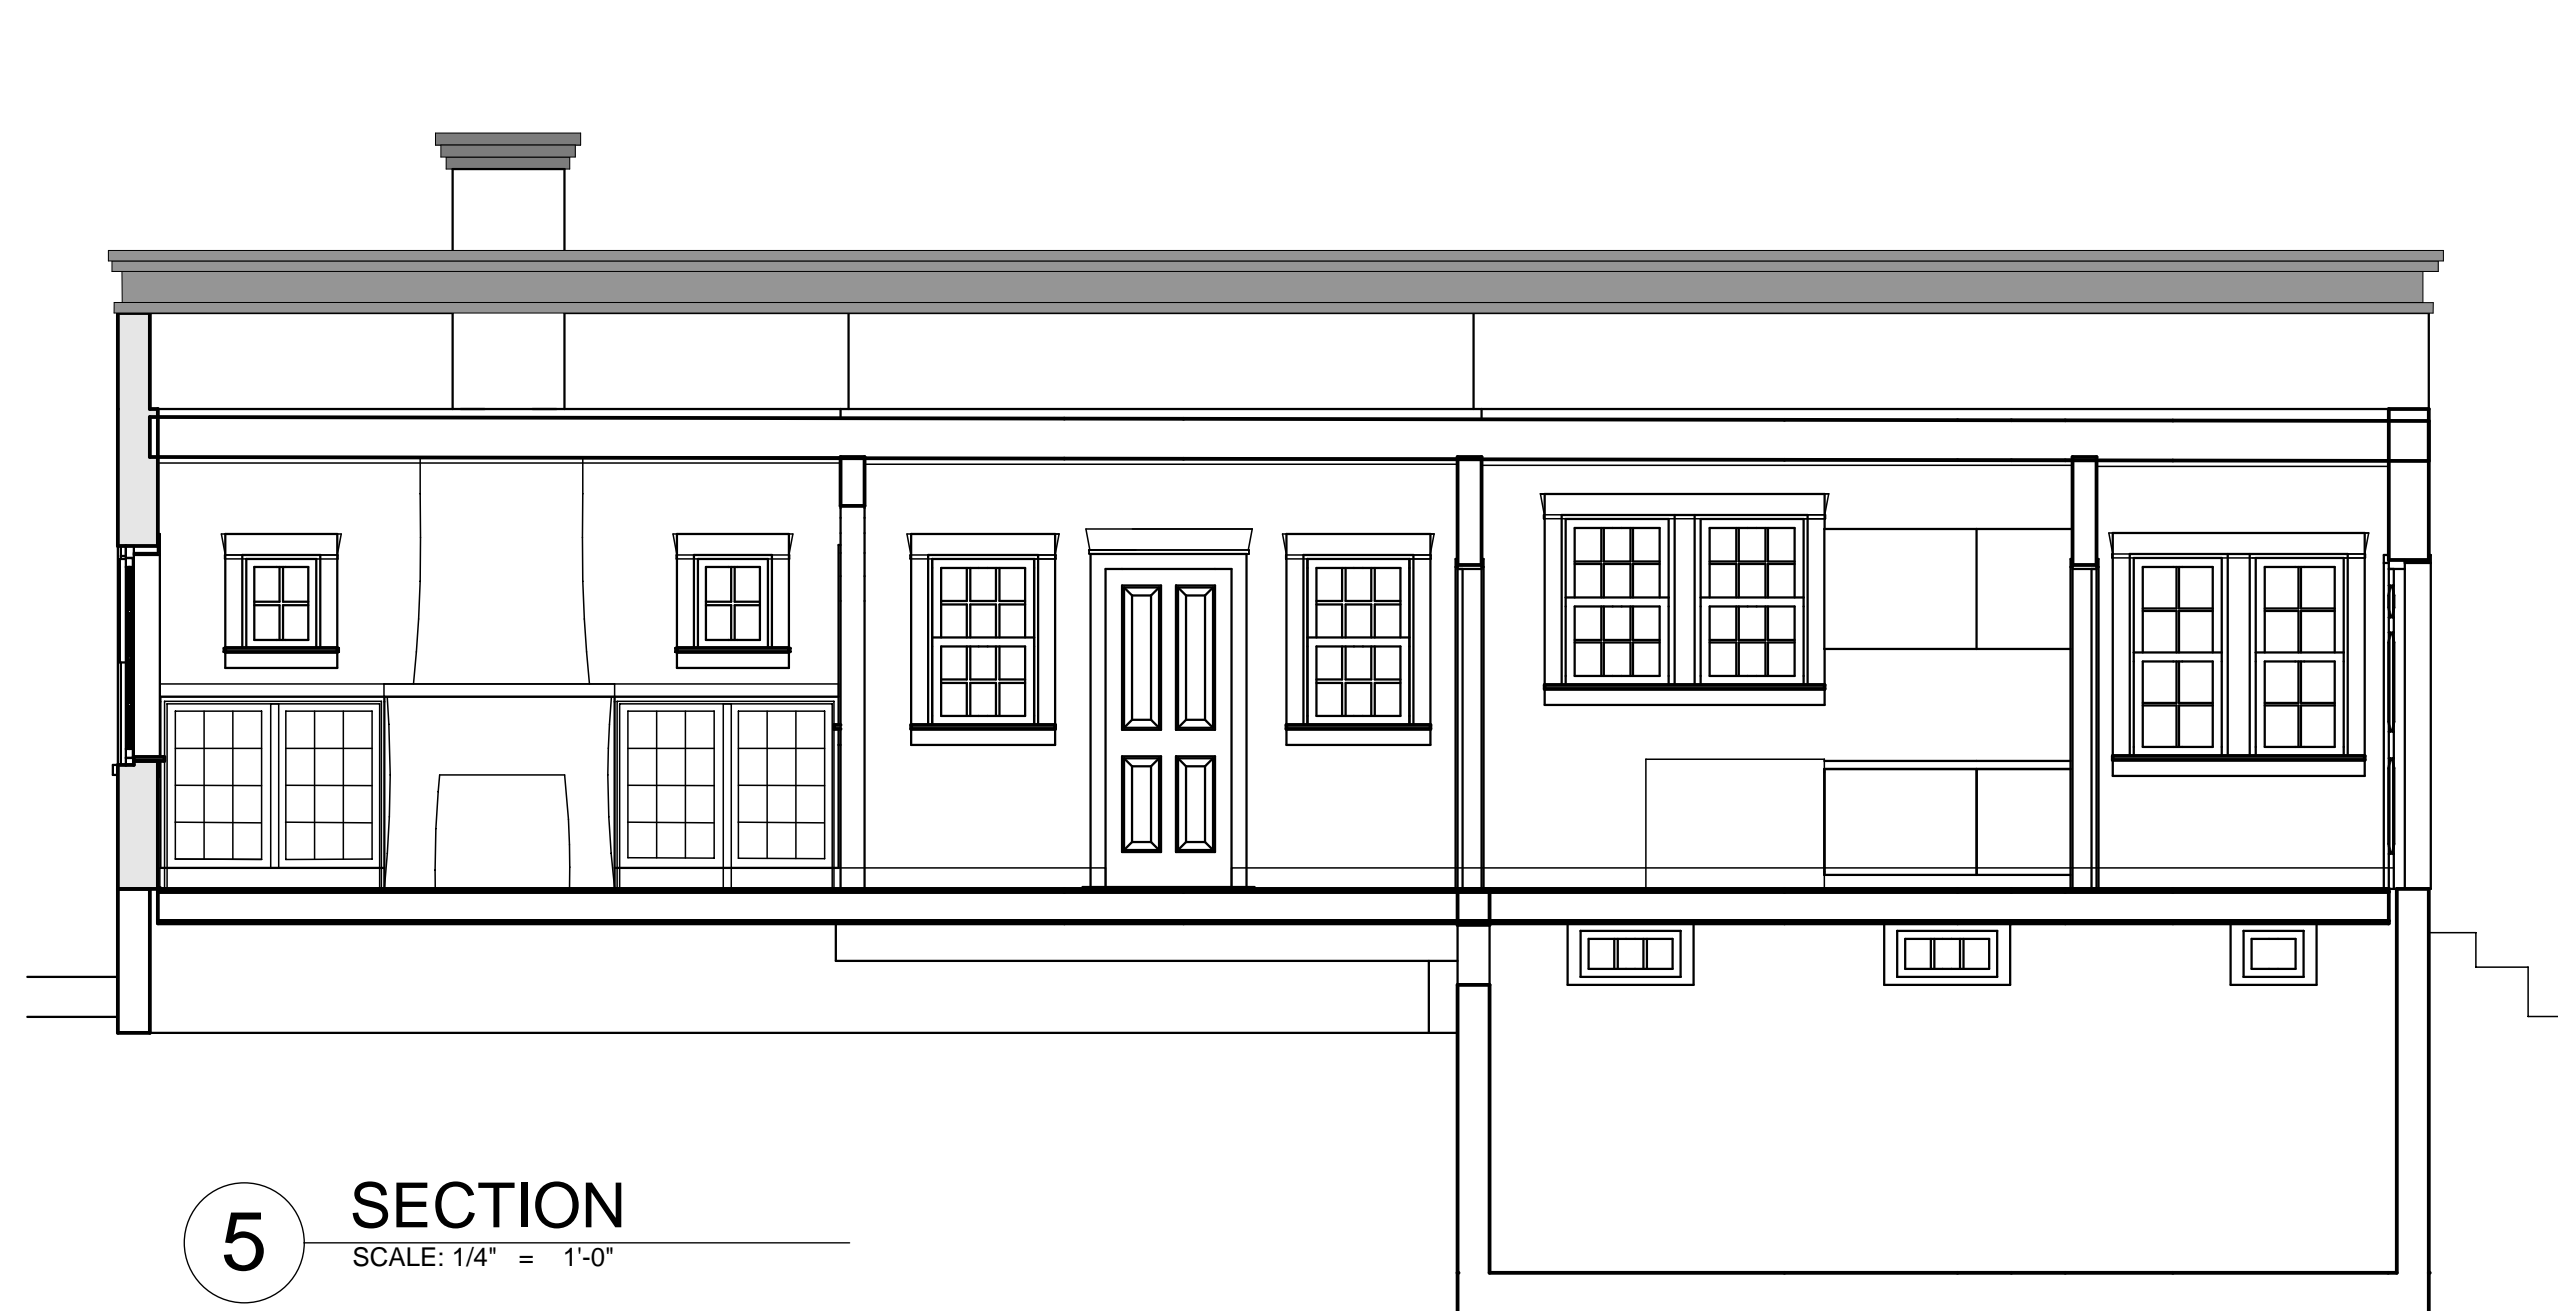
5 SECTION
SCALE: 1/4" = 1'-0"

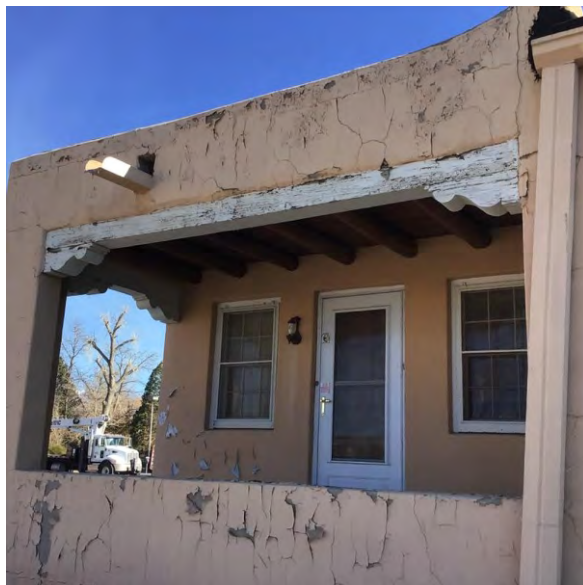
Project 01-001-00019.2003 · Exterior Building Improvements

Stucco and paint are cracking and peeling. The building's windows are single pane, broken, and painted shut. The exterior doors are in disrepair. Exterior lighting is inadequate. A building sign is absent.

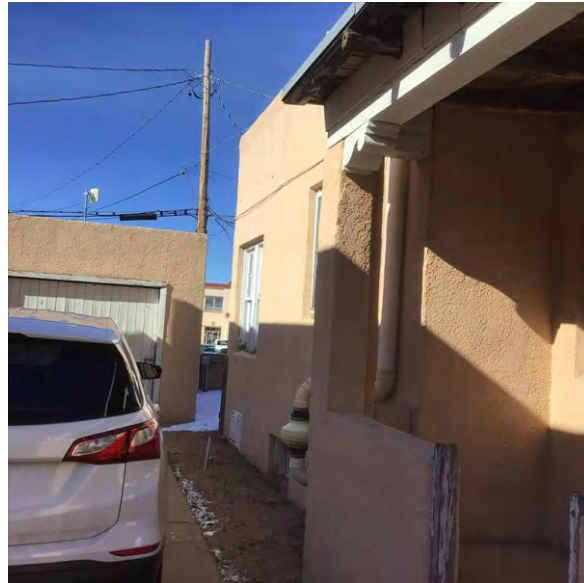
Project 01-001-00020.2004 · Security Upgrades

There is no security alarm or cameras in the building.

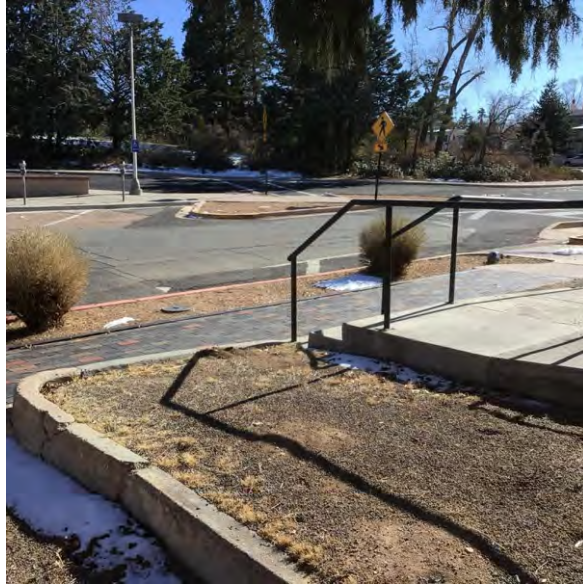
Project 01-001-00015.2002 · ADA Compliance: Site Work

The sidewalks are old, worn, weed-infested, and have settled, creating uneven walks that are not ADA compliant. The ramp at the building entrance is noncompliant. The ramp does not provide a 5' x 5' turn around space in two locations, handrails are noncompliant, and edge protection is absent.
