# City of Santa Fe, New Mexico

# memo

2025-011328-HDRB, 433 Calle La Paz, Downtown & Eastside Historic District, contributing, Martinez Architecture Studio PC, agent for The John C. Gregory Revocable Trust and the Pamela S Austin Revocable Trust, owners, proposes to replace windows and doors, vigas, install wood railings, exterior stairs with hand rails, and construct a 210 sq. ft. portal to a height of 10'-6" on the main residence, install 5'-0" high fencing, and construct at 148 sq. ft. portal to a height of 11'-5", replace windows and doors, and install an overhang on the casita, and refinish the garage door. An exception is requested to 14-5.2(D)(5)(a)(i) for replacing historic windows.

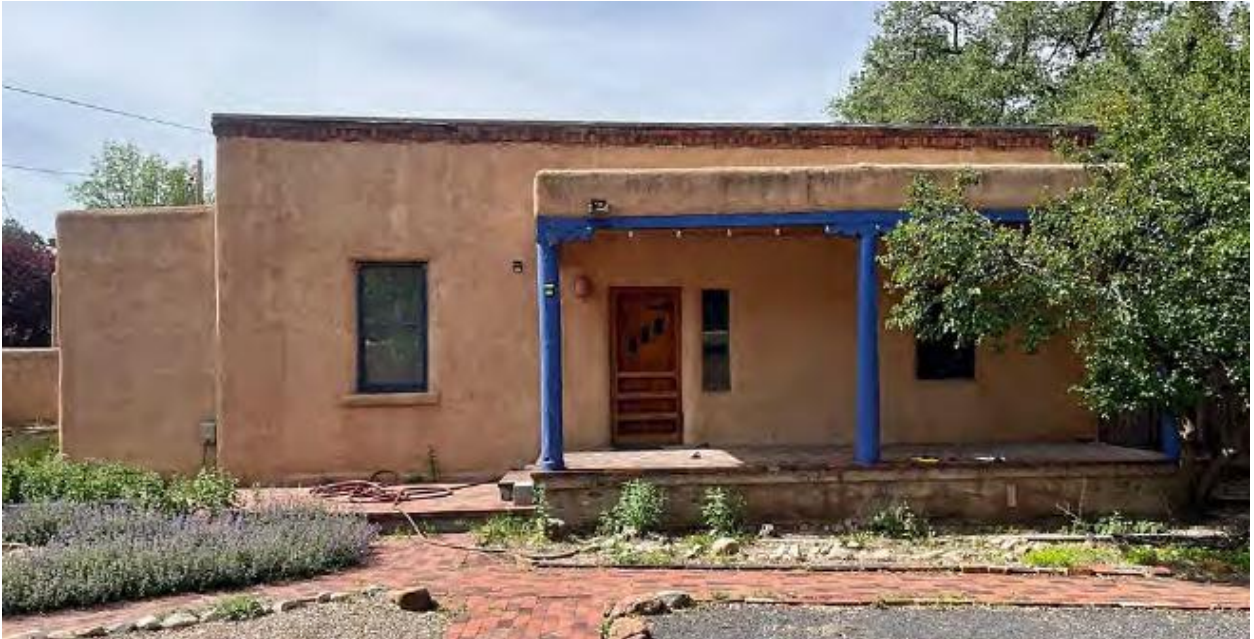
Figure 3: Main Residence

The 1,358 square foot single-family residence at 433 Calle la Paz is listed as contributing to the Downtown and Eastside Historic District. The original portion of the home was constructed in adobe sometime between 1912 and 1930, with four subsequent additions, all of which were constructed before 1970. The residence is a vernacular interpretation of Territorial Style with Pueblo Revival influence in the additions to the historic footprint. The parapet heights vary, with most having a brick cornice, which was installed in 2001. The main entrance of the residence faces north and is covered by a portal that is off-center to the west due to one of the additions. The recent brick floor of the portal is several feet above ground level, and the roof is supported by wood posts set on concrete pier blocks. The residence retains its original fenestrations with mostly two-over-one wood windows, except one six-over-one wood-clad and one one-over-one vinyl window. The doors are wood, except for one metal door on the east elevation. The residence is stuccoed in cement stucco in “buckskin”. Character-defining elements of the main residence include the original core, original fenestration openings fitted with two-over-one wood windows, and the brick cornice.

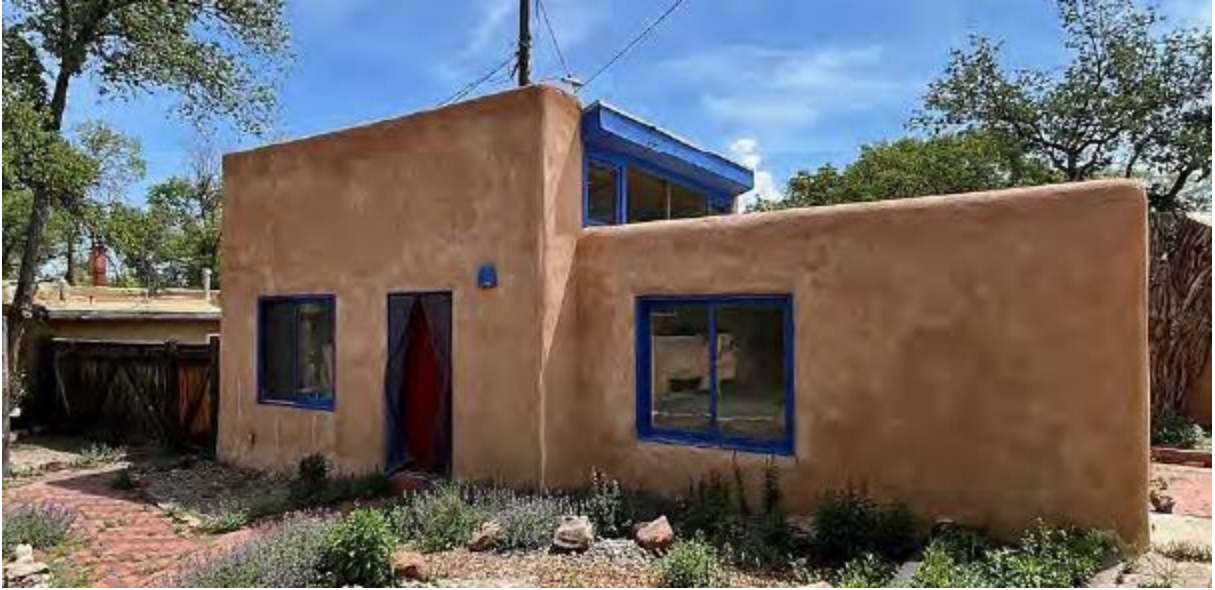
Figure 4: Casita

The 564 square foot casita is listed as non-contributing to the historic district. It was constructed in the early 1980s with frame construction that seems to encompass an older structure on its south end. The casita is a vernacular style with a passive solar design consisting of south-facing clerestory windows and interior brick floors. The main entrance faces west and has a metal panel door and sash windows. The south houses French doors and a sash window, and the upper level has the clerestory windows. The east façade contains wood windows, and the north façade has no openings. According to the window assessment, all windows are non-historic from 1987 to 2015.

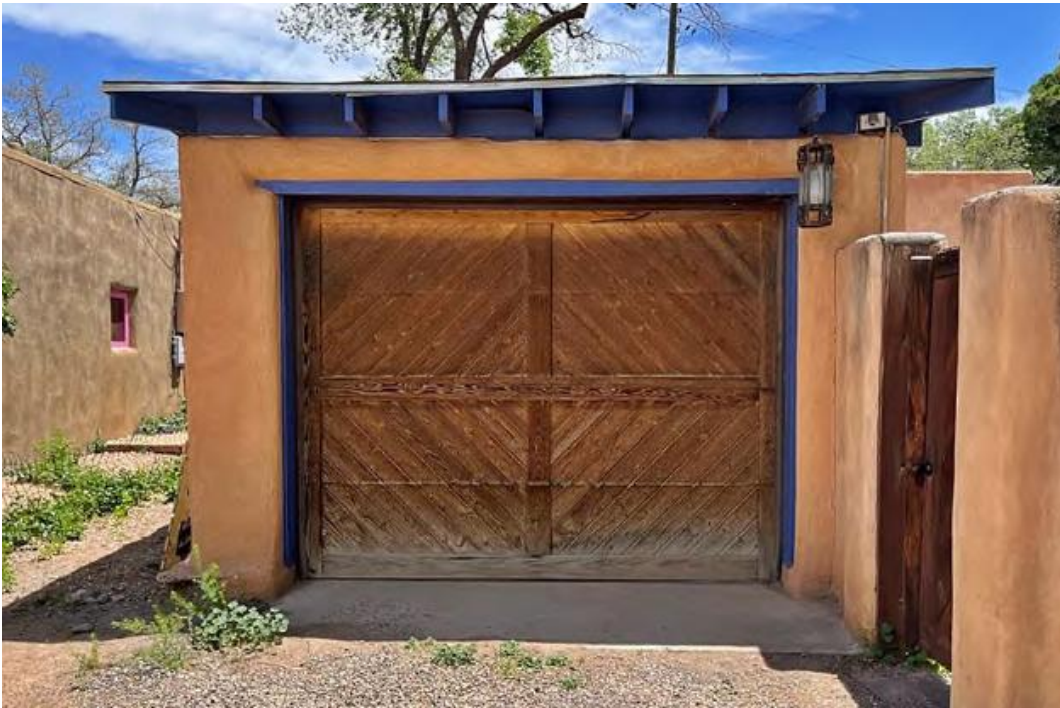
Figure 5: Garage

The 264 square foot west-facing garage was constructed before 1958 of hollow clay tile blocks in a Spanish Pueblo Revival style. The roof has been modified with a flat roof with plywood overhang. The vehicle door is a double chevron wood overhead door in a natural color with blue trim surround that matches the blue of the roof overhang. There is a metal light fixture to the south of the door. The south façade holds a non-original 1990 wood pedestrian door painted red, and an eight-lite sash window turned on its side. The window assessment shows this window as a non-historic 1987 window. The north façade has no openings. The garage is a good example of this type of construction and design.

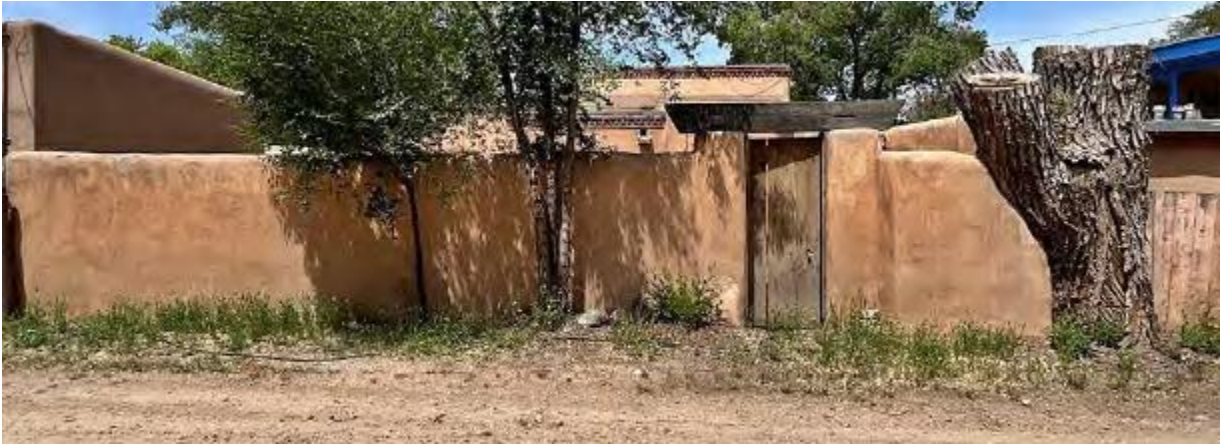
Figure 6: East Yard Wall

There are seventy-inch-tall yard walls along both Calle la Paz and Camino Manzano, which were constructed after 1983. In the 1983 survey photo, a much lower wall was in front of the residence, which was raised in height by 1991, as is illustrated in that survey photo. The west wall contains an arched gate opening that reaches ninety inches and holds a wooden gate. To the south is a seventy-two-inch wood plank fence. The yard wall on Camino Manzano starts at the south corner of the lot and runs to the edge of the guest house. Closer to the guest house is a wooden pedestrian gate topped with a header. At the south end of the guest house starts a seventy-two-inch plank fence that runs for about five to ten feet before ending in a wire fence that is damaged by the overgrown foliage that clings to it.

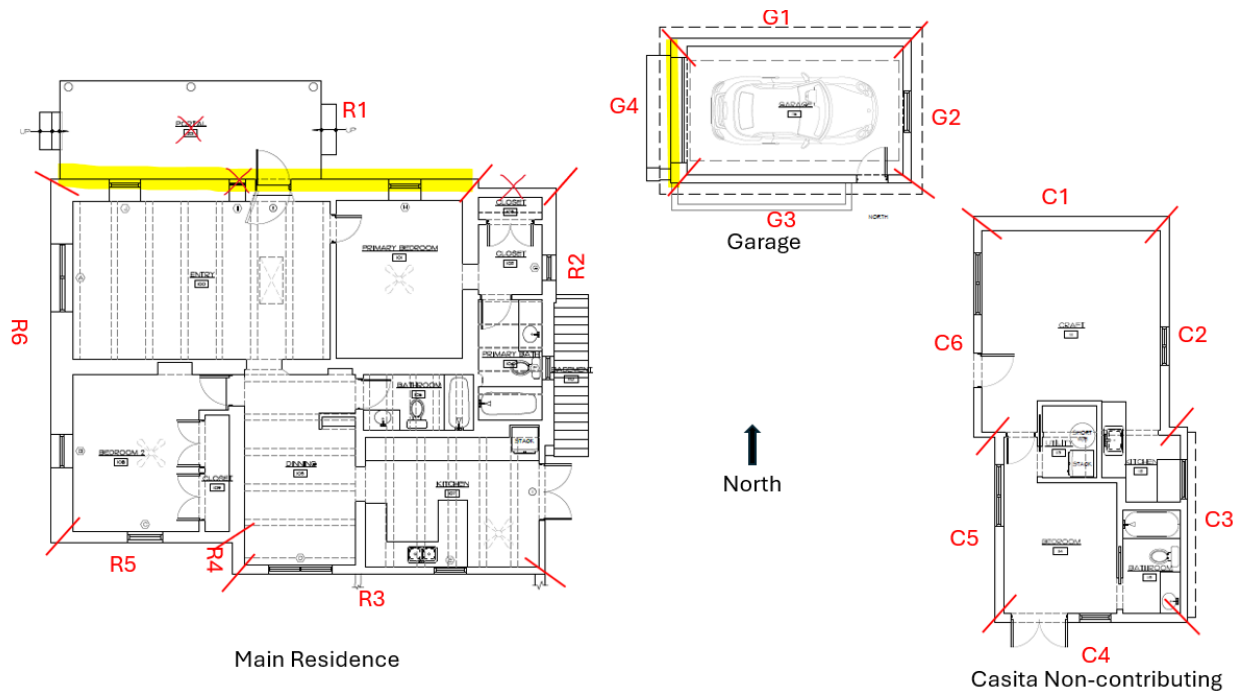
Figure 8: Façade Diagram

2025-010839-HDRB the Board was to maintain the main residential structure's contributing status and designated the north (R1) as the primary facade excluding the portal which appears to be new based on the HCPI that refers to non-weathered wood and a new flooring and decking, the sidelite window which per the HCPI is likely not original, and excluding the eastern addition wall which has no coping unlike the rest of the house, designated the garage as contributing with the west (G4) as the primary facade, and designated the guesthouse and yard walls as non-contributing due to their age.

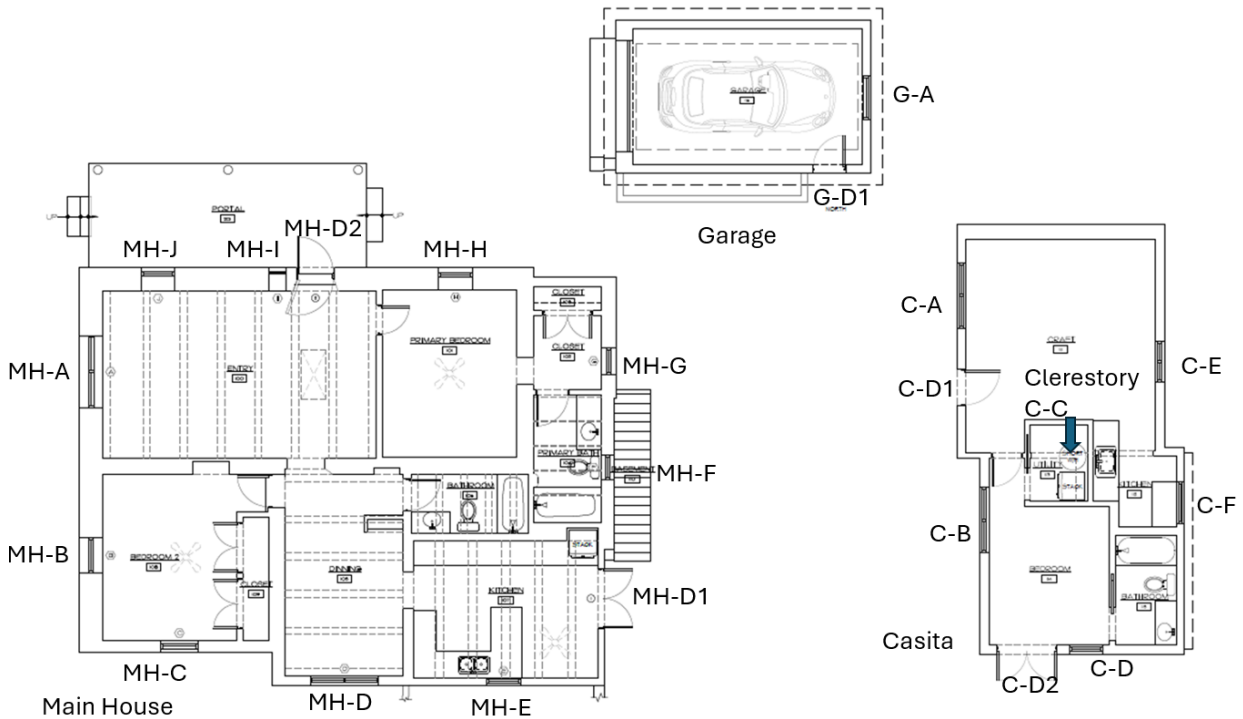
Figure 9: Window Schedule

1. Replace windows and doors. An exception is requested to section 14-5.2(D)(5)(a)(i) to replace historic windows on a primary façade. The windows will be replaced with double-pane wood windows with divided lites, and sizes to match the existing windows.
  - a. North
    - i. Window MH-H 32”x 64” Double Hung
    - ii. Window MH-J 29”x 48” Double Hung
    - iii. Window MH-I14”x 51” fixed (excluded from the primary façade designation).
  - b. West
    - i. Window MH-A 71”x 38” fixed barn sash
    - ii. Window MH-B 32” x 64” Double Hung
  - c. East
    - i. Window MH-F 26” x 32” double hung 2015 clad
    - ii. Window MH-G 21” x 31” fixed barn sash

- iii. Door MH-#1 wood frame door 60" x 81" clad 2015 will be replaced with a wood sliding divided lite door.

Staff Response: Staff finds that this criterion is met. Per the window assessment: "Windows B & H and J are historic; however, there are signs of water penetration underneath the sills of the windows, causing structural integrity damage to the adobe. The windows would need to be removed to properly flash the openings to stop the water penetration. The window jambs are the buck in the openings. Removal of the window would destroy the jamb and cause the historic window to be non-reusable and non-restorable. Window G is historic; however, rotted beyond 40% and is non-restorable. Windows and doors A, C, D, E, DR #1, F, and I are non-historic." Replacing windows that allow water penetration is necessary to avoid further damage to the contributing building.
