Historic Cultural Properties Inventory (HCPI) Base Form (FORM 1)

1. Name of property: Fényes-Curtin Family – Rental House	2. Location: 424 San Antonio Street Downtown and Eastside Historic District – Santa Fe	3. Local Reference Number: Santa Fe ID: H-3208 4. County: Santa Fe Parcel # 10550912

8. Name of Project: HDRB Status Evaluation		
9. Lat/Long: 35.6793165,-105.9330012		
10. Photo Information: John W. Murphey, photographer. Photo 1: View of east elevation, facing west.

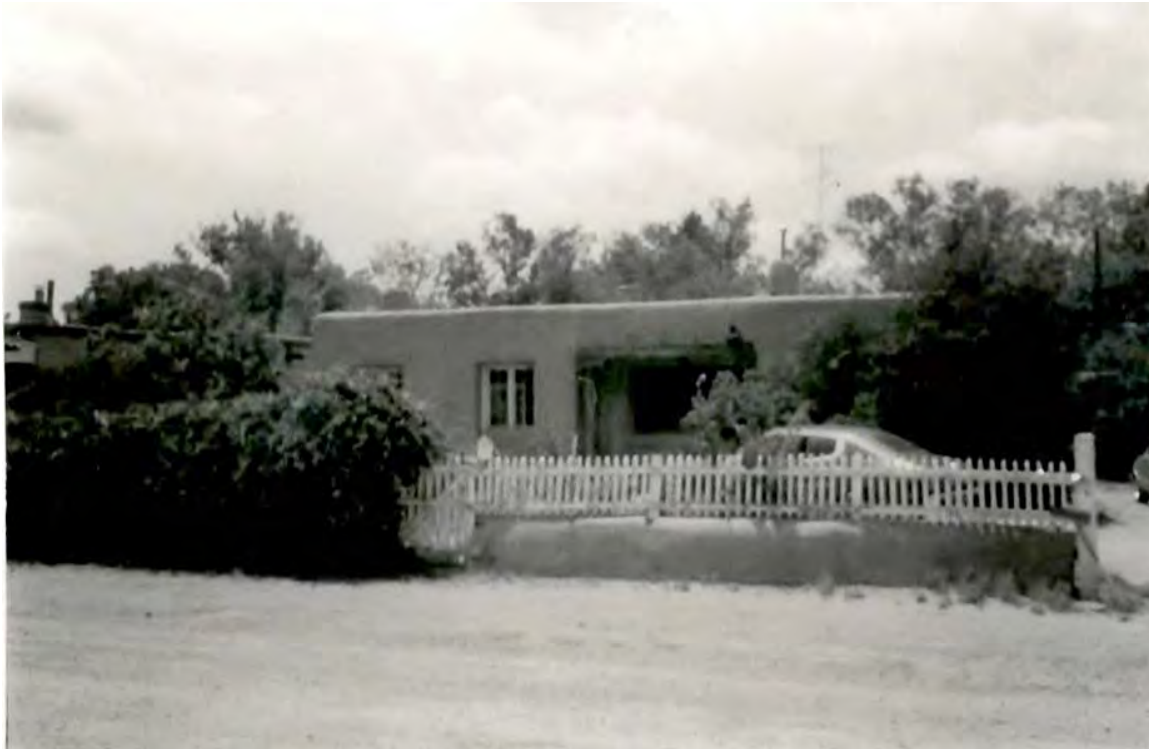
Figure 7: June 6, 1983, HBI survey photo; Michael Belshaw. Note different type of picket fence of top of adobe wall and absence of fence along the driveway. Courtesy of NMCRIS.

Historic aerial photographs indicate that a wall existed in this location, but the picket fence appears to have been replaced over the years (Fig. 7). The current fence boards are attached with modern fasteners and exhibit only a single paint layer, suggesting they are of recent construction.

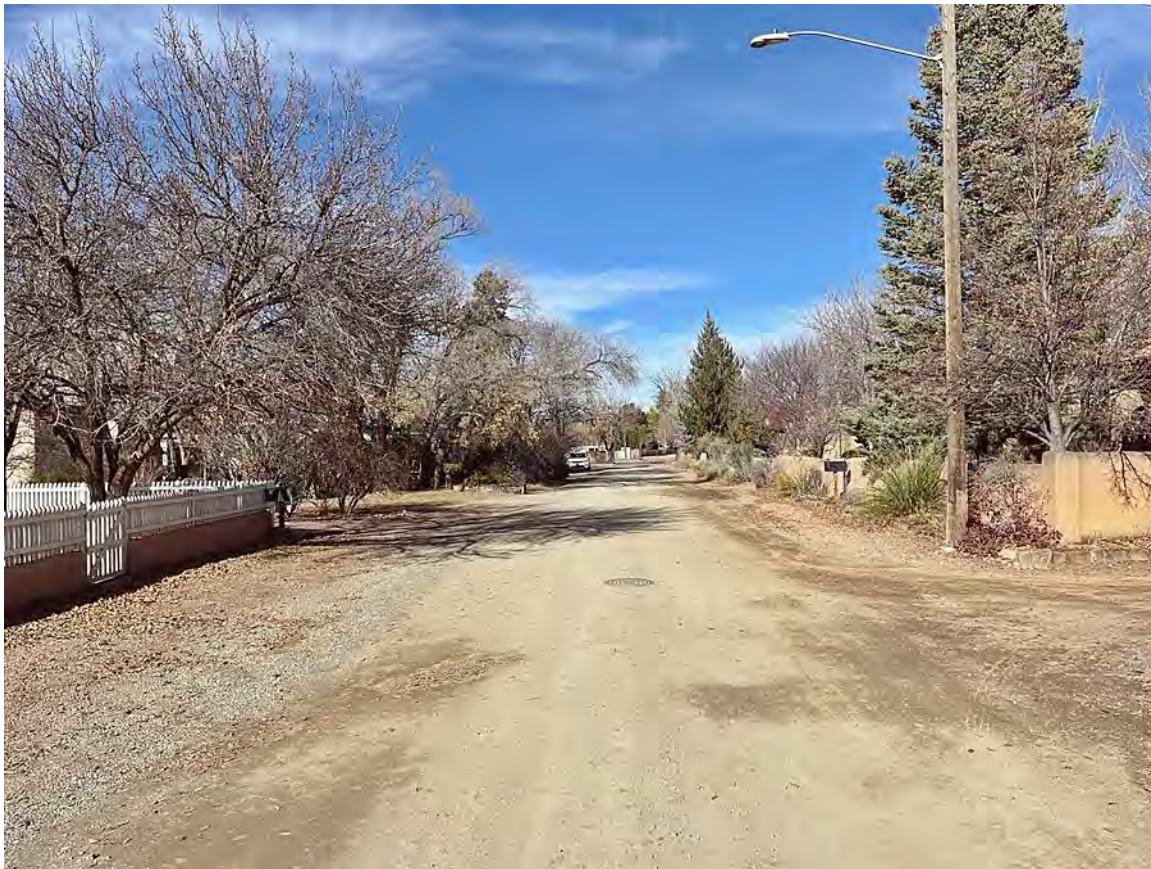
Photo 2: San Antonio Street in front of property. Camera facing north.

The house is located approximately 250 feet south of Acequia Madre, on San Antonio Street, a purposely rural-feeling dead-end lane. Initially developed in the 1920s over former farmland, the street remains unpaved and without sidewalks (Photo 2). The first several hundred feet of the west side contain a sequence of Territorial and Pueblo Revival houses, set back from the road and visually unified by a nearly continuous line of fencing. Four of these houses were constructed by the Fényes–Curtin family, who owned the estate-like “Acequia Madre House” to the west.

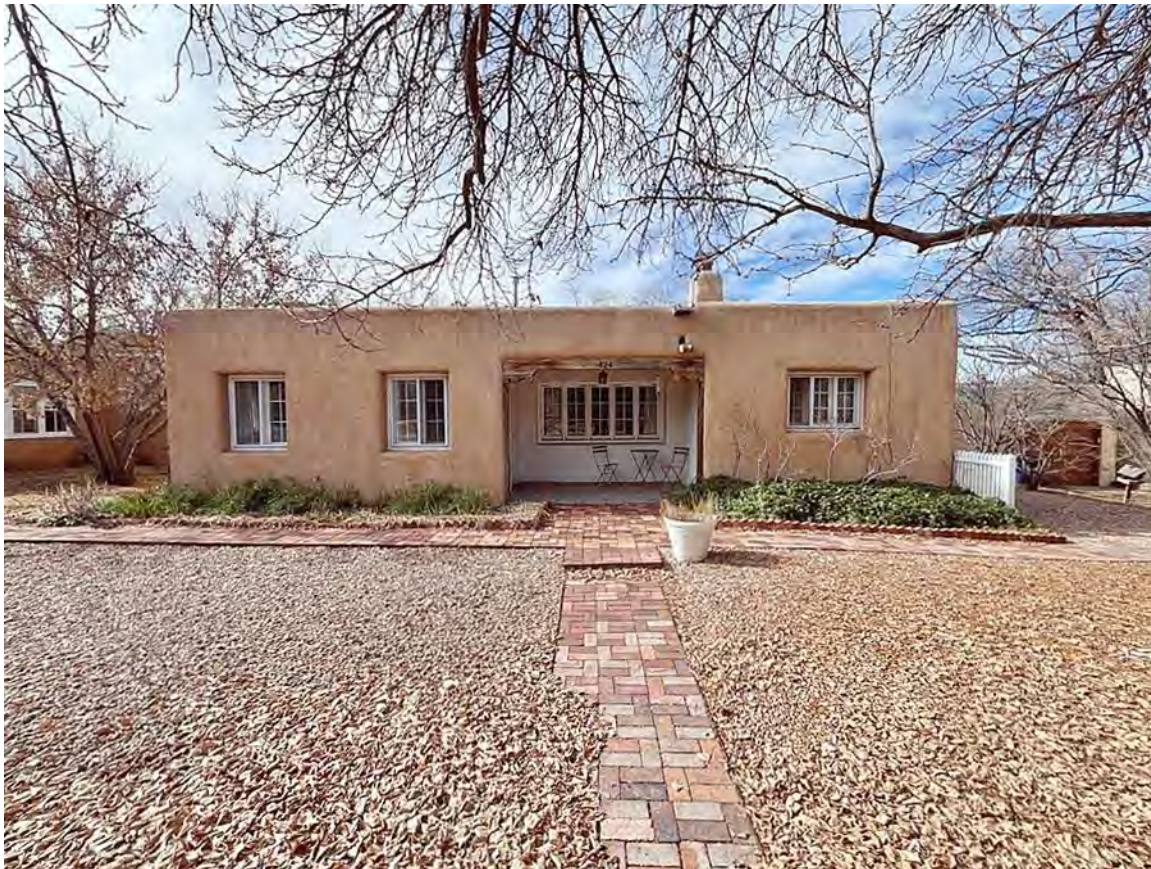
Photo 3: East (front) façade. Camera facing west.

The subject house sits near the center of its lot and is approached from the street by a patterned-brick walkway (Photo 3). It is surrounded by gravel landscaping, with a few mature trees—including old apricots—providing shade and character. A coyote fence encloses the rear of the property and opens toward the Acequia Madre House property (Photo 4).

The house presents a simple, flat south façade to the street, relieved only by a centrally inset portal (Photo 3). This planar composition precedes the later Pueblo Revival tendency to break up façades with projecting volumes. At the south end of the elevation are two window openings that light the living room. Each contains a pair of wood casements that appear to be original. The windows are set approximately 14 inches back from the exterior wall and each sash carries six lights divided by narrow muntins (Photo 5). They open on exterior, top-mounted projecting steel hinges with large, exposed knuckles—hardware indicative of an early vintage (Photo 6). In front of each window is a wood frame that once held summer screens and now contains metal storm units.

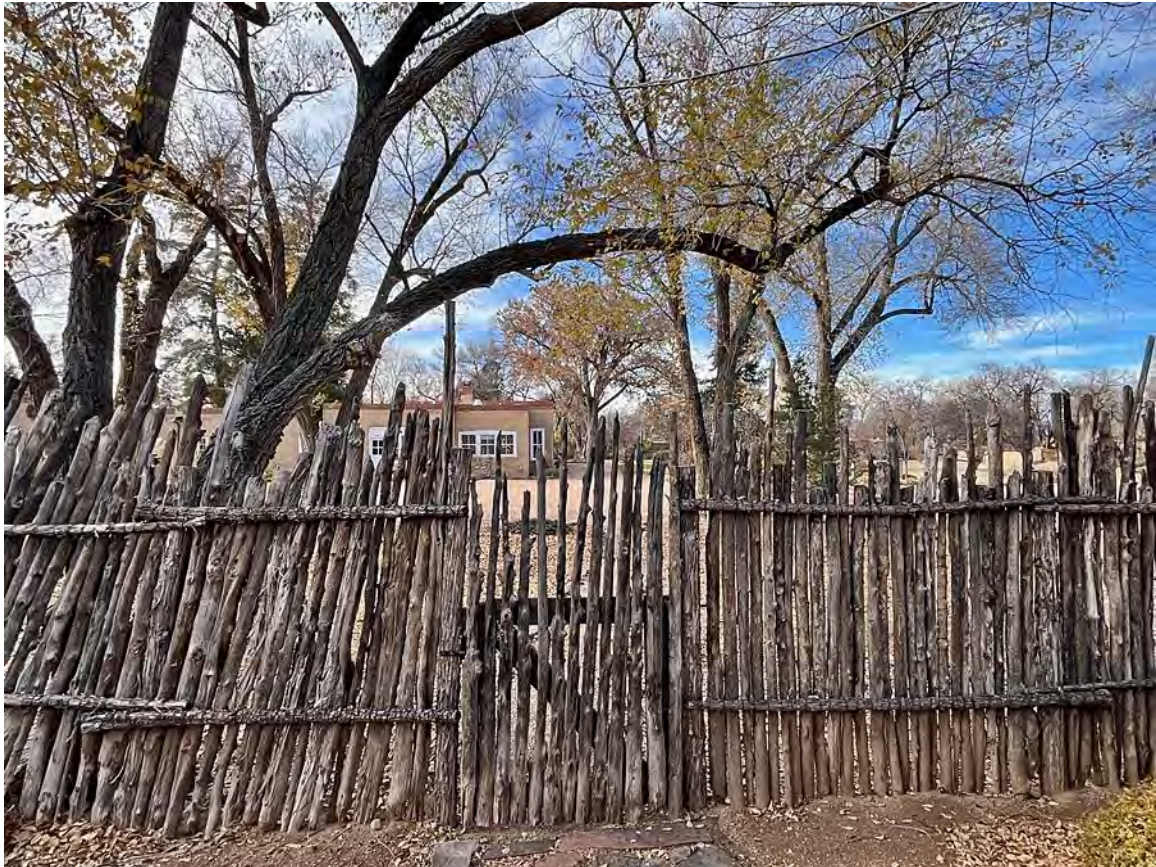
Photo 4: Coyote fence at rear of the lot. Camera facing west.

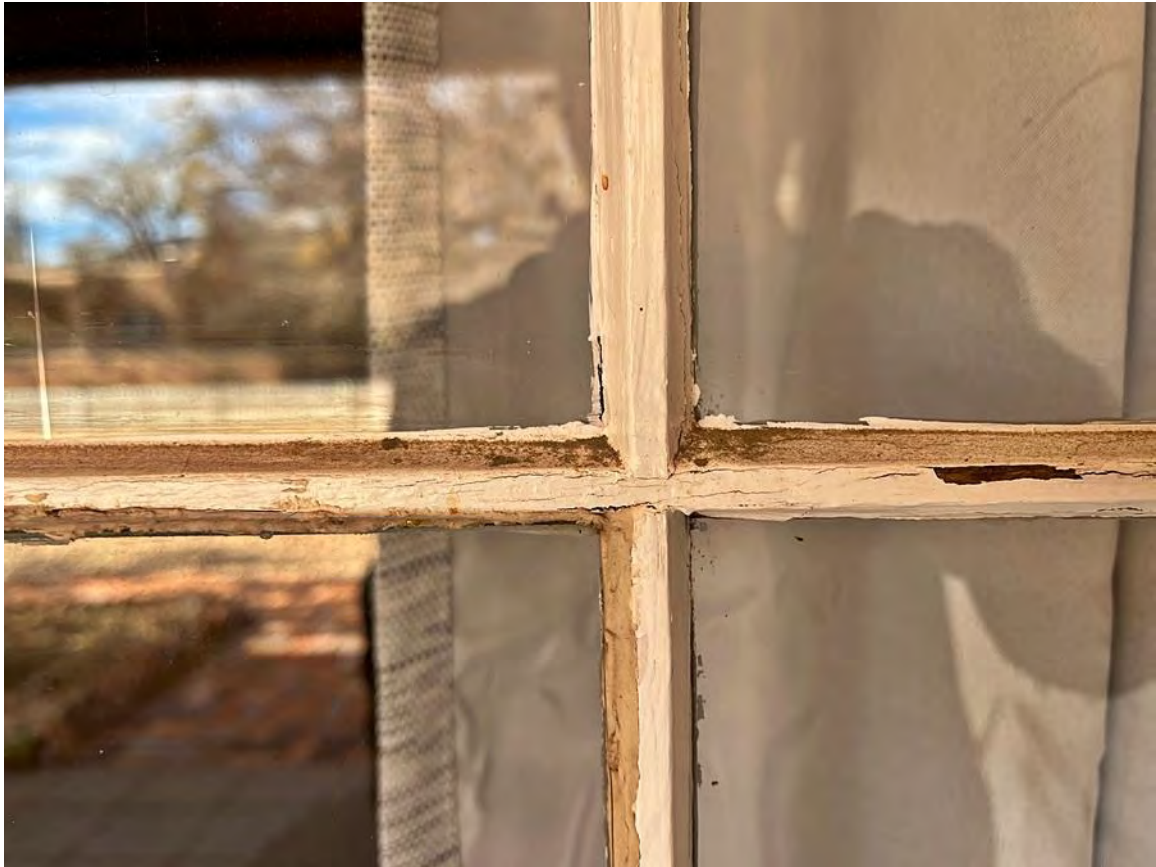
Photo 5: East (front) façade. Muntin profile. Camera facing west.

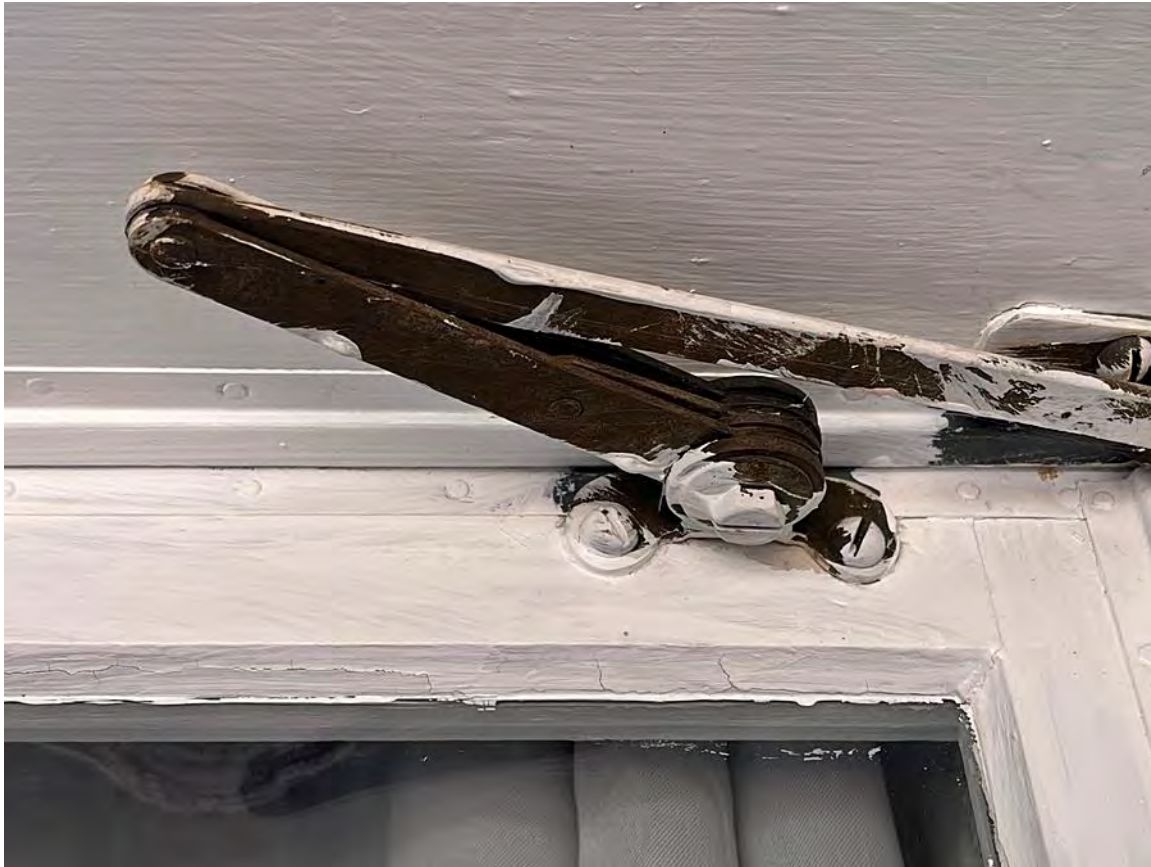
Photo 6: East (front) façade. Casement hinge. Camera facing up.

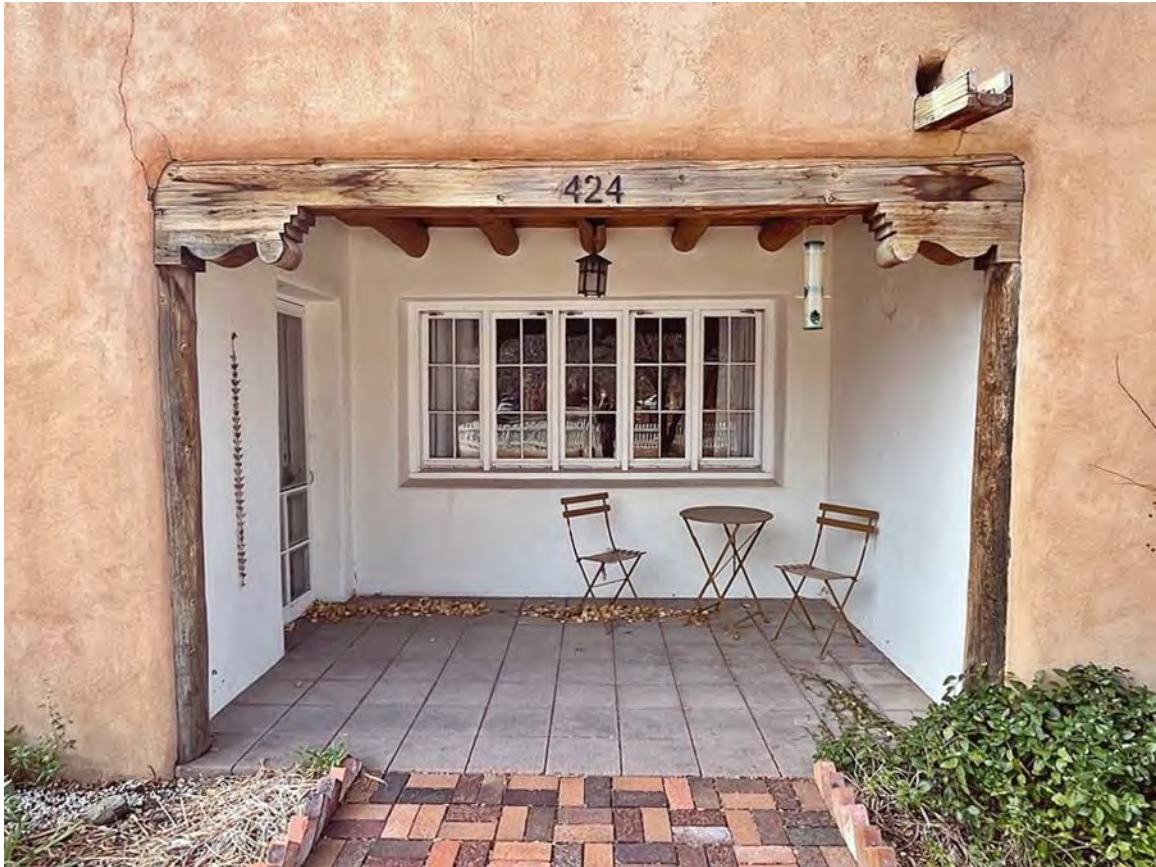
Photo 7: East (front) façade. Portal. Camera facing west.

The inset portal is approximately eight feet deep and features a square-block floor and exposed viga ceiling (Photo 7). To the south is the primary entry door, a wood ¼-light over vertical-panel door with a screen (Photo 8). The door opens directly into the living room. Along the north side of the portal is a 110-inch-wide opening fitted with a bank of wood casements that provide light to the dining room. The portal is large enough to

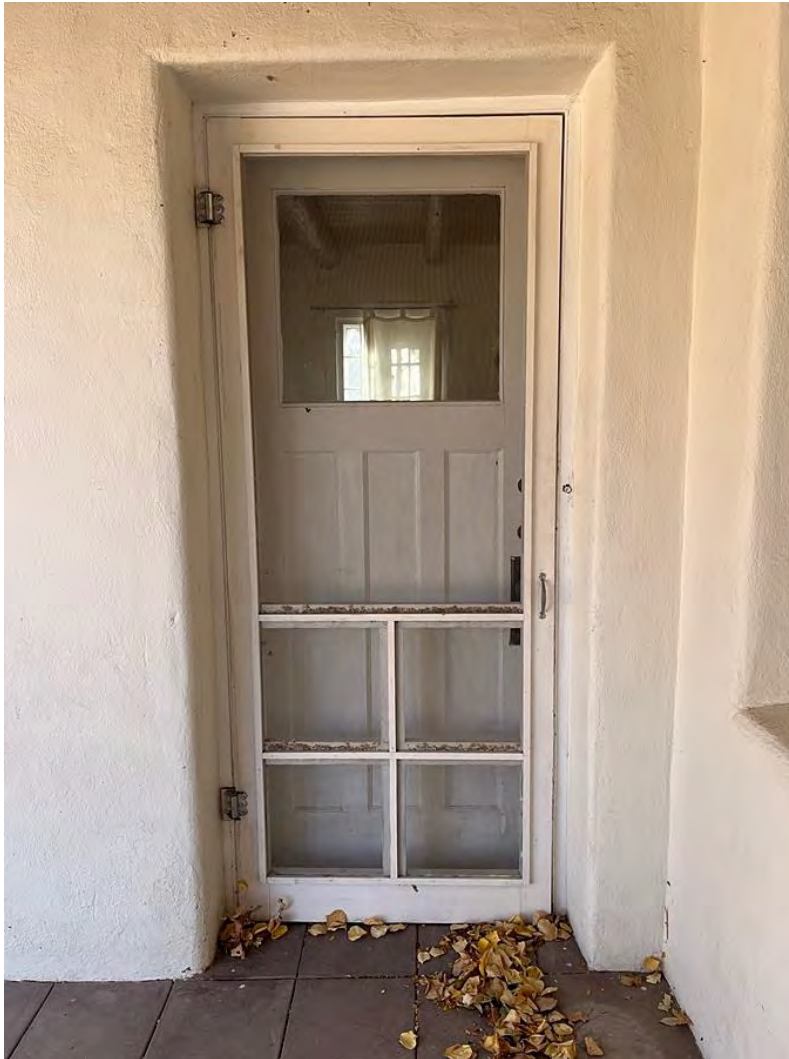
Photo 8: East (front) façade. Portal, entry door. Camera facing south.

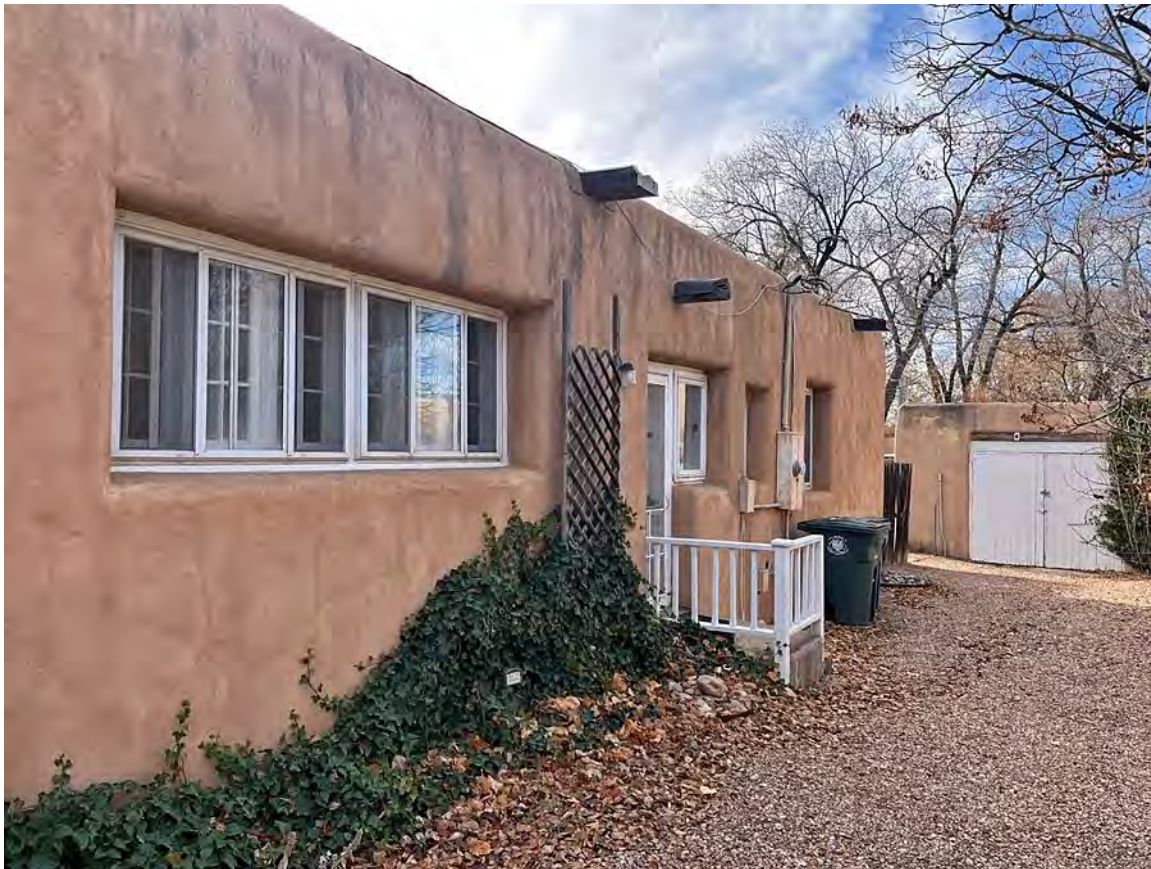
Photo 9: North elevation. Camera facing southwest.

Facing the driveway leading to the garage, the north elevation is the working side of the house, accommodating the kitchen and a secondary bedroom (Photo 9). At the east end is a wide opening fitted with a bank of wood casements. These windows look into the kitchen, which may have served a different function historically. Near the center of the elevation, a set of concrete steps leads to a recessed entry (Photo 10). The doorway contains an older wood panel door—matching the front entry door—although its glass panel has been removed and the opening boarded. A single viga projects above. To the west is a more recent vinyl–metal casement, and beyond it, a boarded window opening. The elevation terminates at the far west with a pair of six-light wood casements.

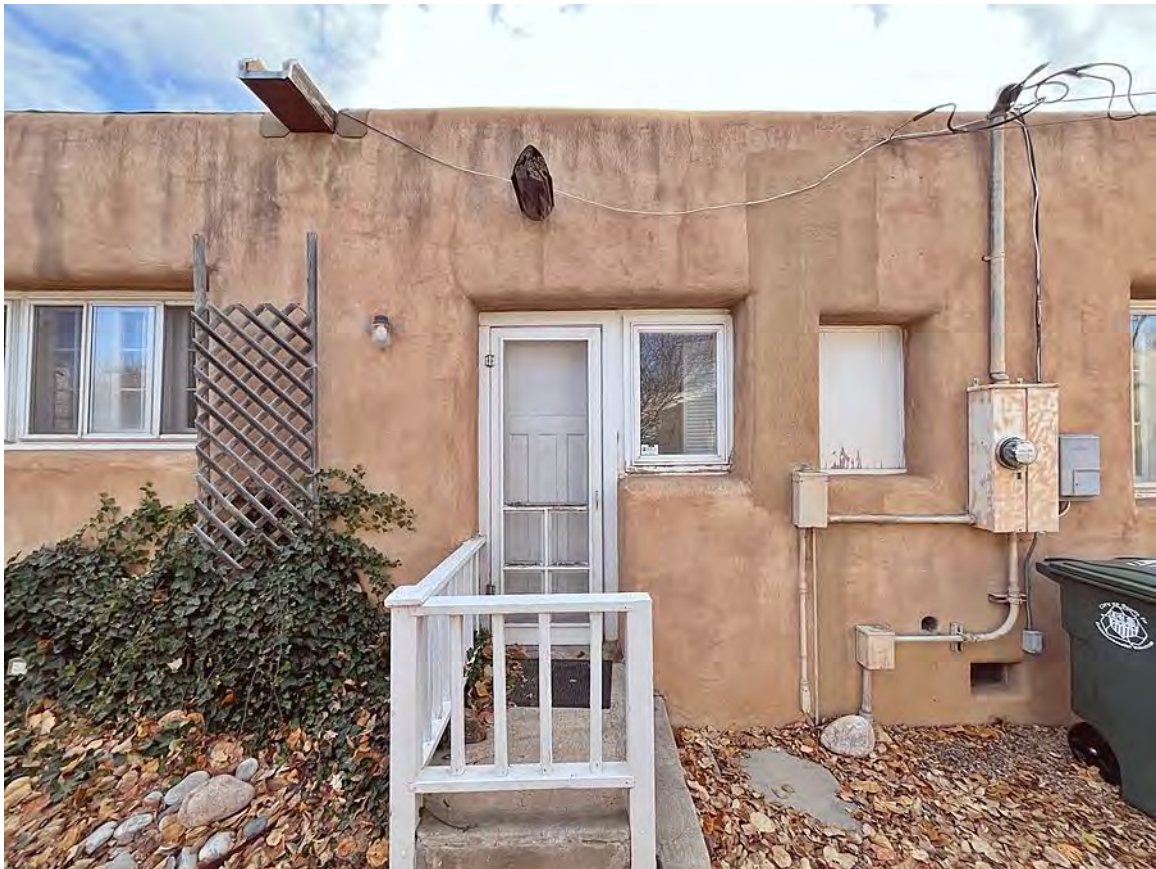
Photo 10: North elevation. Entry door. Camera facing south.

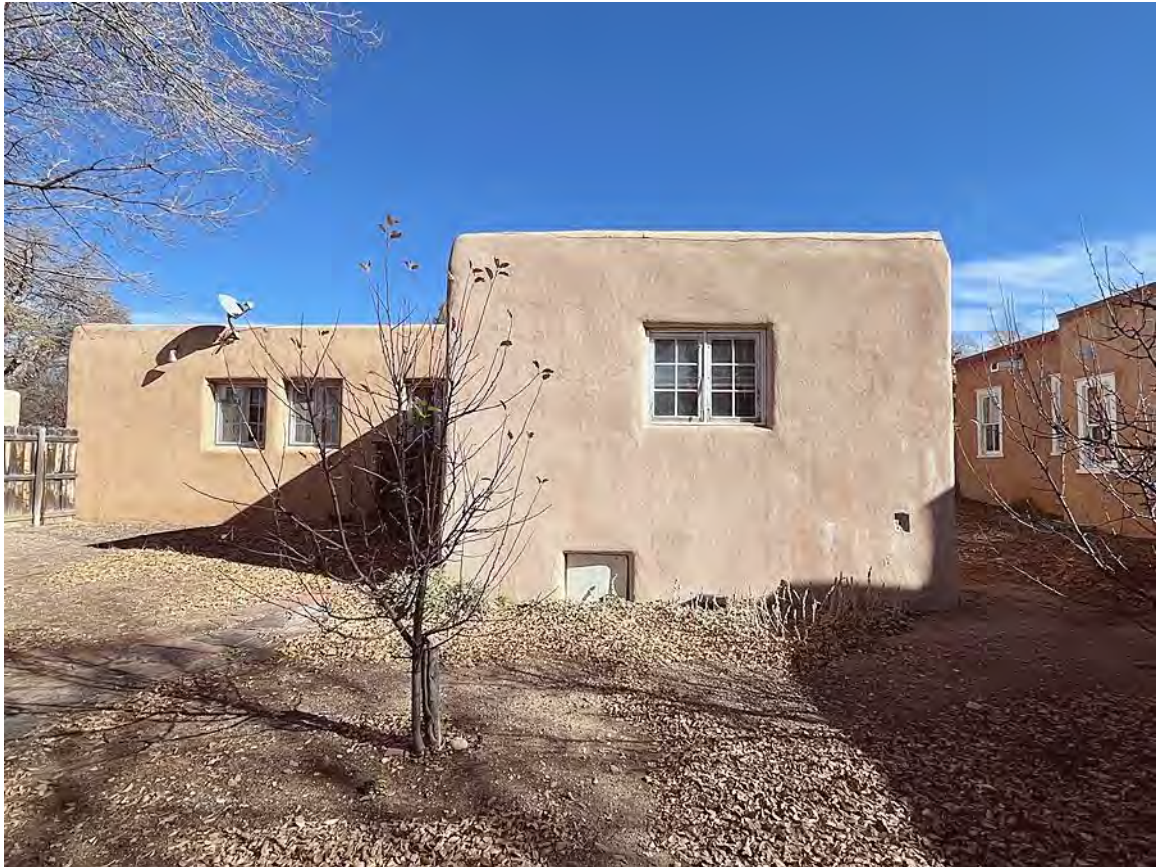
Photo 11: West elevation. 1995 addition at right. Camera facing east.

The west elevation overlooks the backyard and, beyond it, the Acequia Madre House, with which this property is historically associated. This façade combines the original 1931 building with the 1995 addition (Photo 11). The older section contains wood multi-light casements set at the same depth as the front façade of the house. The 1995 addition projects approximately 17 feet to the west and is constructed of wood frame. It has a modern door on its north side and wood six-light casements on its west and south elevations. These later windows are set approximately four inches back from the wall.

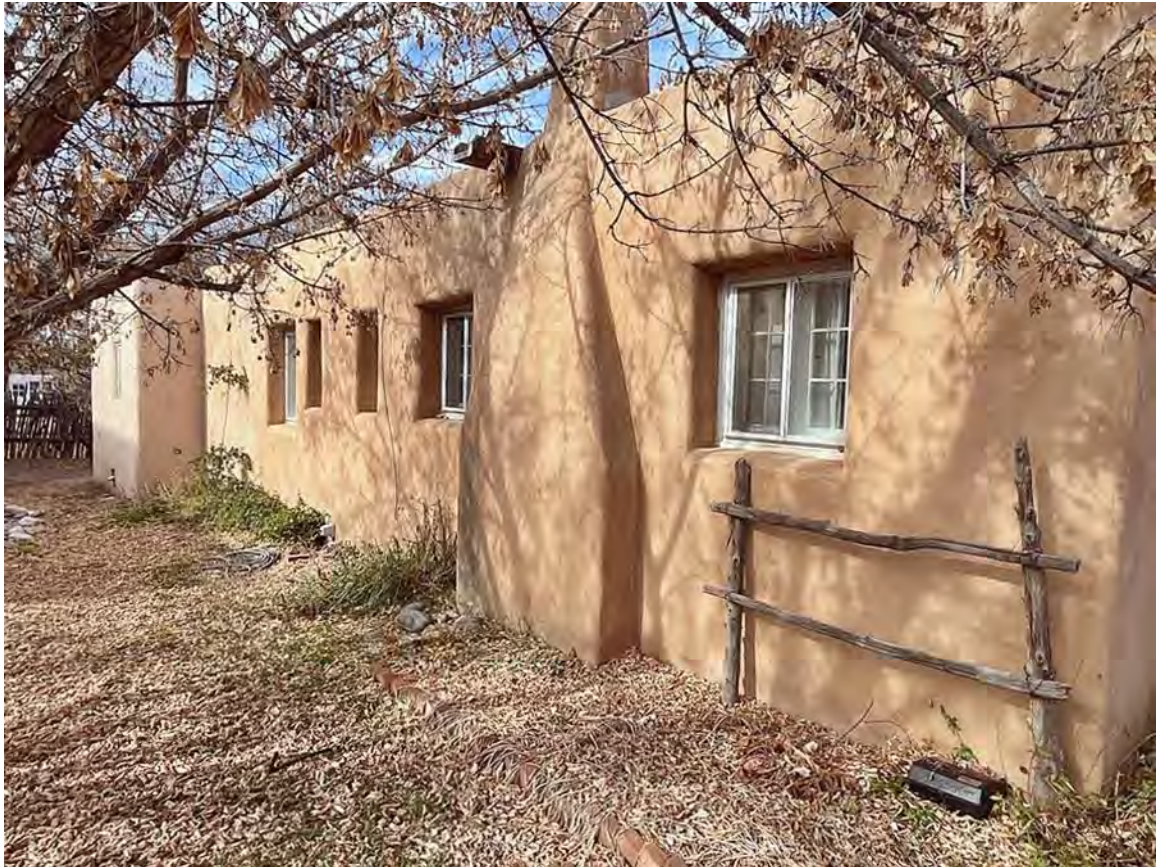
Photo 12: South elevation, east end. Camera facing northwest.

The south elevation combines the original 1931 building with the 1995 westward addition. In the older portion, a pair of wood casement windows flanks a prominent, tapered exterior fireplace mass (Photo 12). Moving westward from the chimney, the elevation contains a sequence of deeply set window openings fitted with older wood casements that match those found on the front façade. These openings vary slightly in size but share the same inset depth and multi-light configuration typical of early Pueblo Revival work.

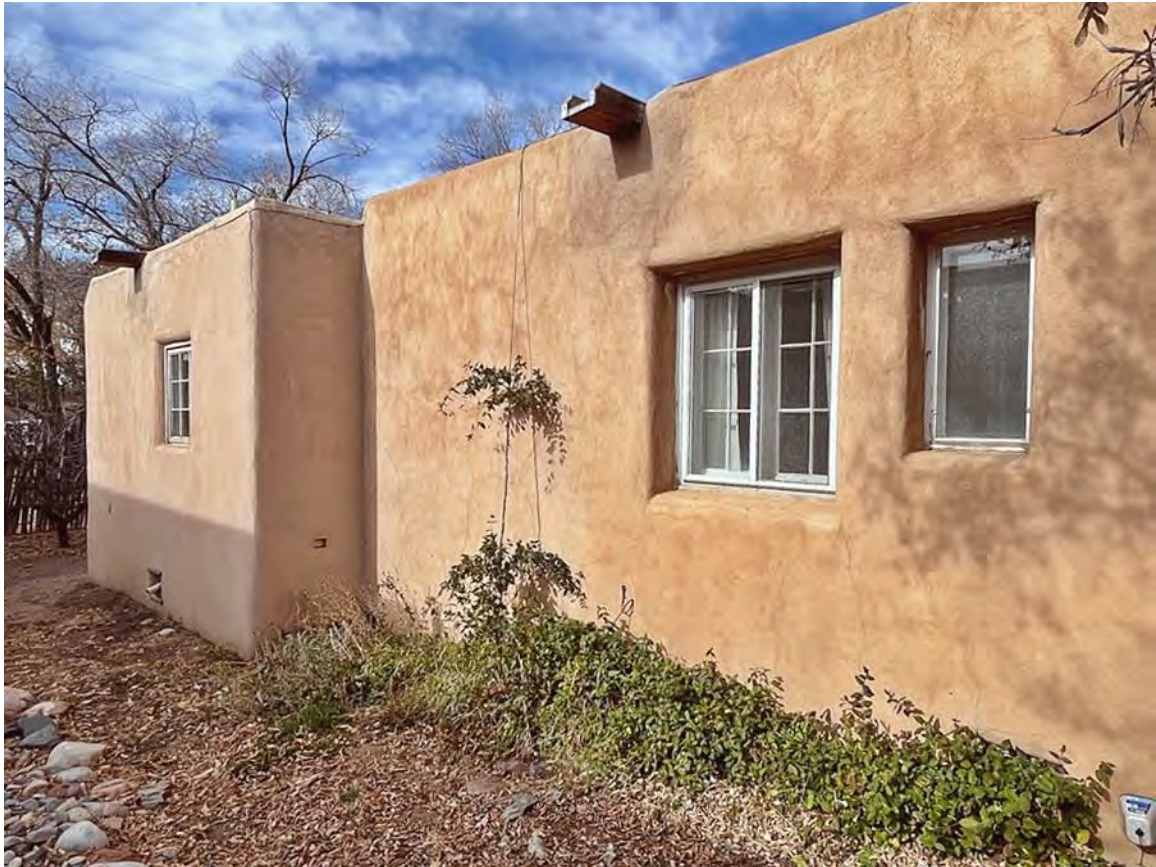
Photo 13: South elevation, west end. Camera facing northwest.

The 1995 addition, visible at the far west end of the elevation, is identifiable by its smoother wall plane and shallower casements (Photo 13). Though compatible in scale and finish, the addition reads as a later volume when compared with the sculptural wall surfaces and pronounced window recesses of the original construction.

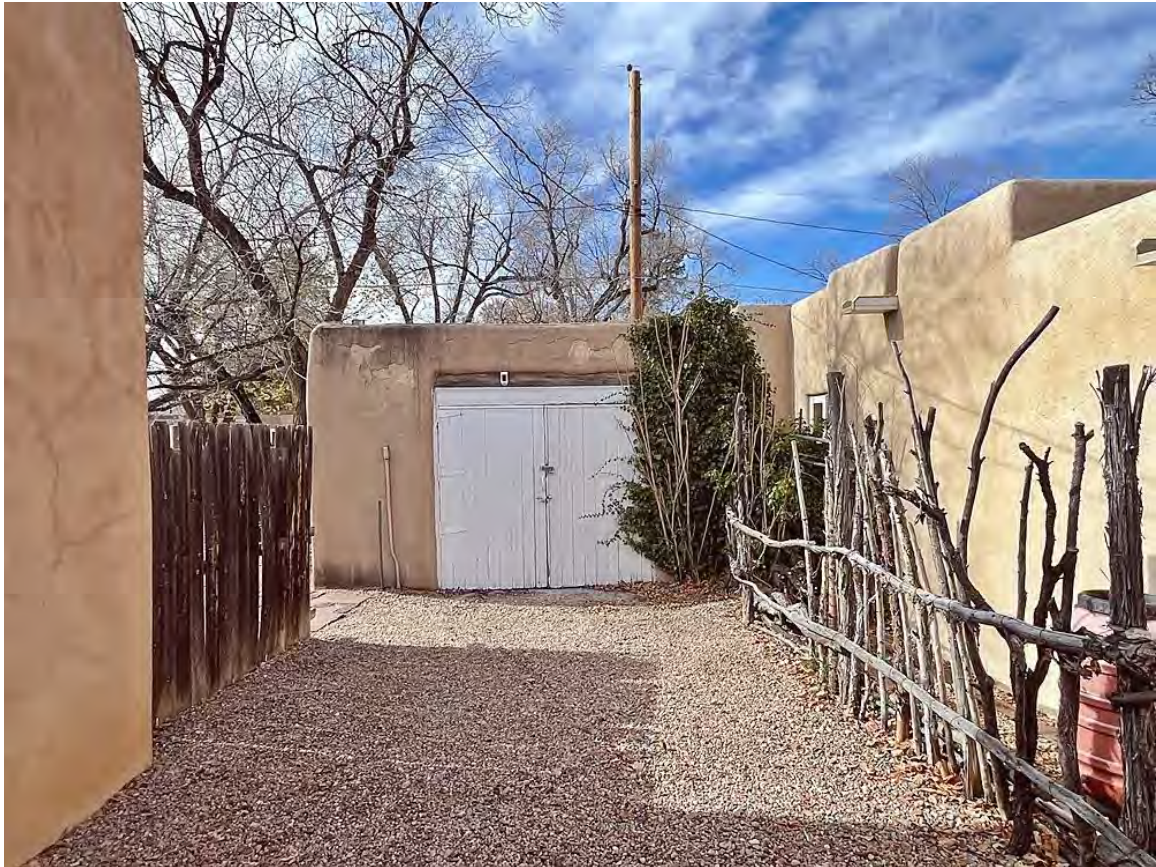
Photo 14: Garage. East elevation. Camera facing west.

Located at the end of the gravel driveway, the one-bay garage measures approximately 362 square feet (Photo 14). It is constructed of adobe and finished in stucco to match the house. The garage door consists of 5-inch-wide tongue-and-groove boards painted white; the door opens outward on metal strap hinges. The south elevation includes a single wood window of historic vintage (Photo 15). Attached at this elevation is a stuccoed frame utility closet measuring roughly 56 by 86 inches (Photo 16). No other fenestration appears on the building.

The garage is likewise recommended for Contributing status, with the east elevation, containing the original garage door, designated as the primary façade.

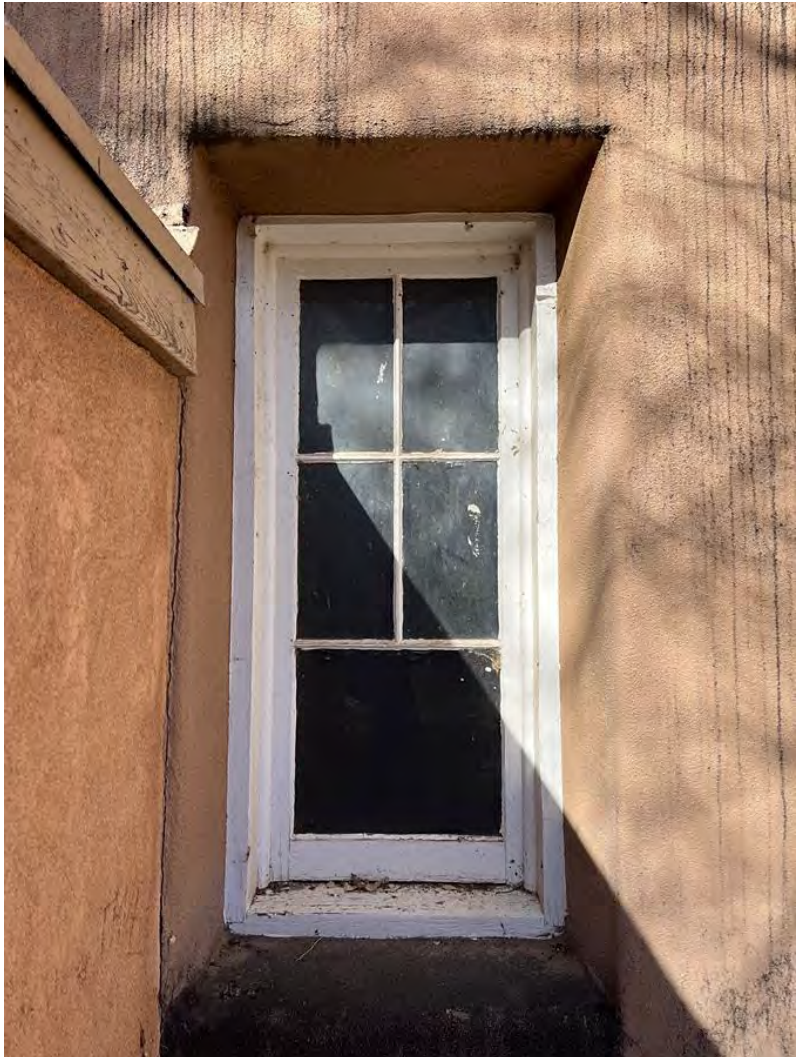
Photo 15: Garage. South elevation window. Camera facing north.

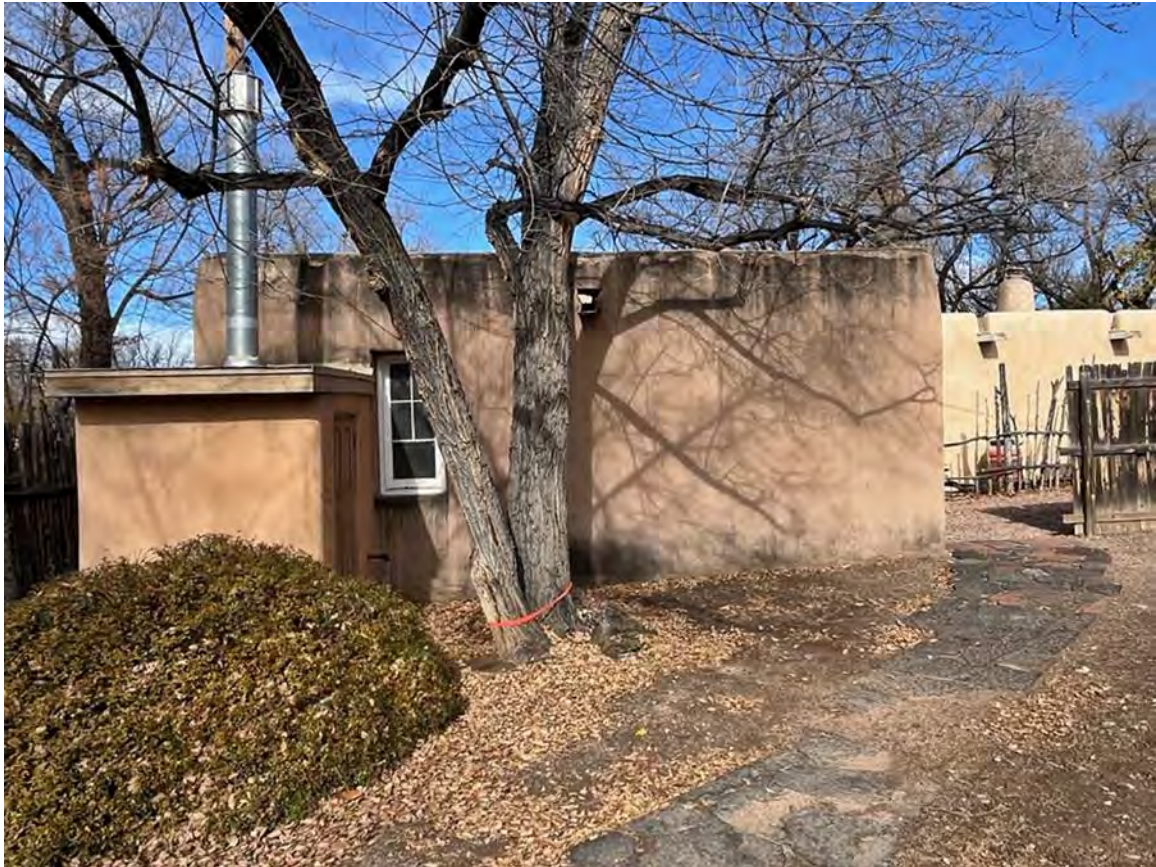
Photo 16: Garage. South elevation. Camera facing north.

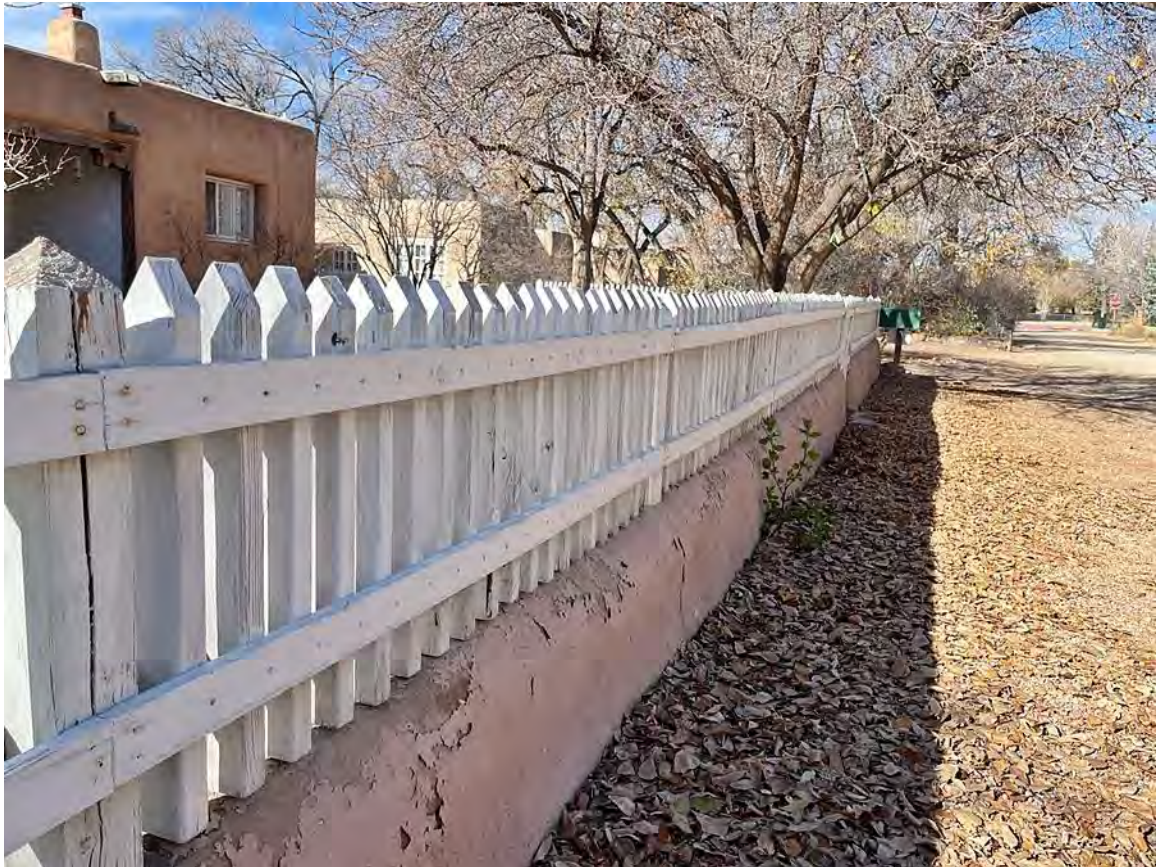
Photo 17: Fence/Wall. Camera facing northwest.

Extending along the front property line is a picturesque combination of low wall and picket fence (Photo 17). The wall portion is approximately 21 inches high and constructed of adobe, finished with multiple coats of stucco, and is currently painted pink (Photo 18). Above it rise panels of pickets made from 1½-by-2½-inch boards with four-sided conical tops; these pickets add another 21 inches in height. The fence portion turns the corner and continues along the driveway (Photo 19).

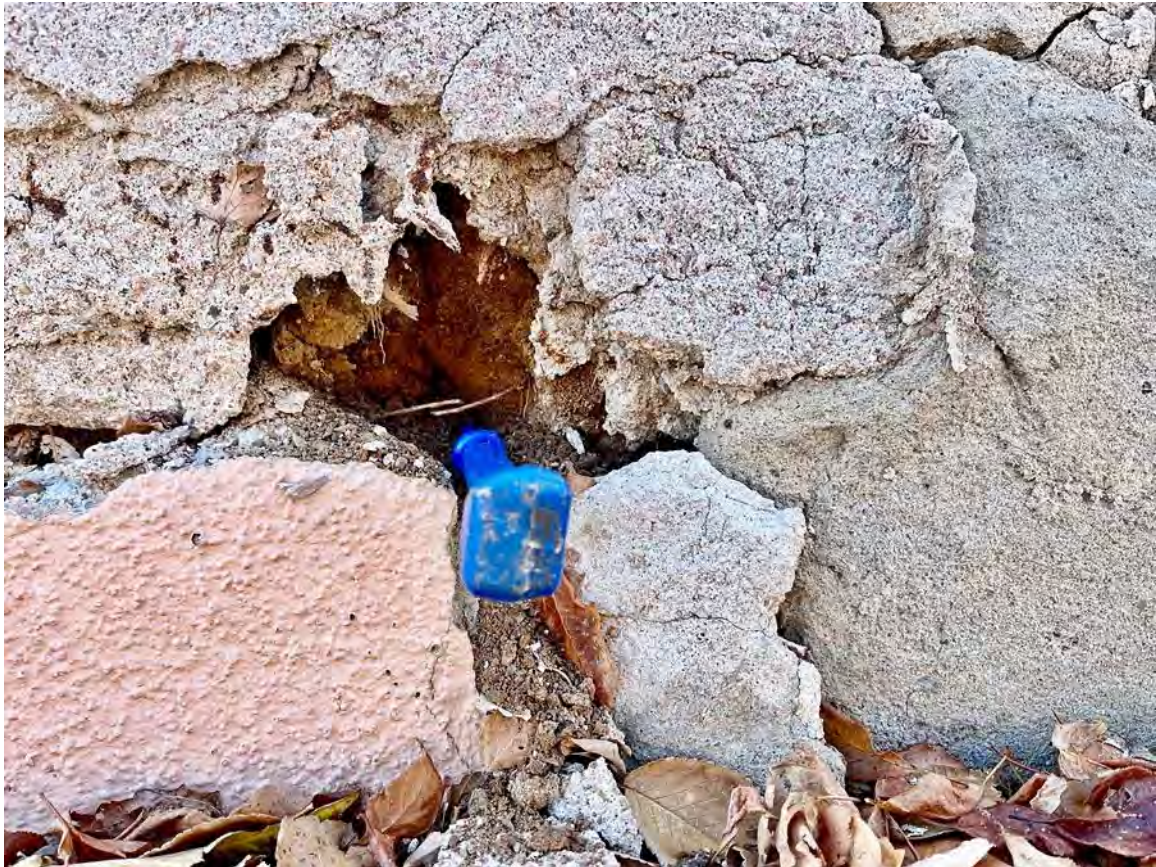
Photo 18: Fence/Wall. Adobe construction and stucco layers of base wall. Camera facing down.

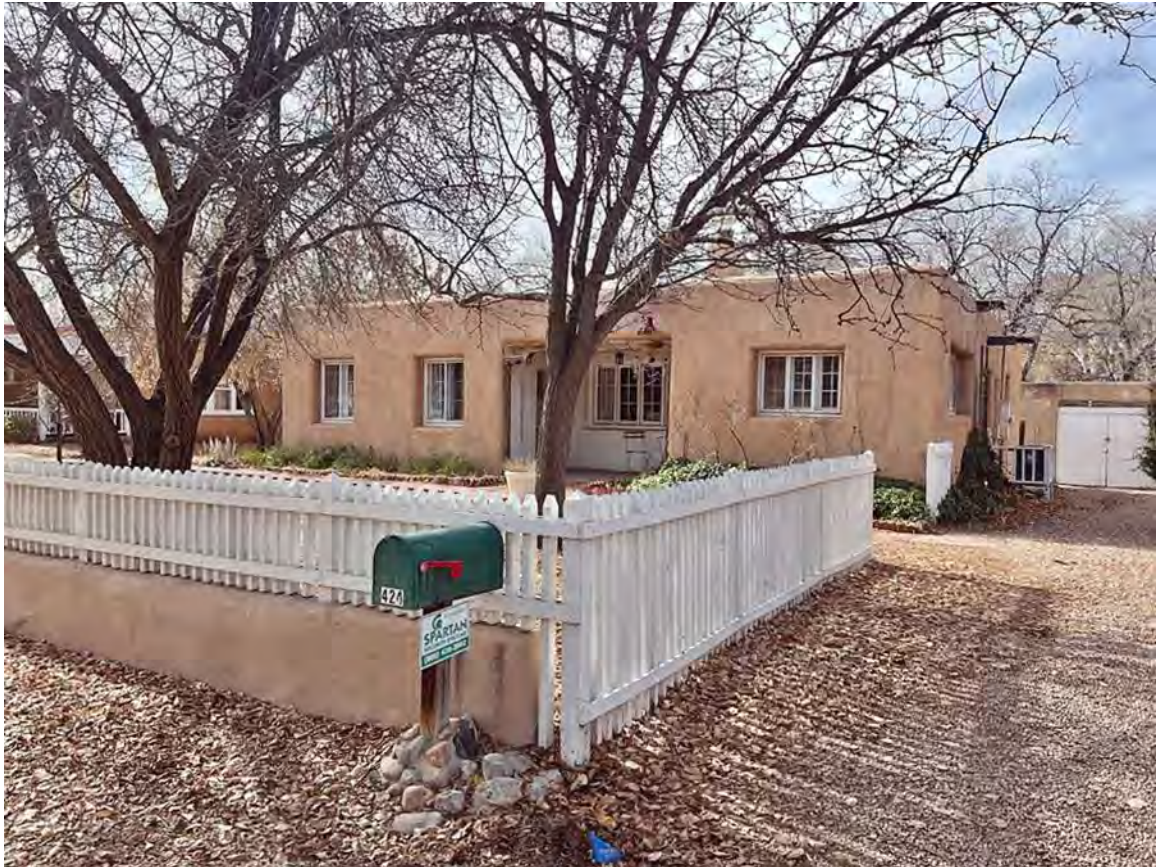
Photo 19: Fence/Wall. Camera facing southwest.

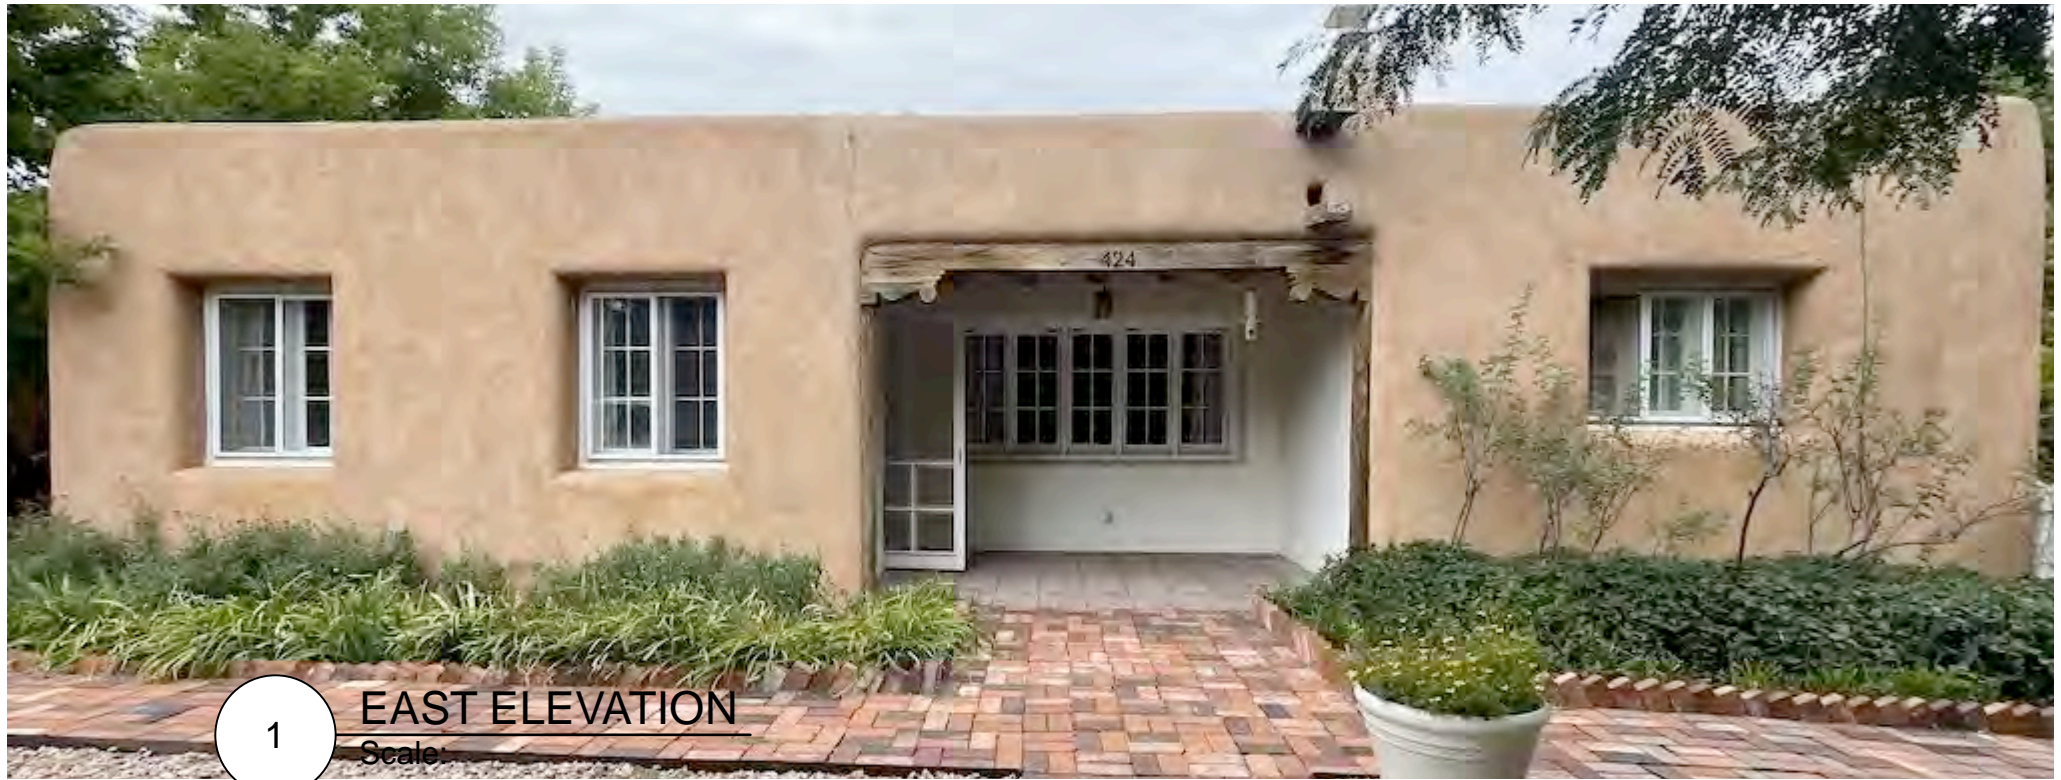
1

EAST ELEVATION
