Historic Cultural Properties Inventory (HCPI) Base Form (FORM 1)

1. Name of property: Fényes-Curtin Family – Rental House	2. Location: 424 San Antonio Street Downtown and Eastside Historic District – Santa Fe	3. Local Reference Number: Santa Fe ID: H-3208 4. County: Santa Fe Parcel # 10550912

8. Name of Project: HDRB Status Evaluation		
9. Lat/Long: 35.6793165,-105.9330012		
10. Photo Information: John W. Murphey, photographer. Photo 1: View of east elevation, facing west.

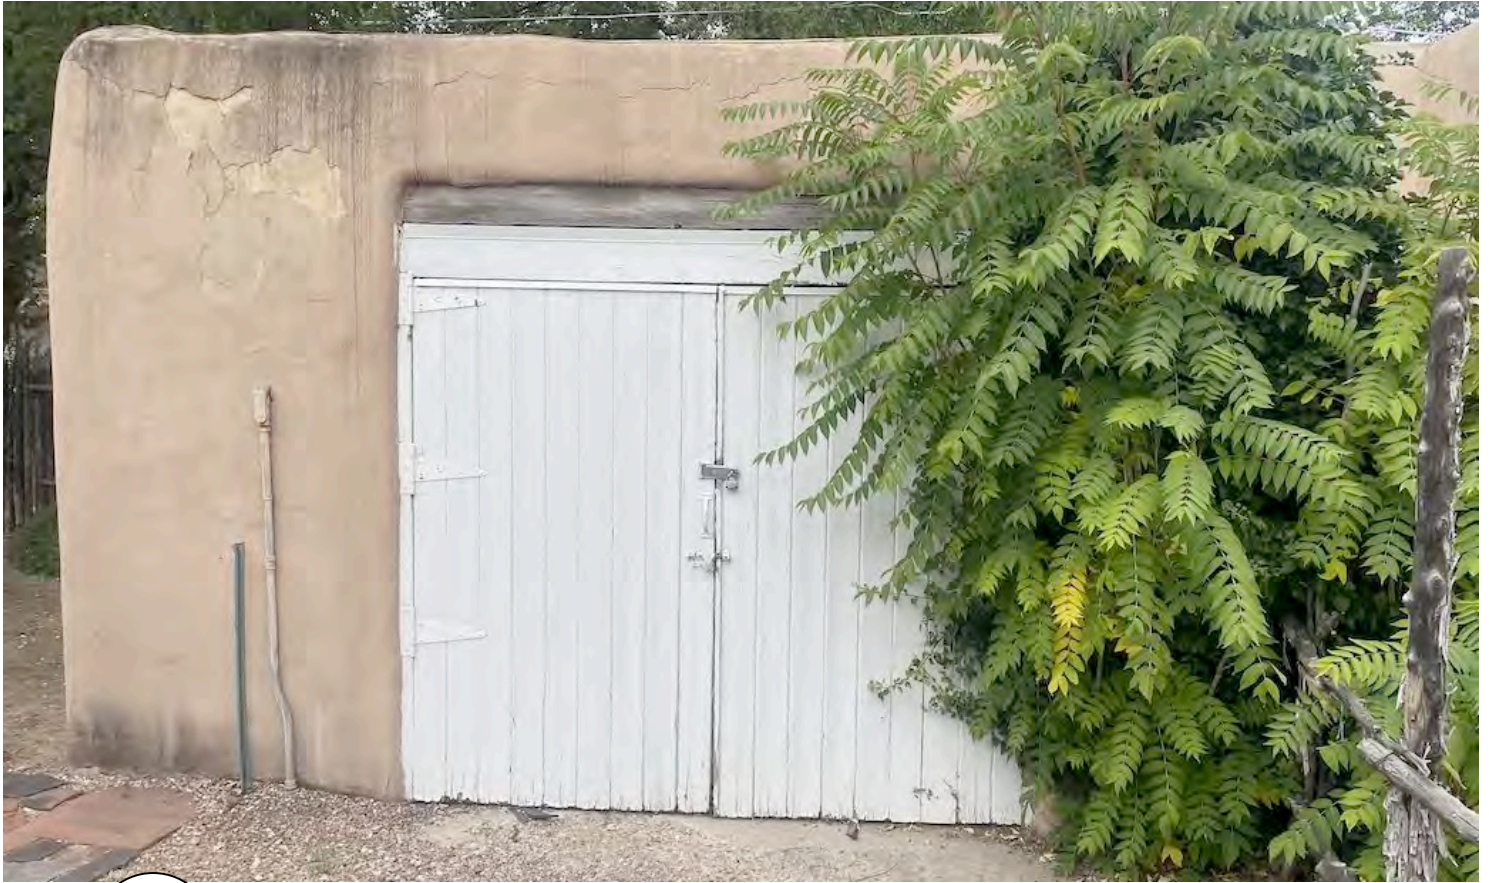
2

G. EAST ELEVATION

The garage is likewise recommended for Contributing status, with the east elevation, containing the original garage door, designated as the primary façade.

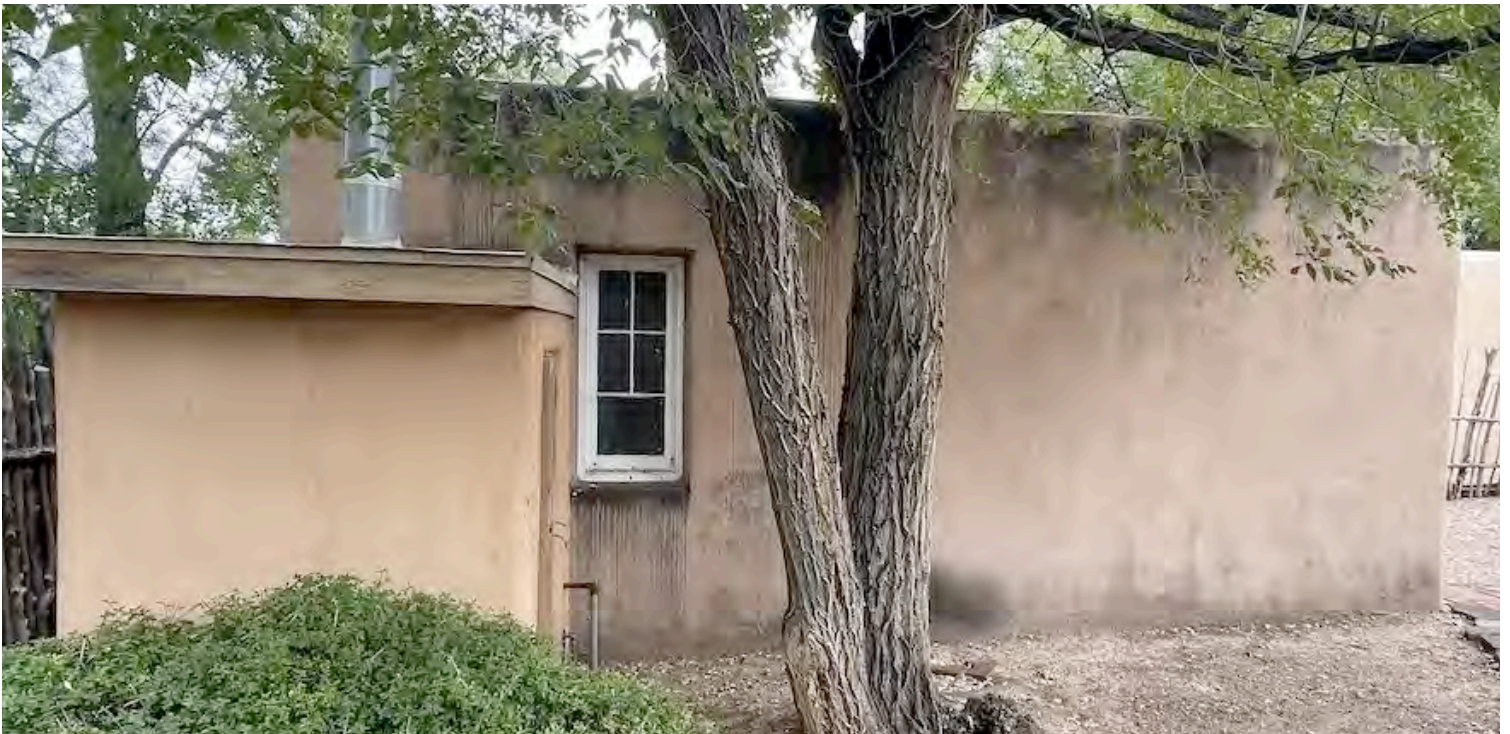
1

G SOUTH ELEVATION

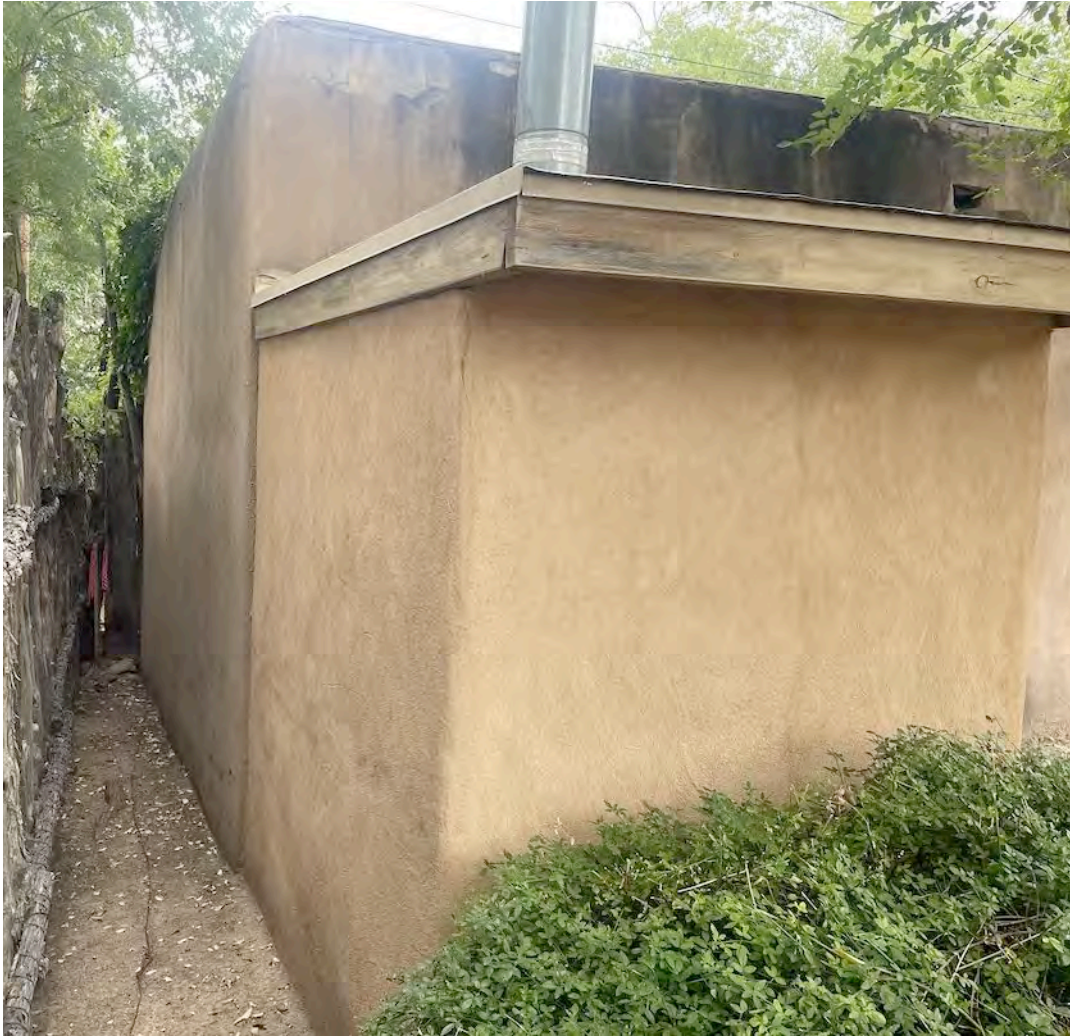
2

G. WEST ELEVATION

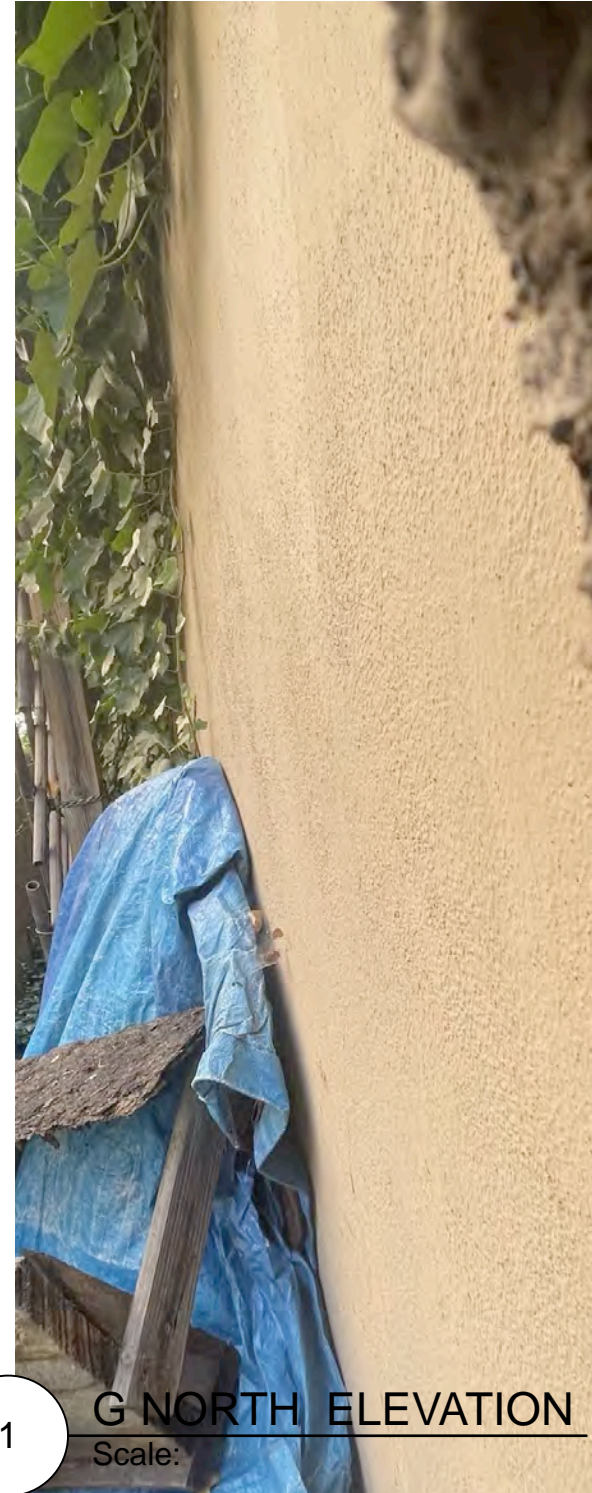
1

G NORTH ELEVATION

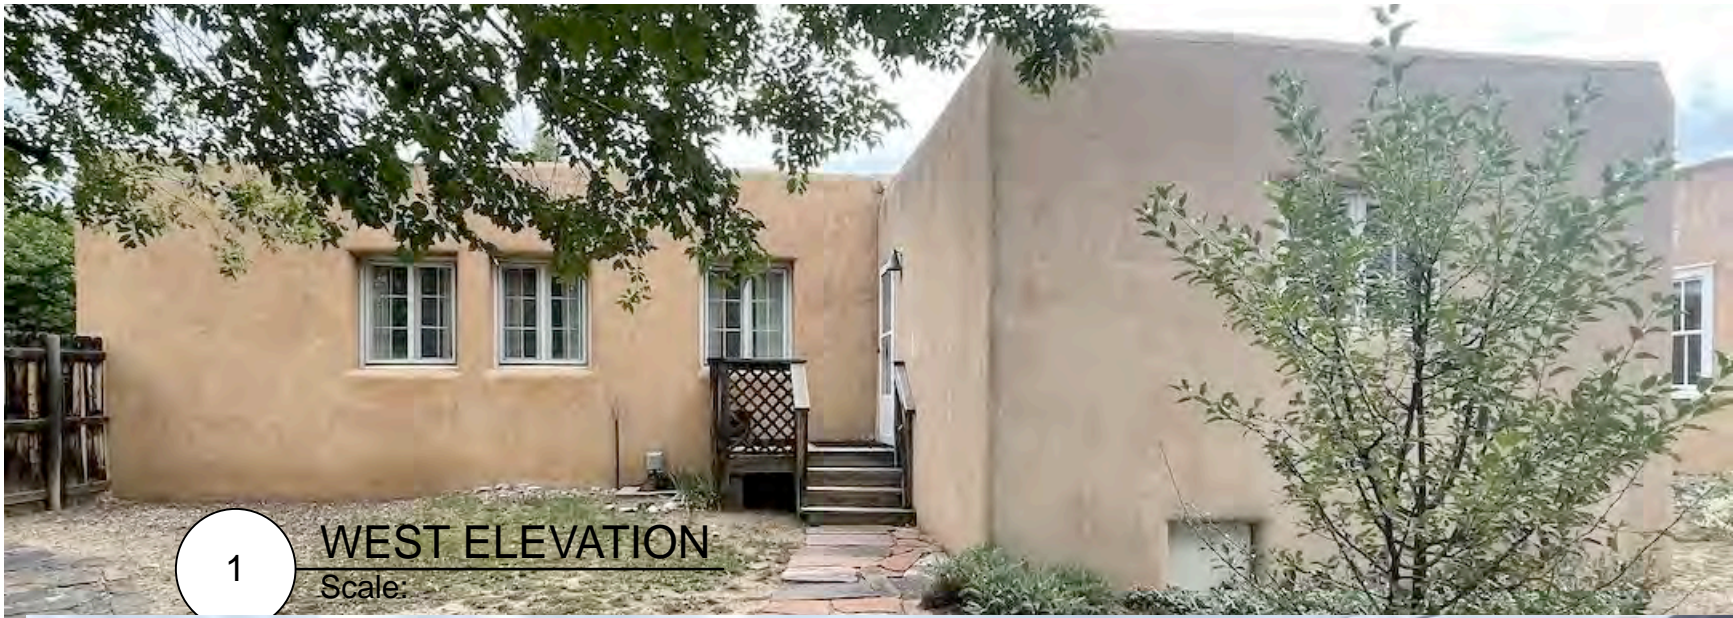
1

WEST ELEVATION

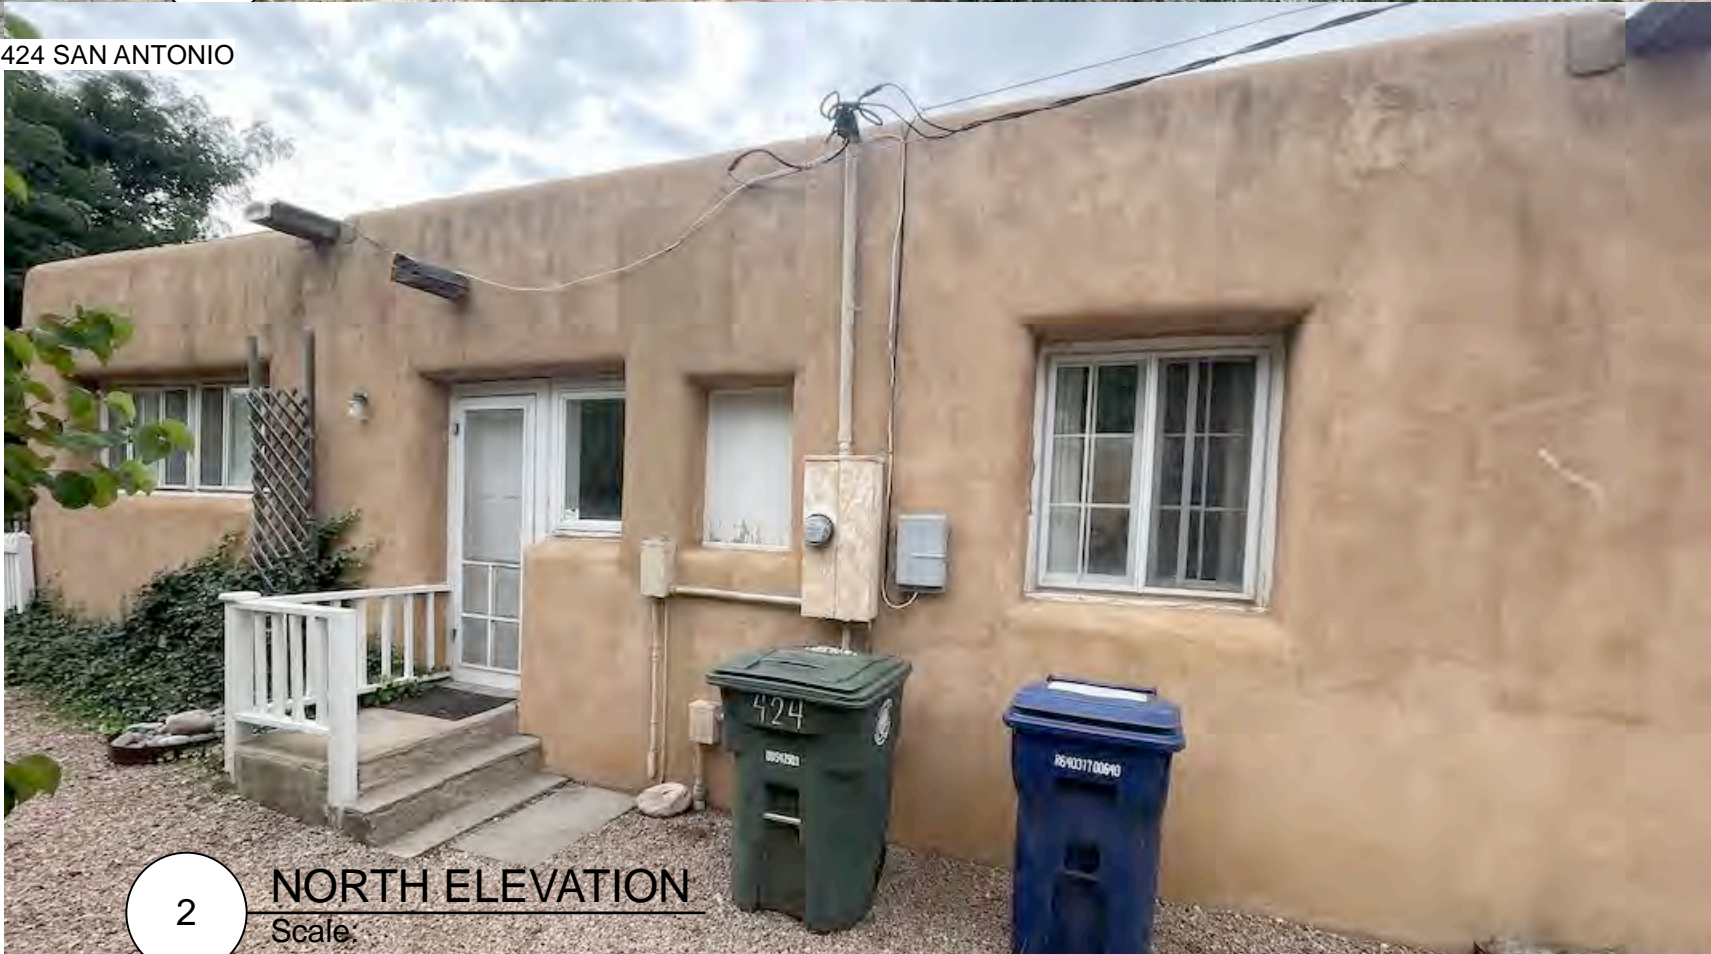
2

NORTH ELEVATION
