# City of Santa Fe, New Mexico

# memo

2026-012103-HDRB, 1121 and 1123 Paseo de Peralta, Downtown & Eastside Historic District, contributing, Architectural Alliance, agent for KCS Oil and Gas LLC, owner, requests status review and primary façade designation, if applicable, for two non-residential structures, yard walls, and a shed.

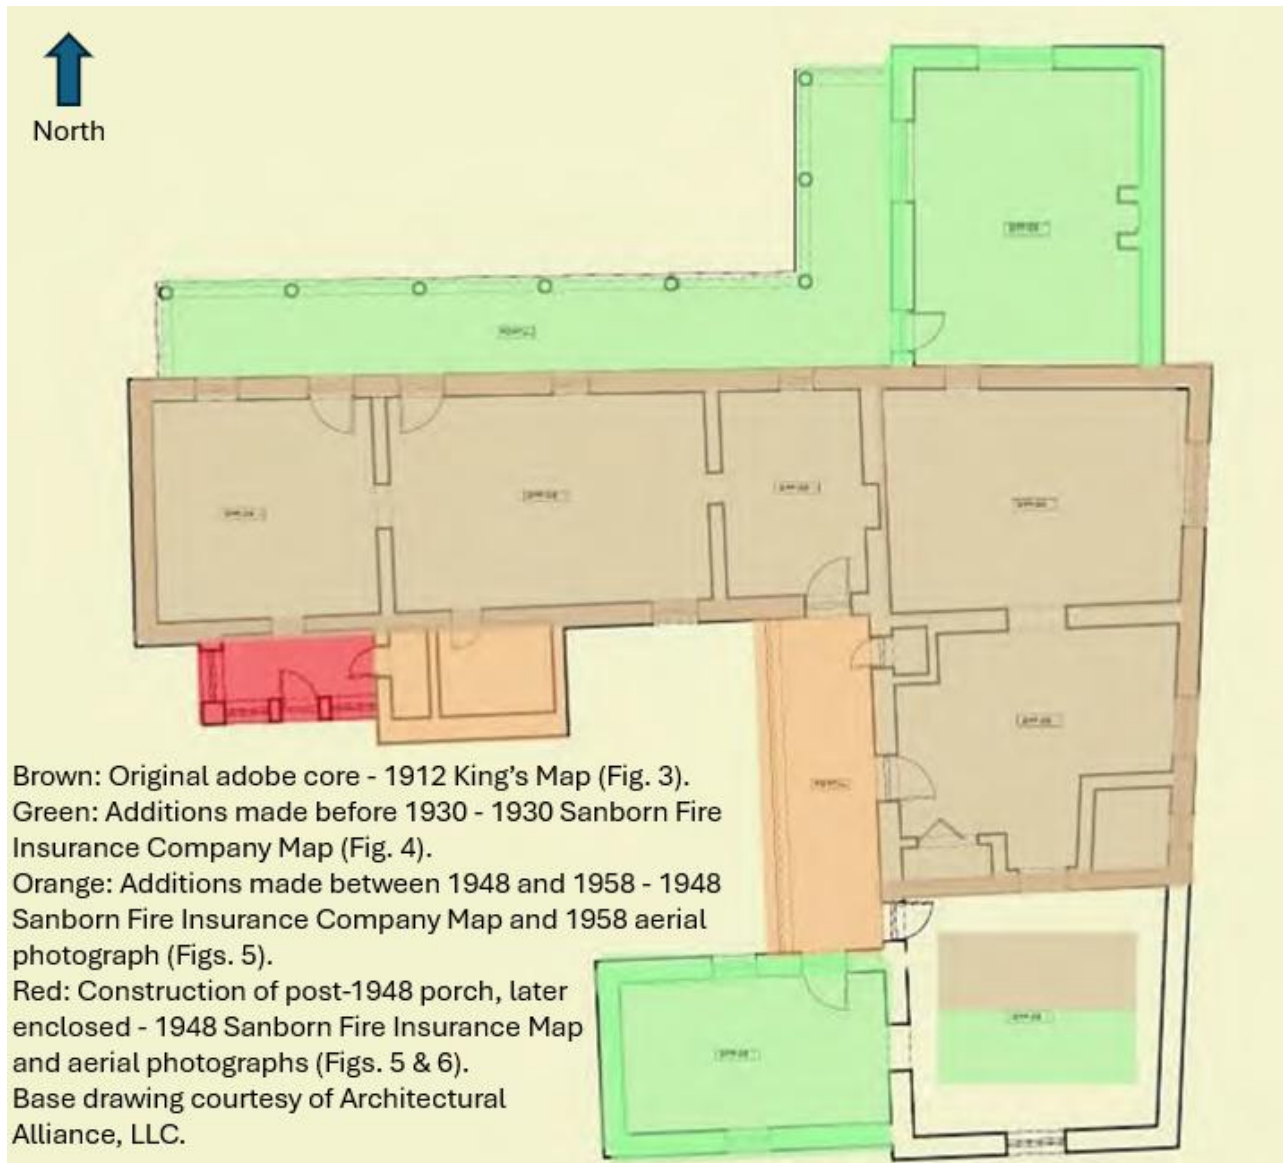
Figure 3: 1121 Paseo de Peralta footprint growth.

The building at 1121 Paseo de Peralta was constructed of adobe in an “L” shape in 1912. The original structure had no portals or projecting exterior features. An “L” shaped portal was constructed on the north façade after 1912. An adobe addition on the east end of the north elevation was constructed after 1930. The portal is supported by wood posts and has corbels and vigas with rough-sawn board decking on the interior. Several supports on the north elevation have been stuccoed. The connecting plate for the portal partially obscures a window opening on the southeast corner. The west wall of the building has no fenestrations. The southwest corner of the south elevation includes a post-1958 addition that has a lower roof, which may be an earlier enclosed porch area, a lower pony wall topped with wood windows, and an older raised-panel Dutch door. Going east, the south elevation transitions to a pre-1958 addition characterized by a rounded parapet and a line of sawn-off vigas. This leads to a west-facing portal, which was introduced between 1948 and 1958. As the building turns south, it incorporates a low, rectangular shed-roofed section that was constructed between 1912 and 1930. The wall of this section has a slight projection near the roofline, which accommodates a chimney. The stepped stucco chimney thickens as it rises above the parapet with a metal stovepipe flue at the top. As the wall proceeds eastward, it increases in height, and the wall plane returns to what may be the original building or an apartment constructed before 1930. Two non-historic chimneys rise above the parapet on the west. The east elevation is limited to fenestration of a mix of older wood sash windows; most are set close to the ground. The windows are obscured by brush, one is partially infilled with stucco, and one window has only one part of the sash elements remaining. The east post-1912 projection holds a stuccoed chimney.

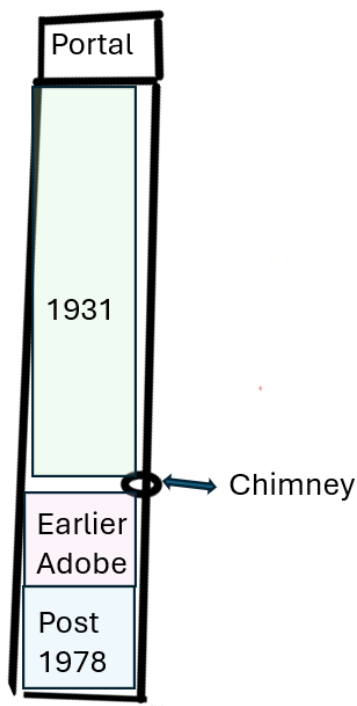
Figure 4: 1123 Paseo de Peralta footprint growth

The building at 1123 Paseo de Peralta was constructed in 1931 on the west side of the property. It appears to have either replaced or incorporated an older adobe outbuilding. The north elevation front porch holds a unique mushroom-shaped opening reflecting a vernacular expression of Mission Revival Design. Either side of the portal has keyhole-shaped openings, which are a form rooted in Mission Revival style. The porch interior holds a plastered ceiling and a concrete floor.

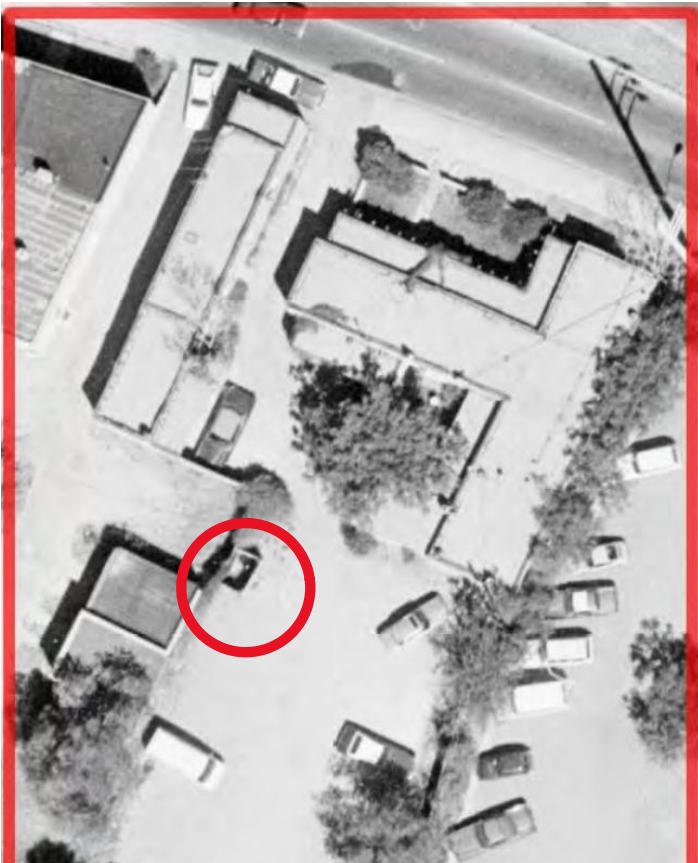
Figure 5: Shed in 1978 aerial

The shed located at the rear of the lot appears in the 1978 aerial, but is not on the 1958 aerial. The small shed is constructed of wood with a corrugated metal roof and a single door on the east elevation. Due to its age, it does need to be reviewed for status. Staff finds the shed to be non-contributing due to its lack of character and location in the parking area.
