City of Santa Fe, New Mexico

memo

2026-012133-HDRB. 1062 Camino San Acacio. Downtown & Eastside Historic District, non-contributing, Gabriel Brown, agent/owner, proposes to demolish a 755 sq. ft. accessory structure.

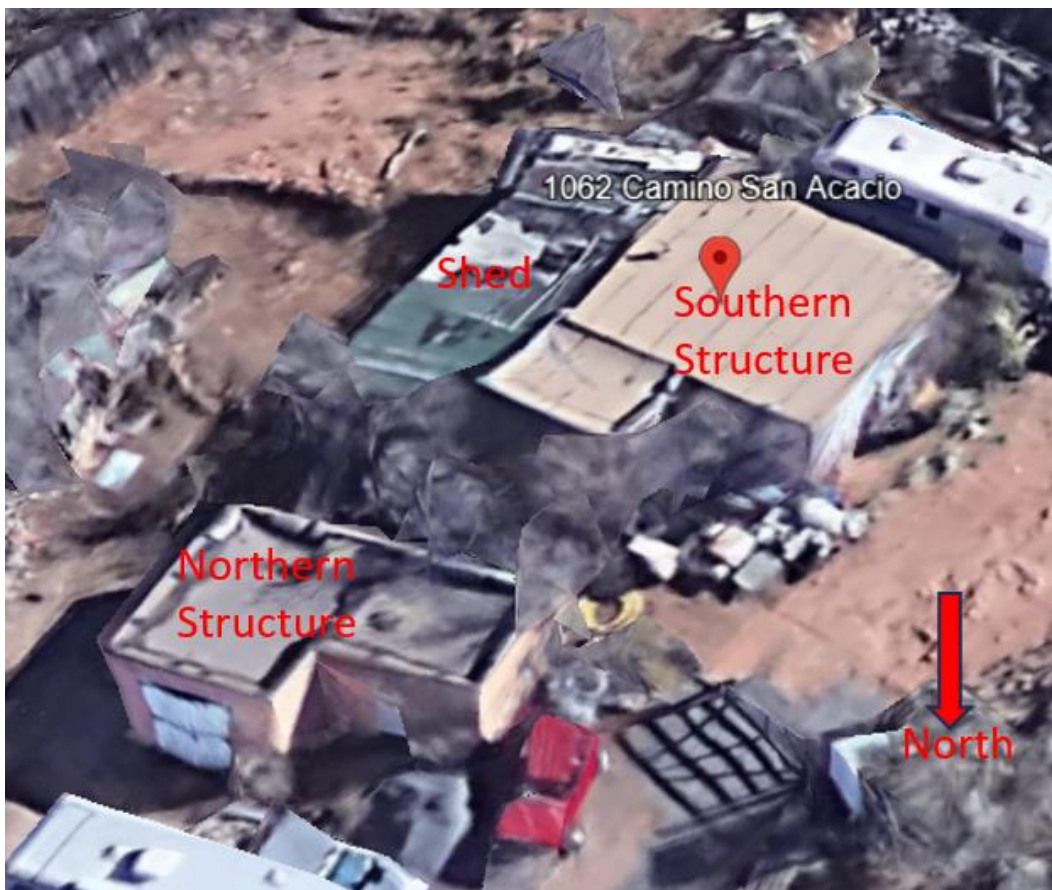
Figure 2: Structures on the Property

The northern structure is an 853 sq. ft. adobe garage, with interior vigas. It is stuccoed with capped parapets and a rowlock pattern working as dentils. This structure is not a part of this request.

The southern structure is 755 sq. ft., constructed of adobe with a shed attached to the east elevation. This southern structure is non-contributing to the Downtown and Eastside Historic District and is the focus of this demolition request.

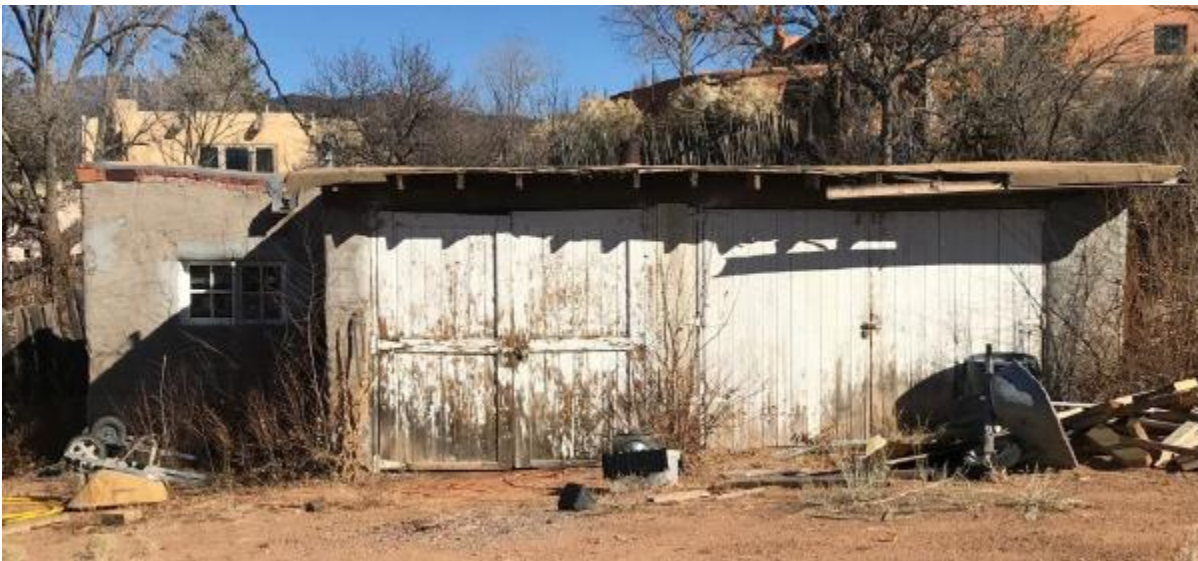
Figure 3: Southern Building West Elevation

The north elevation (see Figure 4) rises above grade on a mixed concrete and rubble foundation, with adobe walls covered with a gray scratch coat on top. The walls are mounted with a coping made of clay tile blocks and bricks. Attached to the east side (see Figure 6) is the beginning of the shed. On the west elevation (see Figure 3), there are two wide garage doors and a window giving light to the interior. While the size of the opening is original, the window has been replaced. The two four-light fixed units are separated by a 1"x 6 1/2" board acting as a mullion. The west elevation was given a scratch coat, and an overhang extends nearly 24" over the openings. The south elevation (see Figure 5) has exposed mostly uniform 7"x 3 1/2" x 16" mud brick construction material laid in a typical pattern and adhered with mud mortar. There is a grouping of newer sash windows fitted into openings with a board mullion. A shallow overhang tops the wall. Rolled asphalt roofing wraps down over the façade roof.

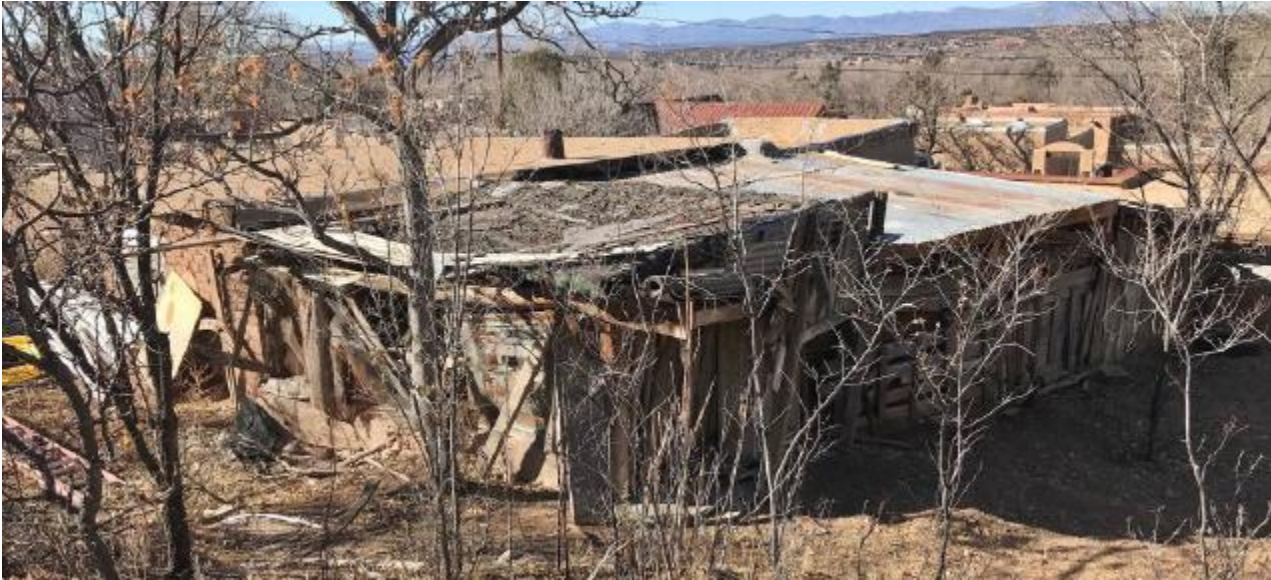
Figure 6: Upper Building East Elevation

A shed covers the east façade and is constructed of a mix of wood materials and corrugated tin, and is split into three divisions. The north elevation of the shed sits on a rubble stone wall and reveals various wood surfaces. It has a south end that has an opening framed by large rough beams. Its structure rests on a mixed concrete-and-rubble foundation. Its roof is partially collapsed. The middle section has an east-sloping shed roof with openings that resemble animal pens. It has been recently reinforced by new 3 1/2" x 9 1/2" beams. The lower north section has a roof sloping in the same direction and erected over a rubble stone wall and has a single gate, sheltered by an overhang of 2' x 4's. Based on the known use of the property, there is a high likelihood that the shed once enclosed animals.

- The northeastern portion of the structure was built as a goat pen. Someone later added a lien-to-roof without proper support and with reused material, which is full of holes. The fences that make up the east and north walls of the structure have been reinforced with reused pallets and other discarded wood. This portion of the building is collapsing as the wooden posts that support the roof rot off at the ground.
