City of Santa Fe, New Mexico

memo

2026-012284-HDRB. 1062 Camino San Acacio, Downtown & Eastside Historic District, contributing, Gabriel Browne, agent/owner, proposes to replace windows and doors and install exterior insulation on the contributing structure. Construct a 3,440 sq. ft. freestanding residence to a height of 20'-9", where the maximum allowable is 16'-9". Construct a 733 sq. ft. guesthouse with a pitched roof and construct a 6'-0" high fence and a 4'-0" high yard wall. Additional height is requested due to slope per section 14-4.6(F)(2)(II)(f). Exceptions are requested to section 14-4.6(E)(4)(II) for placing a new architectural finish on a primary facade and for using material not in keeping with the district.

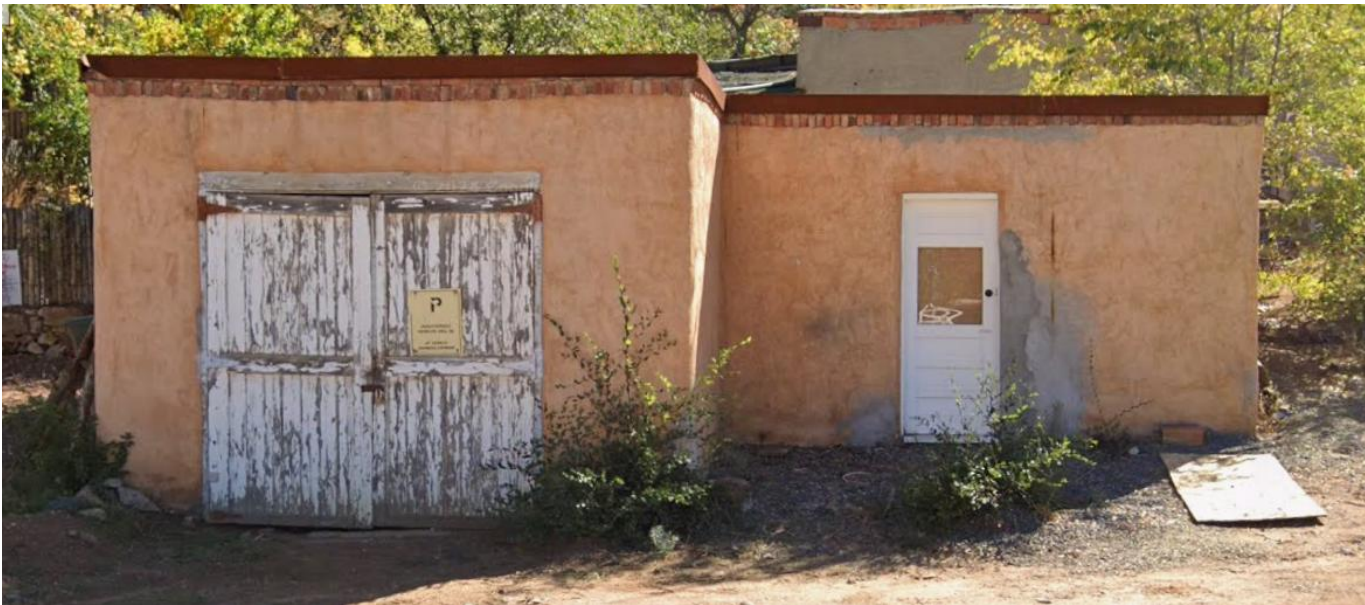
Figure 2: Existing Northern Contributing Garage Structure
Historic Districts Review Board, Case #2026-012284-HDRB

The northern or lower building is an 853 sq. ft. adobe structure, with interior vigas. The building is stuccoed with capped parapets with a rowlock pattern working as dentils. The roof slopes south to the gutter and is modified bitumen. The roof was recently redone, along with replacing areas of the roof and installing new vigas and a concrete floor as approved under permit 2019-5288-EXTR. The garage on the east side of the north facade has swinging wood panel doors. To the west of the north facade is the only pedestrian entry to the building. The door is a stock ¼ glass unit with four raised panels. The west facade has a single four-lite non-historic in-swing casement window with a heavy concrete sill at the bottom of the window. The south elevation is partially dug into the slope and is divided evenly with two openings holding non-historic six-light casement windows and a non-historic overhang spanning the facade. The east facade is an empty wall.

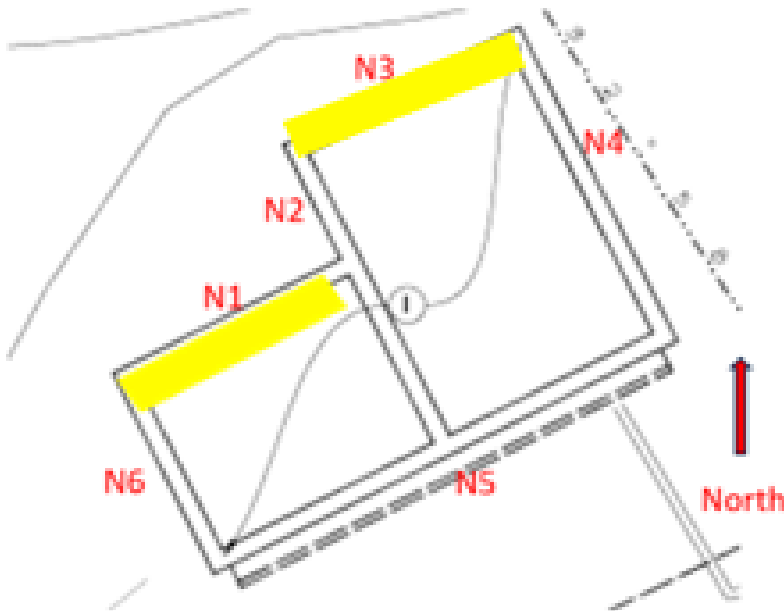
Figure 3: Primary Façade Diagram

Case 2023-007358-HDRB was a status review for the two accessory structures on the property. The northern garage structure was designated as contributing, with the north-facing facades (N3 and N1) as the primary. The southern accessory structure was designated as non-contributing.

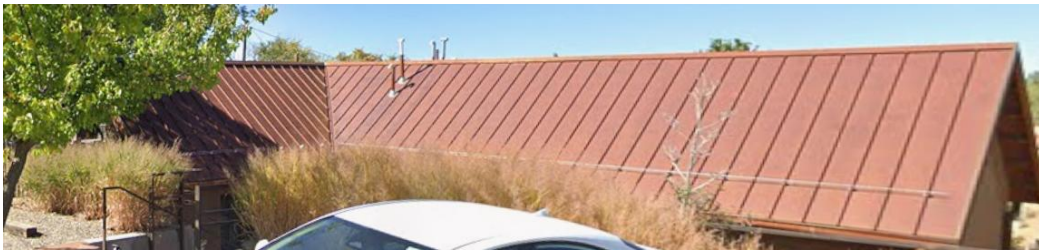
Figure 4: Roof at 1051 Camino San Acacio

- b. The roofs are flat except for the shed roof over the portal on the north elevation and a section on the rear, which will be allowed to rust to match the rusty pitched roofs across the street at 1051 Camino San Acacio. The pitched roof is allowed in this streetscape per section 14-4.6(F)(IV).

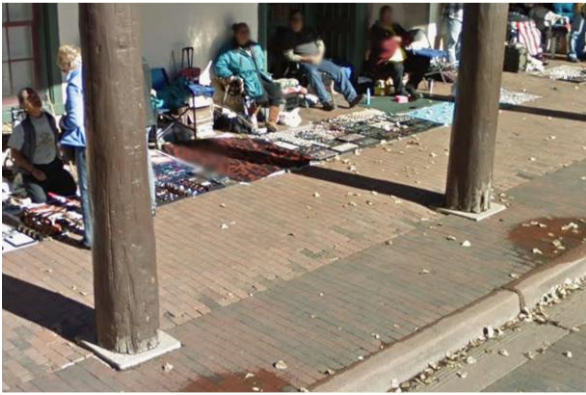
(figure of the Palace of the Governor's offered by applicant)

It has been less than 10 years since the Palace of the Governor's portal remodel. The posts are already rotting out again.

Staff Response: The staff finds that this criterion is not met. The area at the Palace of the Governor's is not consistent with that of Camino San Acacio, especially this property given that it will be constructed on a steep slope. That comparison is not relevant to the request for metal over wood. There are other options to help mitigate wood rot on wood columns, such as, but not limited to, a concrete or rock base for the column to stand on so that the wood does not sit in water puddles and rain runs away from the wood. Also, constructing stucco columns is an option over wood which would not use metal.
