City of Santa Fe, New Mexico

memo

2026-012284-HDRB. 1062 Camino San Acacio, Downtown & Eastside Historic District, contributing, Gabriel Browne, agent/owner, proposes to replace windows and doors and install exterior insulation on the contributing structure. Construct a 3,440 sq. ft. freestanding residence to a height of 20'-9", where the maximum allowable is 16'-9". Construct a 733 sq. ft. guesthouse with a pitched roof and construct a 6'-0" high fence and a 4'-0" high yard wall. Additional height is requested due to slope per section 14-4.6(F)(2)(II)(f). Exceptions are requested to section 14-4.6(E)(4)(II) for placing a new architectural finish on a primary facade and for using material not in keeping with the district.

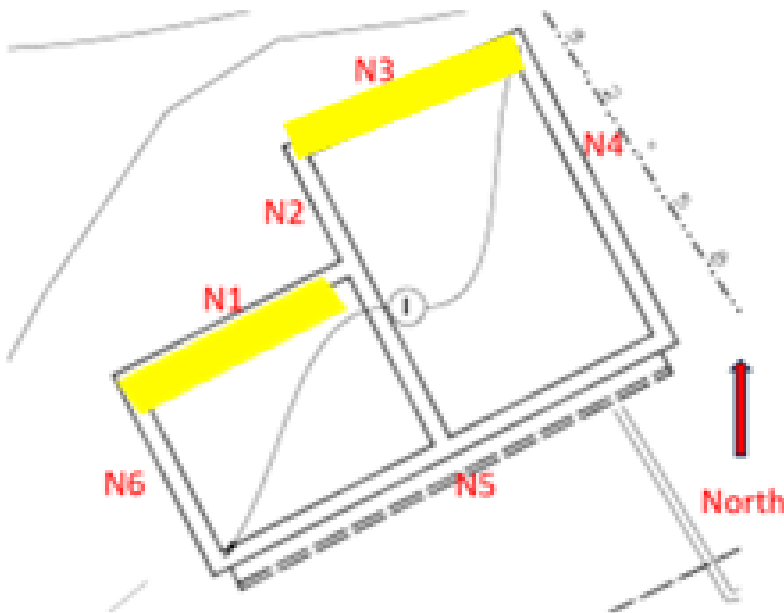
Figure 3: Primary Façade Diagram

Case 2023-007358-HDRB was a status review for the two accessory structures on the property. The northern garage structure was designated as contributing, with the north-facing facades (N3 and N1) as the primary. The southern accessory structure was designated as non-contributing.
