PROJECT 2026-011825-HDRB. 619 W. Alameda St. Westside-Guadalupe Historic District. Contributing.
DESC: Dura Build Construction, agent for Max Scott, owner, proposes to install a bond beam, repair historic windows, re-roof the existing residence, and construct 40” high yard walls. An exception is requested to section 14-4.6(E)(2)(IV)(b) to raise the height of a contributing structure.

CASE NUMBER: 2026-011825--HDRB

PROJECT TYPE: Remodel

LOCATION: 619 W ALAMEDA ST
Santa Fe, NM 87501

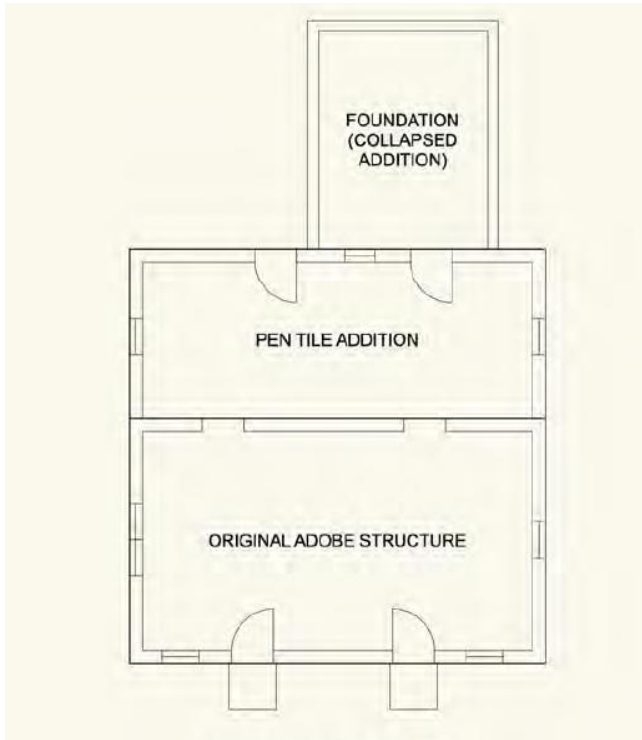
Figure 2: Residential Sections.

The 702 sq. ft. single-family residence at 619 W Alameda Street is listed as contributing to the Westside-Guadalupe Historic District. The Spanish Pueblo Revival structure is constructed of adobe and pentile.

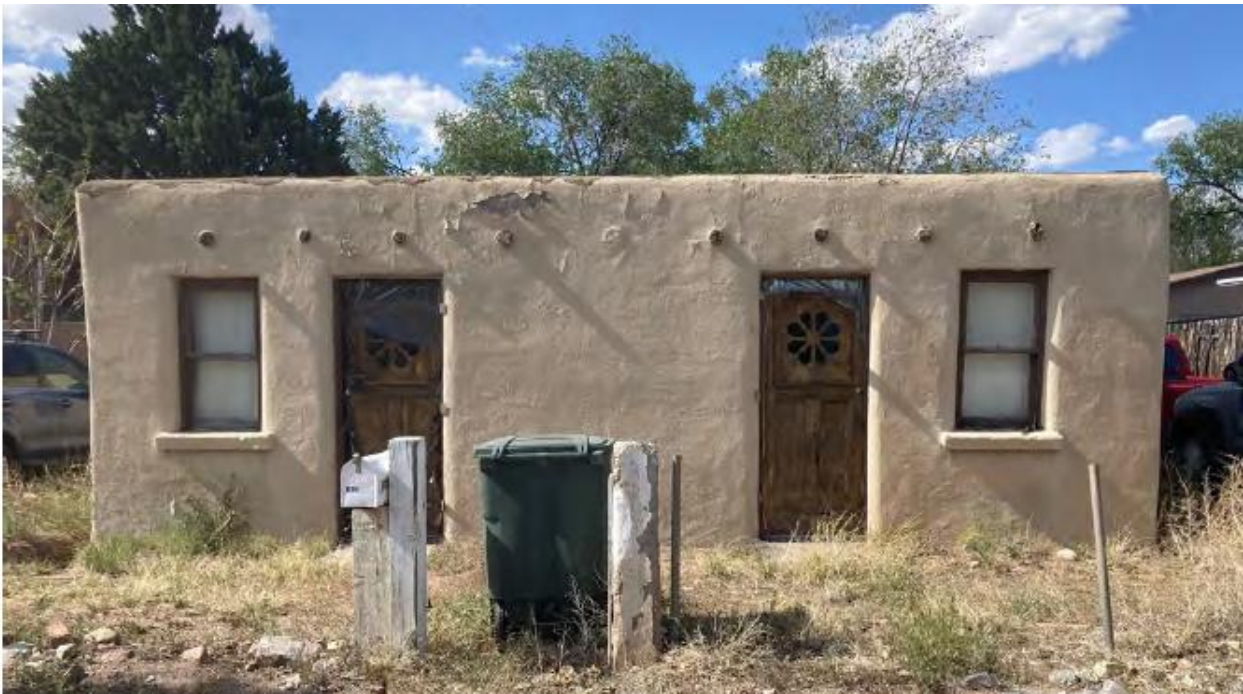
Figure 3: South Façade of Residence.

The adobe portion of the residence was constructed approximately around 1943, with the pen tile addition being constructed by 1951. The wood-framed addition appears to have been constructed in 1975 and collapsed in 2024 which has been removed from the property. There are projecting vigas at the exterior of the adobe south walls, though the interior portion of the vigas appears to have been removed at some point. The north wall has projecting roof joists on the pen tile addition. Roof drainage is a single-sheet metal channel on the north elevation. The exterior walls are cement stucco on chicken wire with paint on the stucco.

All except one window are wood, double-hung hung single-glazed one-over-one windows. There are some wood screens, though not all windows have these screens. The two front doors on the south may be handmade wood, frame, and panel with a glazed flower petal design. The western rear door is a frame and panel, and the eastern rear door is a hollow-core wood door. All windows and doors are recessed about 6", and the windows have projecting concrete sills. The two front doors have two small steps.

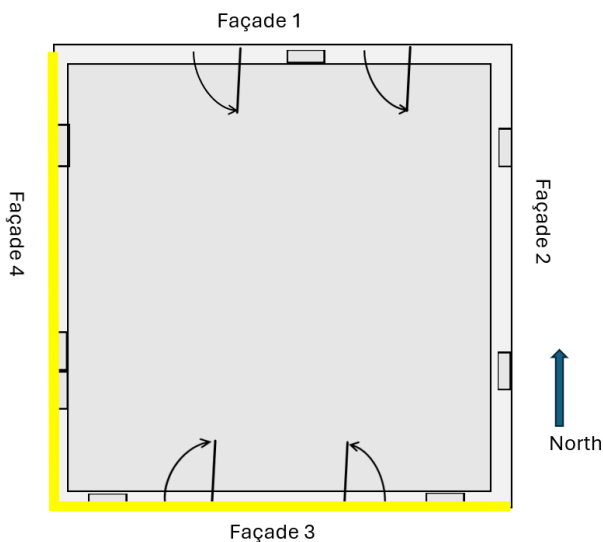
Figure 4: Primary Facades

The property's status was reviewed on July 8, 2025, under case 2025-010664-HDRB. The residence was designated as contributing, and the south and west elevations as primary. The pentile-lined well was designated as contributing.

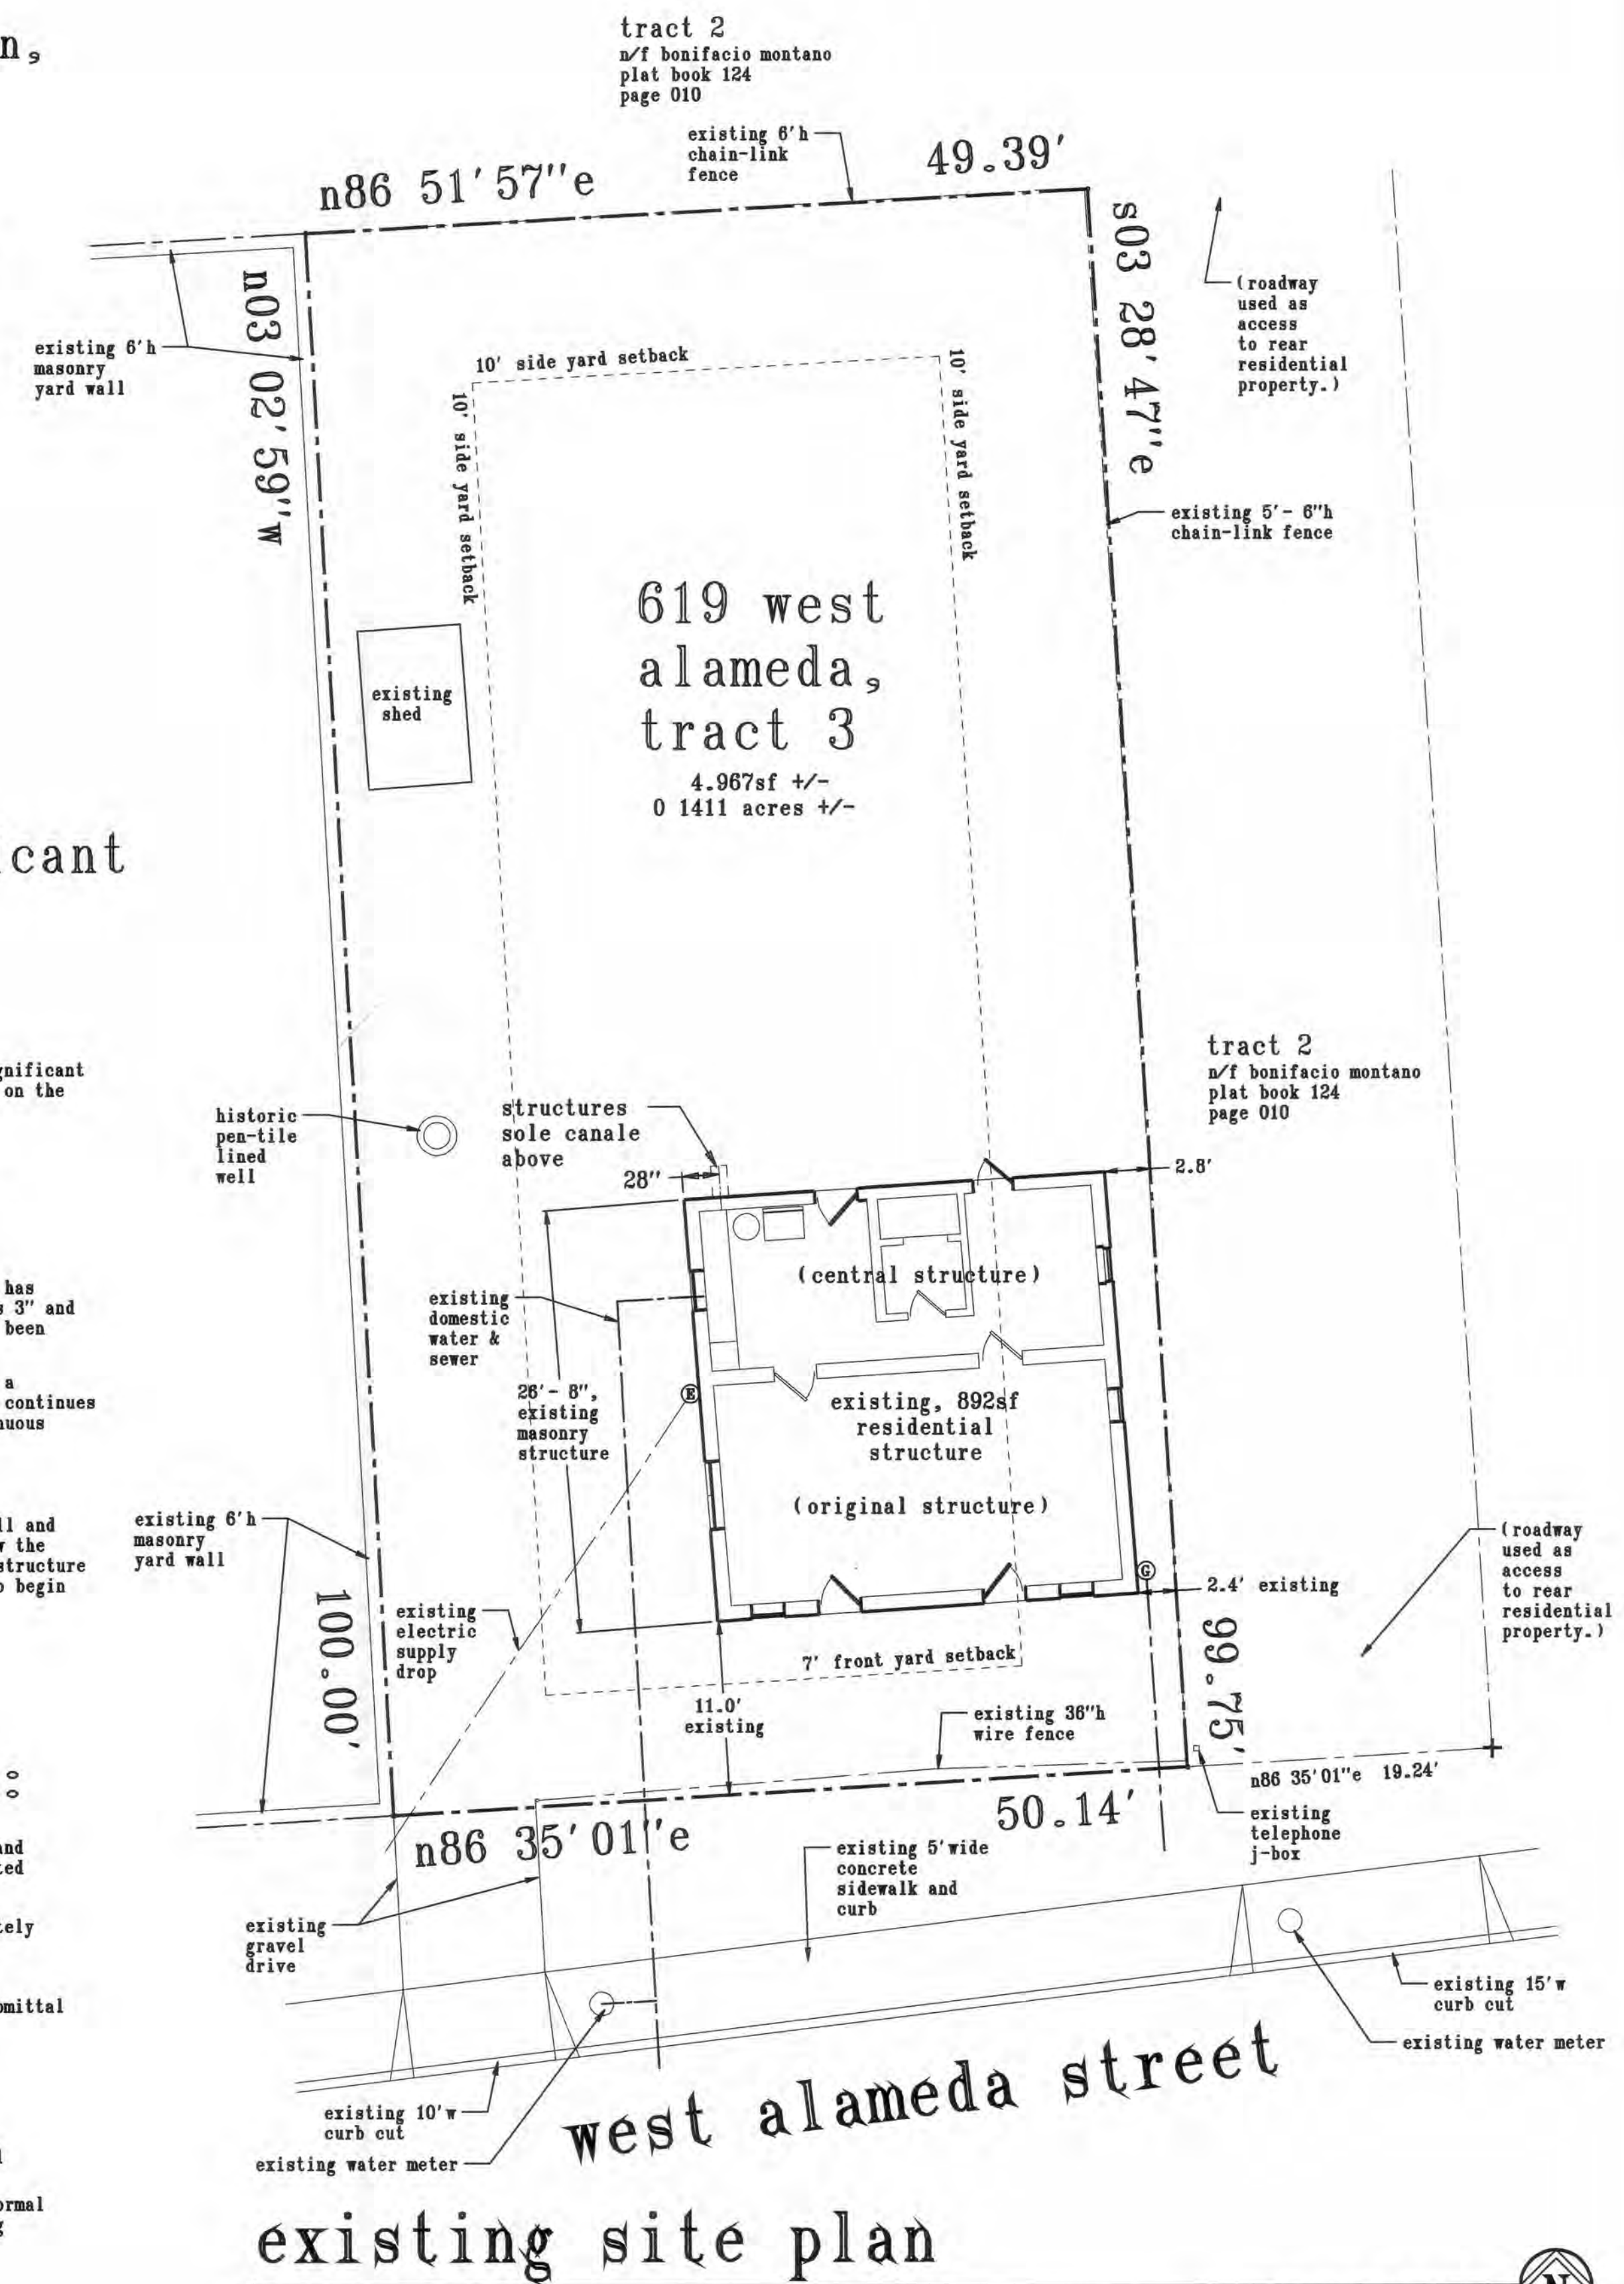
existing site plan

scale: 1/8" = 1'-0"

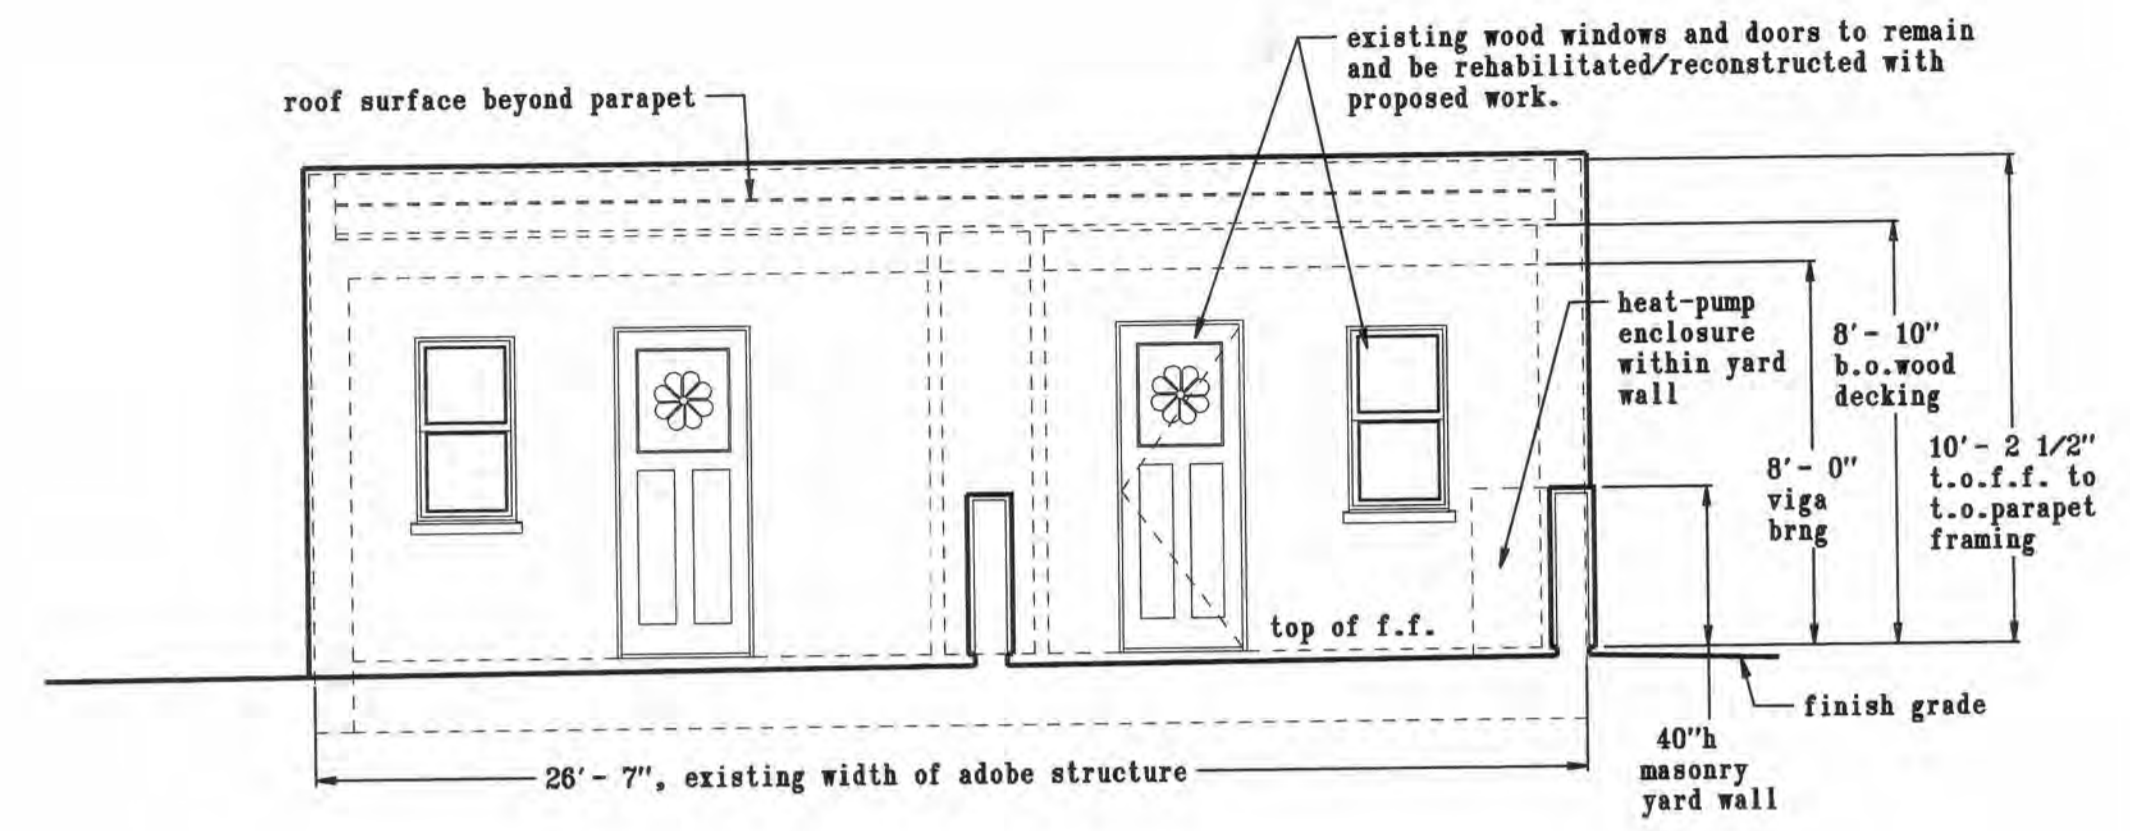
south (street) elevation

scale: 1/4" = 1'- 0"

- 2) Remove the south doors and frames to reconstruct the frames and repair the doors.
- 3) Install a concrete bond beam on top of the adobe and pen tile walls. The bond beam will raise the height of the structure from 9'-4" to 10'-6½". The maximum allowable height is 14'-5". An exception to section 14-4.6(E)(2)(IV)(b) to raise the height of a contributing structure is requested.

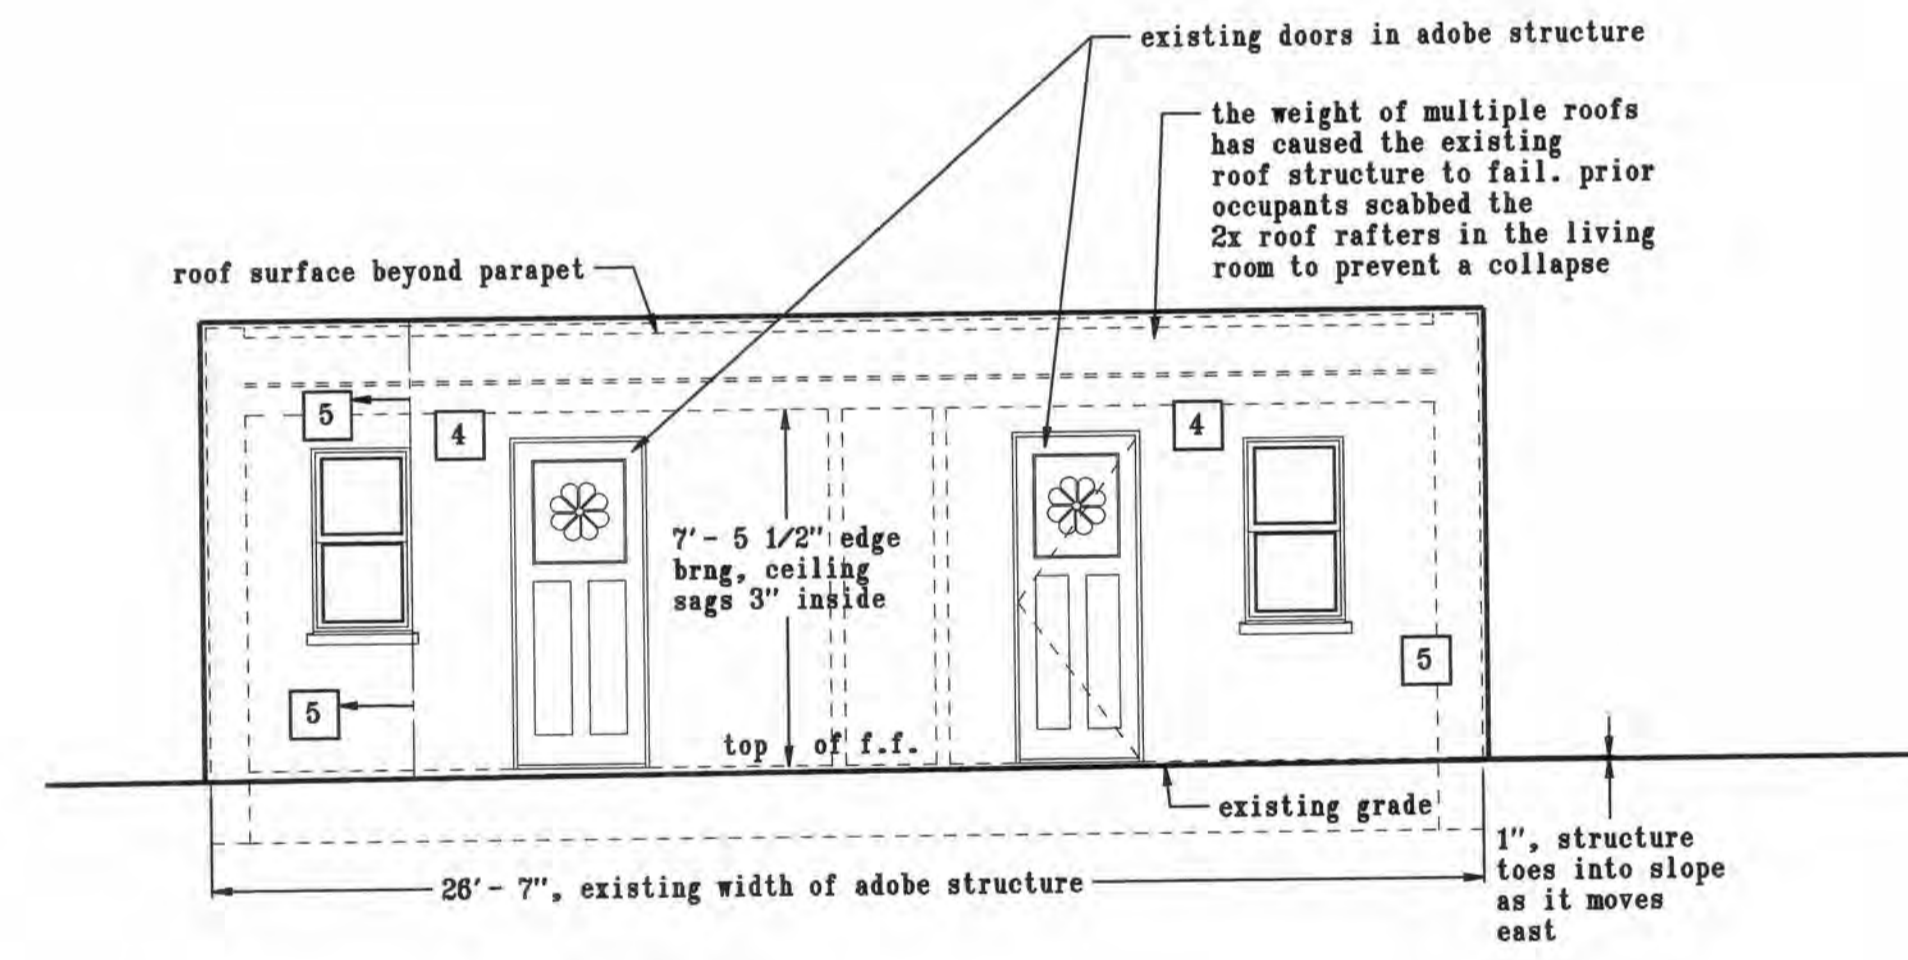
south (street) elevation

scale: 1/4" = 1'- 0"

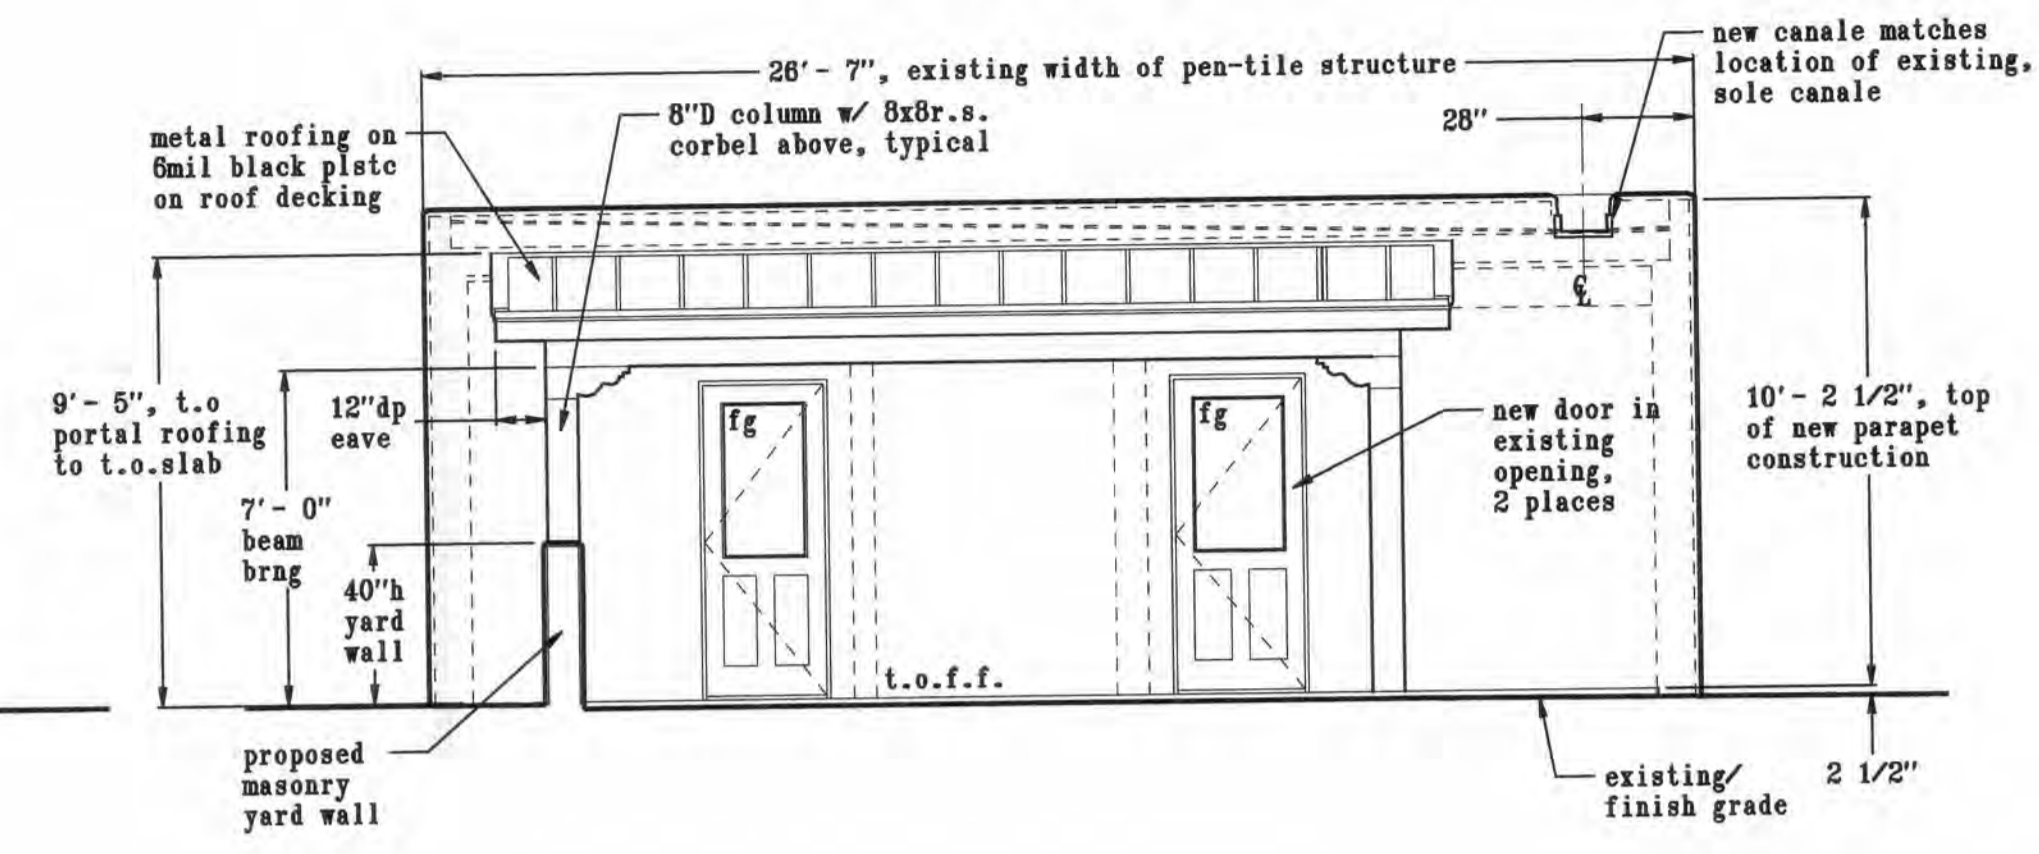
north elevation

scale: 1/4" = 1'-0"

- 9) Replace both north pedestrian doors with half-lite wood doors with panels.
- 10) Install a ground mounted HVAC condenser on the southeast corner of the building (publicly visible).
