# City of Santa Fe, New Mexico

2025-011227-HDRB, 925 Canyon Rd., Downtown & Eastside Historic District, non-contributing, Trey Jordon, agent for John and Mary Ann Vigil and Concepcion Lujan, owners, requests a status review with primary façade designation, if applicable.

# Historic Cultural Properties Inventory (HCPI) Base Form (FORM 1)

# Historic Cultural Properties Inventory (HCPI) Detail Form (FORM 2)

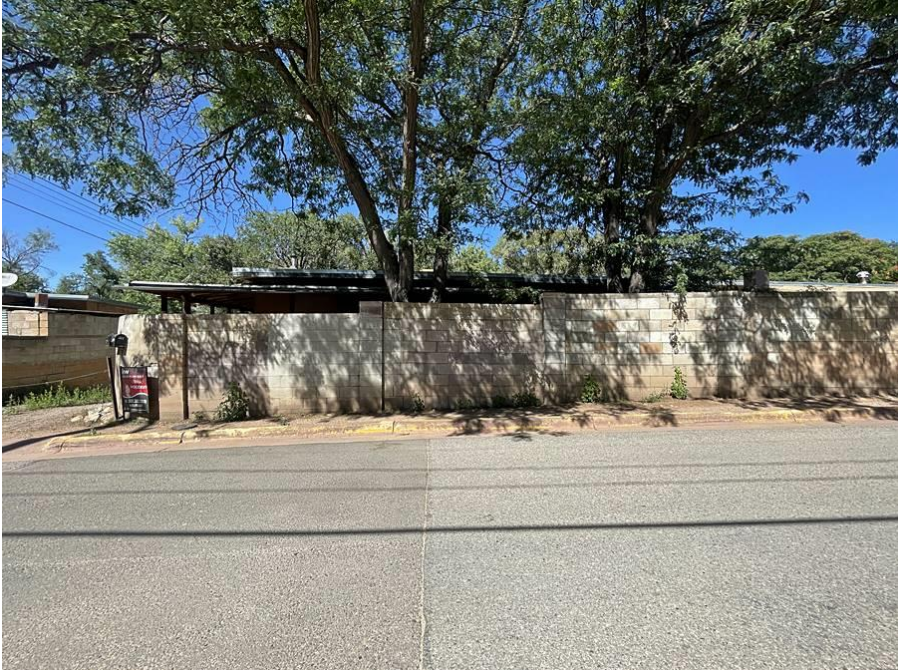
<b>9. Lat/Long:</b> 35.6798765,-105.9246747			
<b>10. Photo Information:</b> Giulia Caporuscio, photographer. Photo 1: View of south elevation from Canyon Road. Camera facing north.			
<b>11. Brief Description of the Property:</b>  Constructed in phases between the 1950s and 1980s, 925 Canyon Road is an owner-built vernacular dwelling that incorporates modest midcentury design elements at the façade with a two-story portion at the rear. The house is built of adobe and CMU walls and is fenestrated almost entirely with standard aluminum sliding windows. Midcentury features are expressed in the blocky massing, crisp edges, and a pronounced seamed-metal fascia. The later addition of two rough, plywood-roofed porches on the west and south elevations substantially altered the house's appearance. The dwelling has a footprint of approximately 1,558 square feet, containing three bedrooms and one bath. It is designated Non-contributing to the Downtown and Eastside Historic District. <b><i>Continued on Page 5.</i></b>

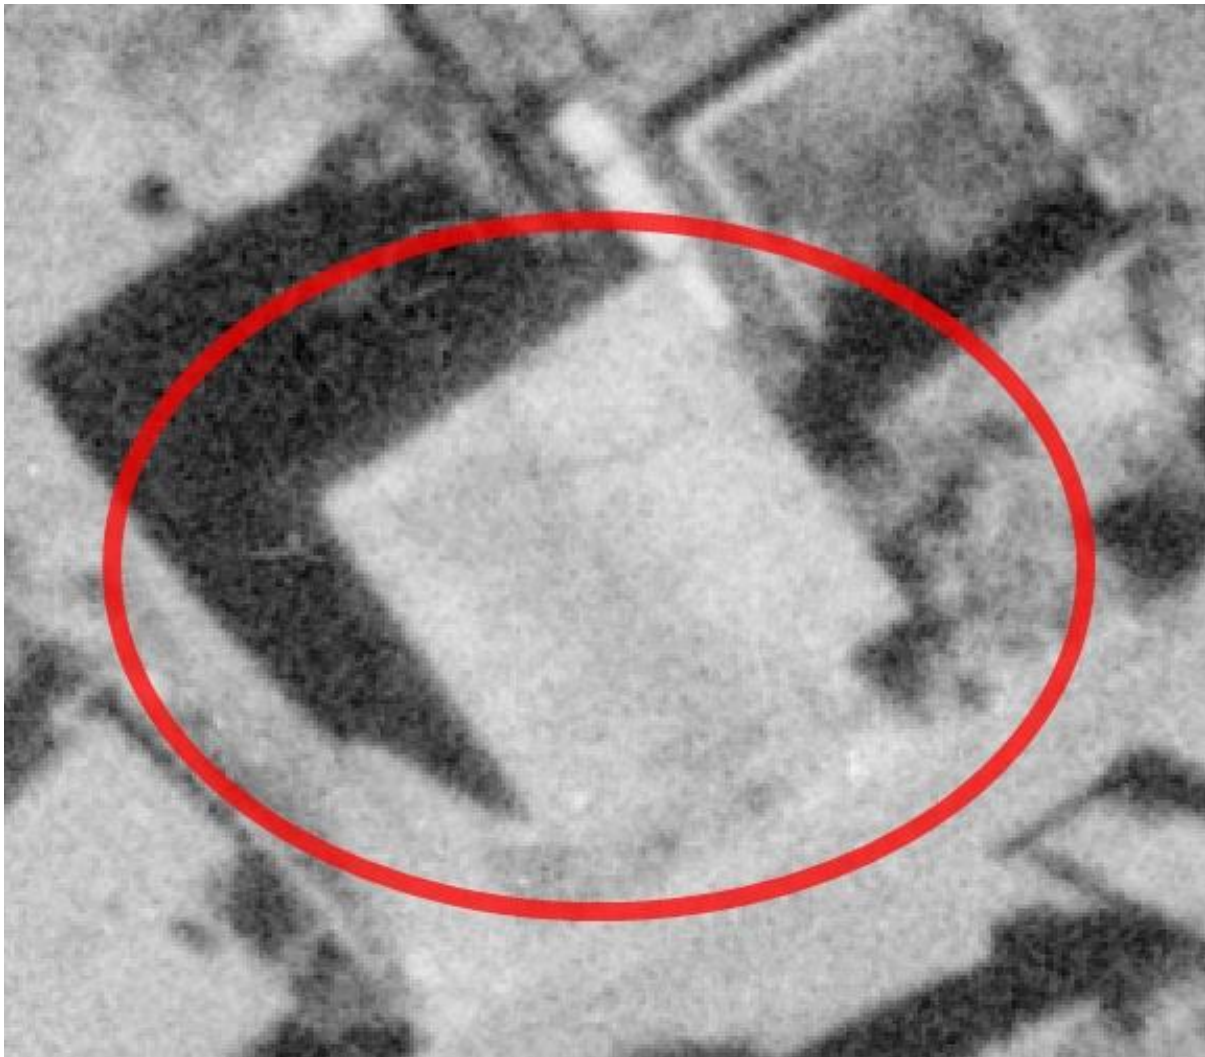
**Figure 5: November 10, 1958, aerial photograph. Apparently unfinished house.**

In the 1950s, Edward Vigil, a Maytag repairman, began building a house on an empty lot along Canyon Road, near his family home. Born Eduardo Isidro Vigil in 1924, Edward had his hands full with work and little money to spare. With help from his father, Jacobo (Jake) Vigil, and other relatives, he managed to raise the foundation and walls, but could not take the project any further. He capped the structure with a temporary roof and boarded the window openings with plywood to keep children out. According to his nephew, Frank Vigil, the unfinished house stood in this state for five to six years.<sup>1</sup> This explains its presence on a 1958 aerial photograph (Fig. 5), but its absence from city directories until the early 1960s.

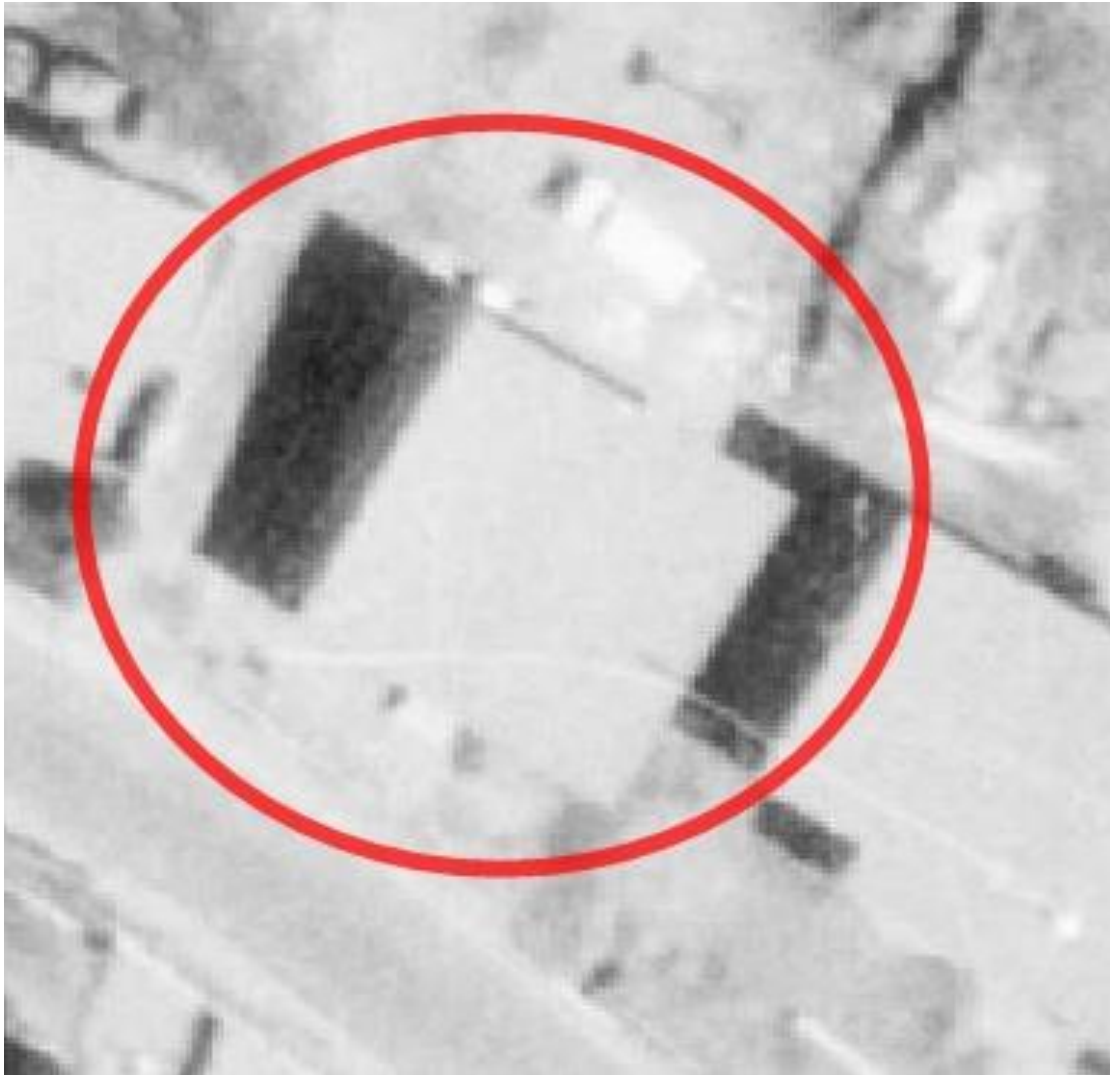
**Figure 6: May 2, 1966, aerial photograph. Completed home without west addition or porches.**

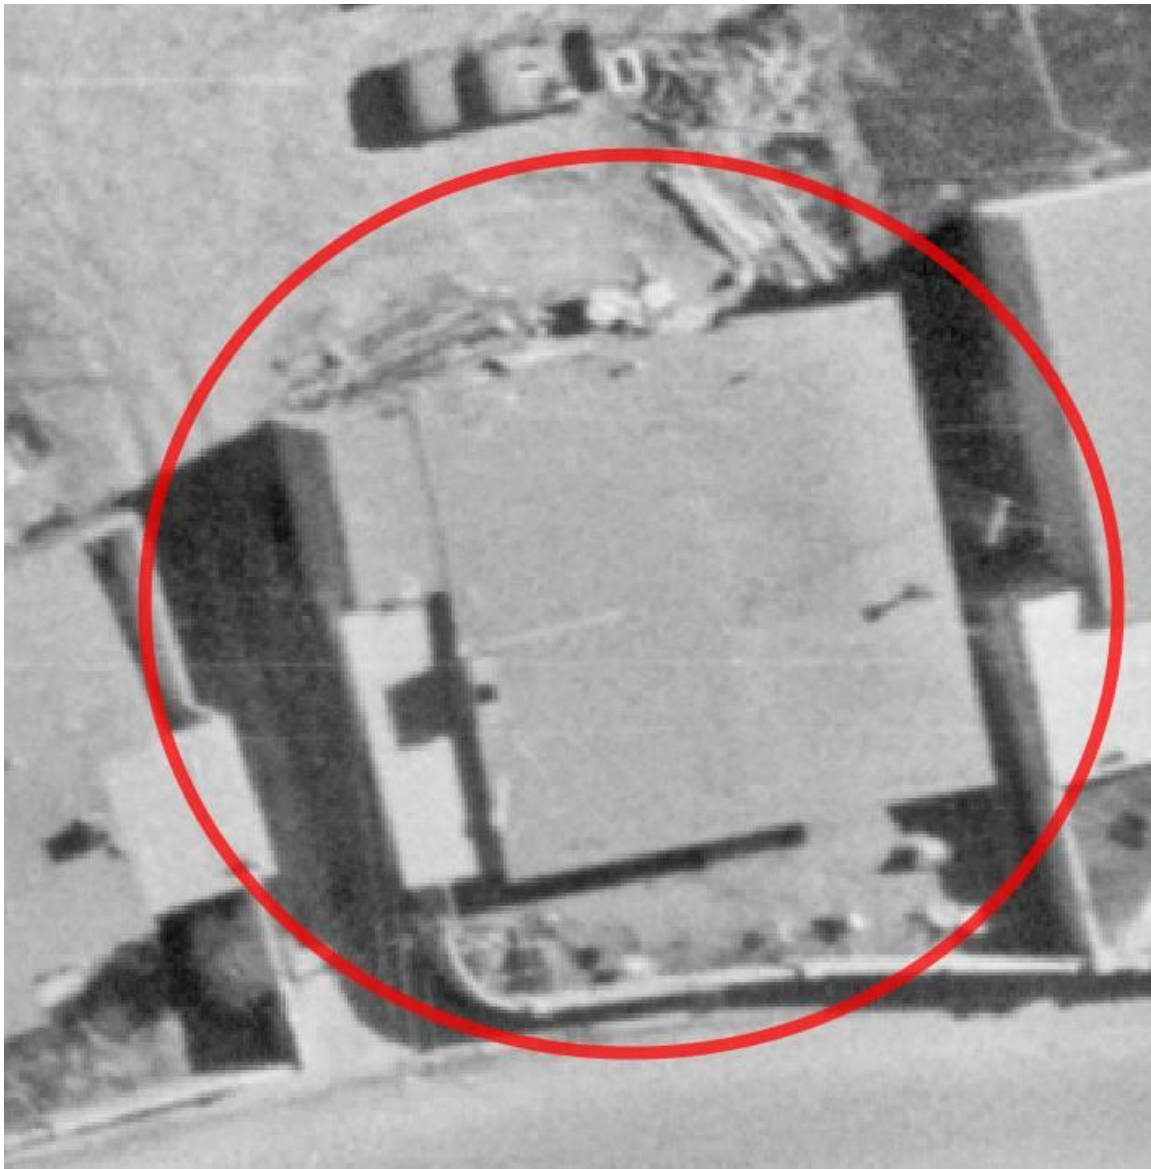
**Figure 7: May 11, 1973, aerial photograph. West elevation addition and porch and front wall in place.**

sliding windows except for the one steel casement in the basement. The south, street-facing elevation consists of the core 1950s construction with a central entry flanked by windows. The 15-panel door is covered by a decorative security grille. The windows are aluminum sliding units conforming to the rest of the residence. A non-historic 1984 plywood porch with a shed roof is located on the south elevation and wraps around to the west elevation. The west elevation, while part of the 1950s core structure, has been altered with additions and the porch. The chimney that bumps out is part of the original structure. The early 1970s laundry room addition introduced a new entry into the building and houses a single aluminum sliding window under the portal. The west and south elevations of the residence are obscured by a concrete masonry unit wall at a height that ranges from 5'-9" and 6'-10". This wall was constructed sometime before 1973, but after 1966.

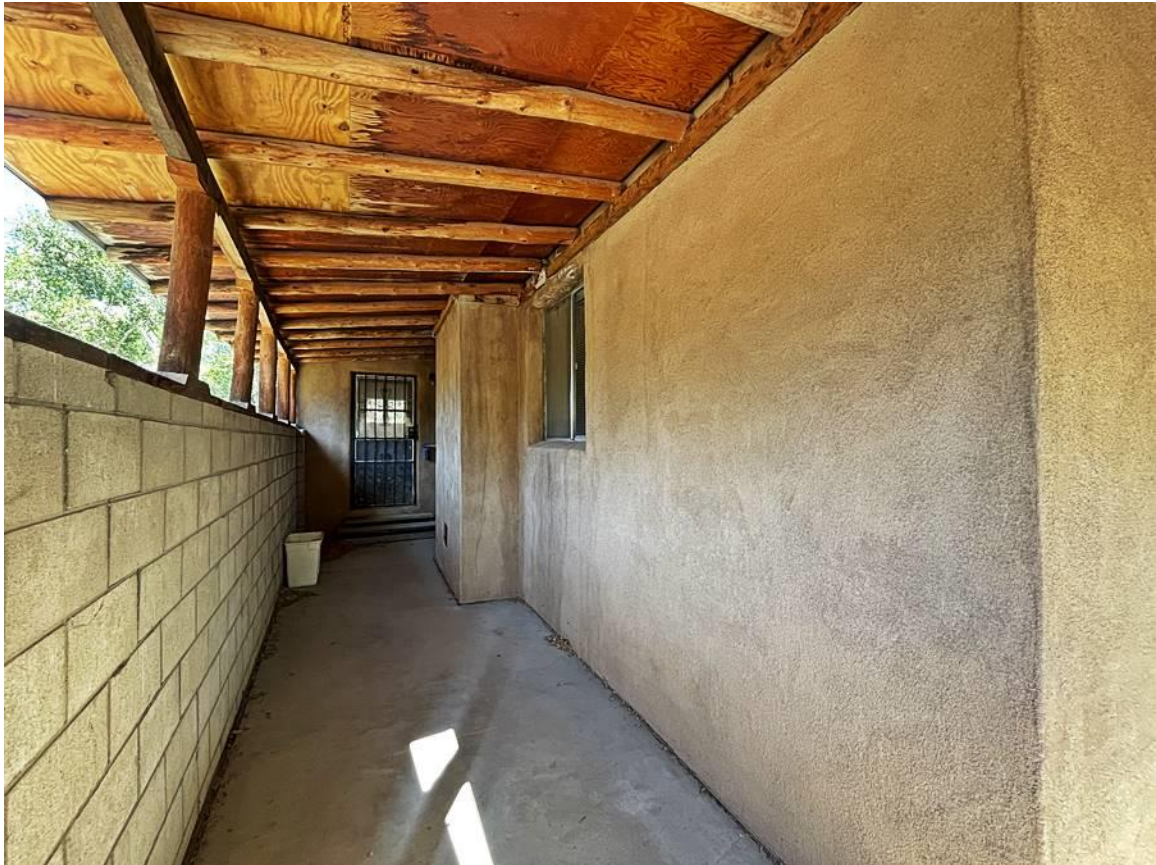
**Photo 7: West elevation and porch. Camera facing north.**

introduced a secondary entry to the façade (Photos 7 & 8). The laundry room is entered from the south through a half-light wood door. This area is shaded by the wood porch supported by improvised “Doric” columns set on a CMU wall. The remainder of the elevation is defined by the laundry room addition, marked by a single aluminum sliding window (Photo 9).

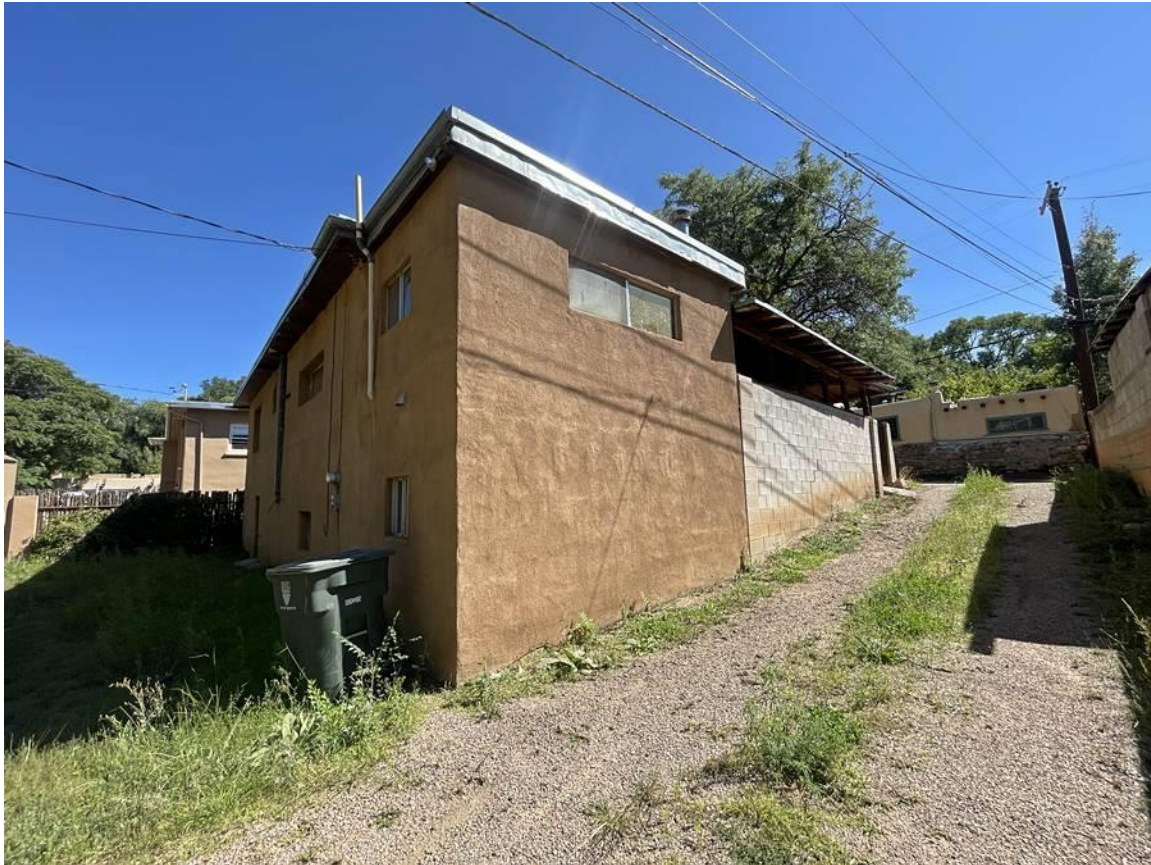
**Photo 9: North and west elevations. Laundry room addition at center. Camera facing southeast.**
