## Stormwater Subcommittee Update for 10 April 2025 River Commission Meeting

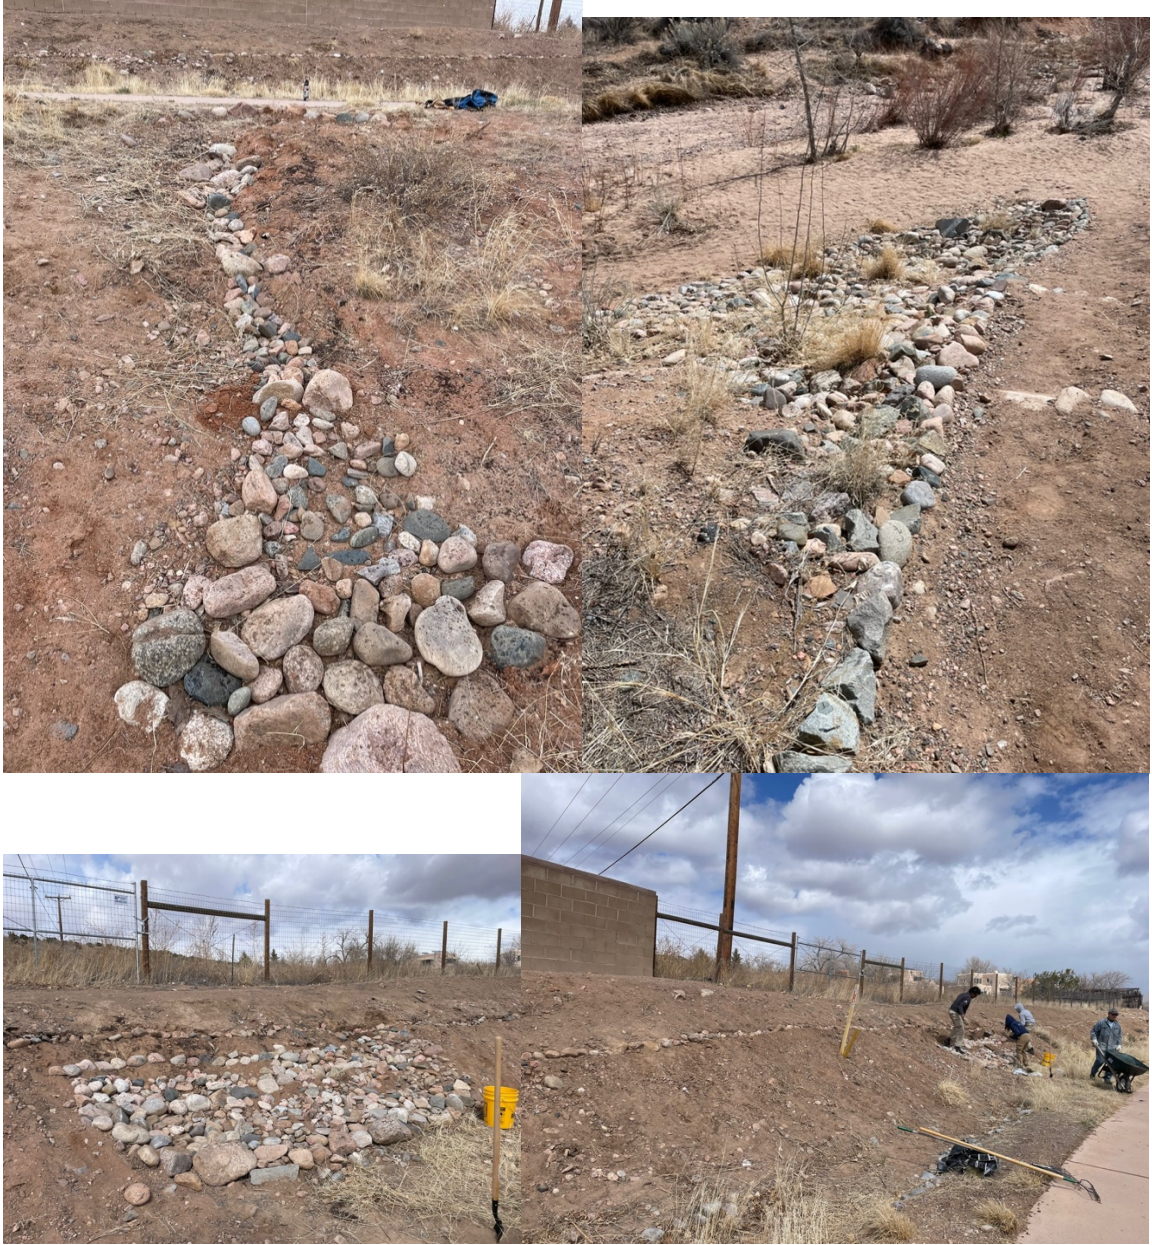
- Photos:

- We raked and put seed down on this elevated bank and spread mushroom compost.
- Upstream from the tumbleweed weeding area, we worked to stabilize the steep slope below the sheep farm by creating a mid-slope slot/trench, placing rock in the trench and spreading seed and compost into the trench.

- Just a bit further upstream from the sheep farm on this same embankment, there were two deep, erosion gashes (bigger than rills) which we stabilized with rock, scattering seed and mulch between rows of rock anchors.

- Near Frenchy's bridge, we stabilized the lower slope adjacent to a footpath by spreading seed and compost and filling with a rock layer.
- Downstream from this location, we blocked off a footpath down to the riverbed that was deeply eroded and defined an alternative route with rock outline.

- Further downstream, we created media luna and rock fill with seed and compost in two side-by-side rills.
- We used about 4 lbs of seed in this work.
- Among the volunteers were 3 River commissioners (Bill C, Jim R. and Bill H.).

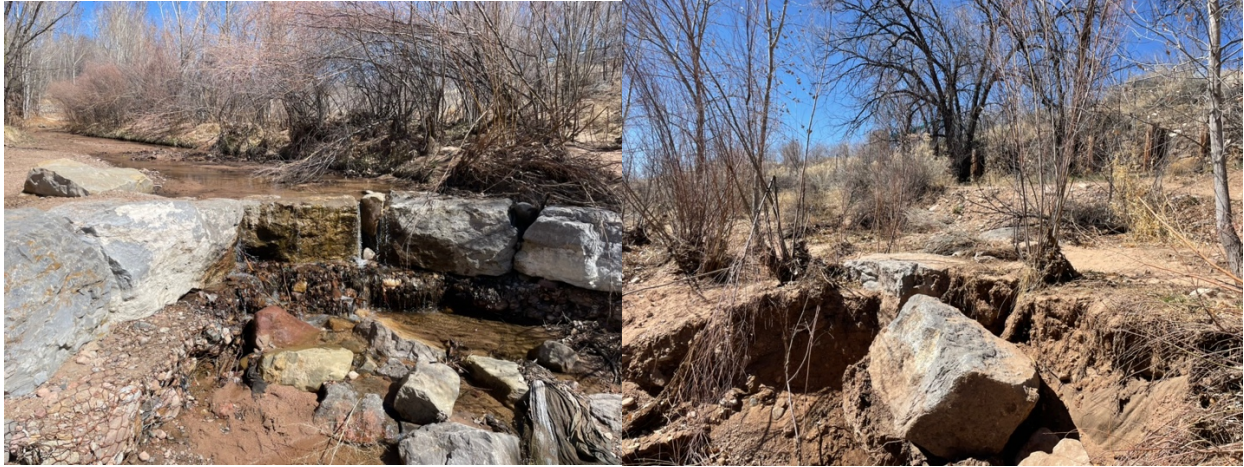
4 March 2025: Bill Carey attended a community meeting on planned city work to restore river bed grade controls in the stretch of river between Ricardo Street and Camino Alire. This damage resulted from storm flooding in 2018. A suggestion made during the meeting was for the contractor to remove Siberian elms as part of the restoration. It would be good idea to pursue this possibility. (Zoë can speak to this as she is running or is one of the leads on the project.) Here are some photos of some of the damage that I took showing how the existing structures were undercut:

The plan is to create grouted boulder ramps similar to those installed further downstream which were installed in 2020 and 2022. These have been found to be much more stable than the ungrouted, gabion-style structures supported by geotextiles. Grade of 0.4% will be established between the boulder ramps. This will help raise and restore the river bed.
