An Assessment of Facades:

*Old St. Vincent Hospital
Santa Fe, NM*

By: Gayla Bechtol, AIA

March 24, 2009

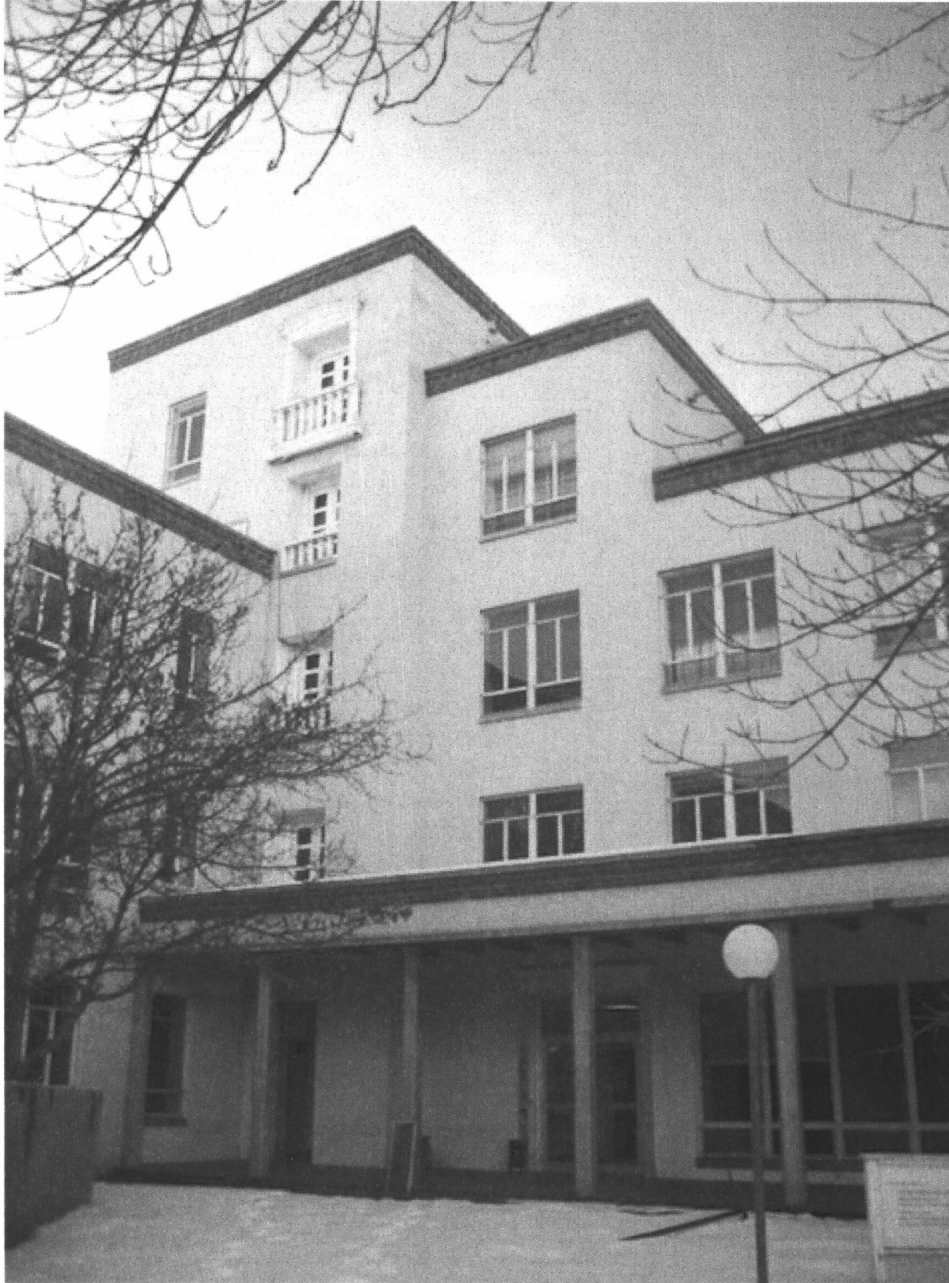
Figure 4: The Primary entry to hospital core as designed by Meem and with associated tower element. The wood entry doors have been replaced with Aluminum, some trim has been removed, light fixtures have been added, and the former parking lot is replaced with lawn.

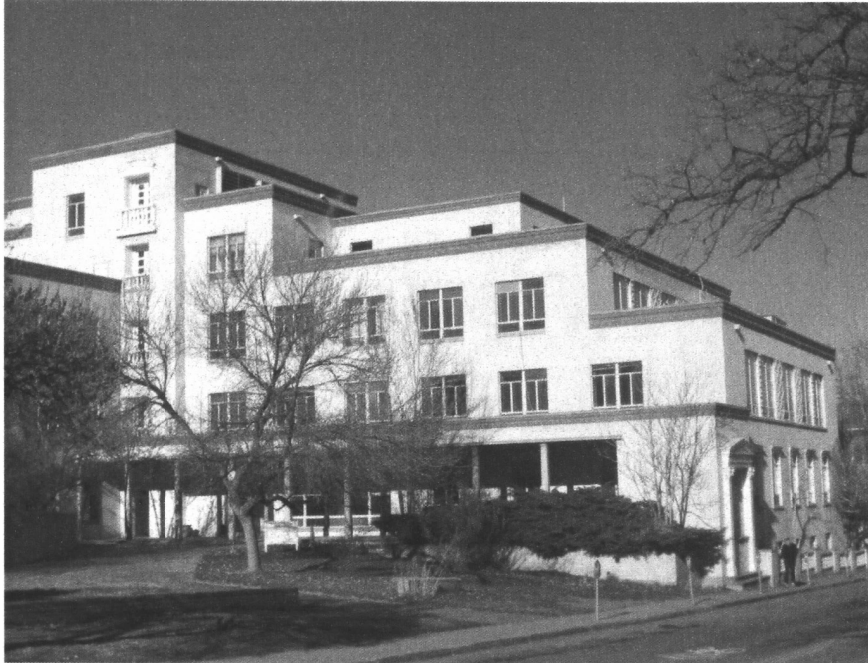
Figure 6: The Northeast corner of the North wing at Palace Avenue. These are the two primary facades of this building. Note the detail of the windows on the North façade, the decorative capitals at the now bricked in portal entry, the natural concrete columns at the portal leading to the main entry that faced the former parking lot/drop-off. Note the absence of the sign (See Figure 22) that used to be on the east wall, the missing cross at the top of the bricked up portal entrance pediment and the missing cruciform on top of the tower element.

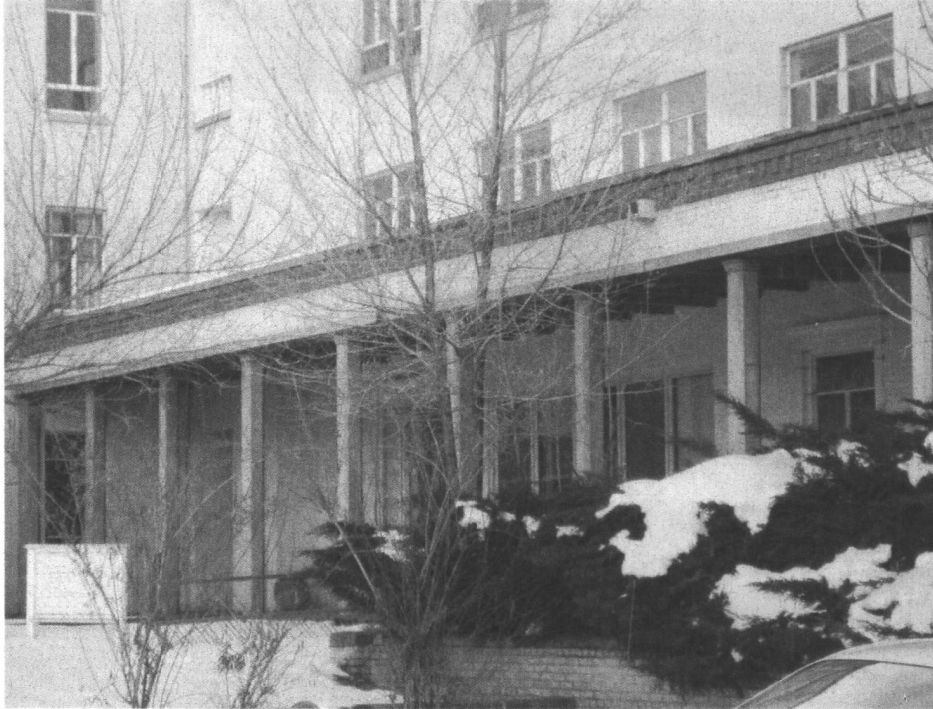
Figure 8: The entry portal. The columns, capitals and the beams are natural concrete, a traditional form in modern material selection at the time.

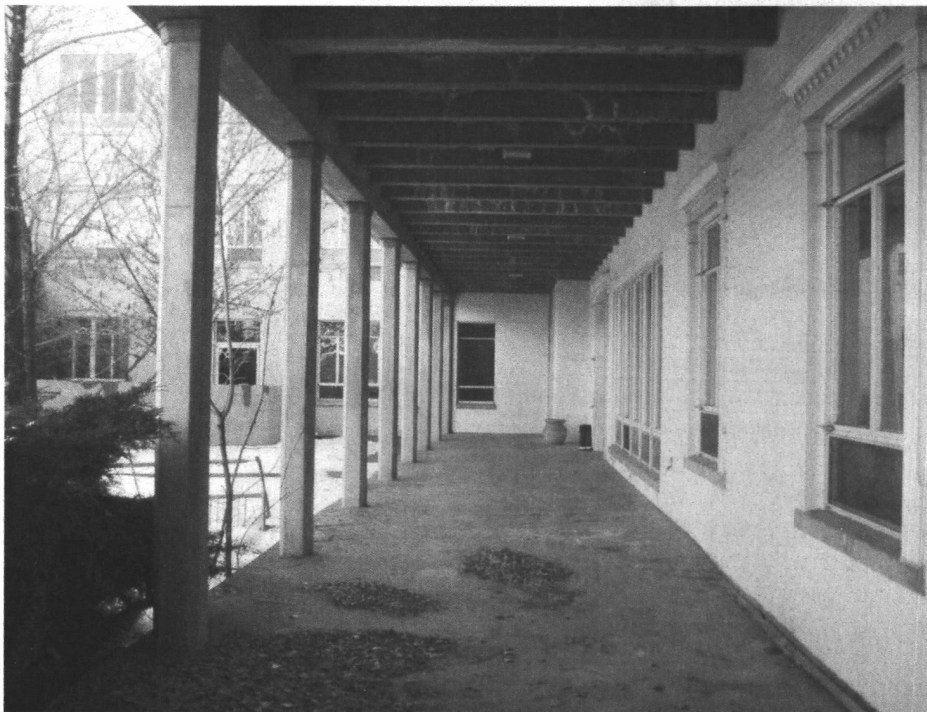
Figure 9: The entry portal at the entry off Palace. Note the chamfered capitals and columns, the natural concrete sills on the Windows (a detail found throughout the building), and the classical detail topping the windows.

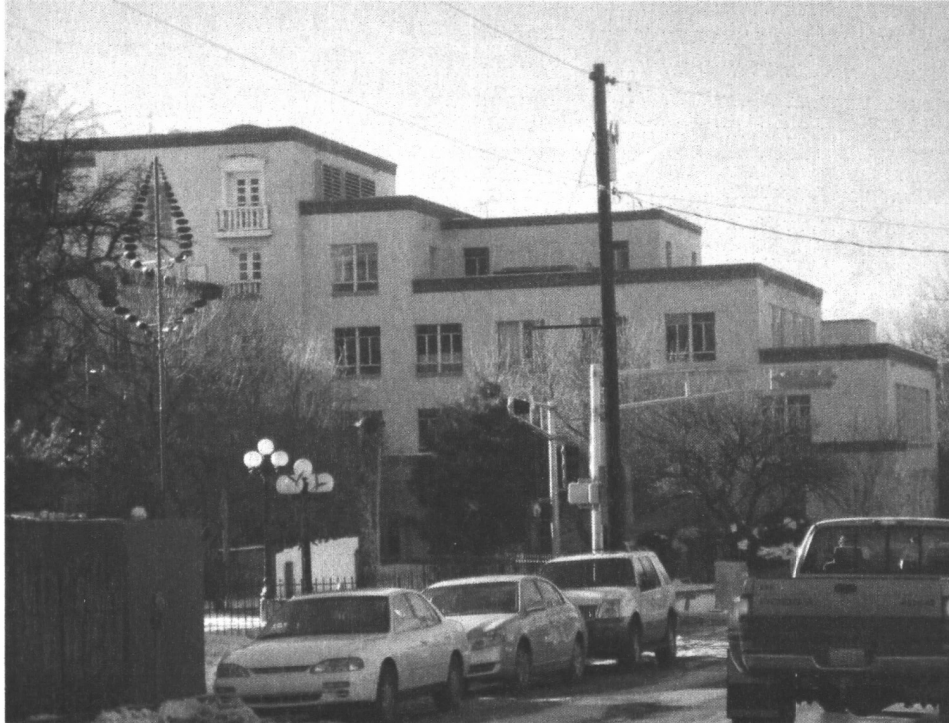
Figure 10: The view from Palace Avenue and Paseo de Peralta. From a distance the same as Meem designed although the cruciform is missing atop the tower element. Note the stepping down of mass toward Palace Avenue.

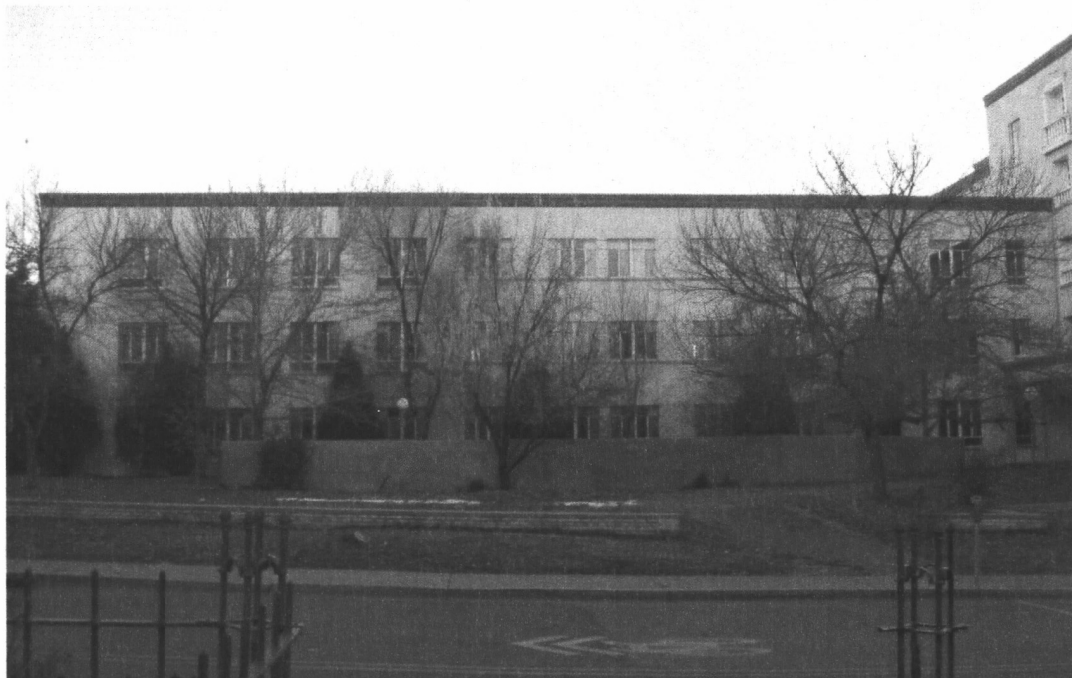
Figure 11: View from Palace Avenue of the Eastern Supporting Façade generating interest from the East toward the building center and main entry. Note the window patterning in the center of this East wing is modulated with a common sill (A detail repeated on the West wings Palace facing façade).

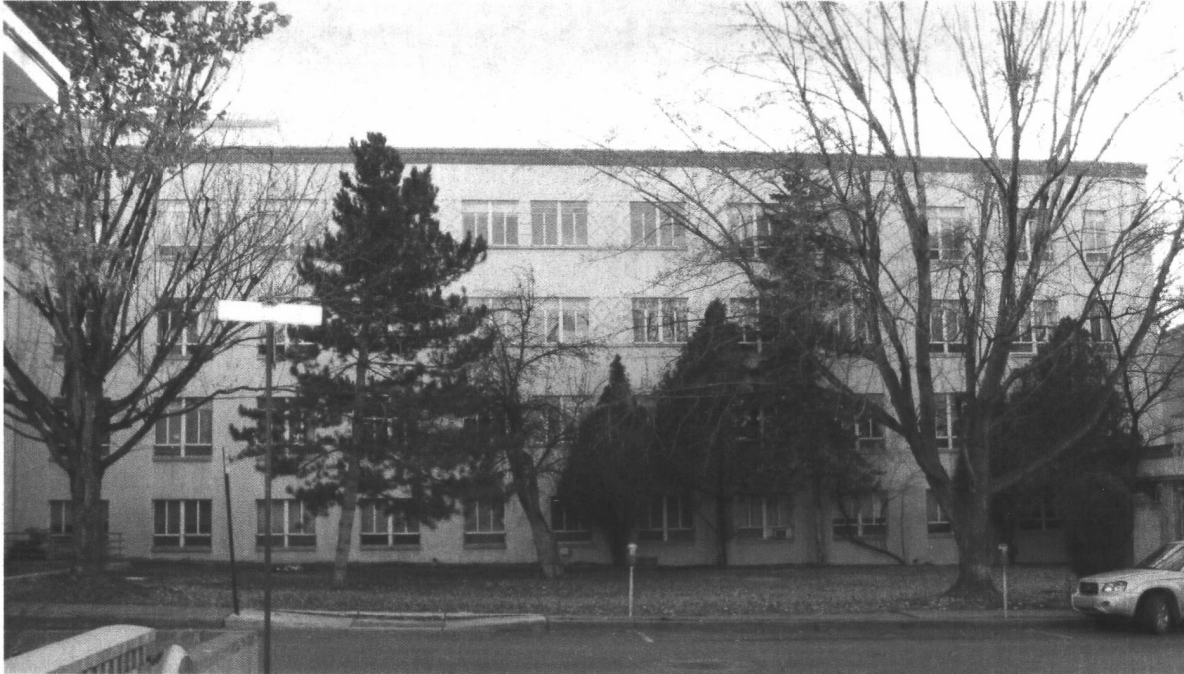
Figure 12: View from Palace Avenue of the Western Supporting Façade generating interest from the West toward the building center and main entry. Note the window patterning in the center of this West wing is modulated with a common sill (A detail repeated on the East wing's Palace facing façade).

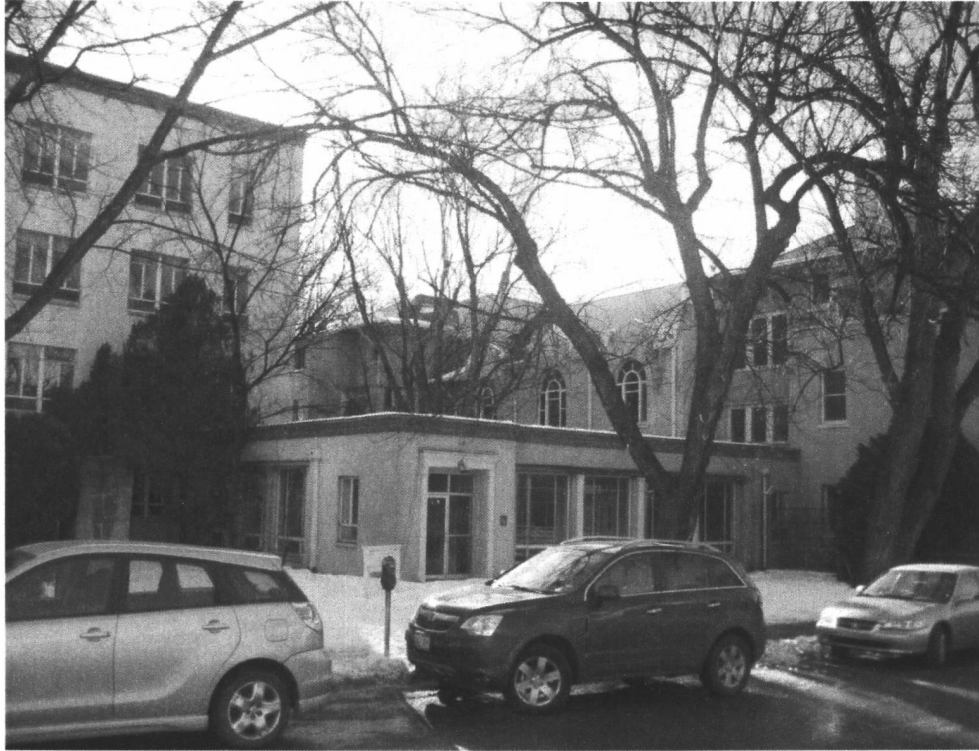
Figure 14: The connection to Marian Hall on Palace Avenue. Is it a breezeway? ...a portal? ...a secondary entrance? ...an enclosed courtyard? This element does not seem to be architecturally clear or function as intended. Note there was a drop off here originally for ambulatory patients that remained until the late 70's. The connection effectively serves to obscure the elevation of Marian Hall (a significant structure) where the dining room and chapel window detailing is located.

Finally, in assessing the hospital building and its relationship to Marian Hall, I have also concluded the connecting links between Marian Hall and the hospital are an unimpressive fit architecturally. The East façades of Marian Hall (revealing the first story dining hall bay windows and the second/third story chapel façade detailing) are hidden by these added links. Although these connecting links do serve to form a courtyard, it is difficult to find the space in harmony with either Marian Hall or the St. Vincent Hospital (Figure 14).

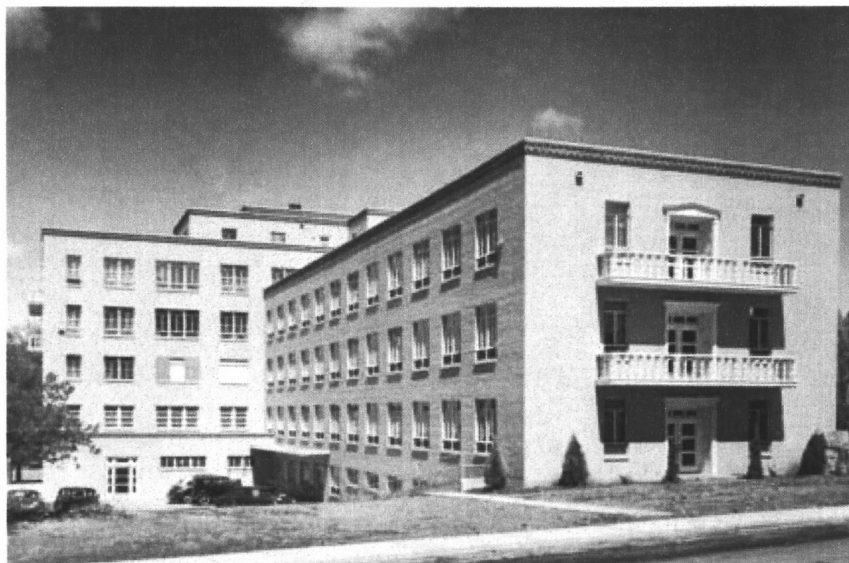
Figure 15: A 1950's photo of the Castillo facing façade with the classical details at the doors and balconies contrasts with the simple planar quality of the South. Note the cantilevered canopy, now a portal with brick parapets.

The doors at the main entry and end of the East & West wings were originally wood and glass with three divided lites, a divided lite transom (above each pair of doors), and trimmed with a wood Territorial Revival detail (Figure 15). This door detail was also originally used on the Southeast façade under the former cantilevered canopy and in the enclosed courtyard between St. Vincent hospital and Marian Hall. At the end of each wing a pediment arch was used above the recessed door openings. Some of the doors still survive while others have been replaced with aluminum and glass doors.

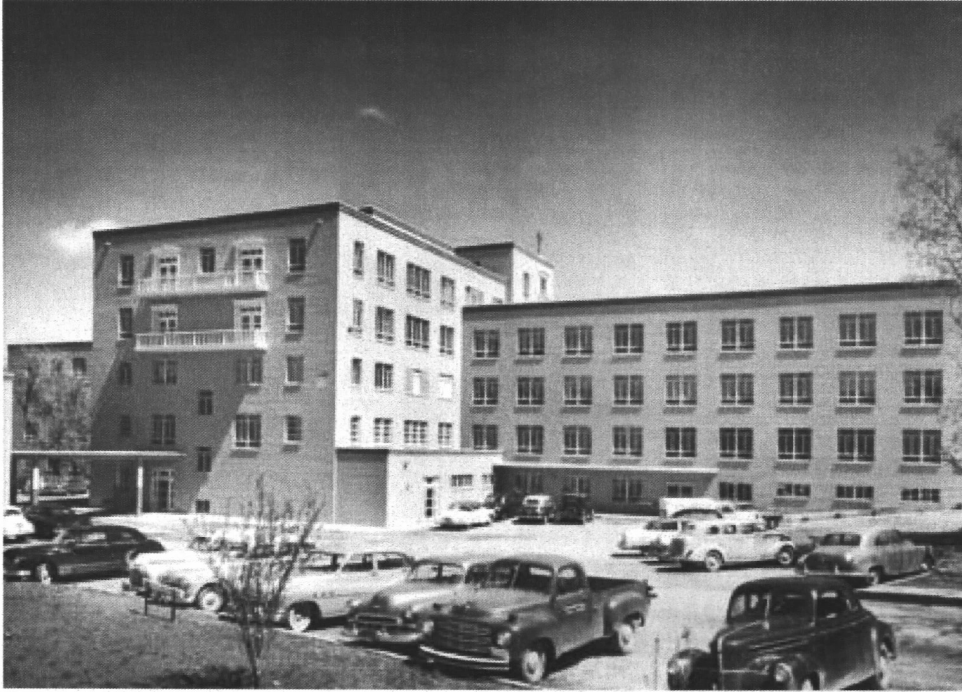
Figure 16: A 1950's view of the South wing with classical details on the upper floors that unify this elevation. Note the canopy connecting the Boiler Building now also serves as pipe rack for the steam heating system.

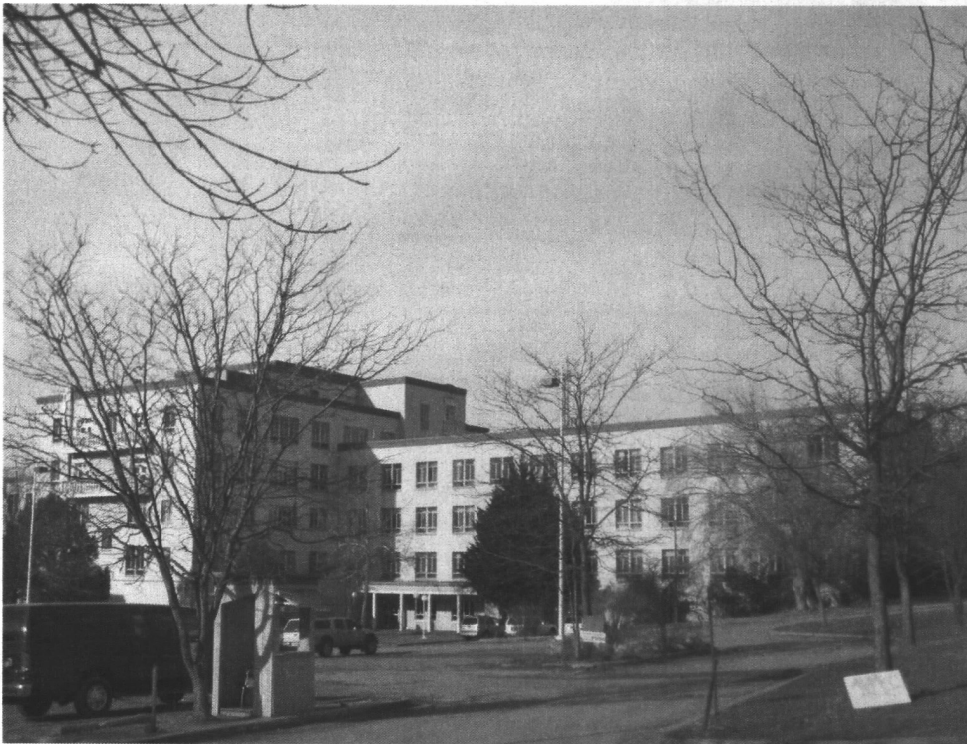
Figure 17: A similar view as Figure 16 as photographed in 2009. Note the added portal on the East wing.

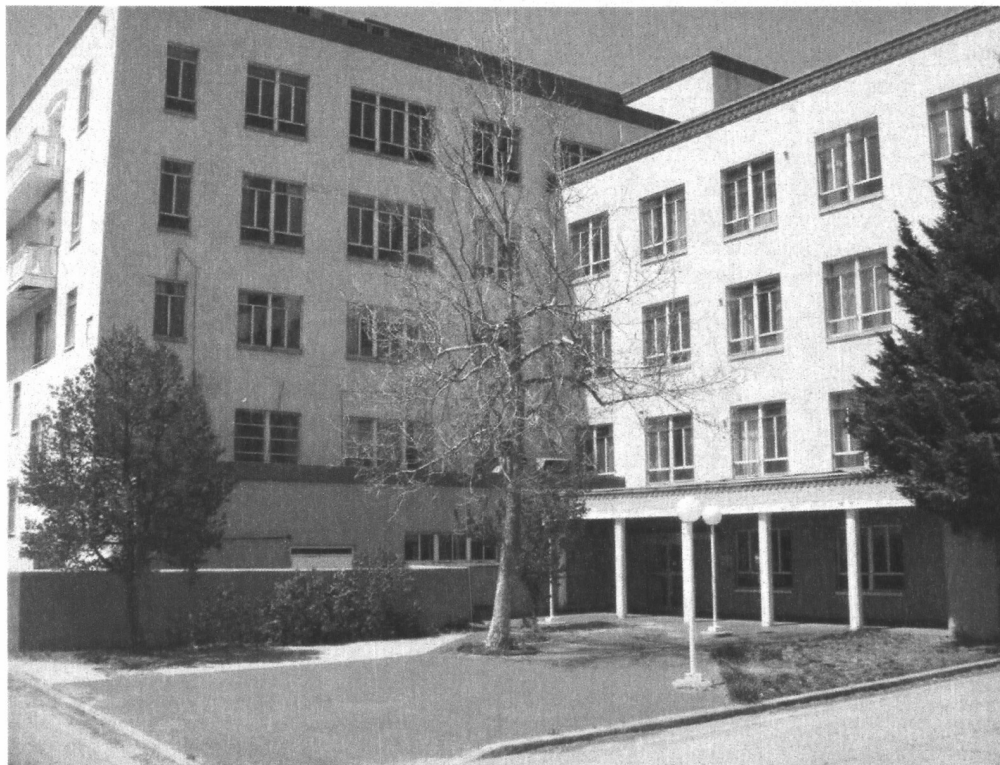
Figure 19: One of the south facing entrances showing the changes made to this façade in the 1980's that diminished the integrity of Meem's back of house entry originally created with a short cantilevered canopy.

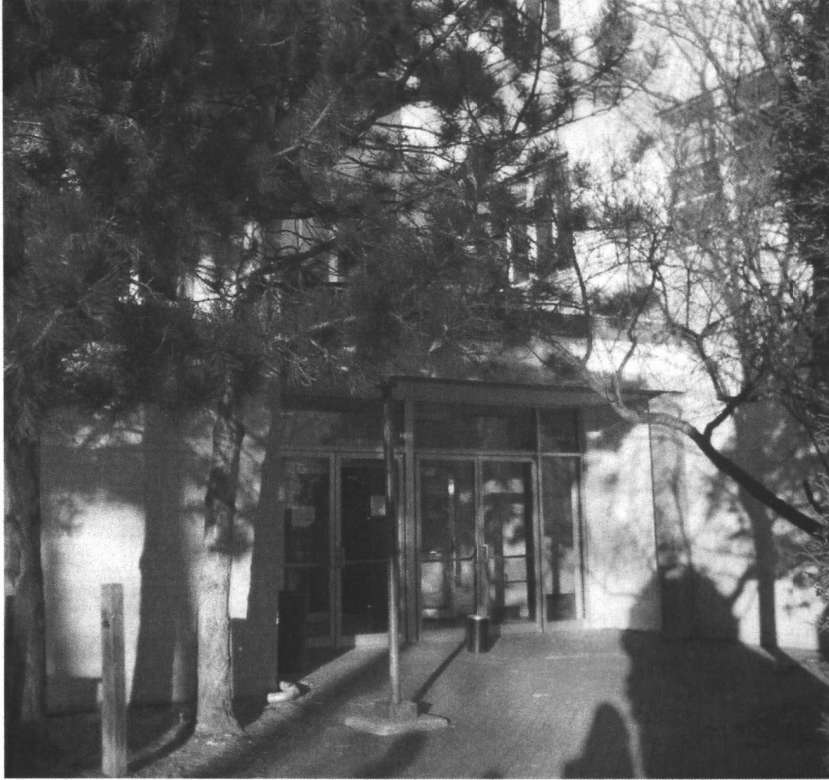
Figure 20: Another South facing entrance modified in the 1980's. There is little architectural merit in either this or the entry depicted in Figure 18 as compared to the original entry Meem created on the North.

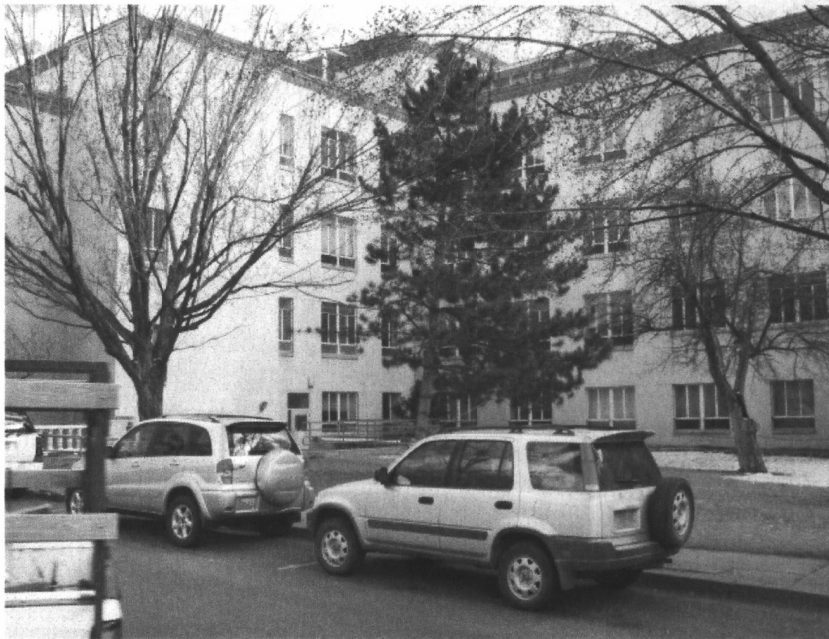
Figure 21: The West face of the North wing showing the addition of the stair tower which dilutes the development of a three-sided courtyard opportunity between Marian Hall and the hospital structure. It also serves to obscure the stepped massing from the West.

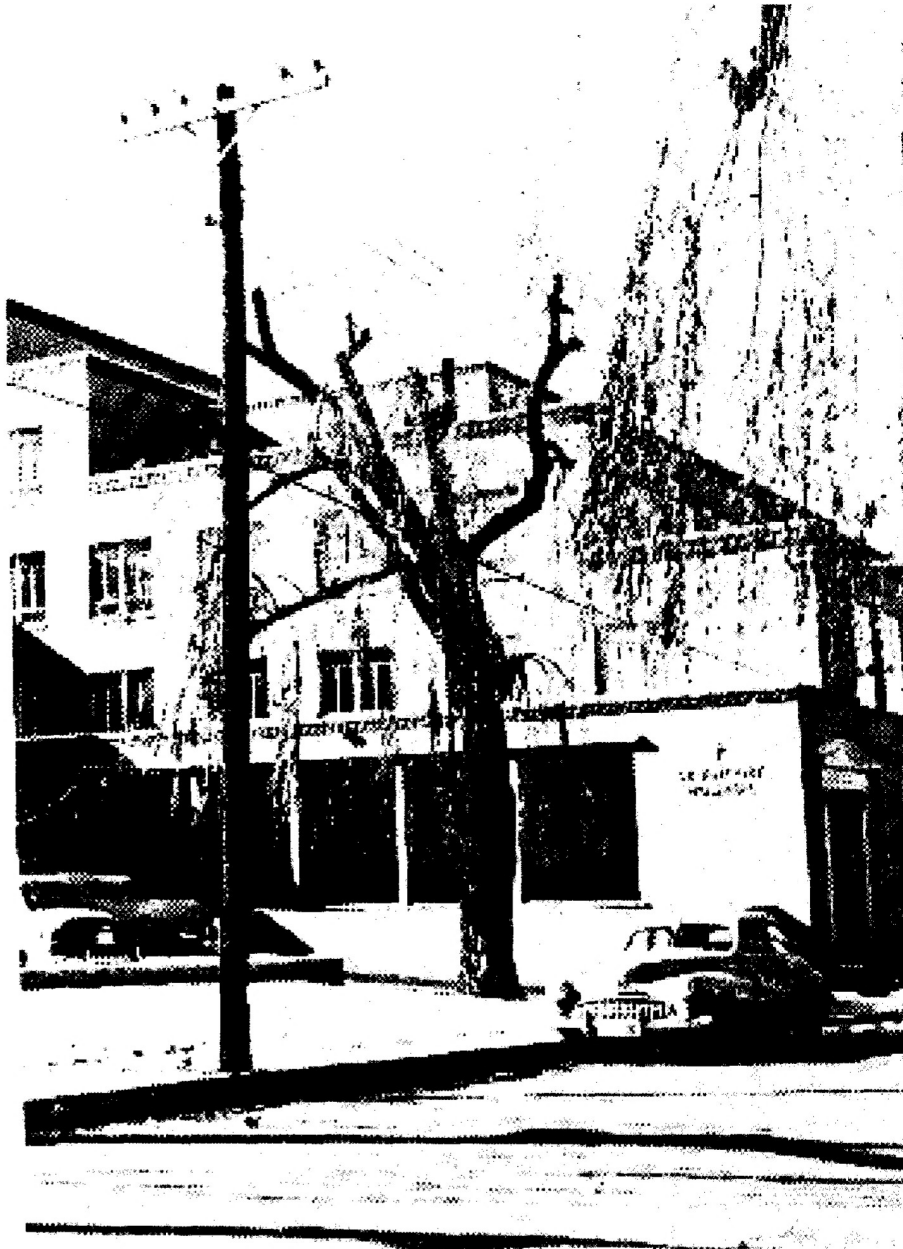
Figure 23: The Main Entry Portal. Note the St. Vincent Hospital sign literally faces East, but metaphorically faces Palace Avenue.

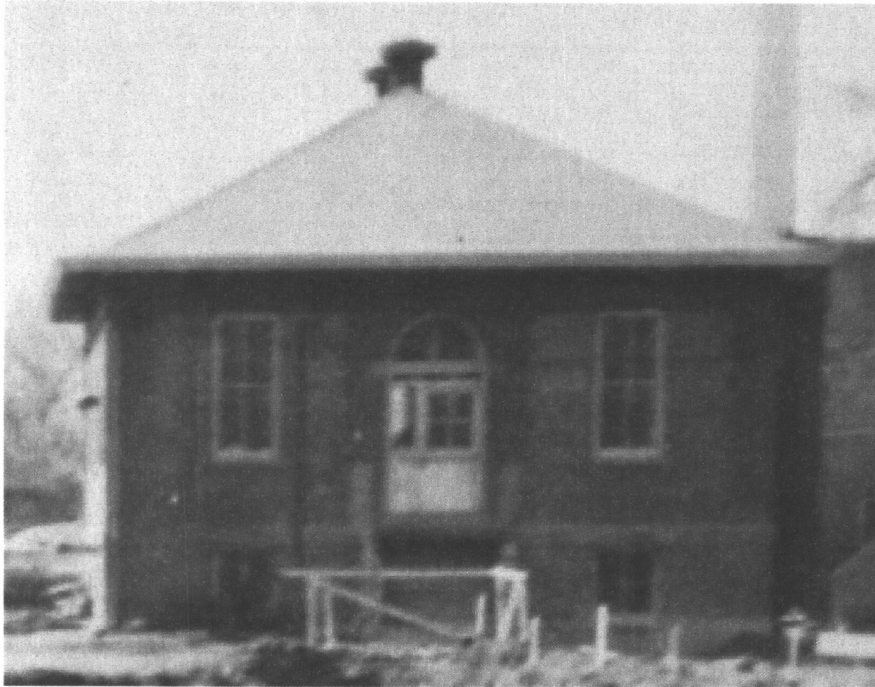
Figure 30: A 1951 photograph of Boiler Buildings North face. Note the pitched roof and Victorian detailing. Also note the entry stair had just recently been removed in preparation for the “New” hospital construction.

The Boiler Building is a Victorian-Era structure originally built in 1904 as a laundry facility (Figure 30). Likely an Italian Renaissance (or possibly a simplified Italianate Style) when built, the structures design employed exposed red brick with a low to medium hipped roof, quoins, an arched doorway, paired and single double hung windows with masonry lintels. During the St. Vincent hospital project in the early 1950’s, the Boiler Building underwent major alterations as well as received additions on the East and South sides. The North exterior stair at the main entry was removed. The arched doorway was also removed and replaced with solid wood doors, the sandstone rusticated belt course, walls, and window lintels were painted pink, the same color as the then new hospital. The hipped roof and eaves were removed and replaced with a decorative brick parapet and concrete coping matching the hospital. The East and South additions used the same brick, similar steel casement windows and an exposed brick parapet. It’s understood Meem’s intention was to unify the site with the new identity of the Modern Hospital and propagate/establish the Santa Fe style. However, its reality is again confused as both the remaining original Italian Renaissance fabric can be read right along with Meem’s regional territorial style. In trying to establish the relevance of the structure both can be represented with equal cause and both are historic. The resulting palimpsest is instructive to the history of the site and historical architectural styles that exist in Santa Fe.

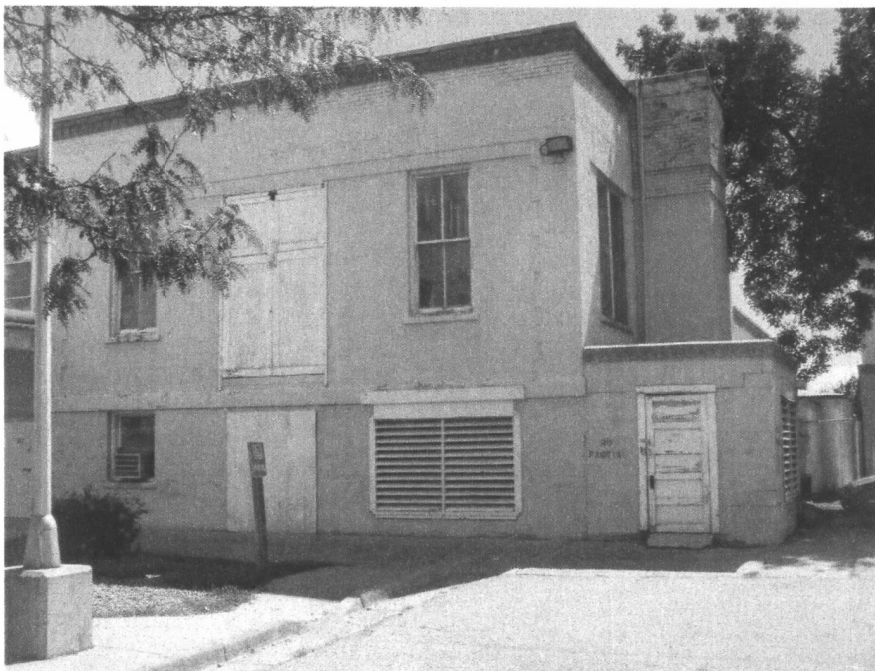
Figure 31: A 2008 photograph of North face. Even with the changes the original building can be read.

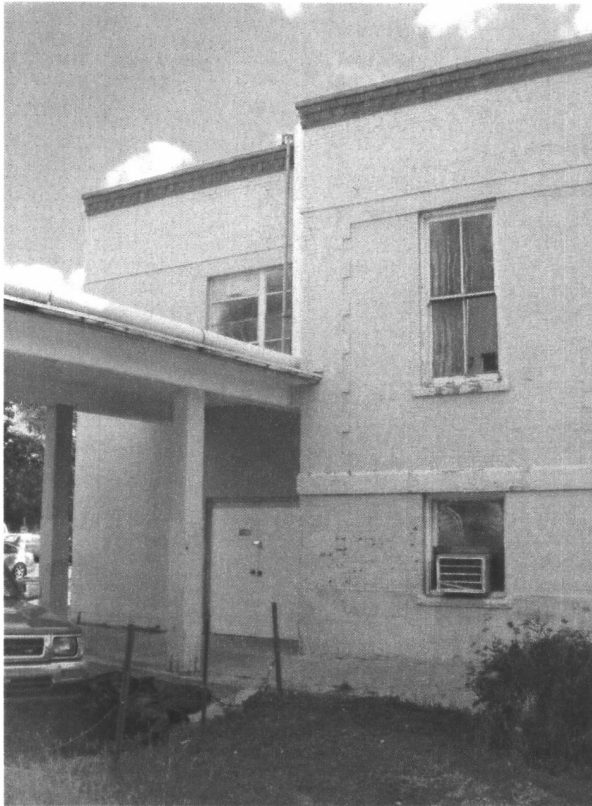
Figure 35: Connection of Meem design and original boiler building with canopy/pipe rack that connects to the hospital structure.

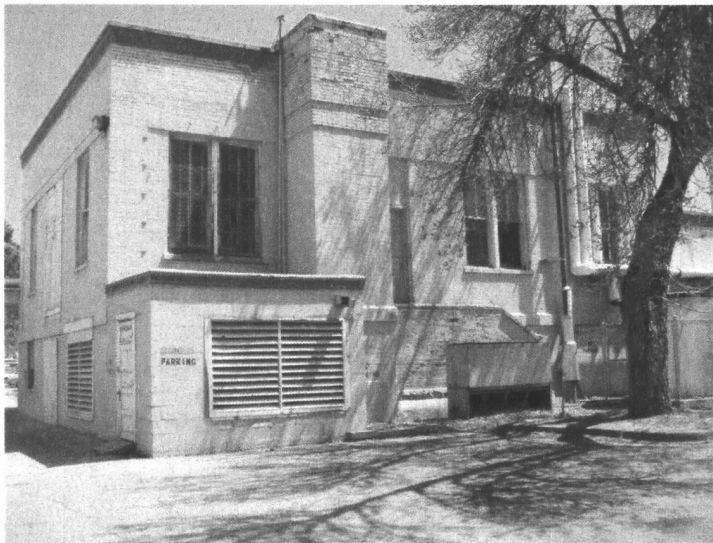
Figure 36 and 37: West elevation. The original Boiler building can still be read through the Meem modifications.

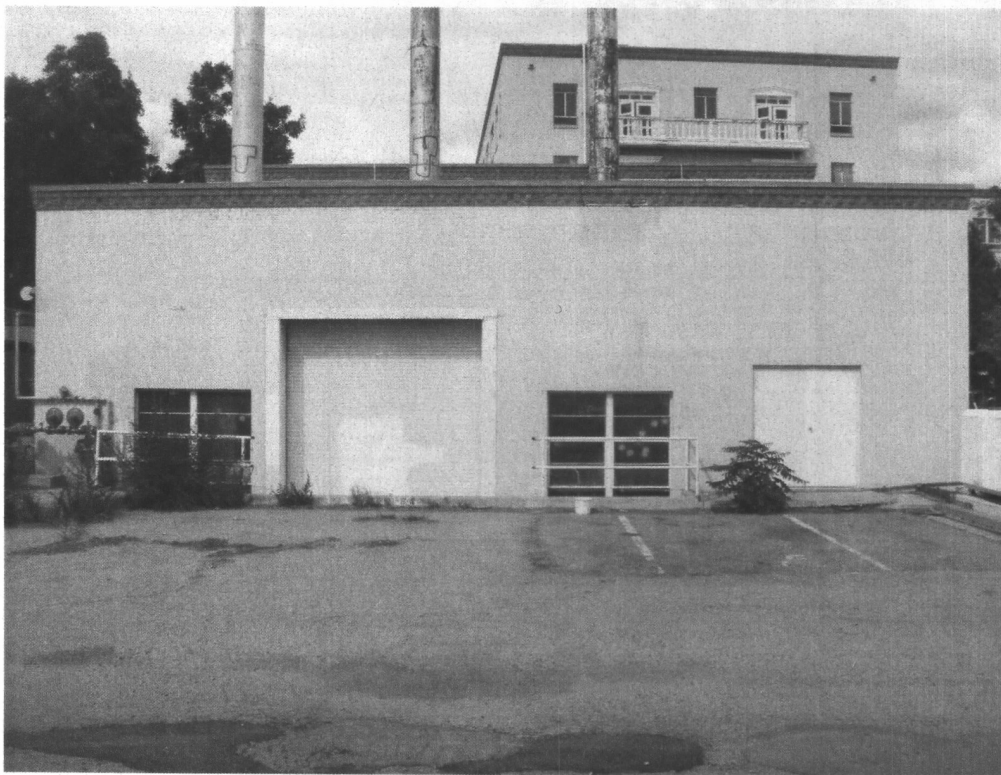
Figure 39: The South Elevation of Meem's addition

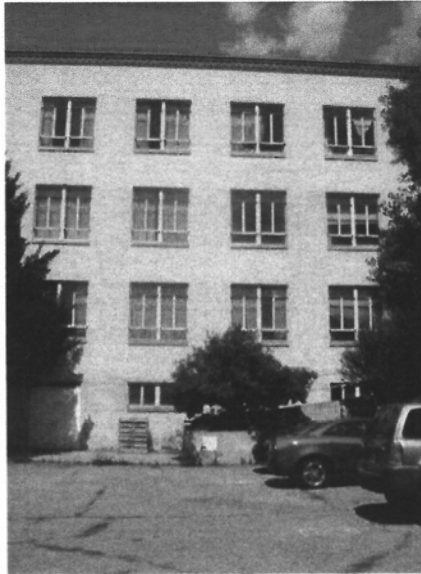
Facade: #7 – South Facing

1. Two ground level windows replaced with entry doors
2. One ground level door replaced with window
3. Shallow canopy replaced with portal

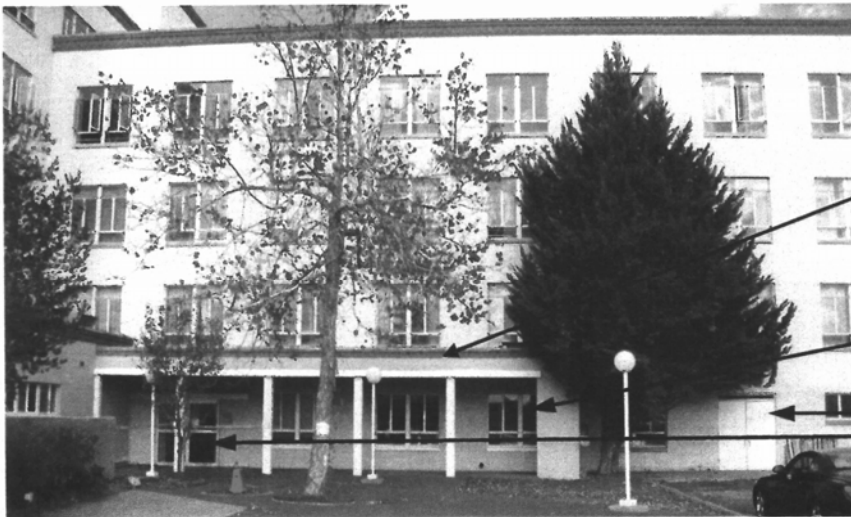
1982-83 Façade Modifications

New portal added

Door removed

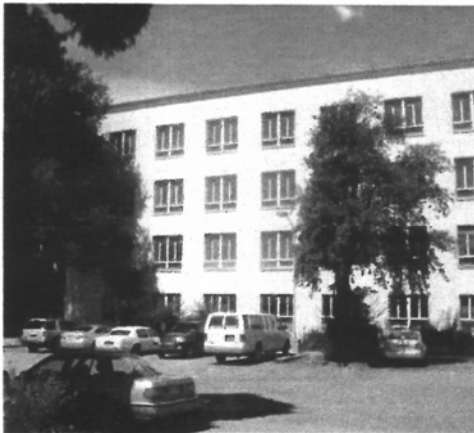
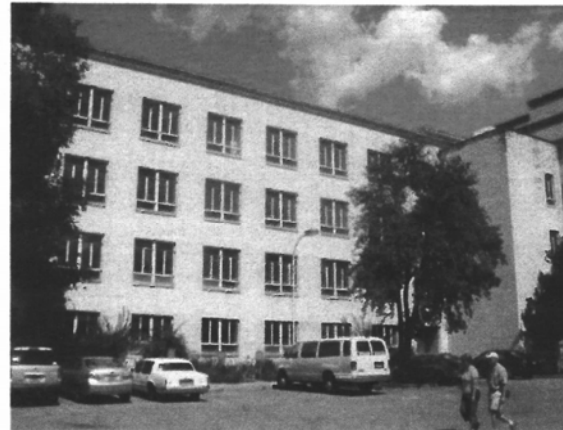
1982-83 Façade Modifications

1. Exterior Stairwell & Elevator Shaft added
2. Double entry doors moved to West
3. Ambulance garage & canopy removed

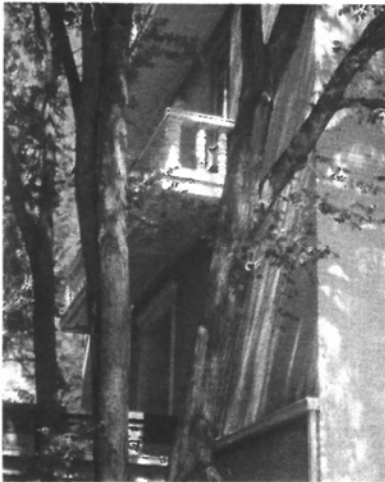
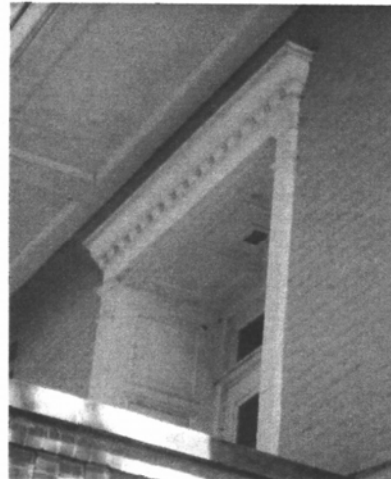
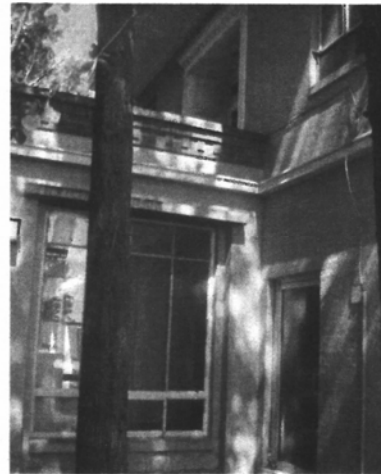
1. Classical details and balustrades are not unique to this facade.
2. Modifications to facade addition of connecting halls to Marion Hall.

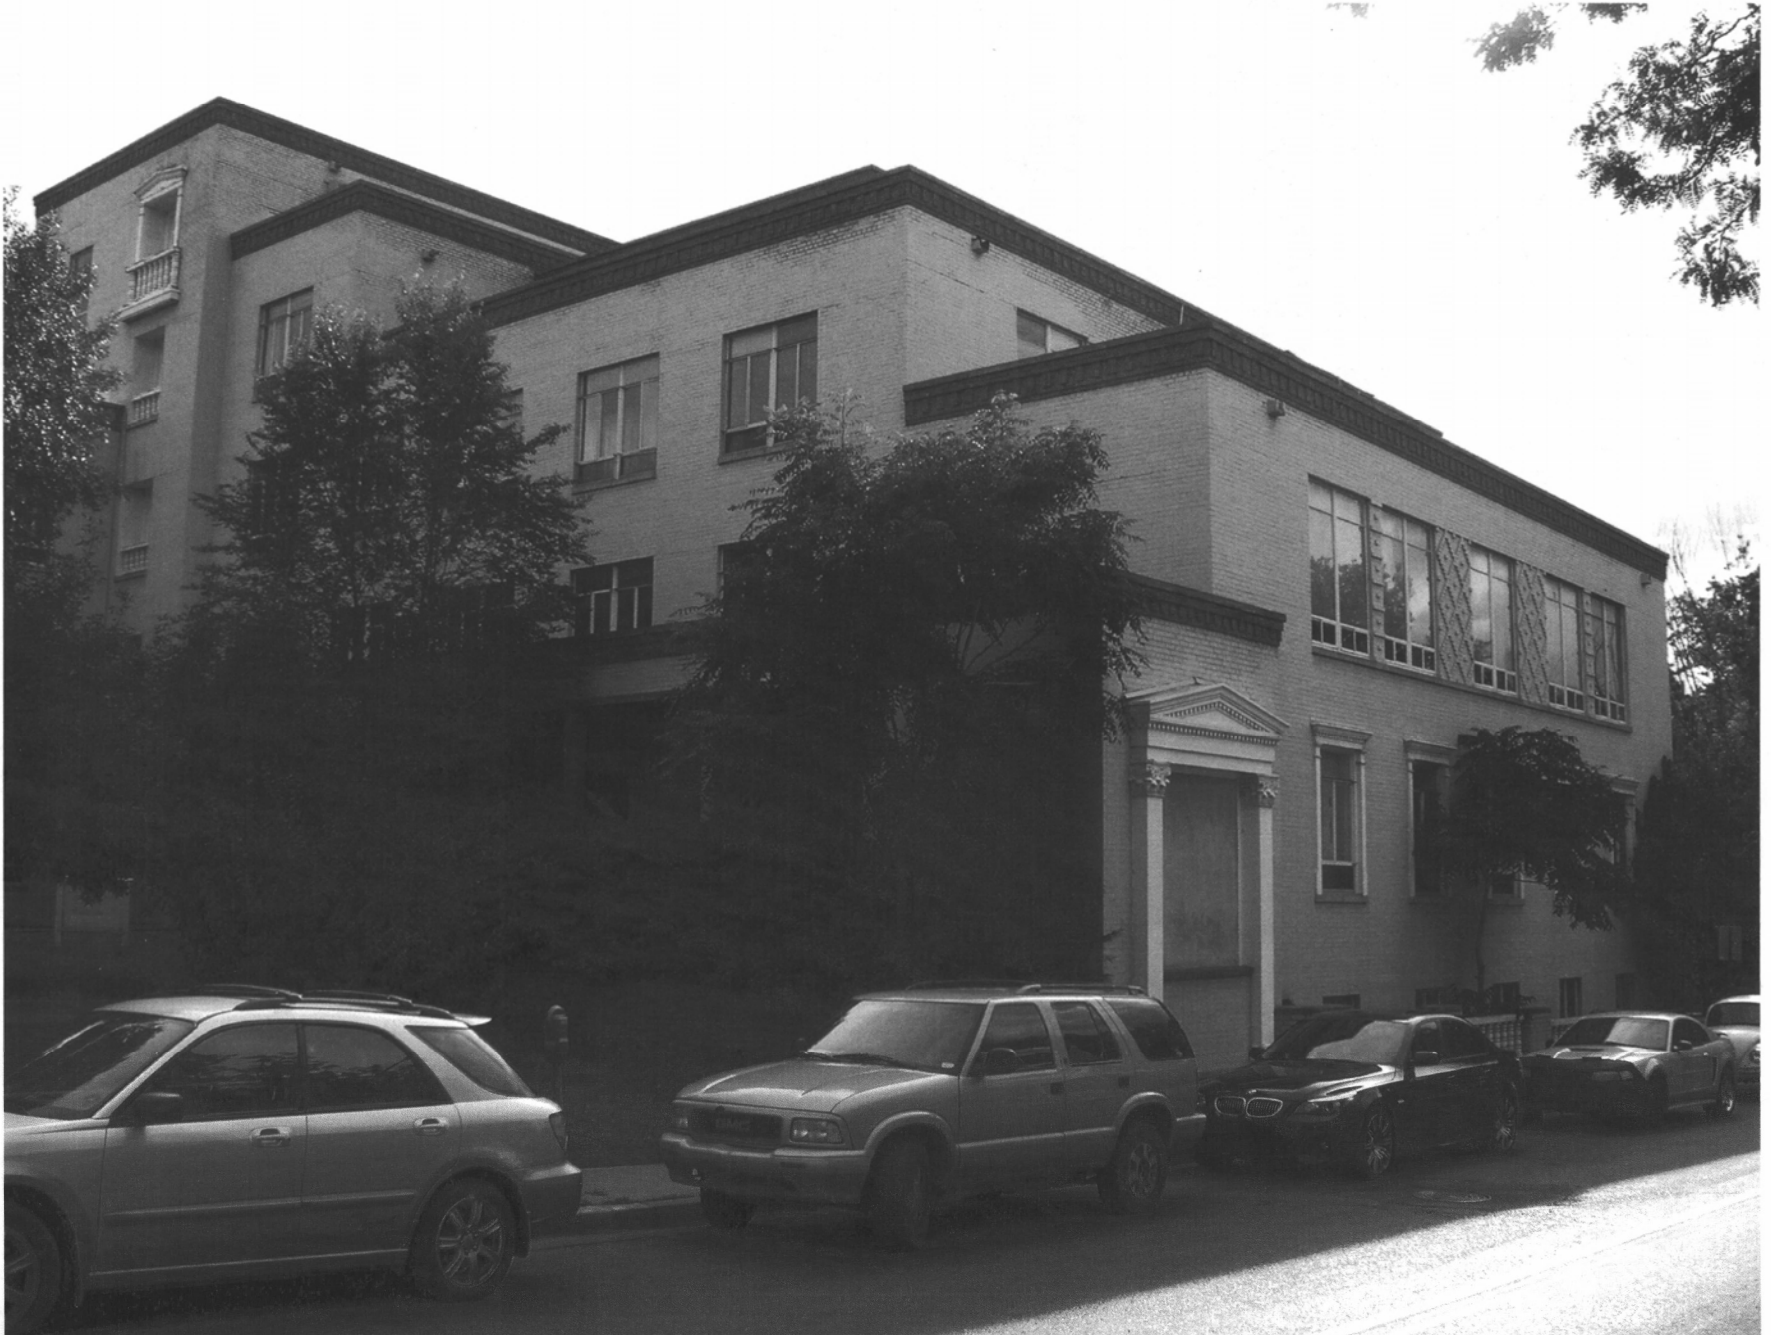
SW corner Palace & Paseo

east

north

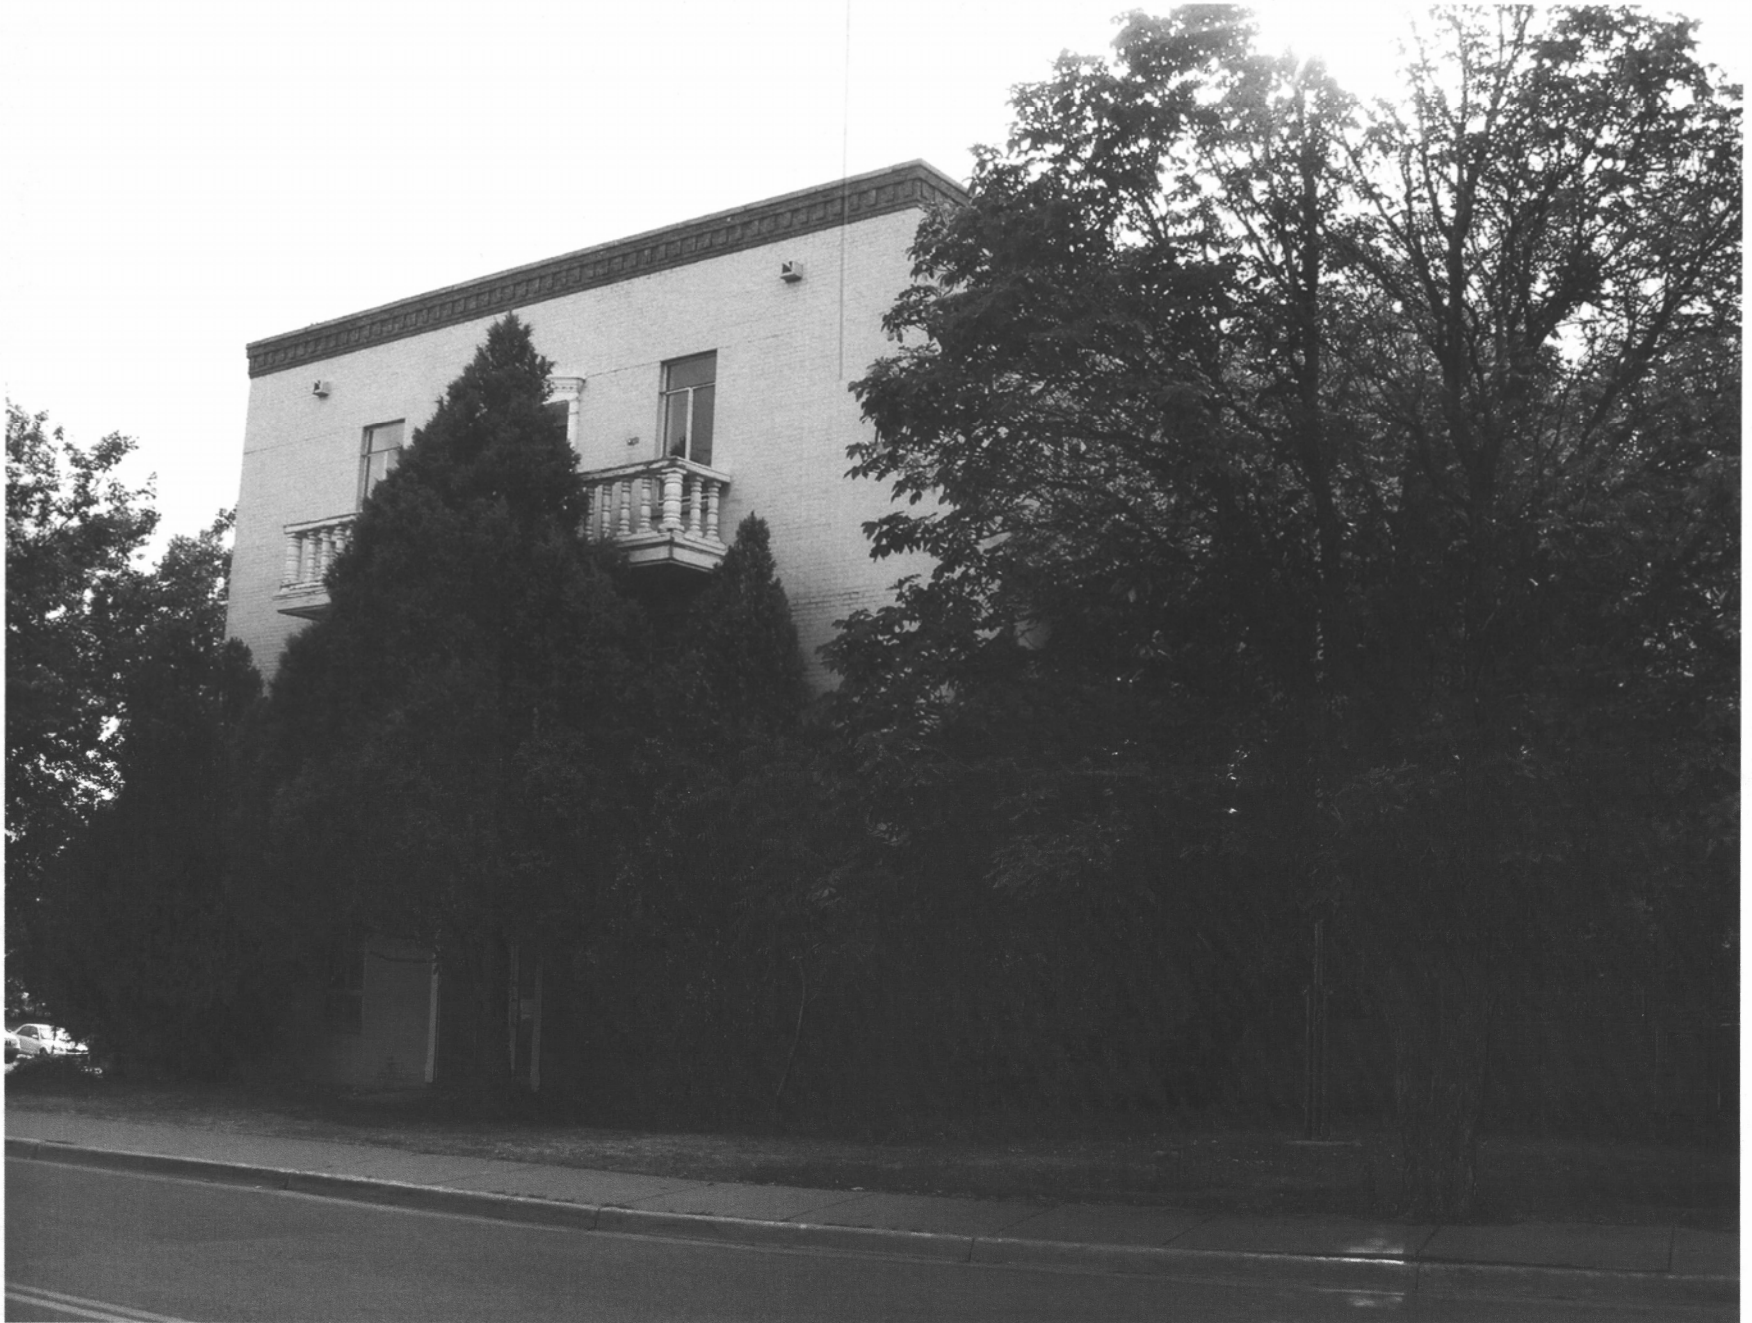
SW corner Palace & Paseo

east
