An Assessment of Facades:

*Old St. Vincent Hospital
Santa Fe, NM*

By: Gayla Bechtol, AIA

March 24, 2009

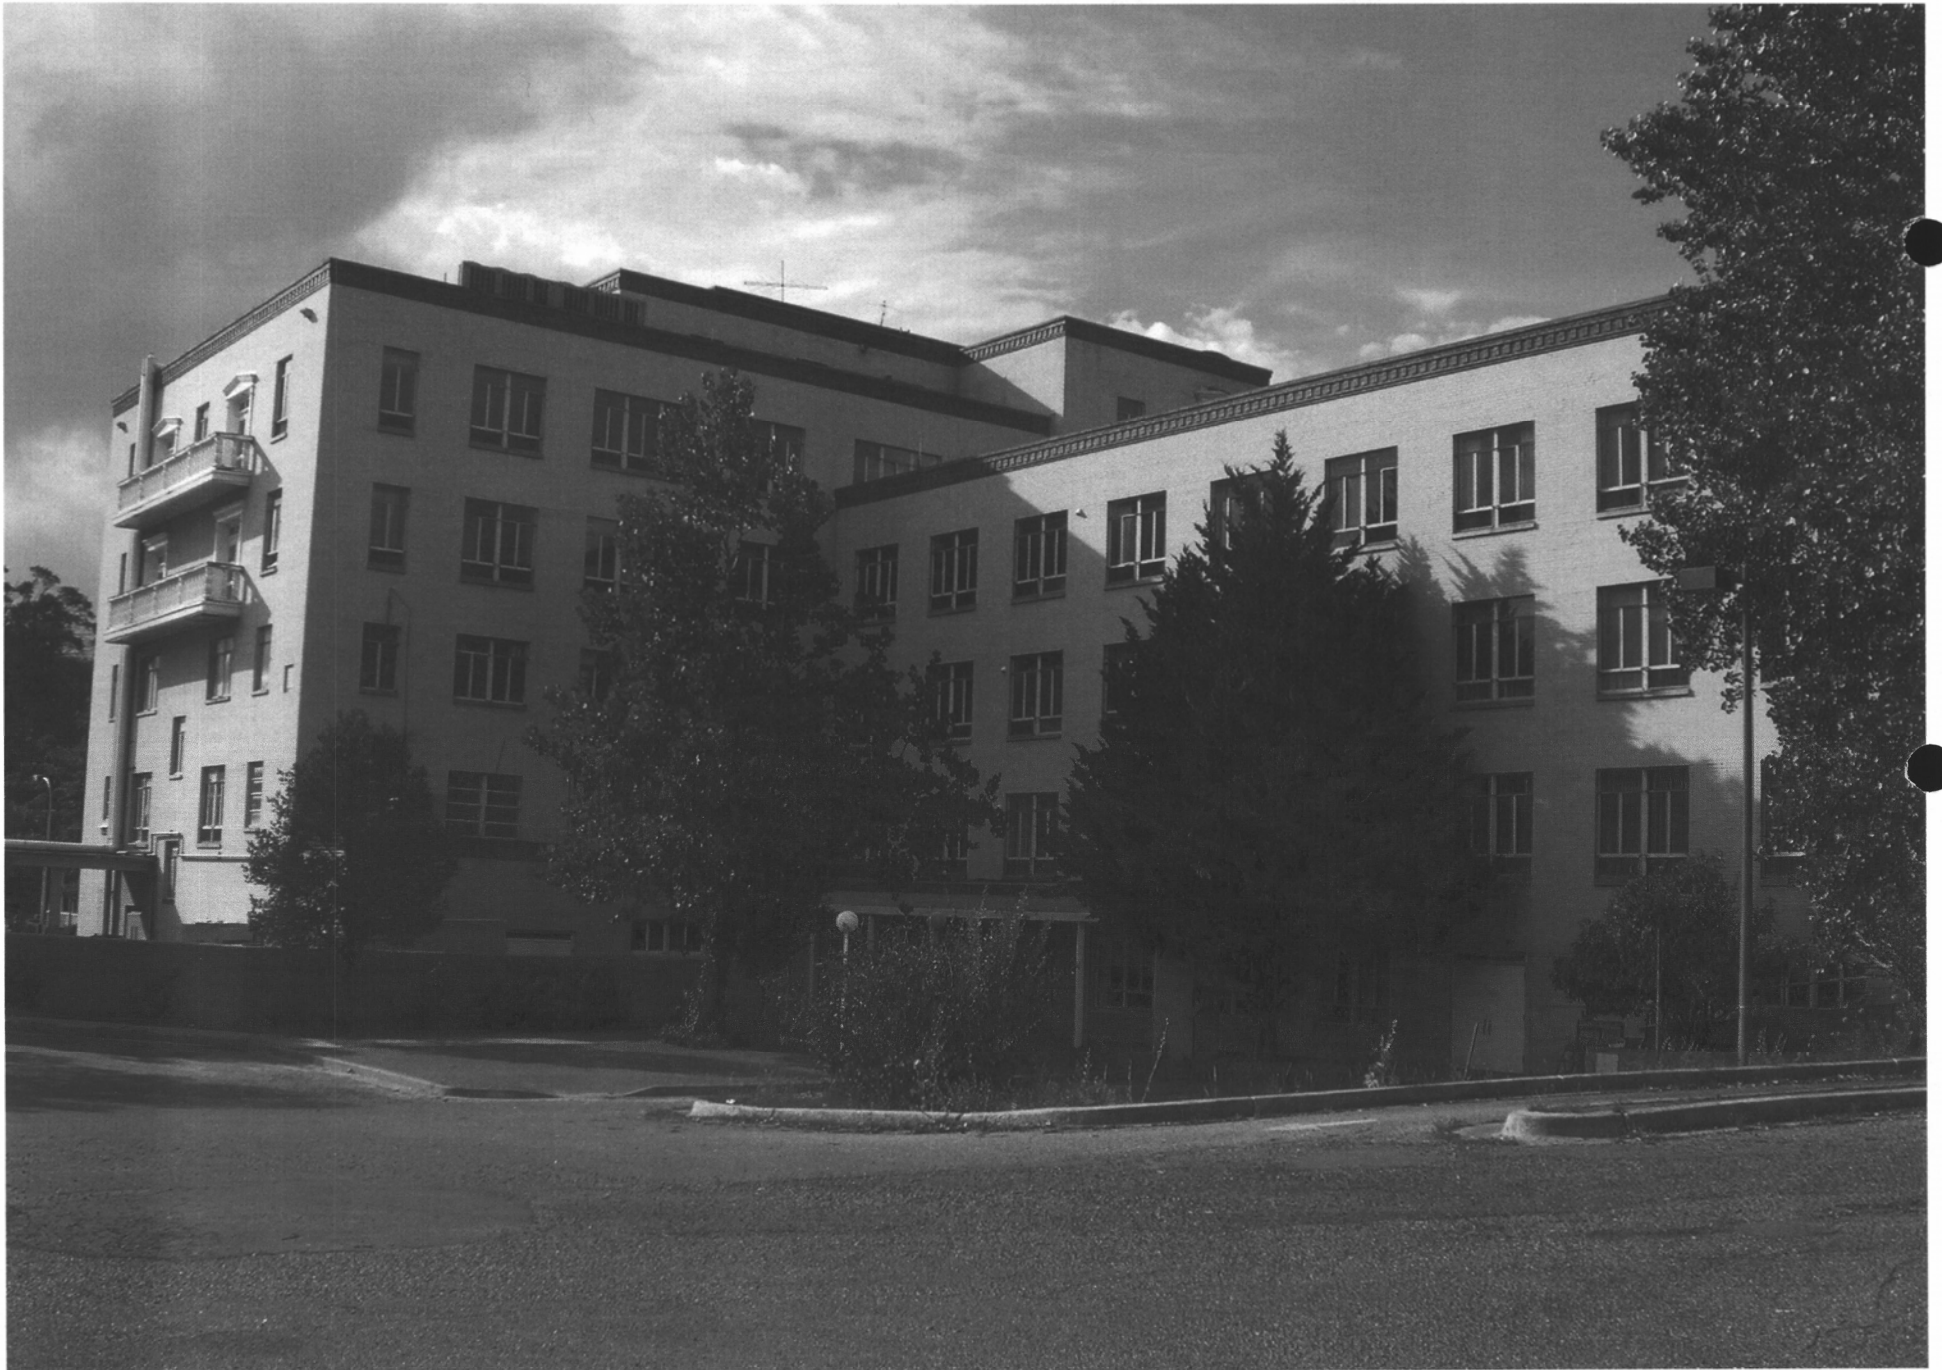
SW corner Palace & Paseo

South

East

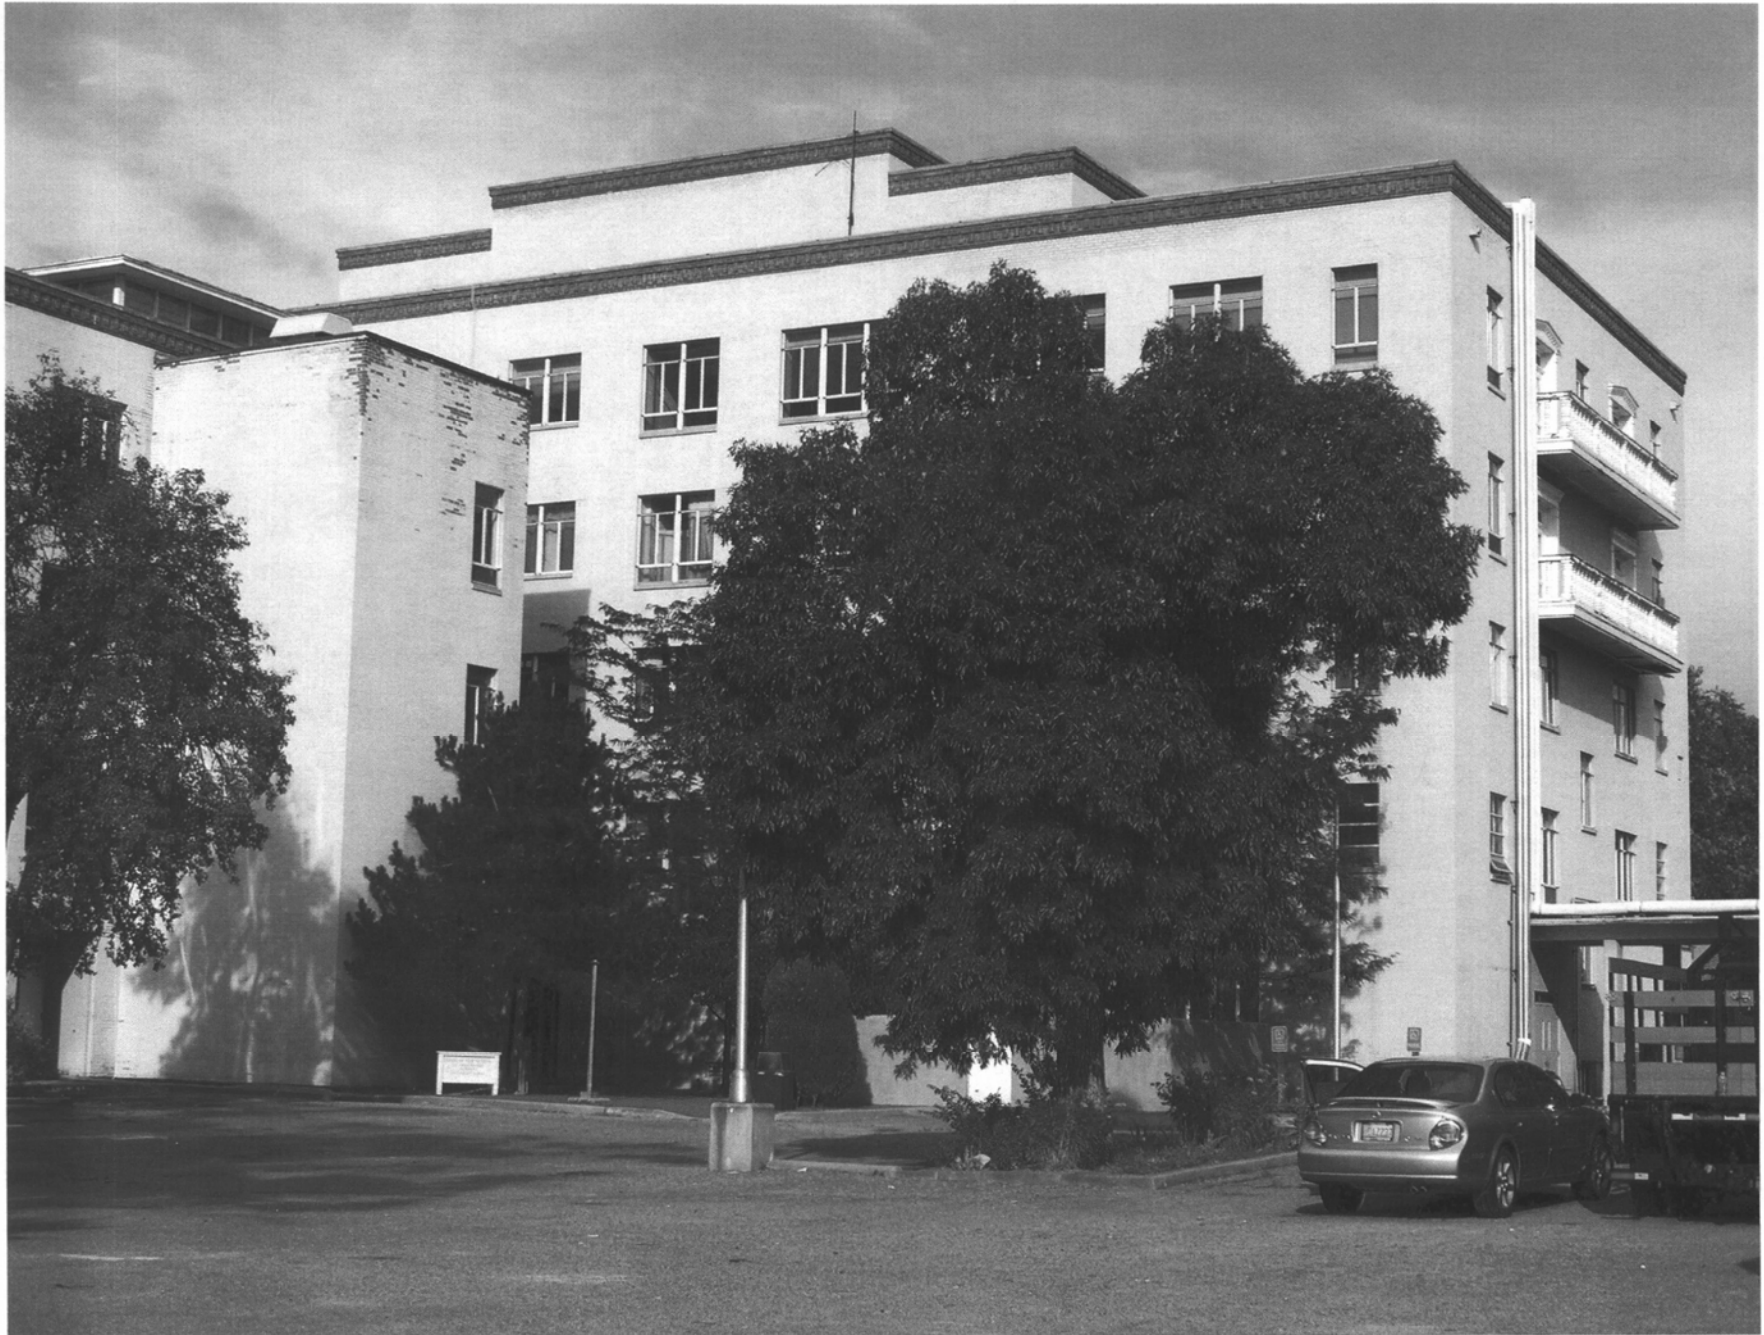
SW corner Palace & Paseo

South

West

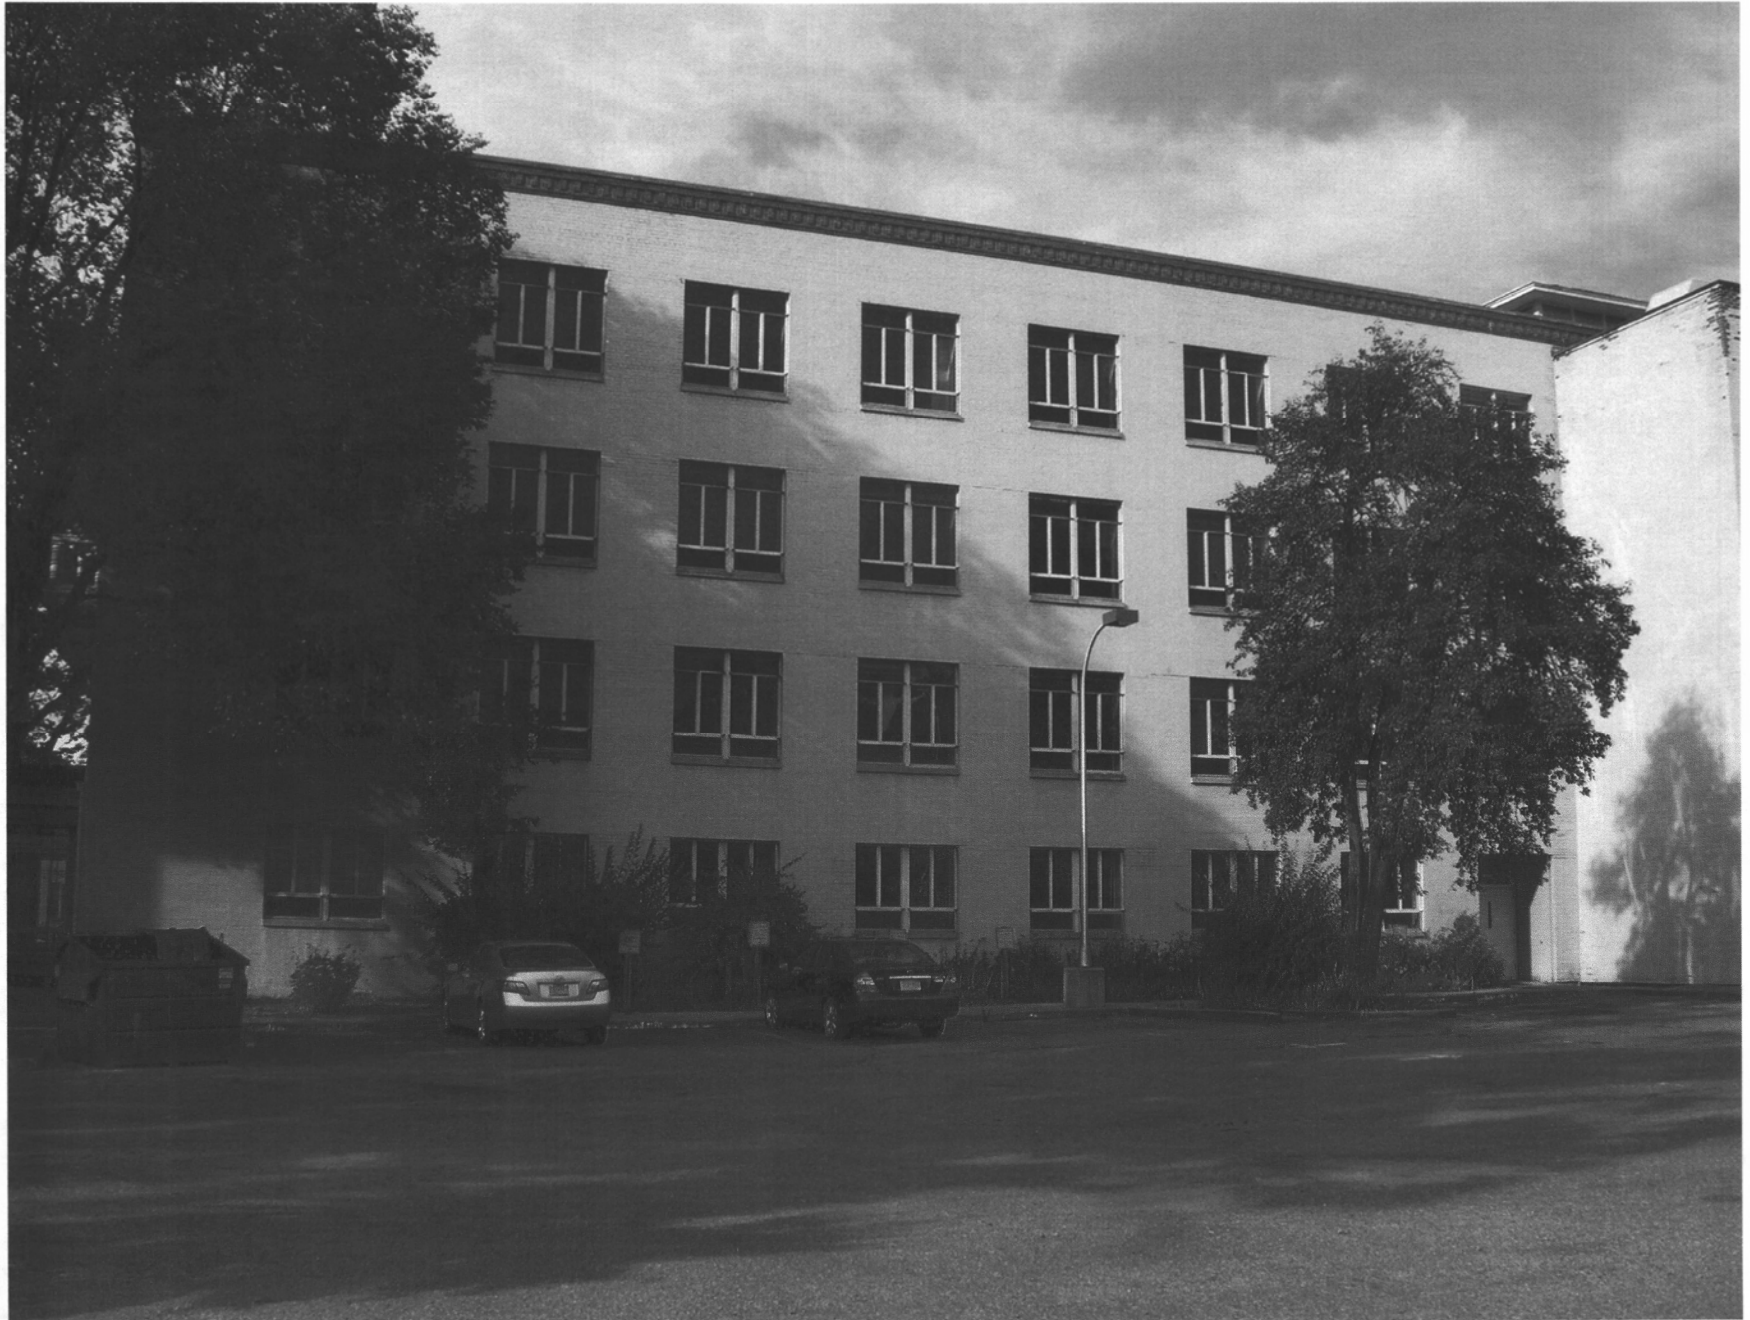
SW corner Palace & Paseo

South

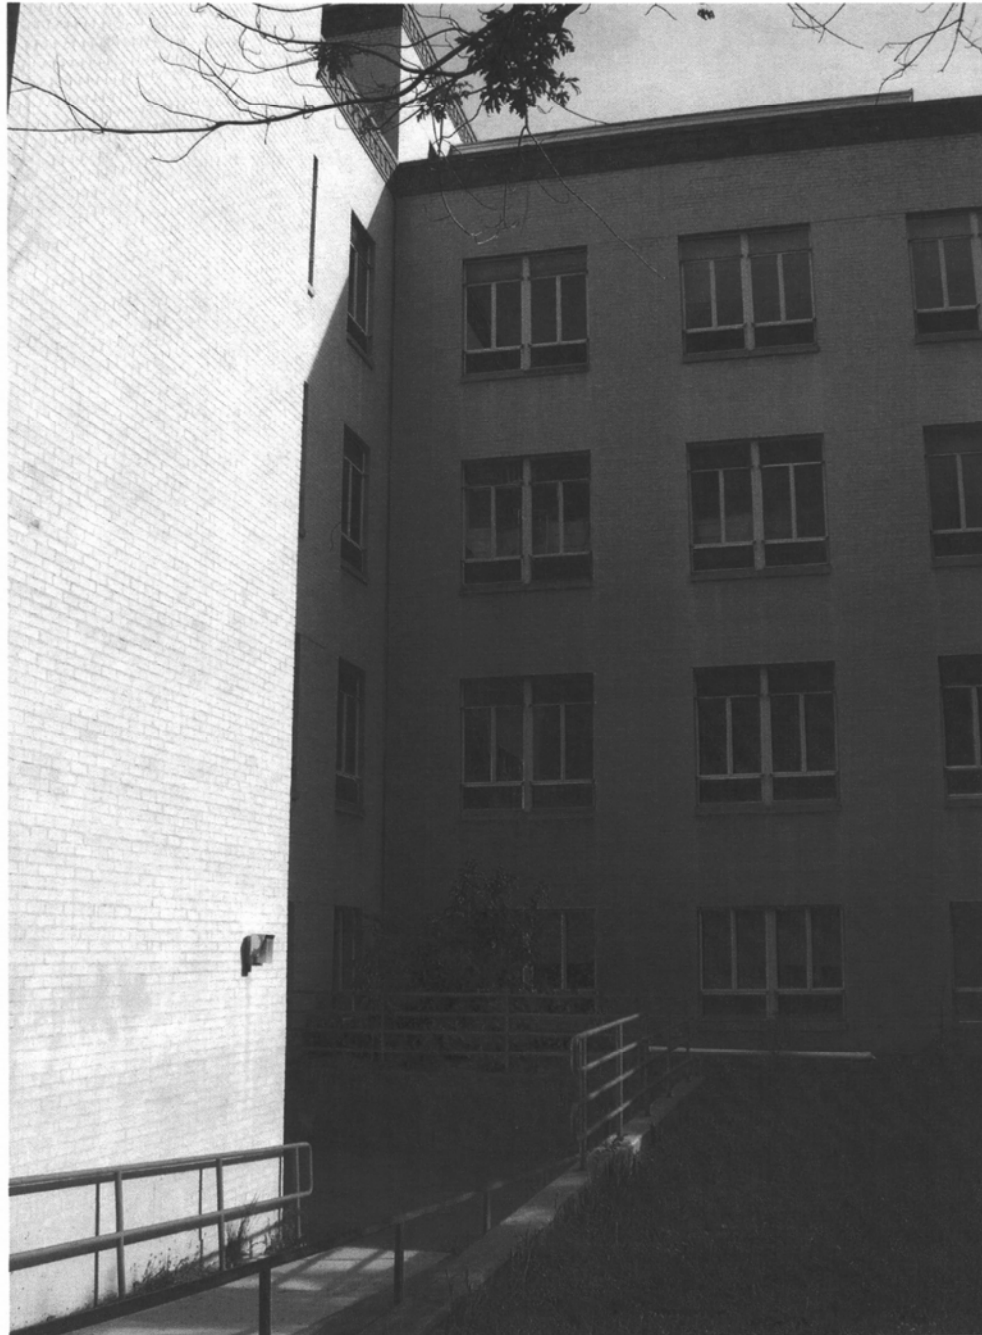
SW corner Palace & Paseo

west

north

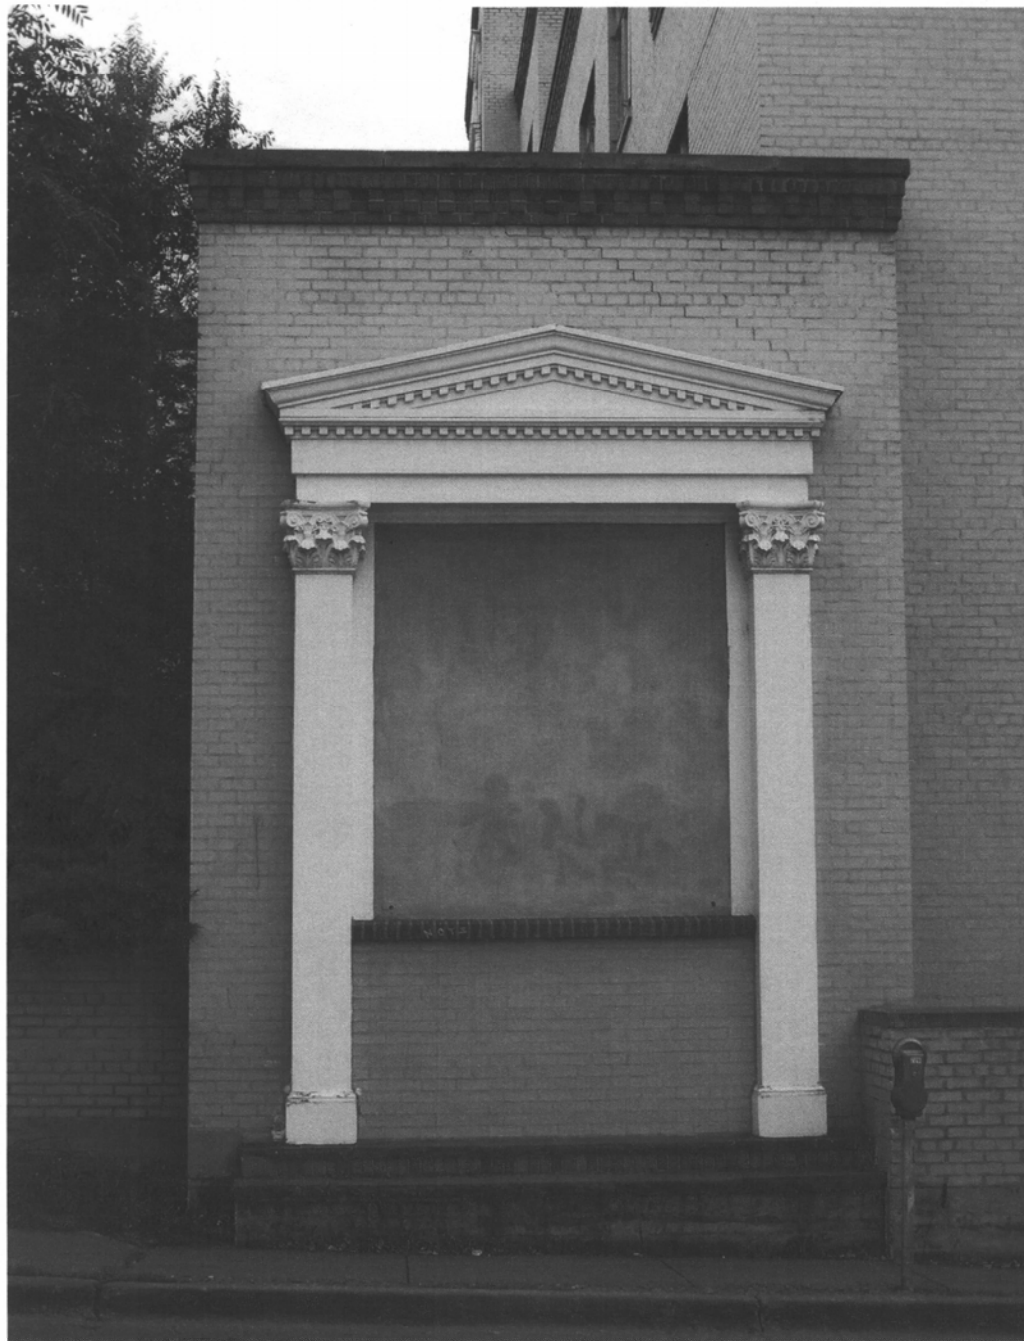
SW corner Palace & Paseo

north
