# Historic Cultural Properties Inventory (HCPI) Base Form (FORM 1)

1. Name of property:  José Alfonso and Celine C. Armijo House	2. Location:  345 Garcia Street Downtown and Eastside Historic District Santa Fe	3. Local Reference Number: Santa Fe ID: H-2090  4. County: Santa Fe Parcel # 11697280

8. Name of Project: HDRB Status Evaluation		
9. Lat/Long: 35.6815363,-105.9331141		
10. Photo Information: Giulia Caporuscio, photographer. Photo 1: View south and east elevations, facing northwest.

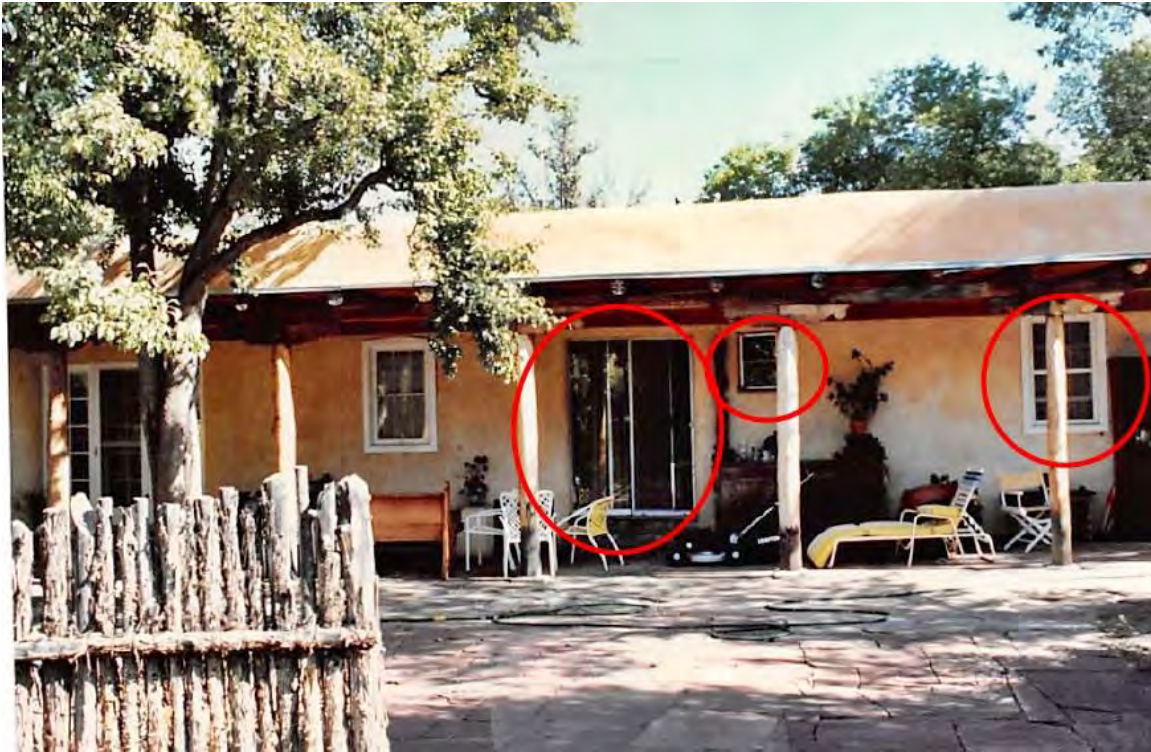
In its shadow is a line of fenestration that has been altered over the years. This is established by comparing current conditions with how the porch appeared in 1987 before being renovated (Fig. 9). Some window openings were removed, while others were newly installed. One enters the house at the west end of the portal through a narrow ten-light wood door flanked by divided side lights. Marching east are various multi-light windows, all with pedimented heads.

**Figure 9: 1987 photograph of south elevation. Circles indicate fenestration that was changed by either elimination or enlargement of opening. Compare with Photo 3. Courtesy of City of Santa Fe Historic Preservation Division.**

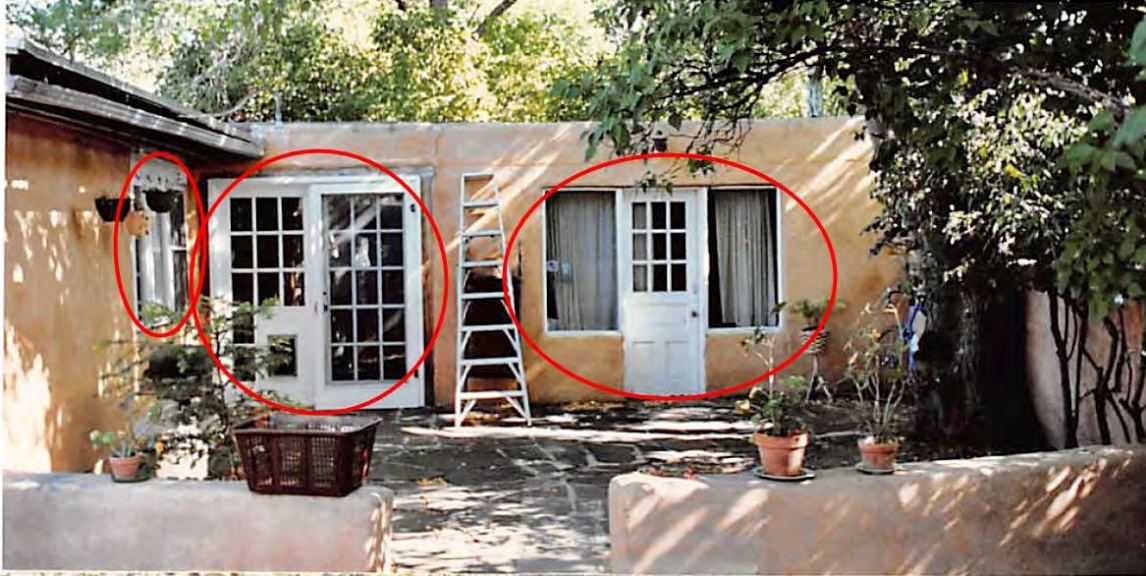
**Figure 10: 1987 photograph of south elevation, primary bedroom suite. Circles indicate fenestration that was changed by new openings. Compare with Photos 5 & 6. Courtesy of City of Santa Fe Historic Preservation Division.**

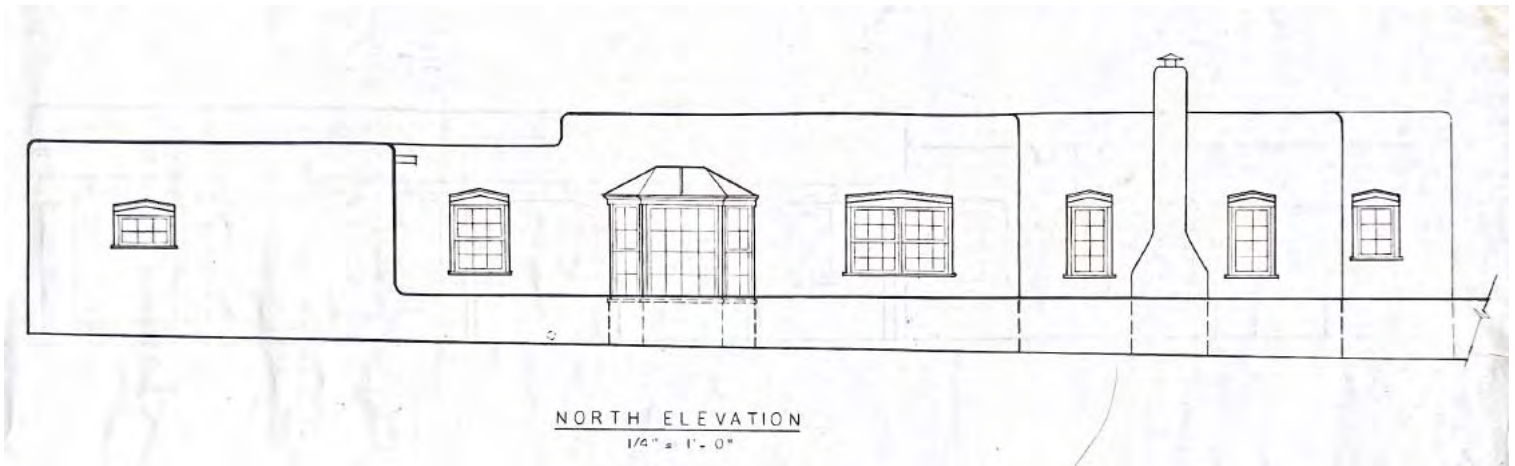
**Figure 13: North elevation, proposed, August 1987. Courtesy of John Dessau. Note introduction of bay window.**

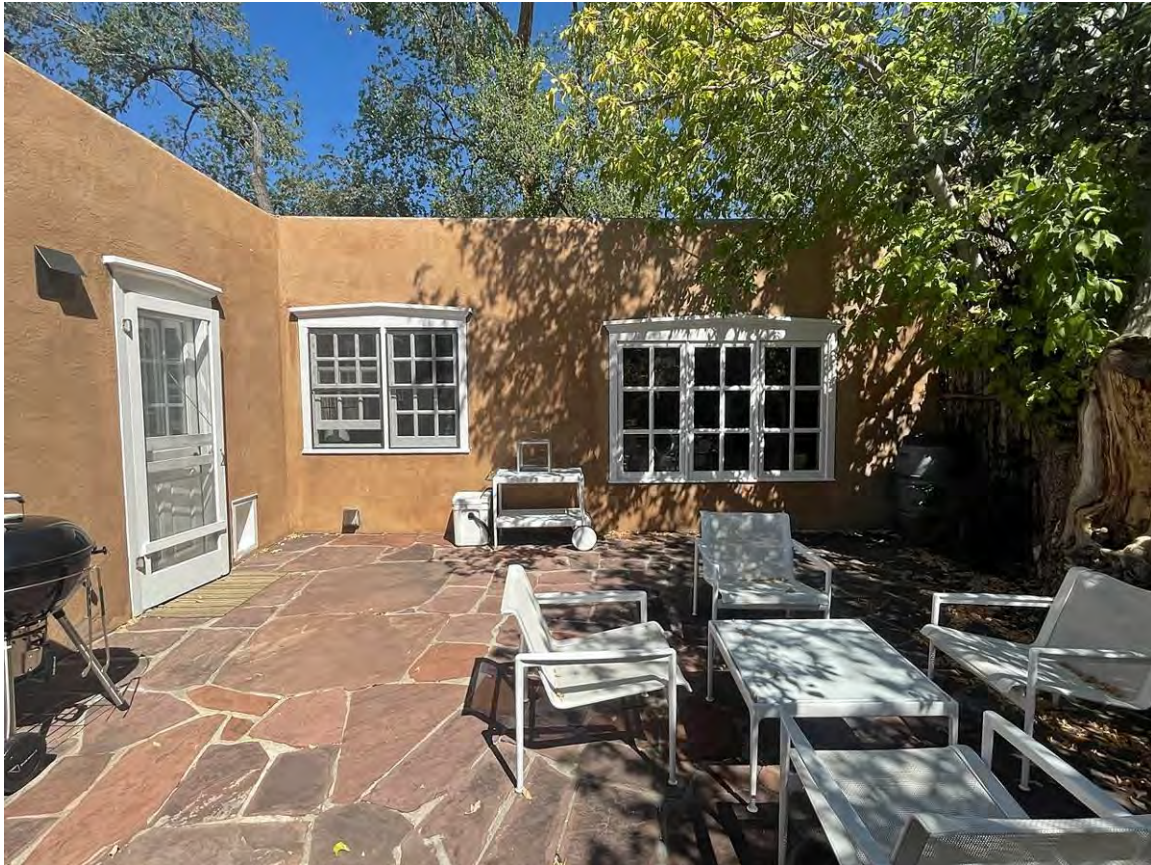
Stepping 18' back from this section is the last piece of the house — the primary bedroom suite (Photo 5). Based on aerial photographs, this room was constructed by 1958 but may have served a different purpose (Fig. 5). The enclosed porch is now a bathroom, which along with the bedroom frames a private patio (Photos 5 & 6). According to a 1987 photo, the patio elevations have significantly changed in fenestration — both doors and windows (Fig. 10). Like the rest of the house, the elevations are presently pierced with newer units topped with pedimented heads.

**Photo 5: South elevation, primary bedroom suite. Camera facing north.**
