City of Santa Fe, New Mexico

2025-010488-HDRB, 140 Romero St., Westside-Guadalupe Historic District, non-contributing, Camilla Kennedy, owner, requests a historic status review with primary facade(s) designation, if applicable, for a residential structure and a yard wall.

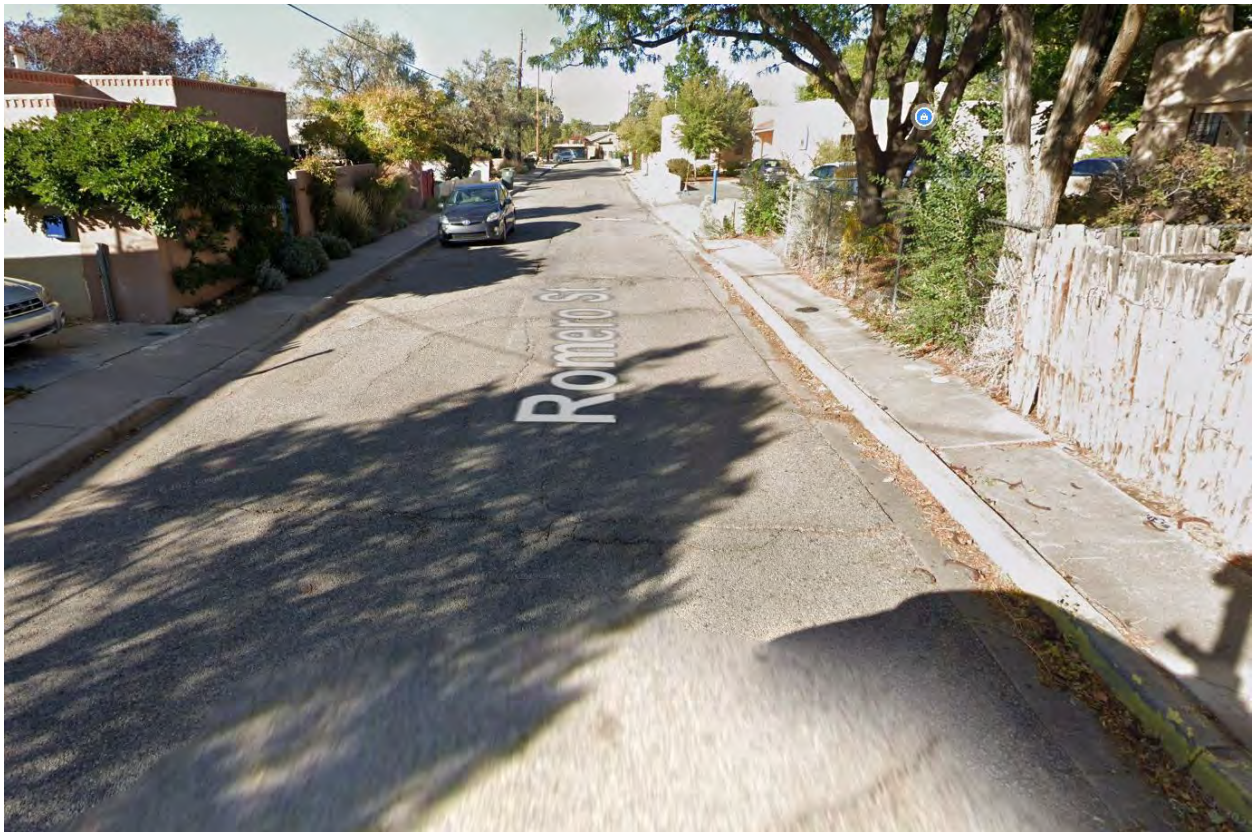
Romero Street is a mix of architectural styles, including vernacular, Pueblo Revival, a bungalow with a hip roof, and an early twentieth-century bunkhouse. A variety of low fences line the street, constructed from materials such as wood boards, latillas, steel wire, stuccoed concrete blocks, and clay structural tiles.

Figure 1: The Romero Street Streetscape

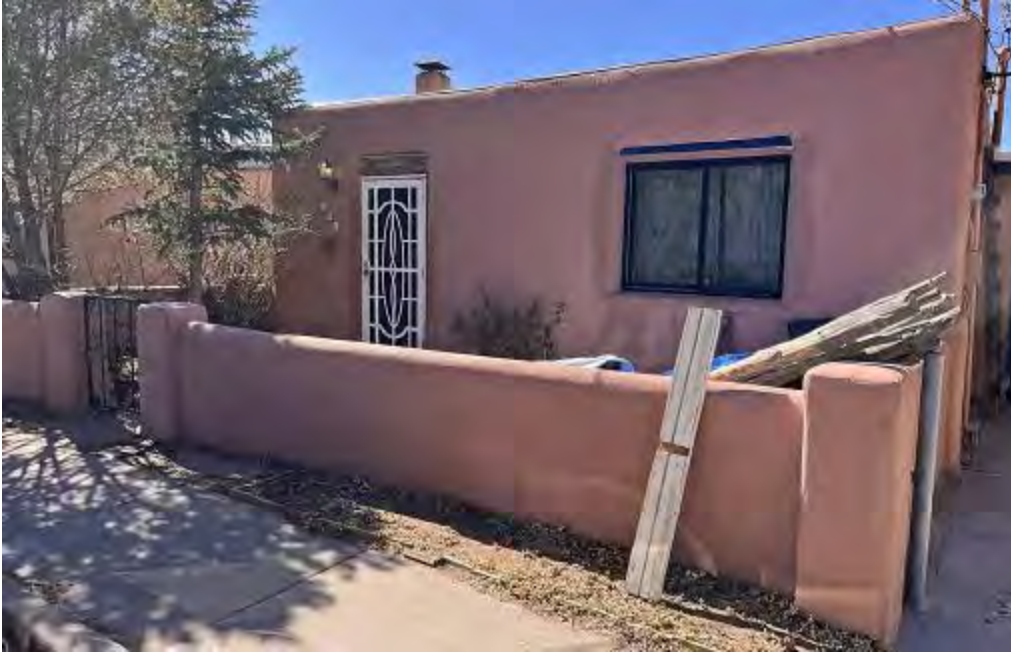
Figure 2: East elevation of Residential Structure with yard wall.

The Adobe residence was constructed in the 1940s. An addition was constructed on the rear in 1948. A carport was constructed along the north side in the 1950s and was enclosed after 1985. A porch on the northwest corner was enclosed around the same time. Most of the windows are non-historic post-1985 installations except for a few steel casement windows on the north and west elevations.

Staff recommends the historic status of the residential structure be retained as non-contributing due to the alteration and window replacements which diminish the historic character of the structure, and the yard wall be designated as contributing due to the character which has remain unchanged since the 1960s and is consistent with the Romero streetscape dominated by low yard walls and fences per section 14-5.2(C)(2) Designation of Significant, Contributing or Noncontributing Status Within Historic Districts.

The front yard wall was likely constructed in the 1960s of concrete masonry units (CMU) with square pilasters. The wall was modified after 1985 with a Pueblo Revival-style treatment with rounded edges and stucco. The style of the yard wall retains the relationship to and character of the streetscape, which is predominantly low yard walls and fences.

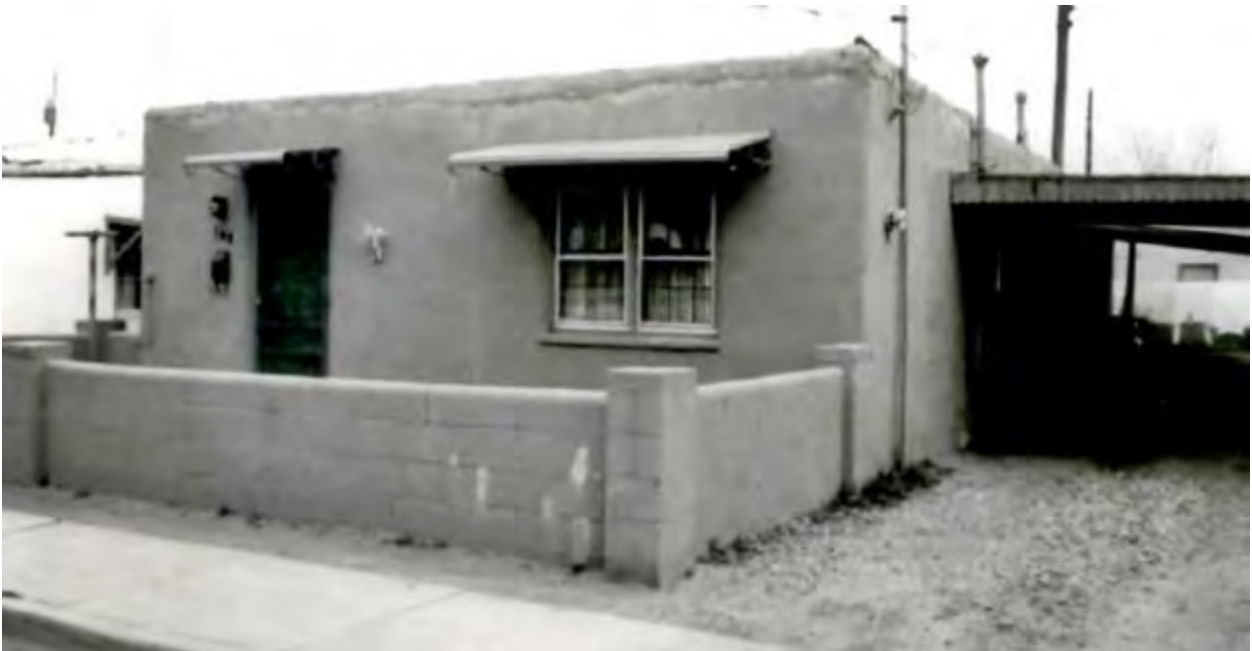
Figure 3: August 1985 Historic Building Inventory Photograph
