Historic Cultural Properties Inventory (HCPI) Base Form (FORM 1)

1. Name of property: Juan and Simona/ Stella and José Salazar/ Christina Ertner House	2. Location: 539 Garcia Street Downtown and Eastside Historic District – Santa Fe	3. Local Reference Number: Santa Fe ID: N/A 4. County: Santa Fe Parcel # 12382336

8. Name of Project: HDRB Status Evaluation		
9. Lat/Long: 35.6787977,-105.9345982		
10. Photo Information: Giulia Caporuscio, photographer, May 7, 2025. Photo 1: View of west elevation. Camera facing east.

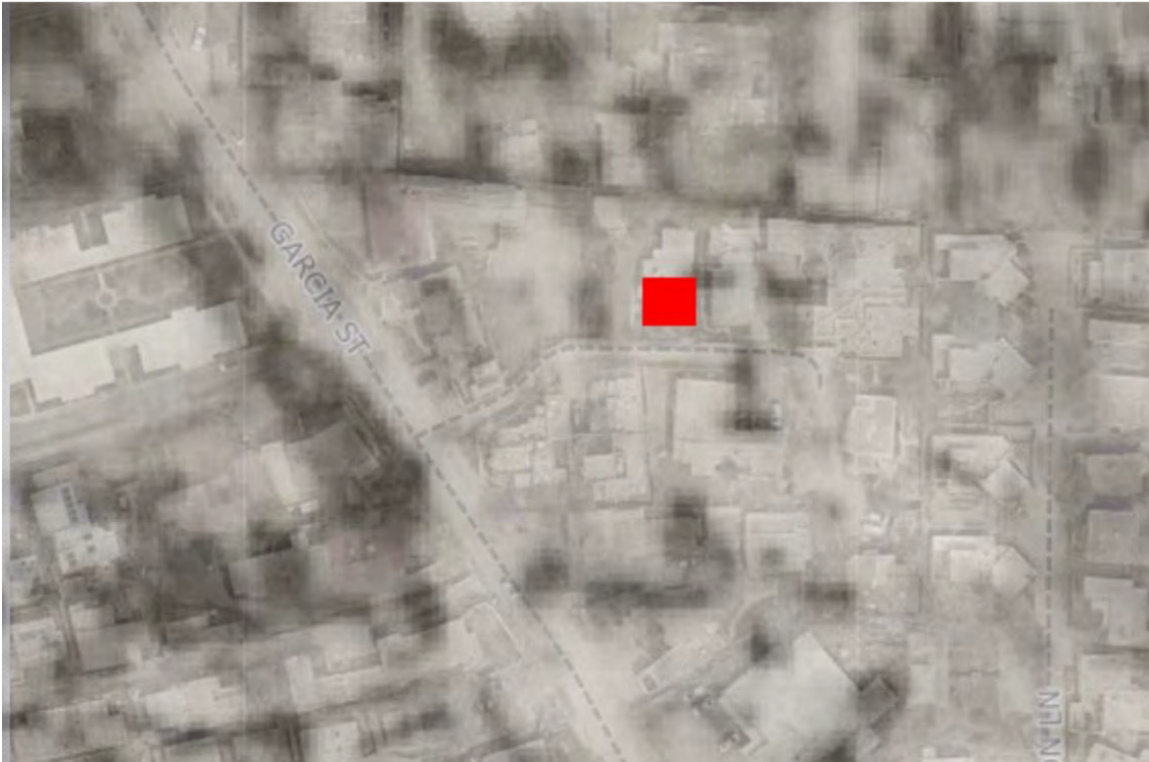
Figure 5: October 25, 1948, aerial photograph overlaid with 2025 satellite image. The overlay appears to establish the core of the house was in existence signified by the red footprint.

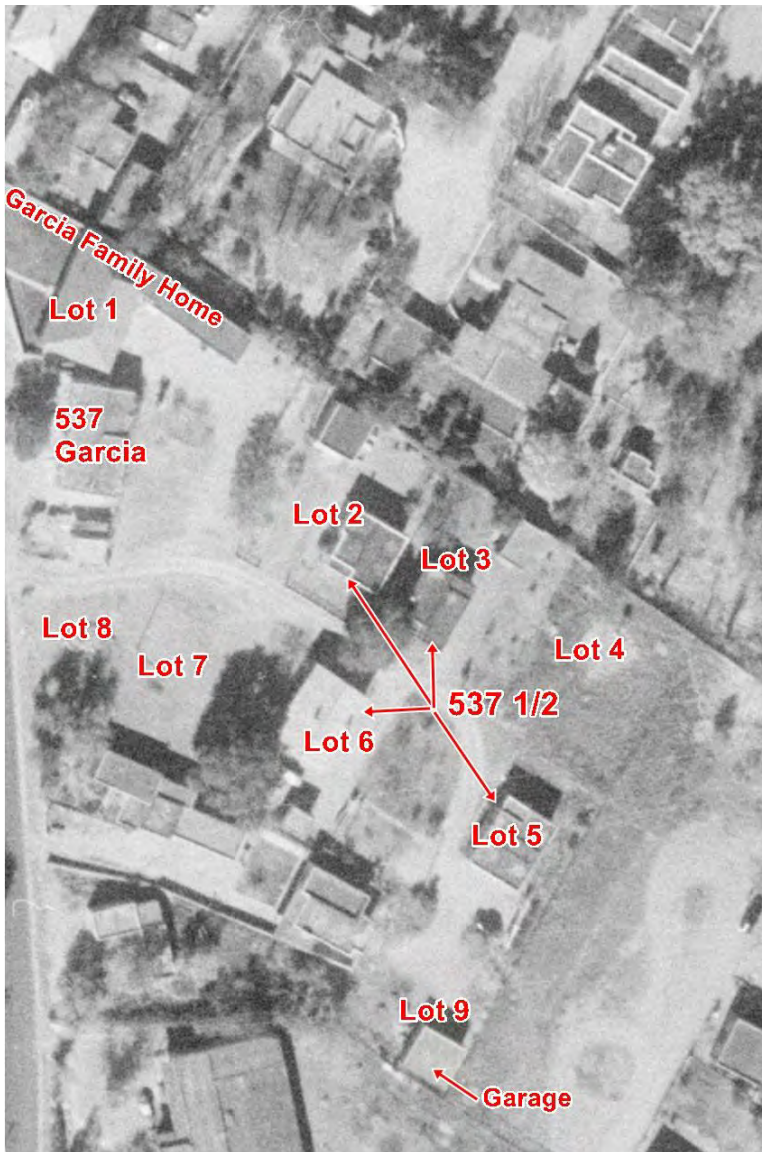
Figure 6: November 10, 1958, aerial photograph. Designation of lots, as per the José Dolores Garcia Estate Subdivision. Lot 2 contains the subject and garage. The house had yet to receive its back addition.

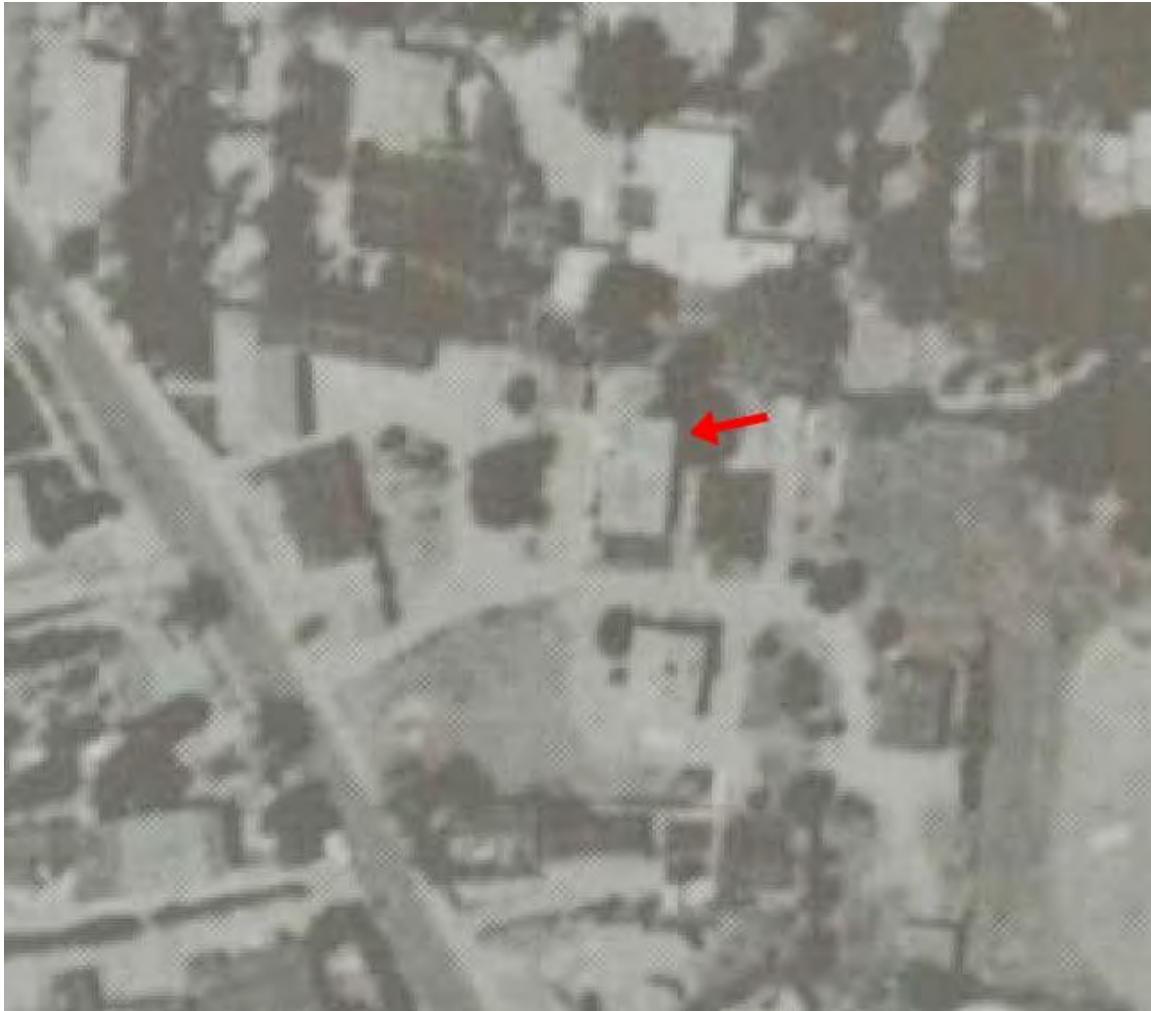
**Figure 7: June 6, 1966, aerial photograph.
 Arrow indicates presence of rear addition.**

#1 Date: 1958-1966: rear addition; aerial photographs

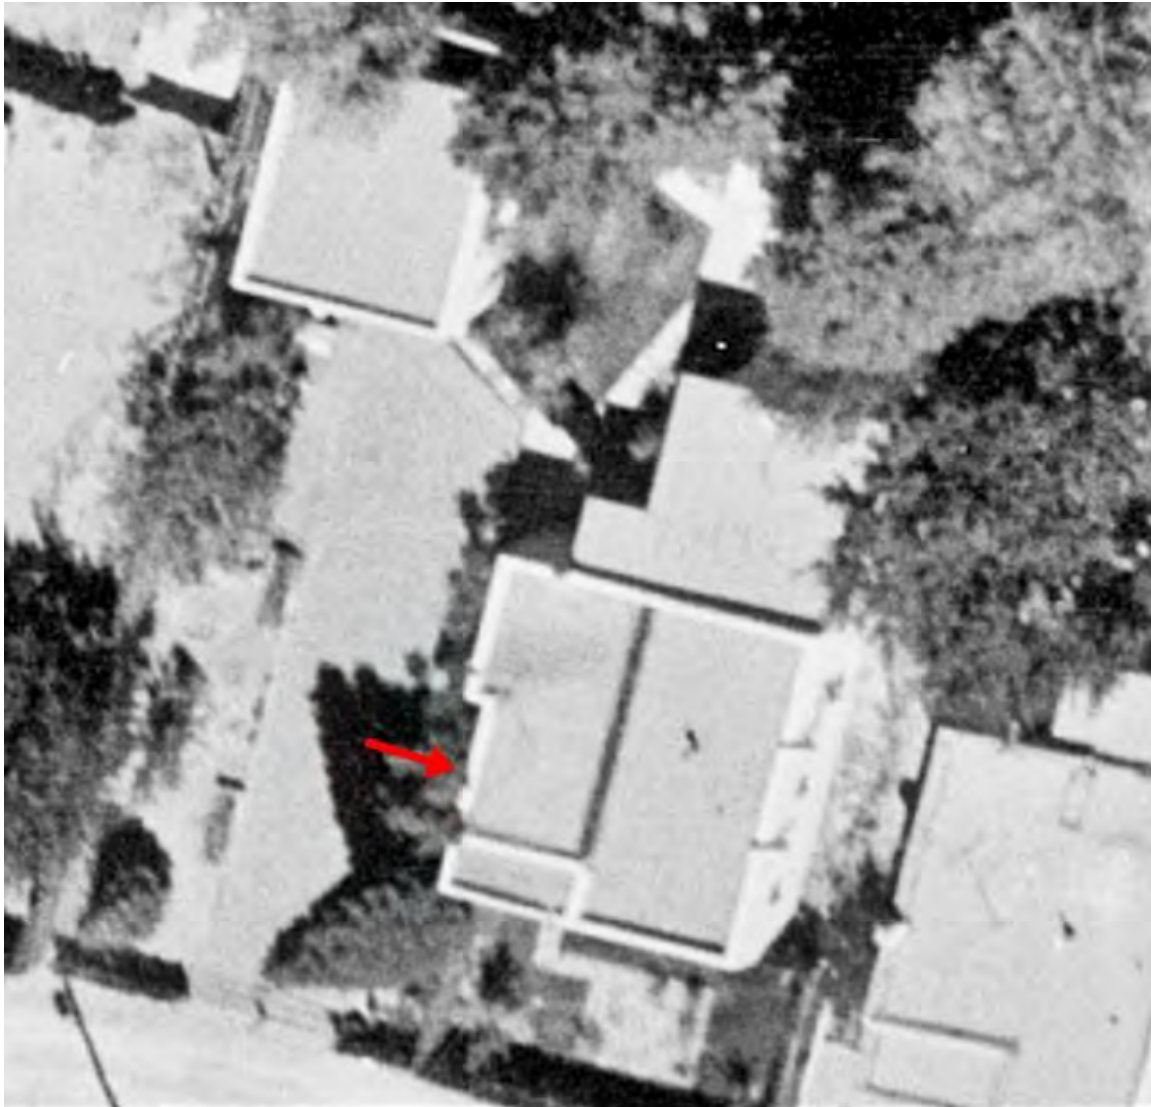
**Figure 9: September 11, 1978, aerial photograph.
 Arrow indicates absence of bay window structure.**

#2 Date: Post-1978: addition bay window and replacement and alteration of openings of two windows; aerial photographs and visual and material evidence

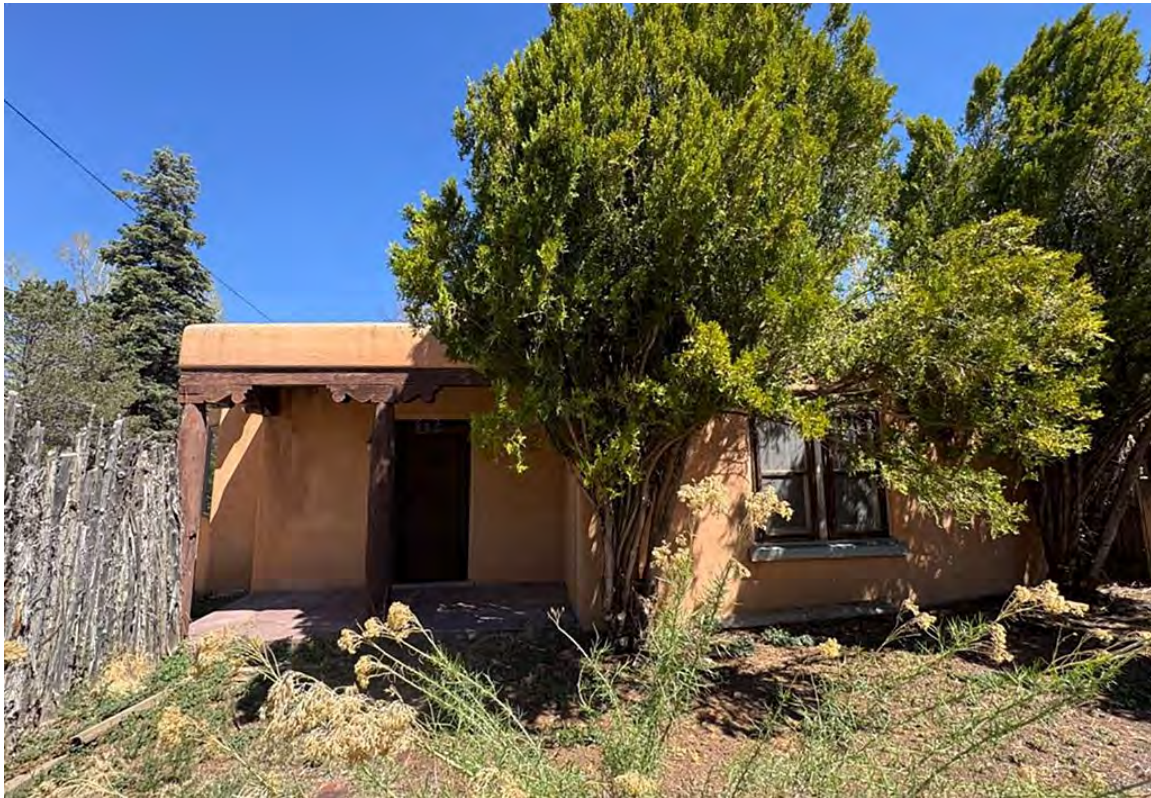
The south façade represents one of the original elevations of the presumed 1940s structure (Photo 4). It has a simple arrangement of a plain stucco façade, penetrated by an entry door and an opening holding two windows.

Photo 4: South (front) elevation. Camera facing north. Aviva Baumann, April 23, 2025.

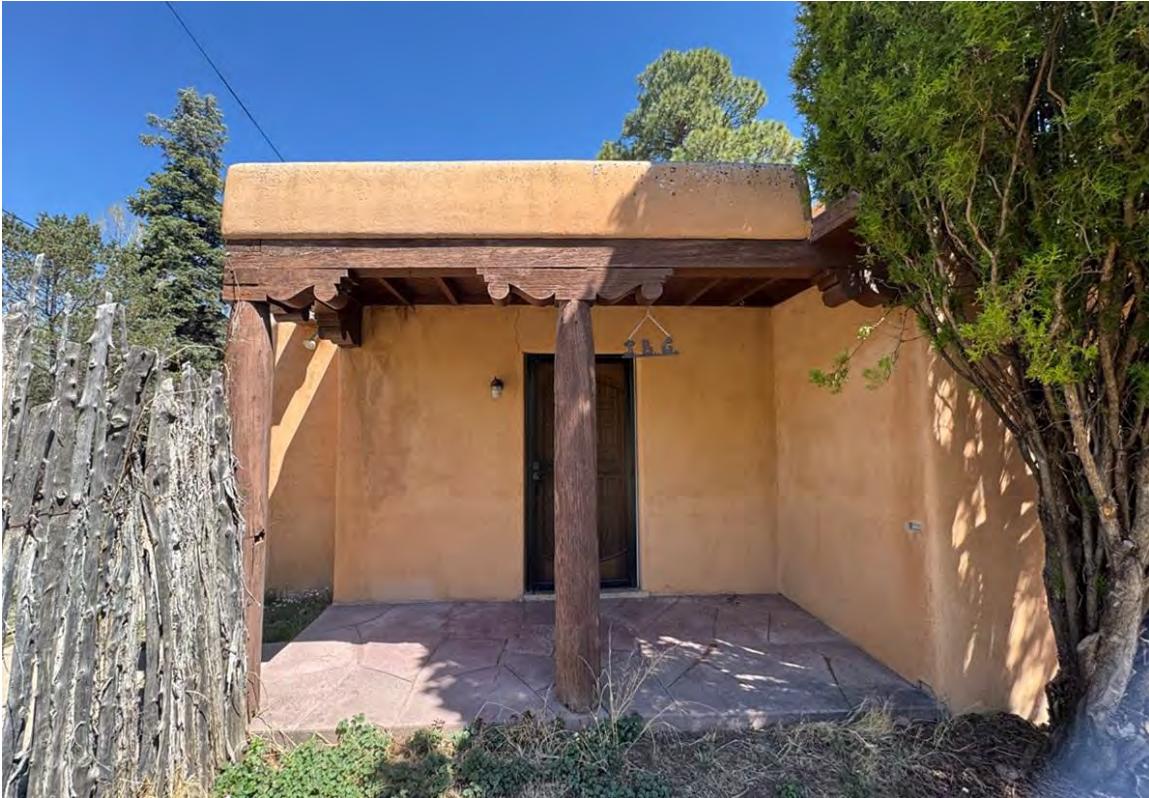
A shallow *portal* protects the entry, which is fitted with a decorative wood door (Photos 5 & 6). While the structure appears in a 1958 aerial photograph, its components, including milled plates and precast corbels, suggest a reconstruction. Its floor is scored concrete made to look like flagstone.

Photo 5: South elevation. Portal. Camera facing north. Aviva Baumann, April 23, 2025.

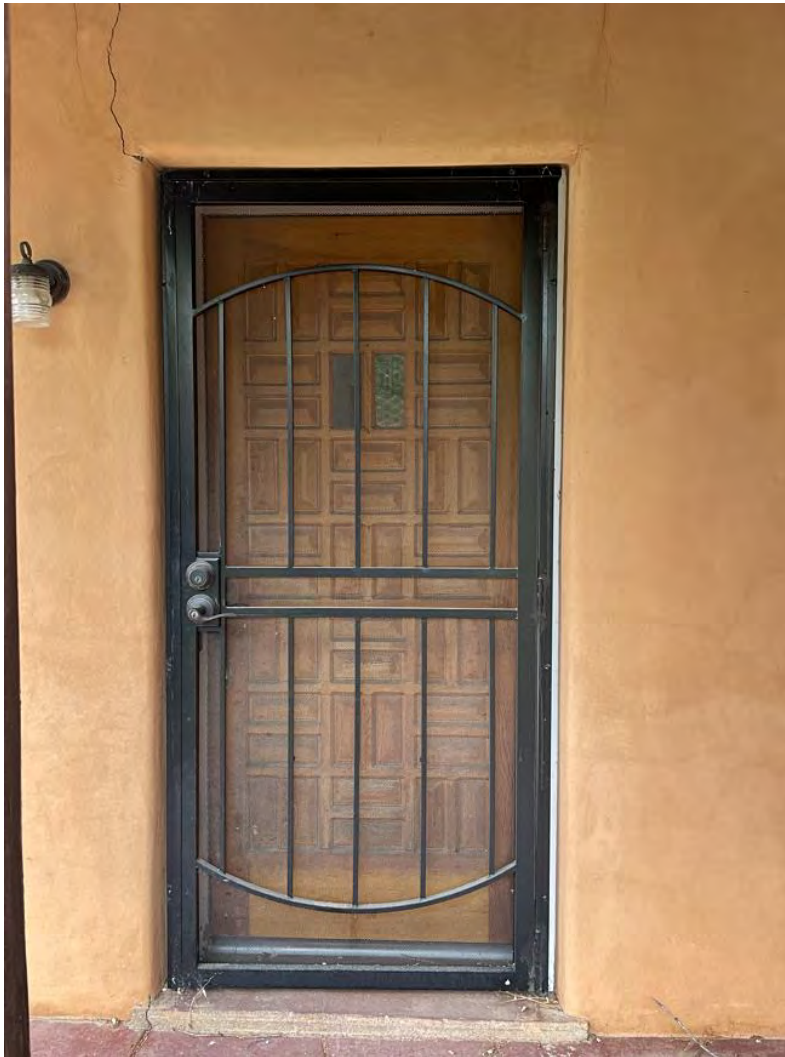
Photo 6: South elevation. Entry door. Camera facing north.

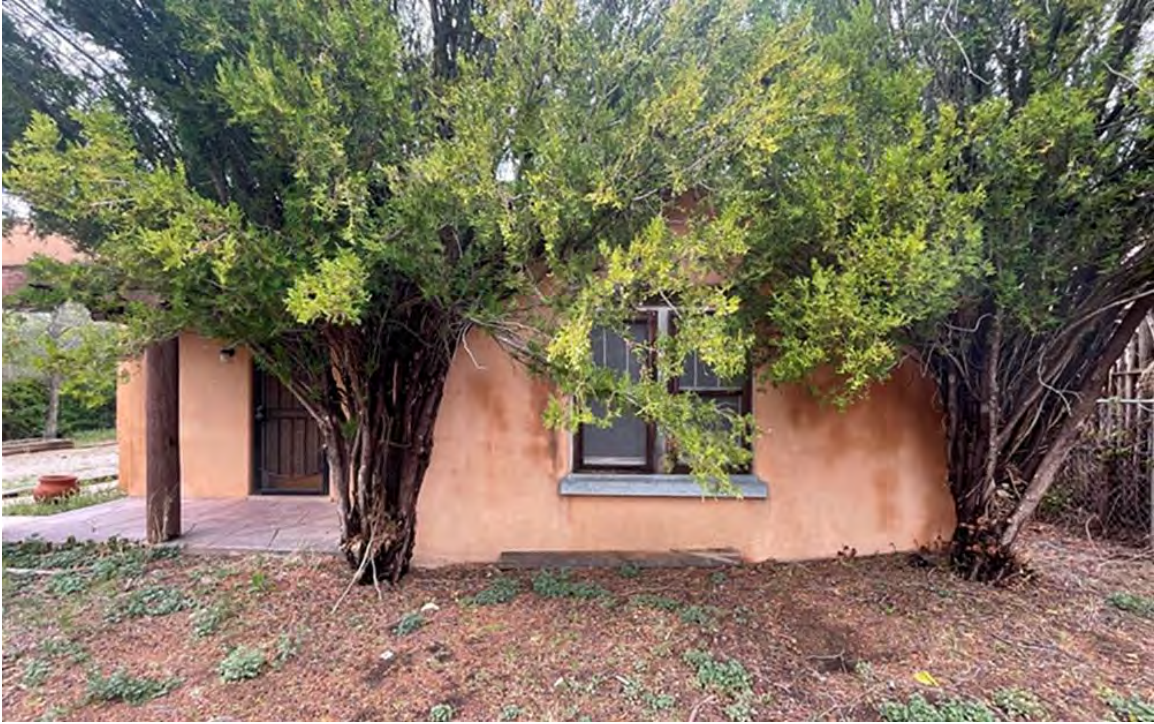
To the east of the entrance, there is an opening fitted with paired wood sash windows, which have a 3/1 configuration and may date back to the original construction (Photos 7 & 8). The windows are covered by a brown-painted screen, and the sill is protected by galvanized metal flashing.

Photo 7: South elevation. Window at bedroom. Camera facing north.

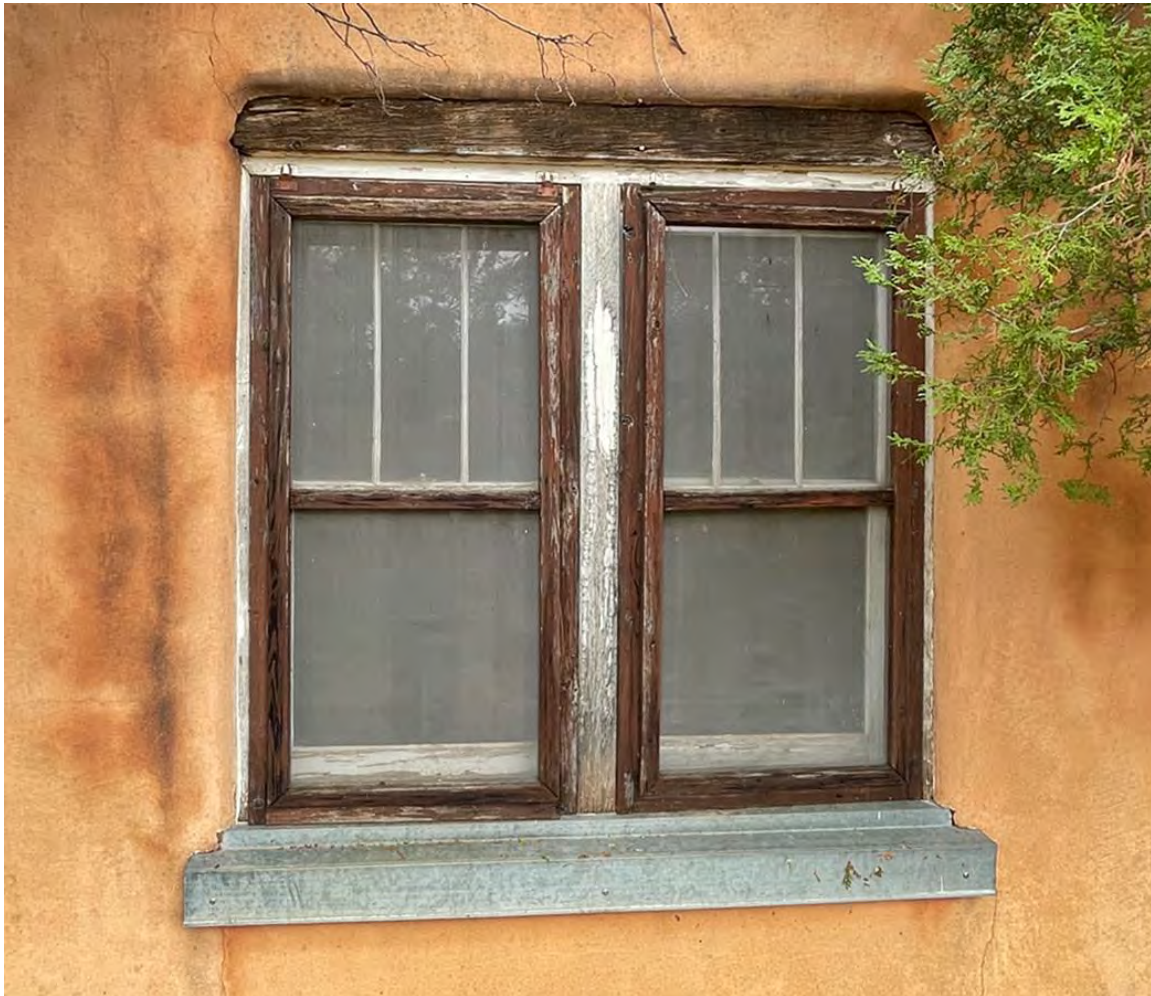
Photo 8: South elevation. Window at bedroom detail. Camera facing north.

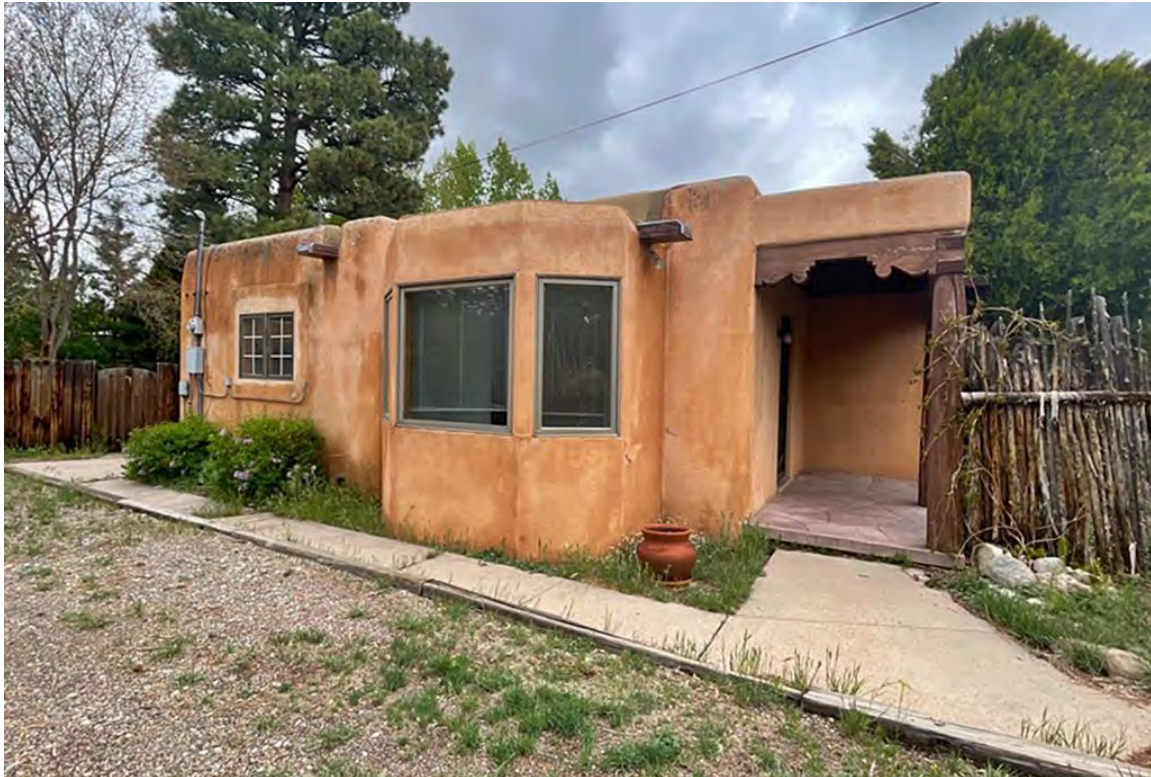
Looking over the driveway, the west elevation also shows alteration, but more dramatically (Photo 9). The change begins at the south end (the original building), with a post-1978 projecting bay window (Photo 10). The three-sided structure pushes out 4’ from the wall and holds three vertical aluminum windows. The structure and its windows are not characteristic of the Pueblo Revival mode of the older portion of the house.

Photo 9: West elevation oblique. Camera facing northeast.

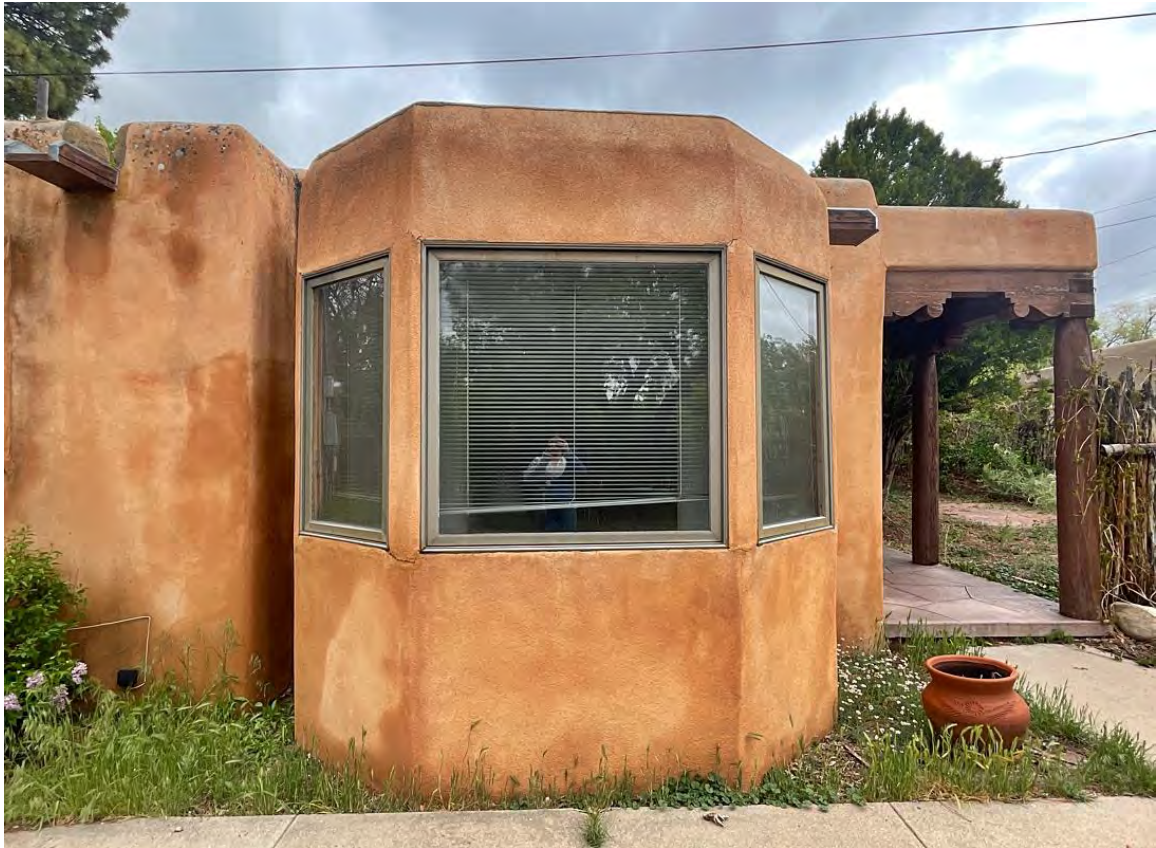
Photo 10: Bay projection. Camera facing east.

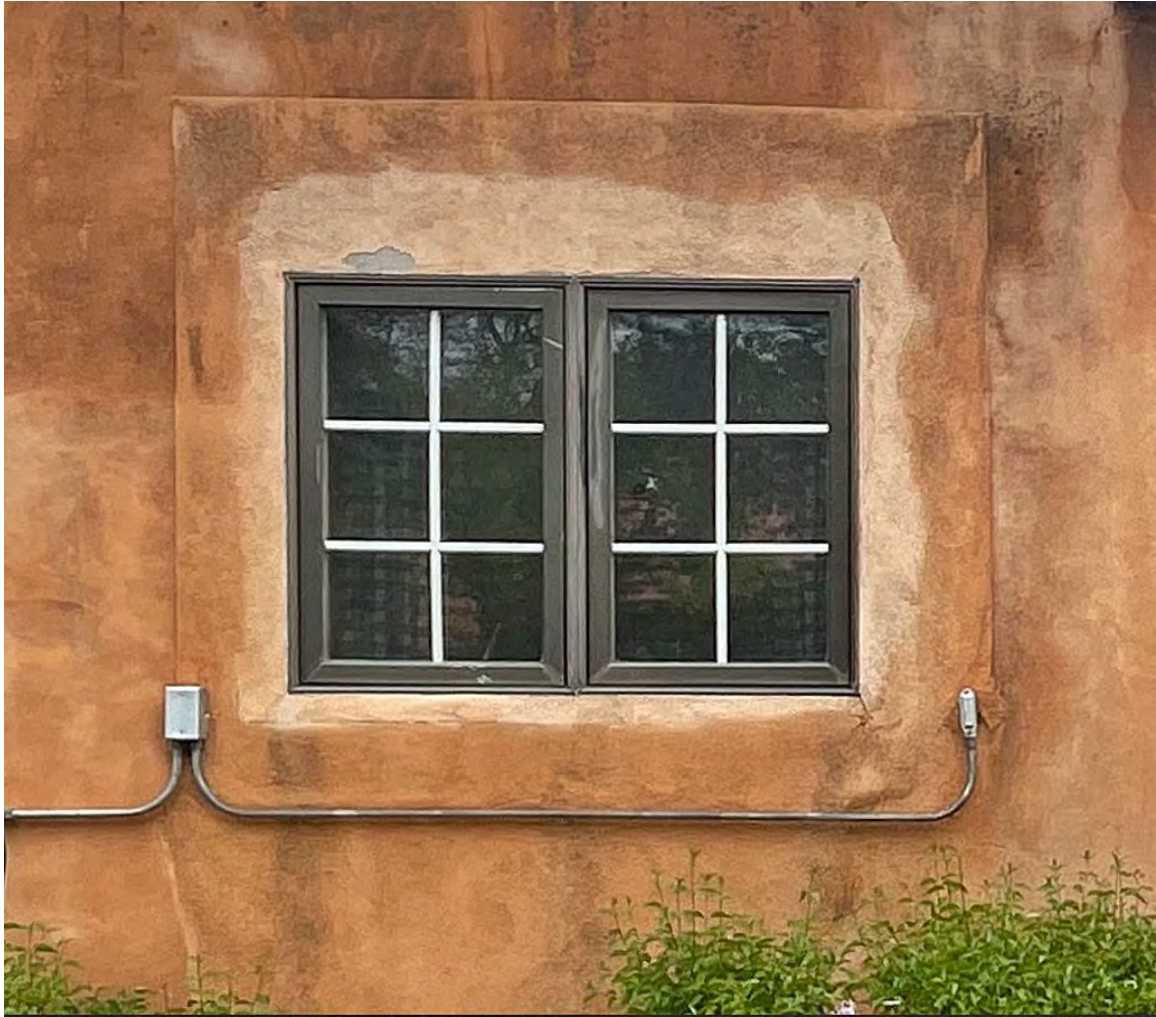
The original portion continues north of the bay window across a projection that historically served to articulate the building’s massing. Centered on this wall is a window opening fitted with non-original casement windows (Photo 11). Its raised surround indicates alteration of an earlier opening. The absence of a sill reinforces the evidence of change.

Photo 11: West elevation. Altered window at kitchen. Camera facing east.

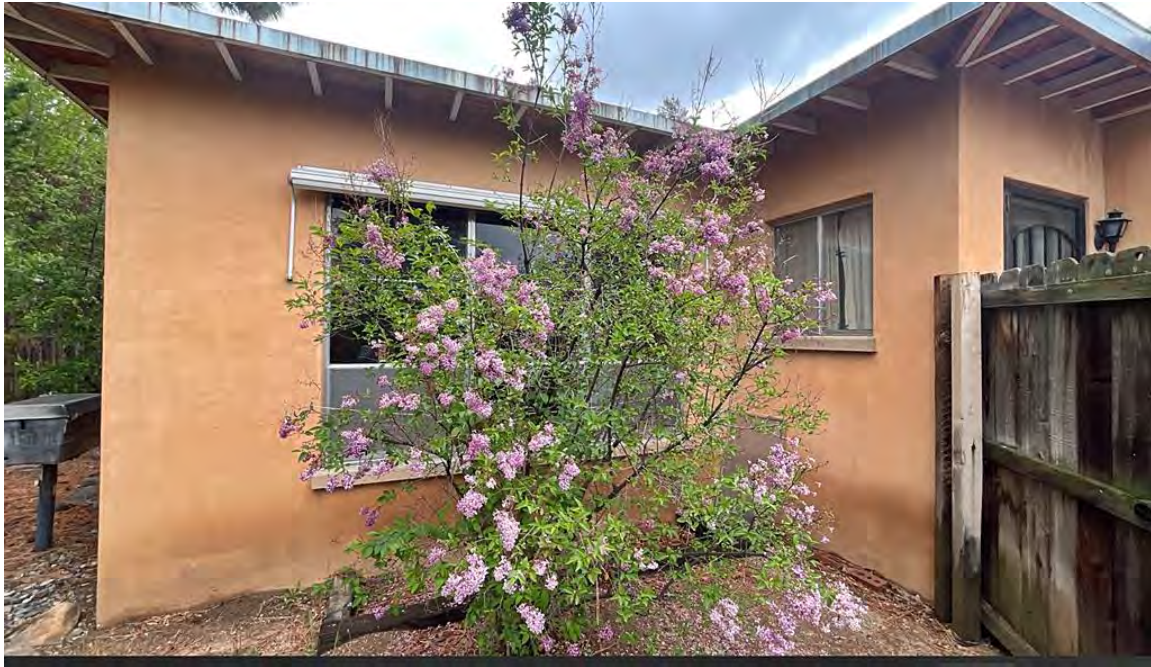
The addition, which houses the primary bedroom, is set back from the original volume through a series of offsets that differentiate it from the earlier construction (Photo 12). Built between 1958 and 1966, it is lower in height and characterized by a low-pitched roof with a plywood overhang and applied fascia — features indicative of midcentury ranch-style design. It sits over a crawl space.

Photo 12: West elevation. Addition. Camera facing southeast.

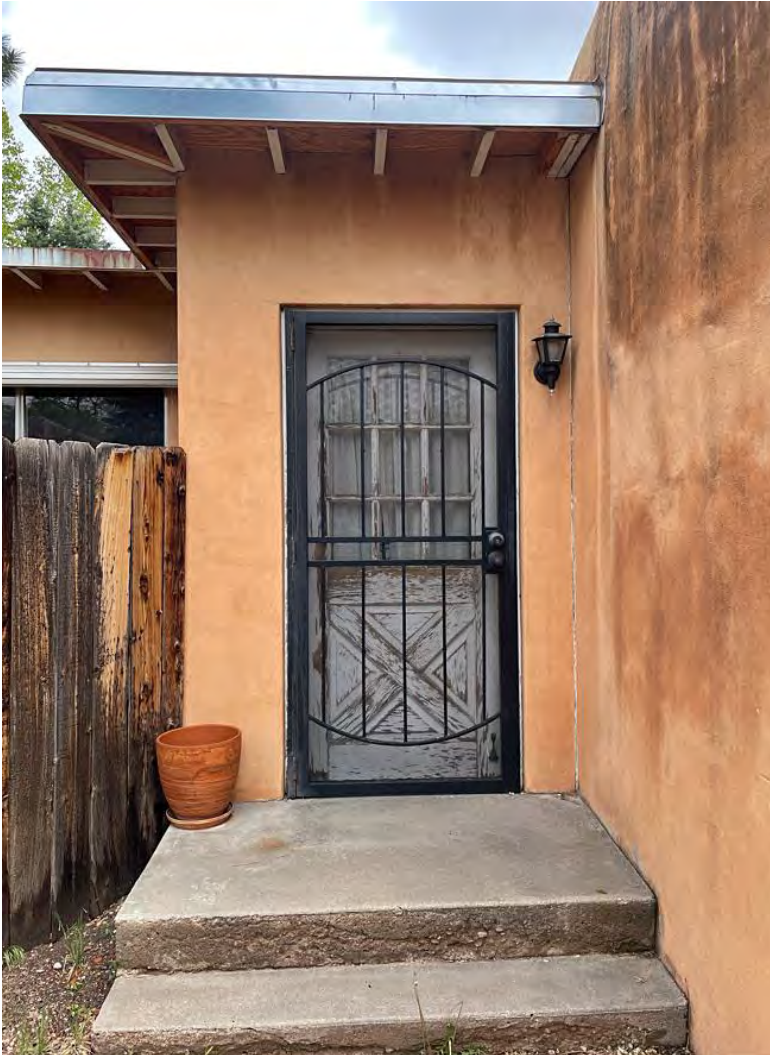
While it shares the stucco finish of the original structure, it makes no attempt to replicate the Pueblo Revival style, instead presenting a distinctly ranch house aesthetic with its aluminum sliding units and window wall. Entry is through a nine-light wood door accessed via two concrete steps (Photo 13).

Photo 13: West elevation. Addition. Detail of entry door.
Camera facing east.

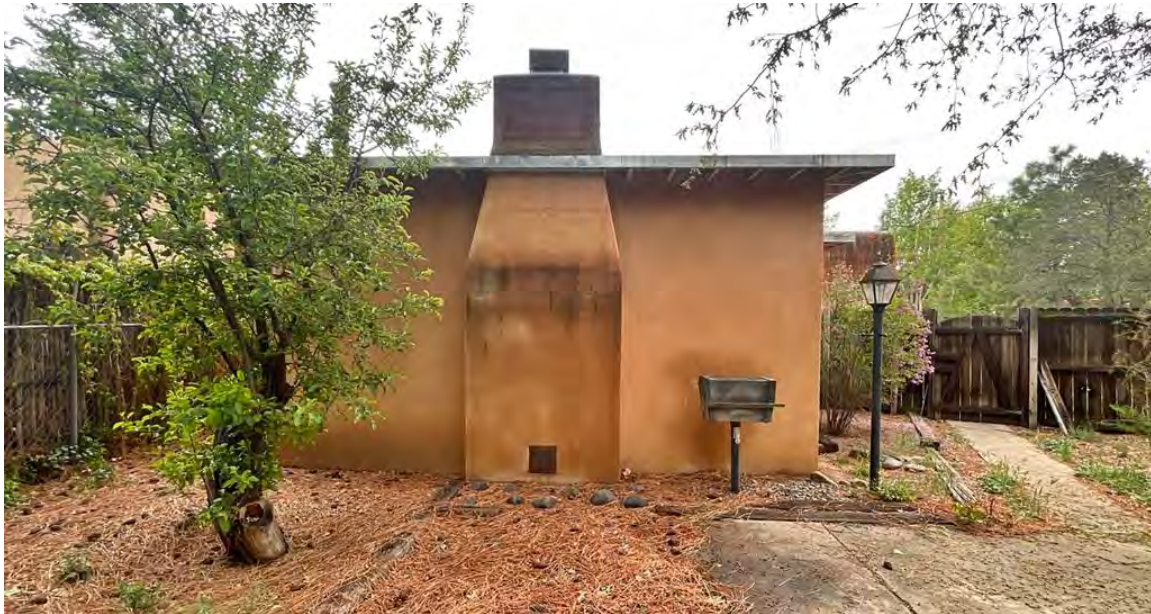
The north side has no fenestration (Photo 14). A boxy stuccoed chimney, breaks through the overhang, rising above the roof with a short, brick chimney stack.

Photo 14: North elevation. Camera facing south.

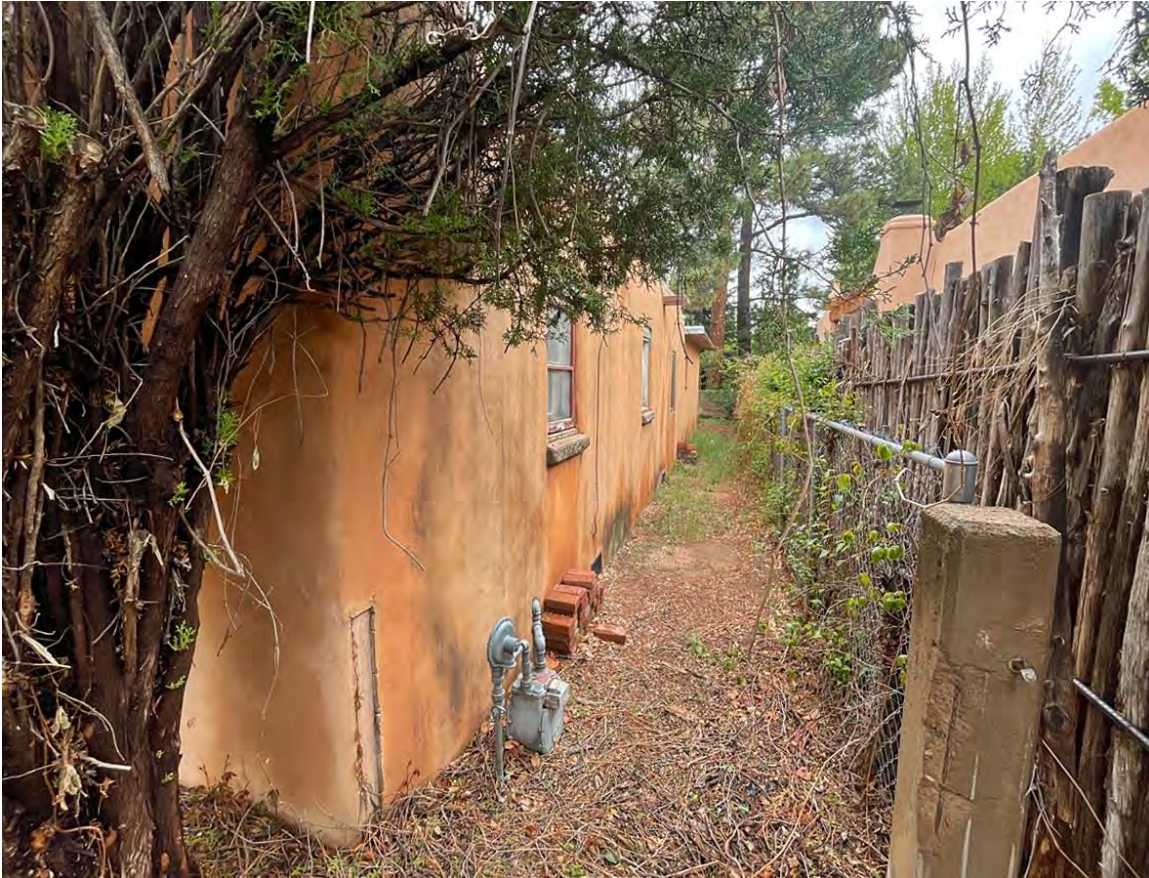
The east side of the building faces what was historically the original owner’s brother’s home. It begins at the south end with the earlier volume, penetrated with two openings with older 1/1 wood sash windows (Photo 15). The older window package has a slanted apron that rests on a precast concrete sill (Photos 16 & 17). The headers have been replaced with concrete blocks, and the wood members are in poor condition. The last window of the original volume has been replaced with a vertical aluminum casement (Photo 19). The 1960s addition takes up the rest of the elevation (Photos 18 & 20).

Photo 15: East elevation oblique from south end. Camera facing northwest.

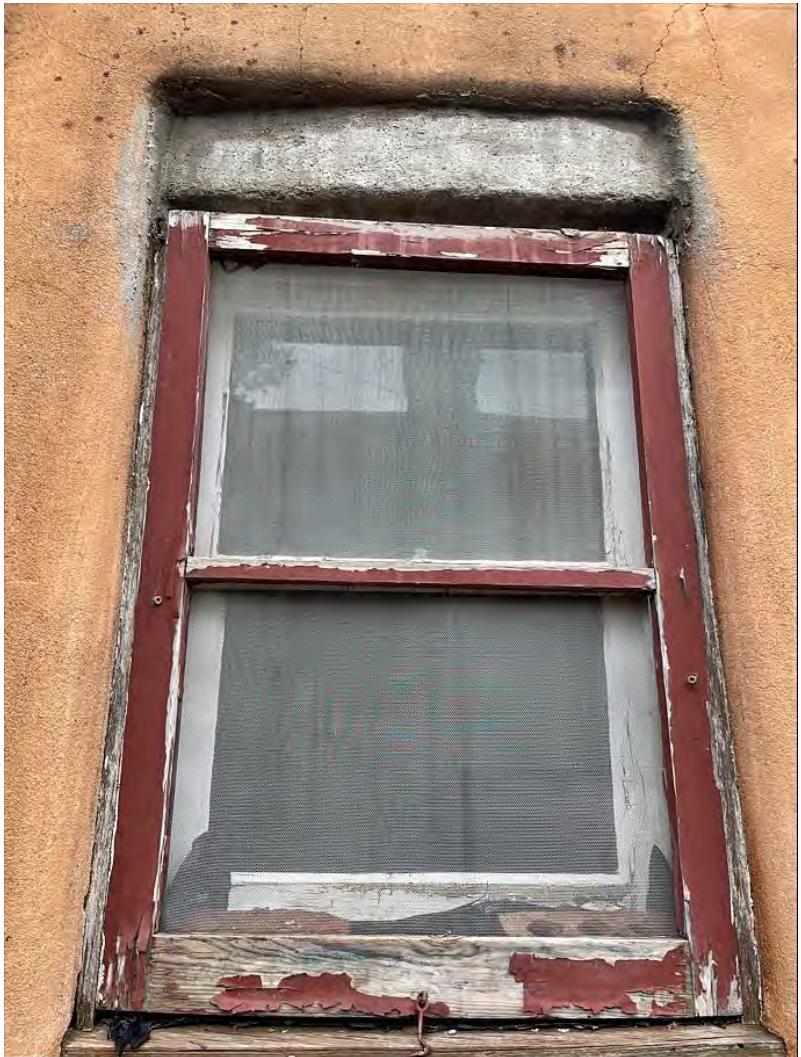
Photo 16: East elevation. Window at bedroom. Camera facing up.

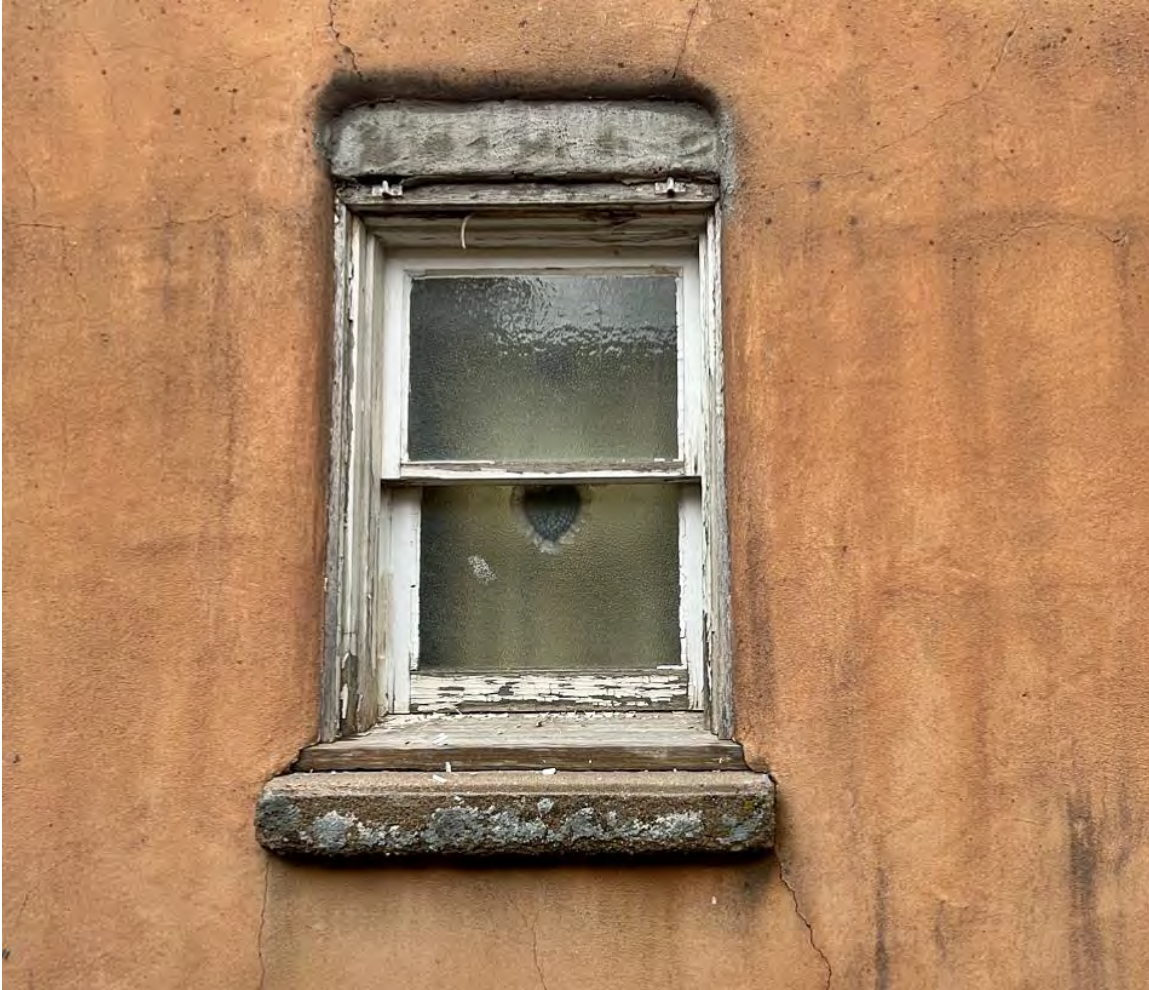
Photo 17: East elevation. Window at bathroom. Camera facing west.

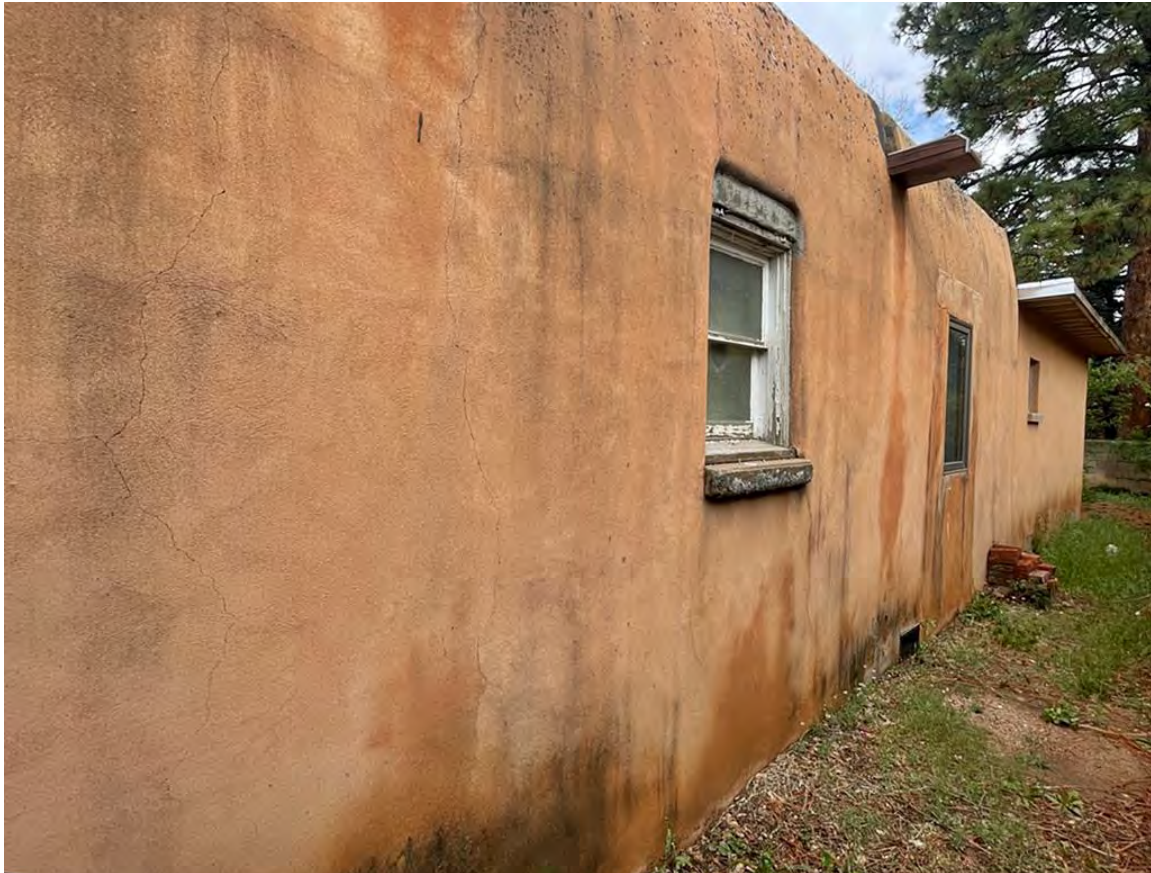
Photo 18: East elevation oblique from midpoint. Camera facing northwest.

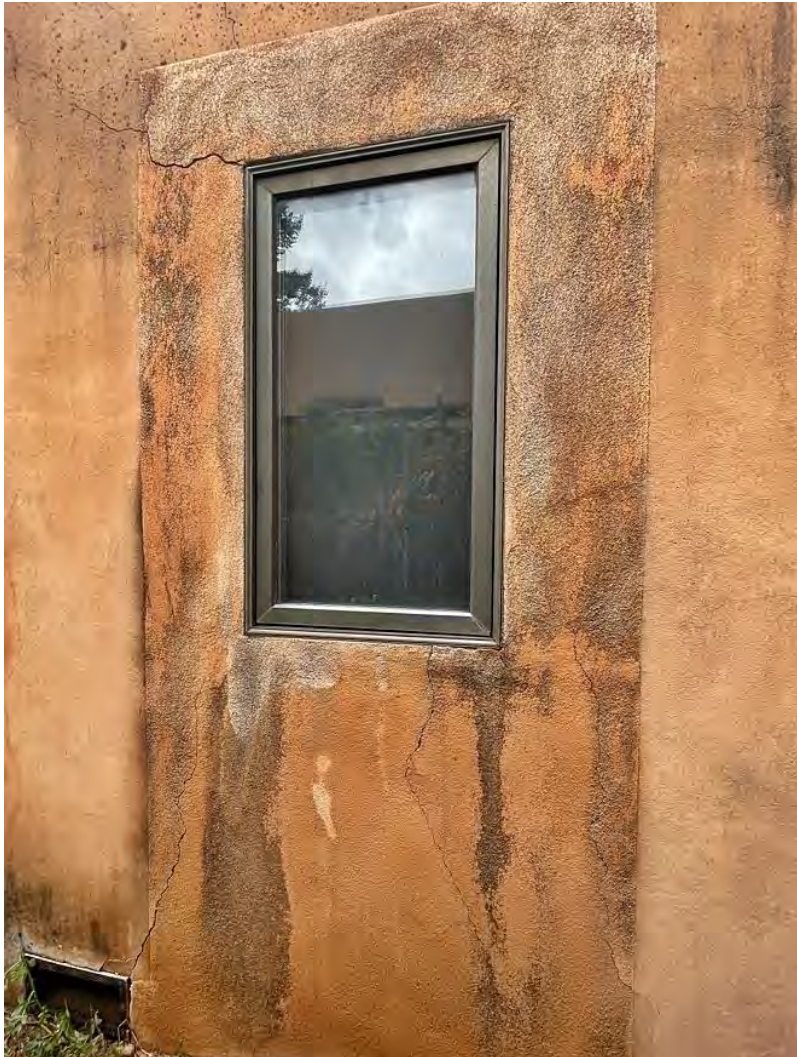
**Photo 19: East elevation. Altered window at bedroom.
Camera facing southwest.**

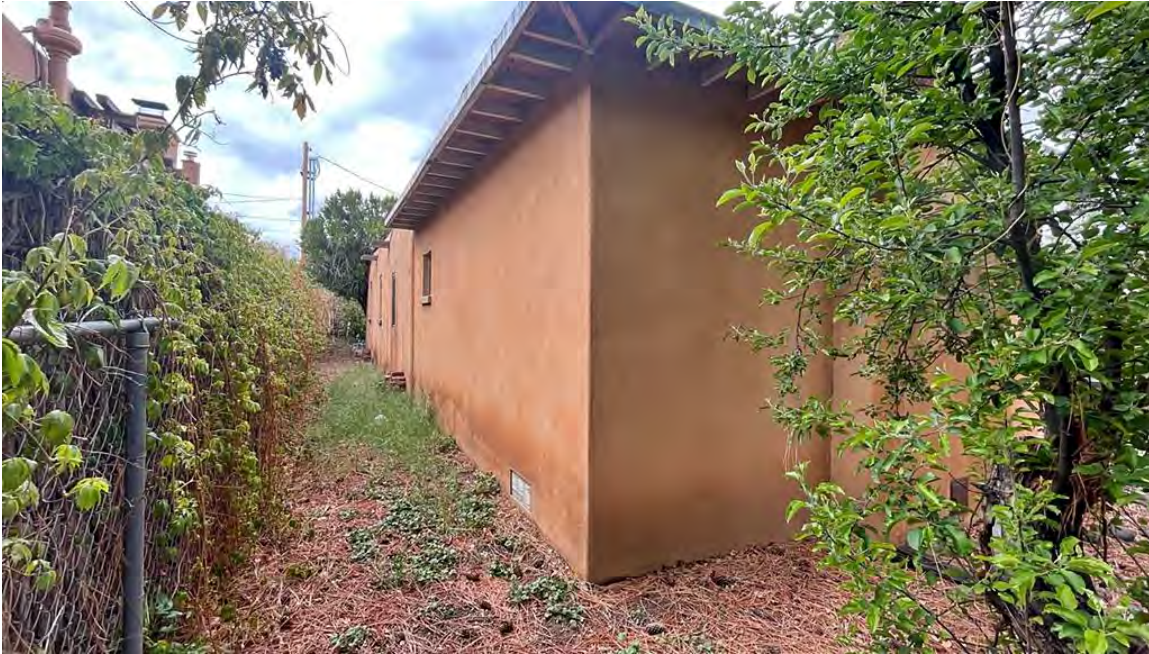
Photo 20: East elevation oblique from north end. Addition in foreground. Camera facing southwest.

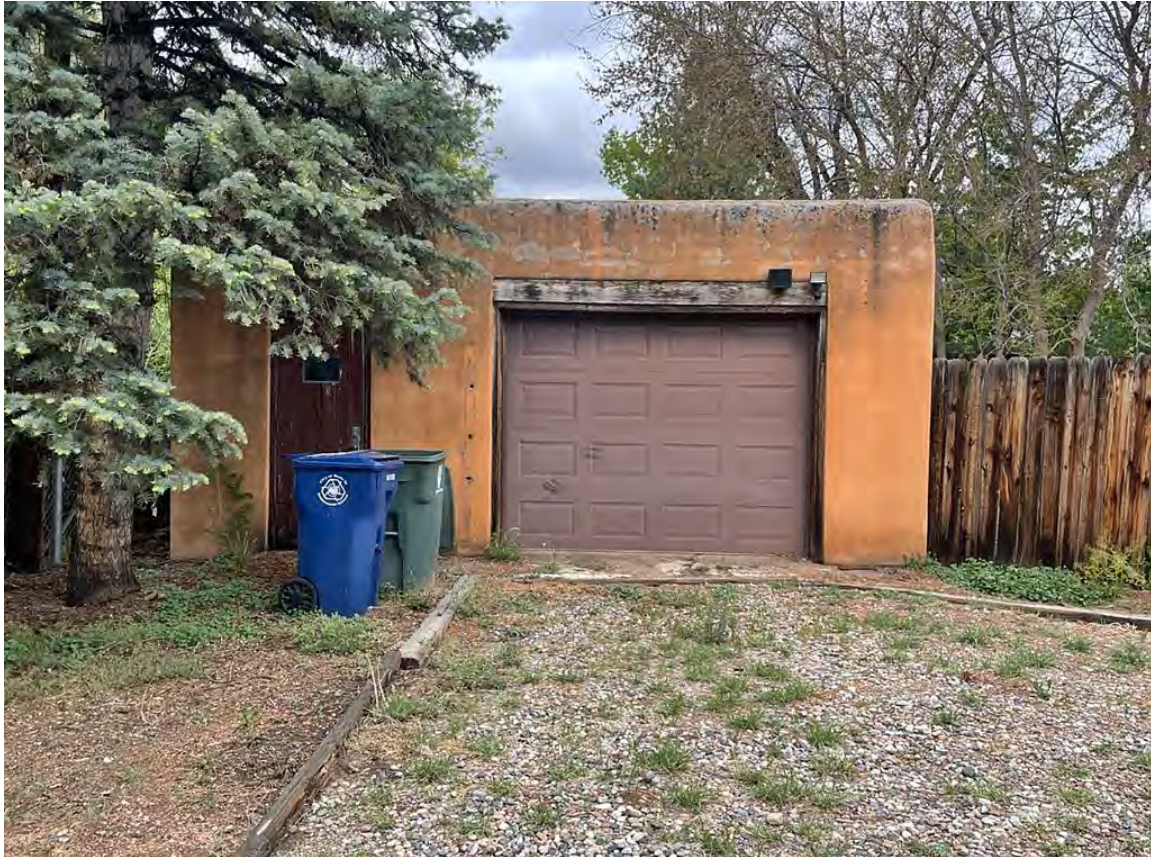
The front façade includes a pedestrian door that provides access to a small workshop area, while the vehicle bay is fitted with a modern retractable overhead door (Photo 21).

Photo 21: Garage. South elevation. Camera facing north.

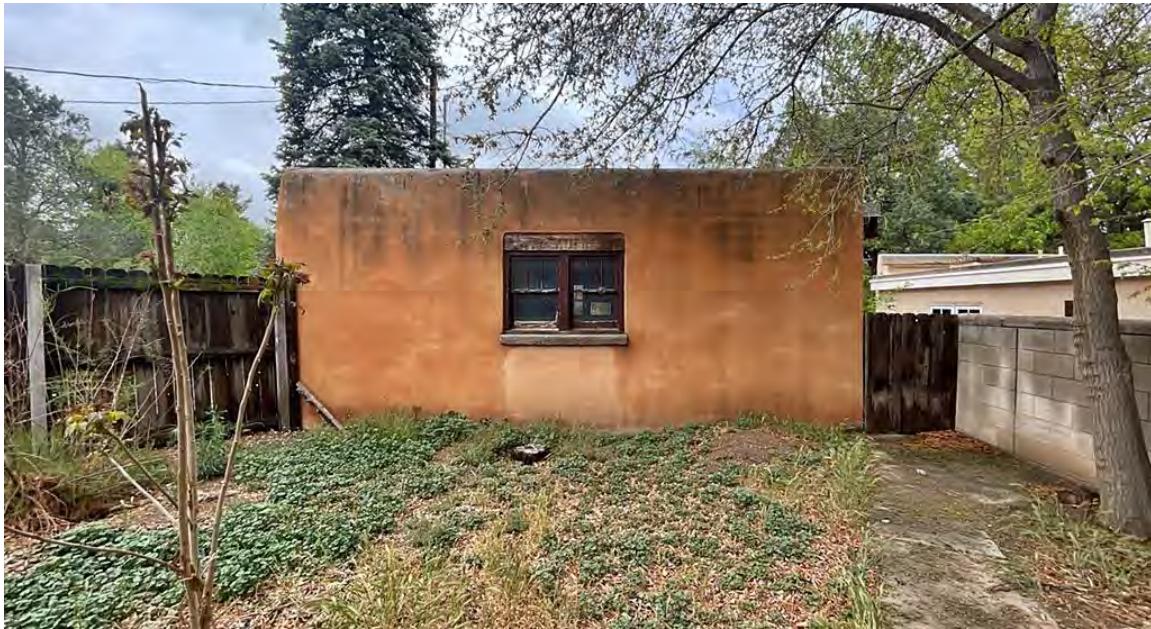
Windows are present on both side elevations. The east elevation contains a pair of 3/1 wood sash windows (Photo 22), framed by a board header shaped to resemble a lintel and set above a cast-in-place concrete sill. A similar arrangement of 1/1 sash windows is found on the west elevation (Photo 23).

Photo 22: Garage. East elevation. Camera facing west.
