Historic Cultural Properties Inventory (HCPI) Base Form (FORM 1)

1. Name of property: Juan and Simona/ Stella and José Salazar/ Christina Ertner House	2. Location: 539 Garcia Street Downtown and Eastside Historic District – Santa Fe	3. Local Reference Number: Santa Fe ID: N/A 4. County: Santa Fe Parcel # 12382336

8. Name of Project: HDRB Status Evaluation		
9. Lat/Long: 35.6787977,-105.9345982		
10. Photo Information: Giulia Caporuscio, photographer, May 7, 2025. Photo 1: View of west elevation. Camera facing east.

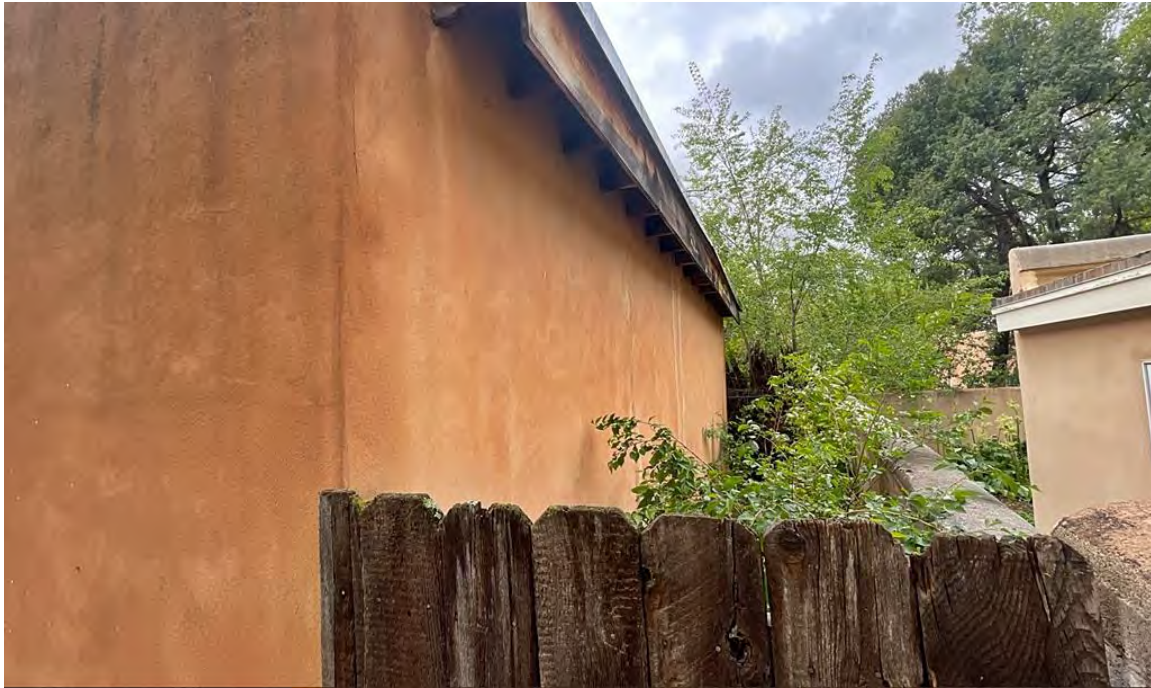
The north elevation is unfenestrated and has an overhanging eave fitted with a gutter (Photo 24).

Photo 24: Garage. North elevation. Camera facing west.
