City of Santa Fe, New Mexico

memo

2025-010506-HDRB, 626 Canyon Rd., Downtown & Eastside Historic District, Contributing, Martinez Architecture Studio, agent for Santa Elena Properties, LLC, owner, requests status review and primary façade designation.

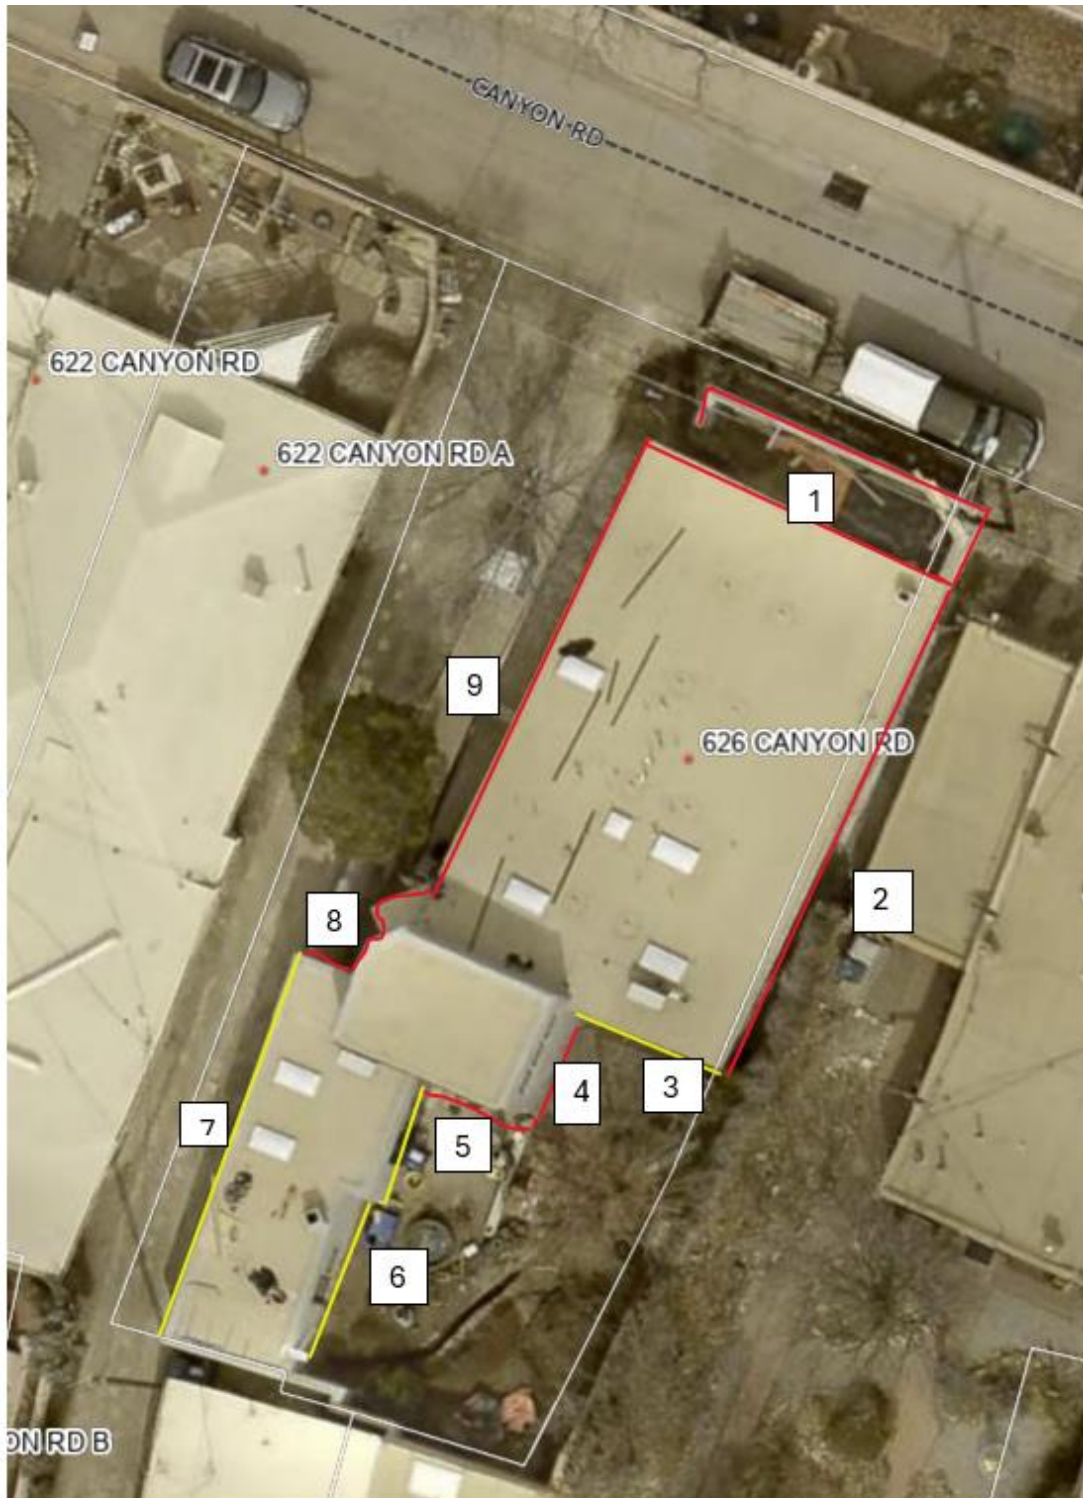
Façade Diagram

Façade 1- Retains historic character at the with low pitched roof, and centered octagonal fixed window.

Façade 2- Original adobe, older wood casements windows

Façade 4 & 5- Showcase the studio that was built by artist Andrew Bacigalupa, 2 story, high windows for good lighting

Façade 8- Features, Stain glass stairwell window, of the 1958 Studio addition.

Façade 9- Nicho and divided lite windows.

Staff recommends the historic status of the structure be maintained as contributing, per section 14-5.2(C)(2) Designation of Significant, Contributing or Non-contributing Status Within Historic Districts, with facades 1,2,4,5, 8 and 9 as primary. Staff recommends the front yard wall be designated as contributing.

- a. In case 2025-010506-HDRB 626 Canyon Rd., the board moves to retain the structure as contributing, designate facades 1,2,4,5,8 and 9 as primary, per the façade diagram, and designate the front street facing yard wall as contributing.
