City of Santa Fe, New Mexico

memo

2025-010871-HDRB, 439 Camino del Monte Sol, Downtown and Eastside Historic District, Contributing, Craig Hoopes, agent for Chris Greulich and Matthew Boland, owners, request status review with primary façade designation(s) if applicable.

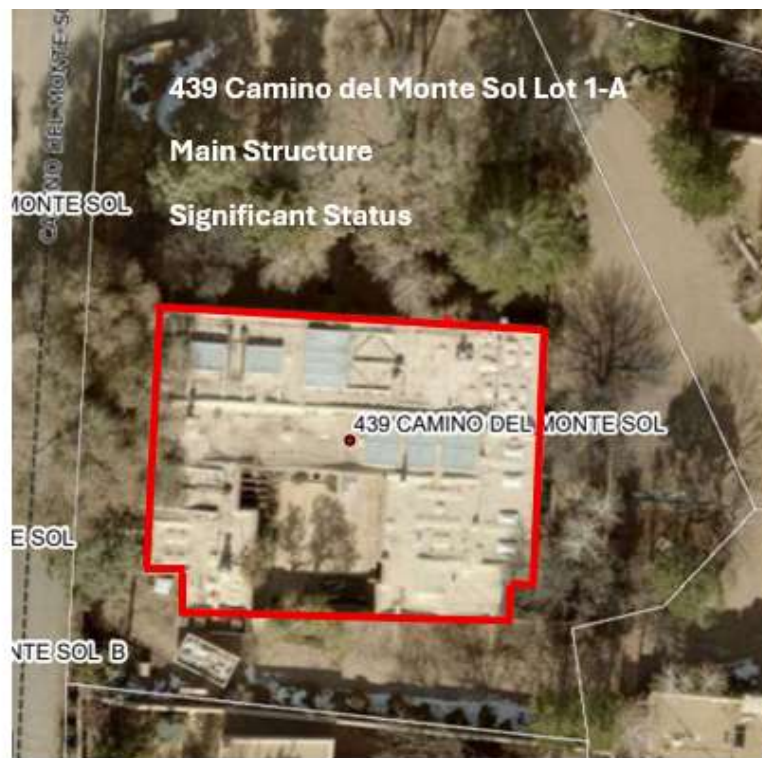
Figure 1: Proposed Façade Diagram for Significant Status at 439 Camino del Monte Sol.

Primary Façade: —————

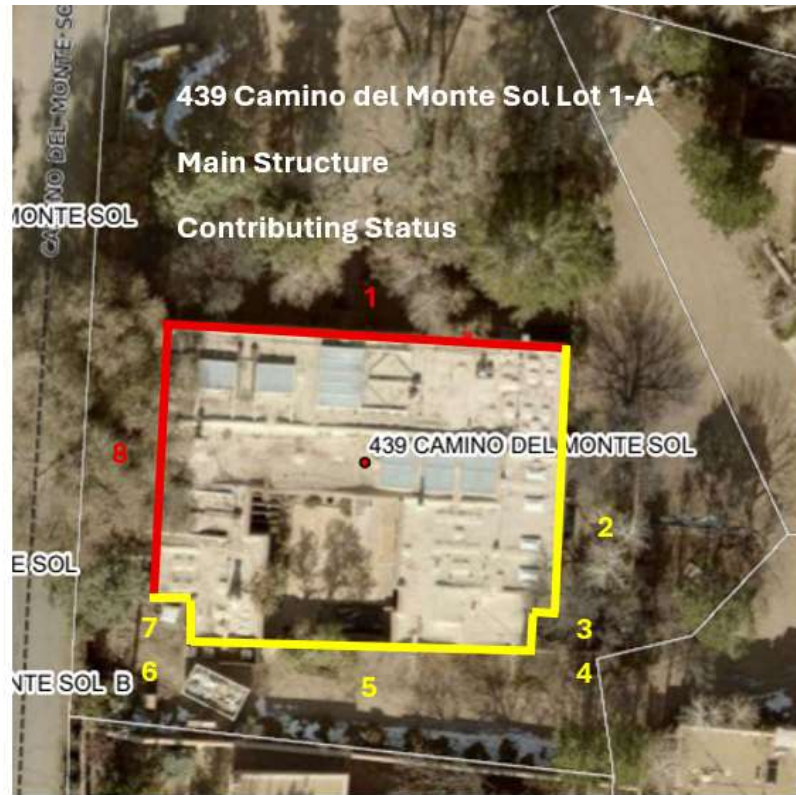
Figure 2: Proposed Façade Diagram for Contributing Status at 439 Camino del Monte Sol.

Primary Façade: ———

Non-primary Façade: ———
