City of Santa Fe, New Mexico

memo

2025-010869-HDRB, 516 and 516 ½ Alto St., Westside Guadalupe Historic District, Contributing, Marc Naktin, agent for Steve Dayton, owner, requests status review with primary façade designation(s) if applicable.

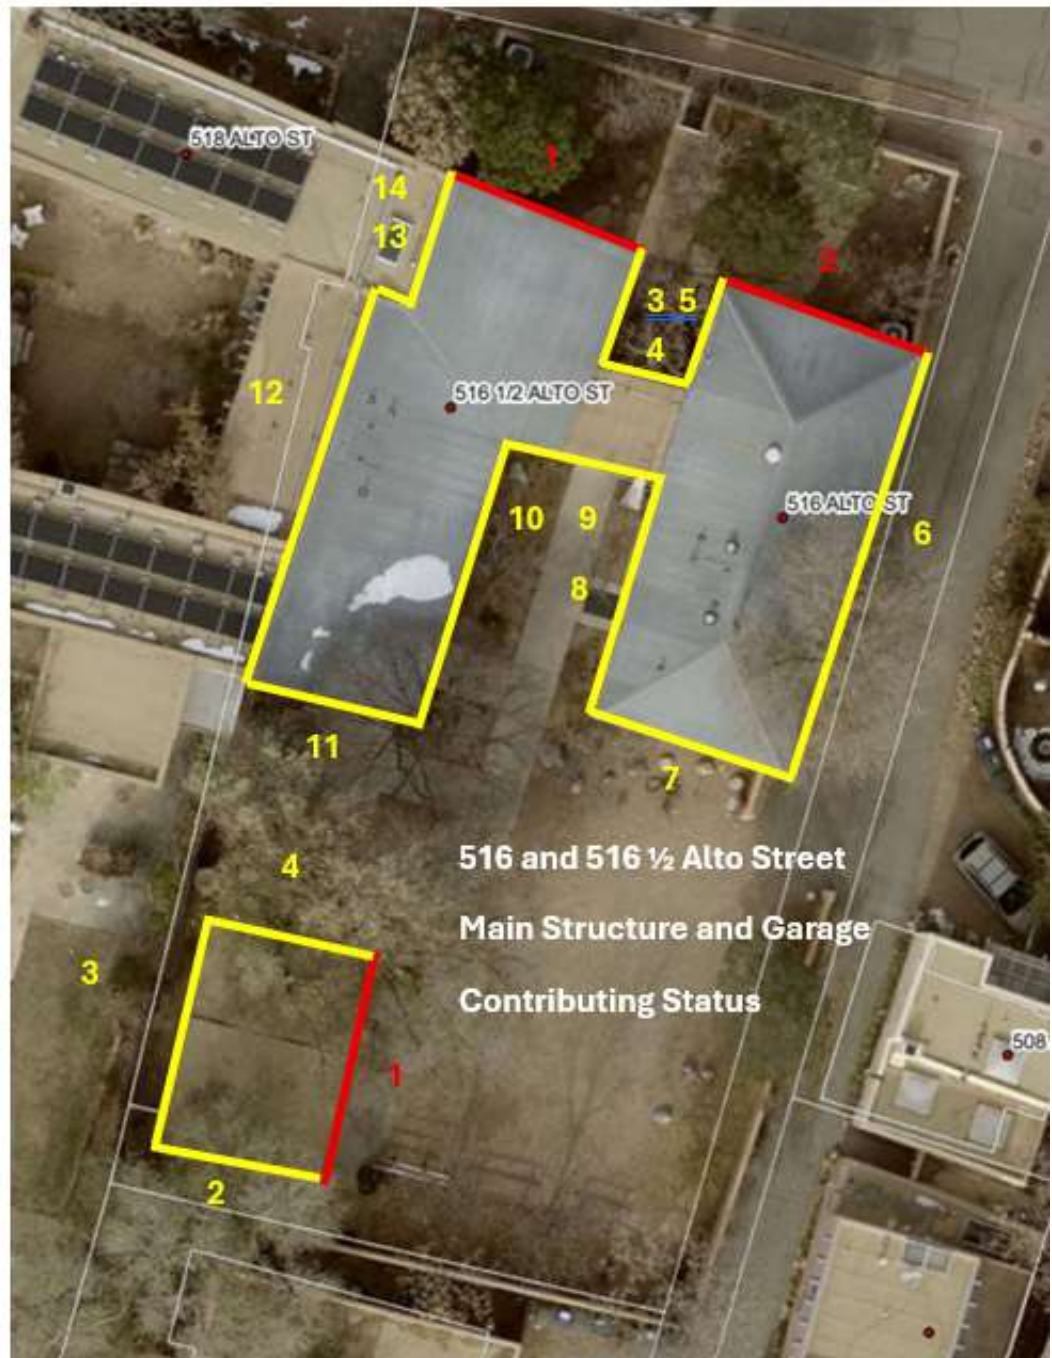
Figure 1: Proposed Façade Diagram for 516 and 516 ½ Alto Street.

Primary Façade: ———

Non-primary Façade: ———

Staff recommends the historic status of the main residential structure be maintained as contributing and the north elevation be designated as primary identified in the Proposed Façade Diagram as numbers one and two and the stand-alone garage retain its contributing status with the east elevation designated as primary identified in the Proposed Façade Diagram as number 1, per 14-5.2(C) Designation of Significant, Contributing or Noncontributing Status Within Historic Districts.
