Historic Cultural Properties Inventory (HCPI) Detail Form (FORM 2)

1. Name of property: 127 Duran Street, Rear House Guadalupe and Simonia Chavez House Martha J. Baca House	2. Location: 127 Duran Street (Rear) Westside-Guadalupe Historic District - Santa Fe	3. Local Reference Number: Santa Fe ID: Old # 051613057 4. County: Santa Fe 5. Date of Survey: November 24 & 25, 2024																																	
ARCHITECTURAL AND CONSTRUCTION DETAILS:

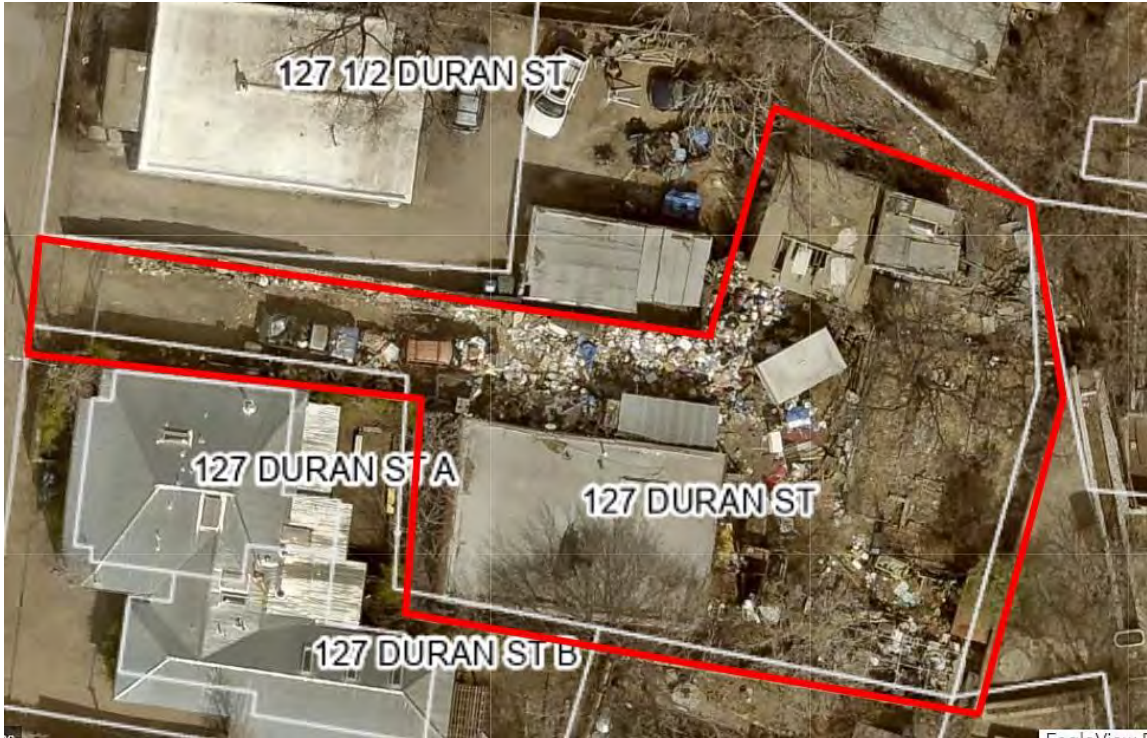
16. Additional Perspective: (Photos, drawing, footprint, etc., indicate north arrow when possible)

Source: Office of the Santa Fe County Assessor
parcel lines are not accurate; above interpretation made by author based on fence lines, etc; see Field # 19, survey plat.

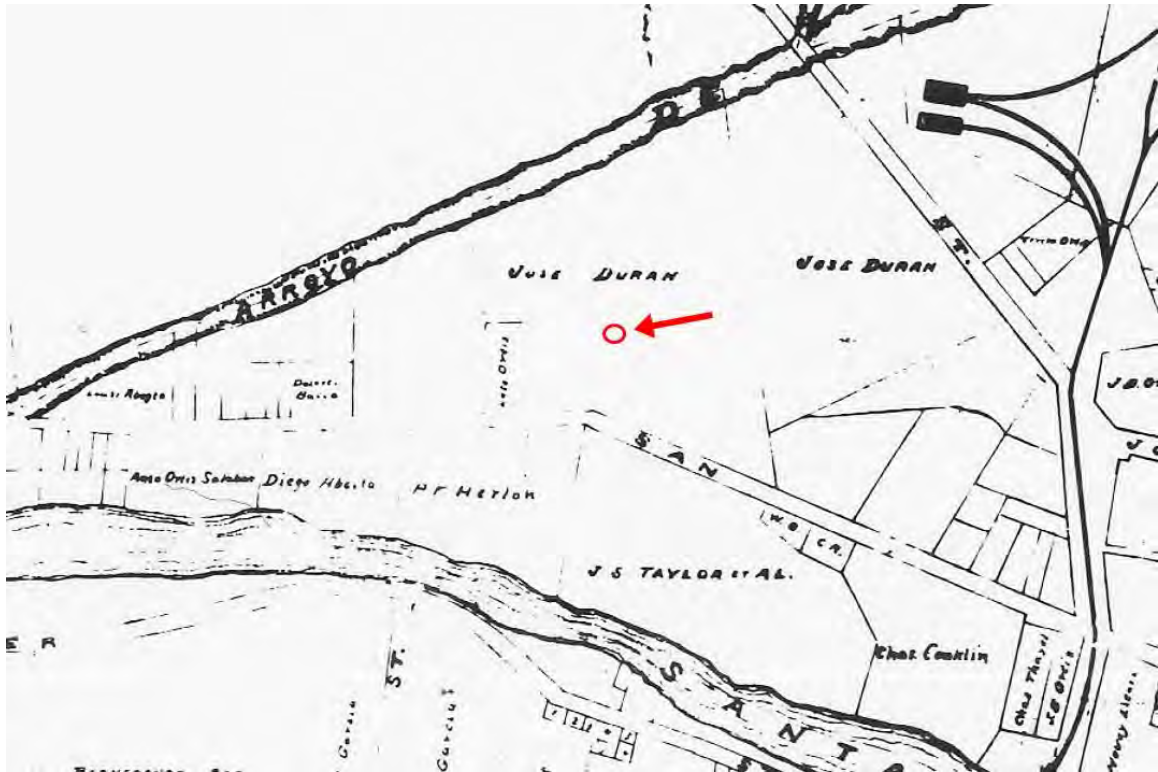
Figure 1: P. C. Gaynor, "Map of Santa Fe," 1892.
Circle indicates the approximate location of current house.

An extension of the railroad tracks made in 1887 had lopped off the area from the city, giving it a separate identity. Farm fields surrounded San Francisco Street west of the railroad, similar to what was shown on Joseph de Urrutia’s map nearly 150 years earlier. According to the 1892 Gaynor map, the Ortiz and Duran families owned much of the land north of the street (Fig. 1).

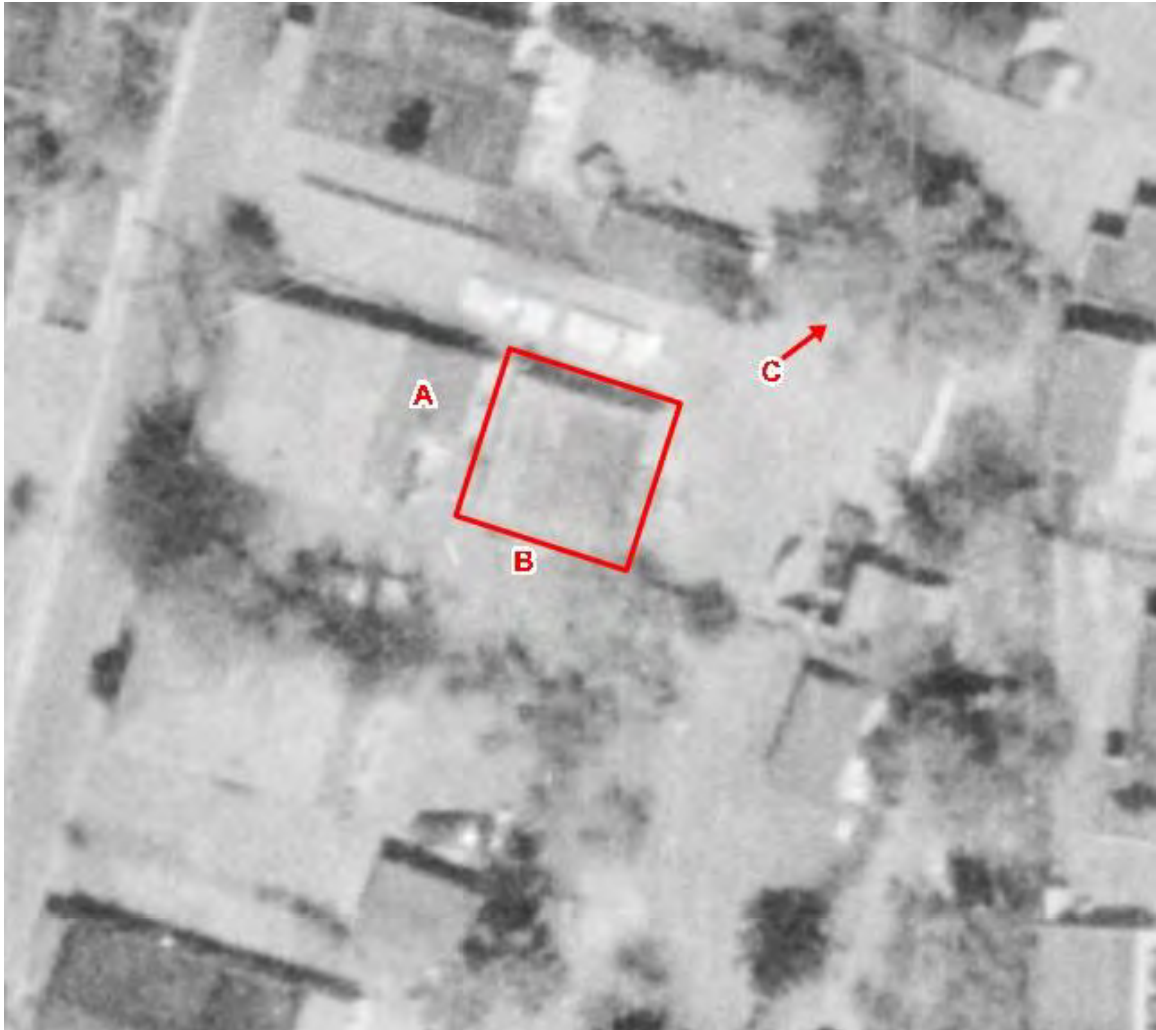
Figure 3: May 6, 1966, aerial photograph.
A. Structure located between front house and subject house; B. subject house, note square footprint; C. note absence of shop.

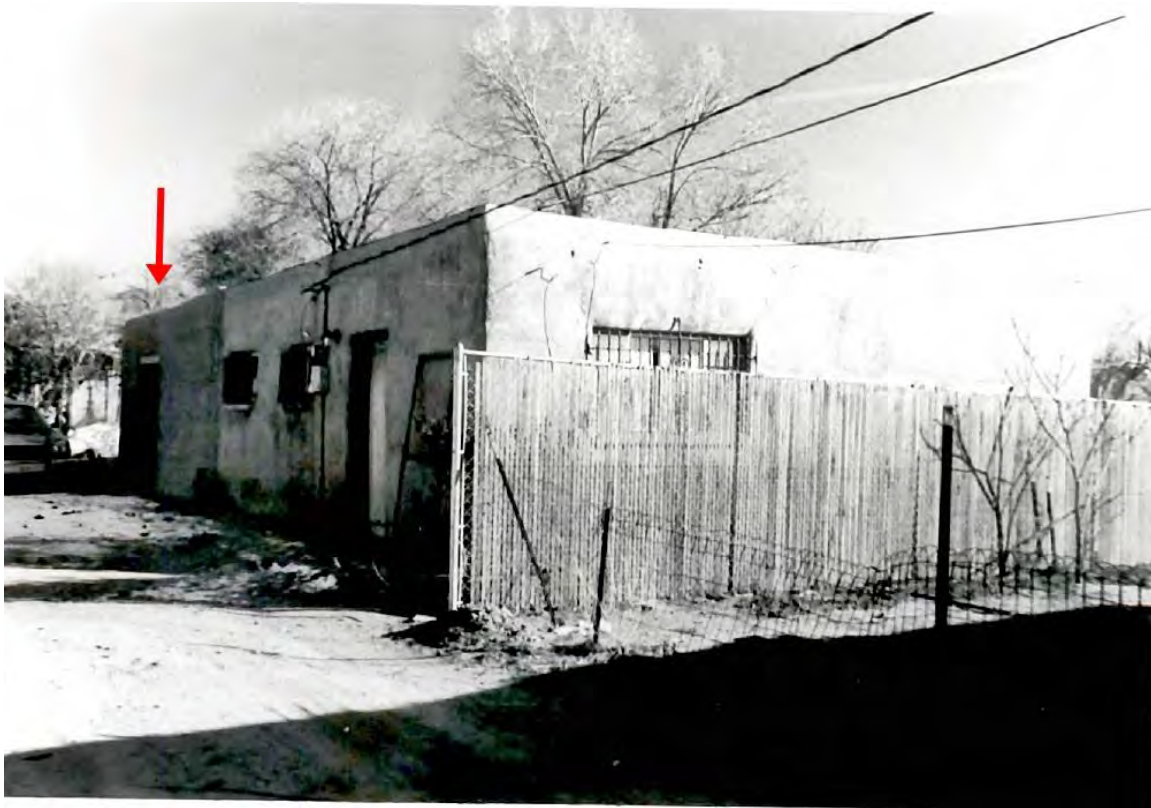
Figure 5: August 1985 HBI survey. The arrow indicates 1980s east addition. Susan Lopez, photographer. Courtesy of NMCRIS.

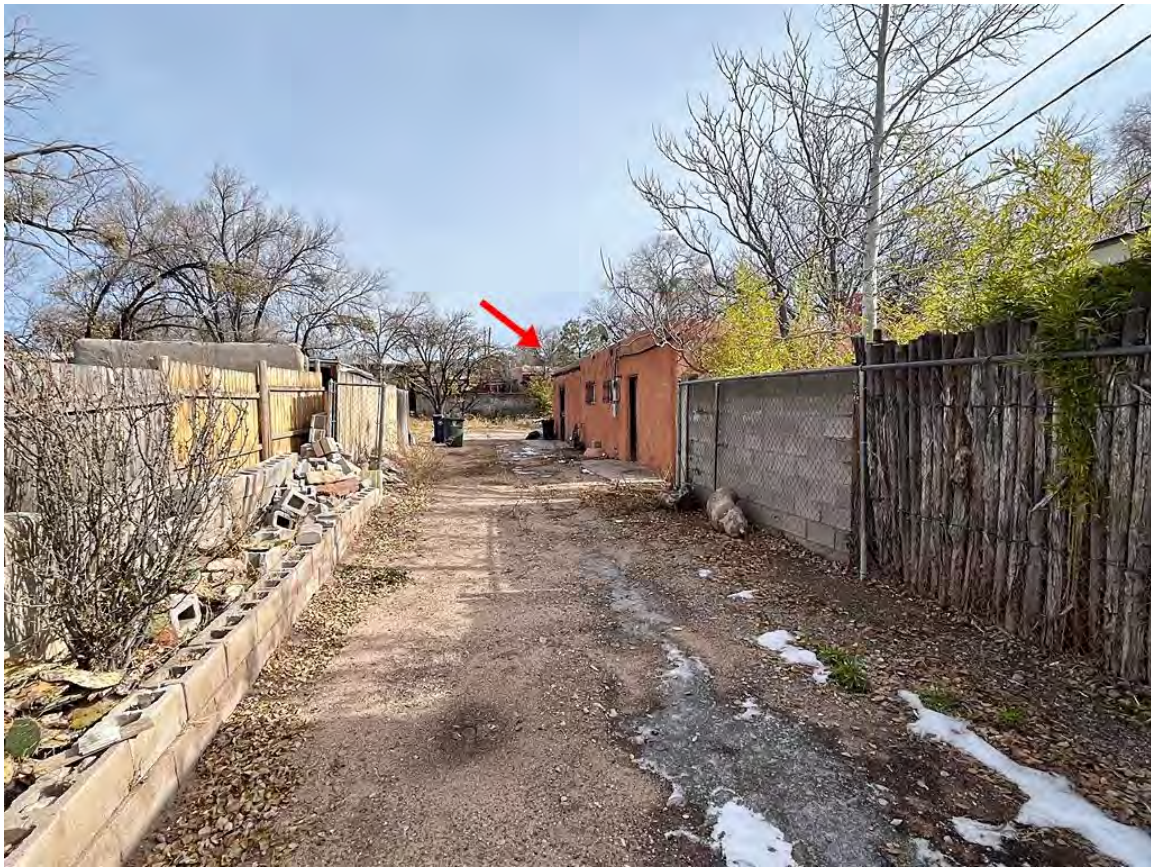
Photo 2: View of property from near the west end of the driveway. Subject house highlighted by arrow. Camera facing east.

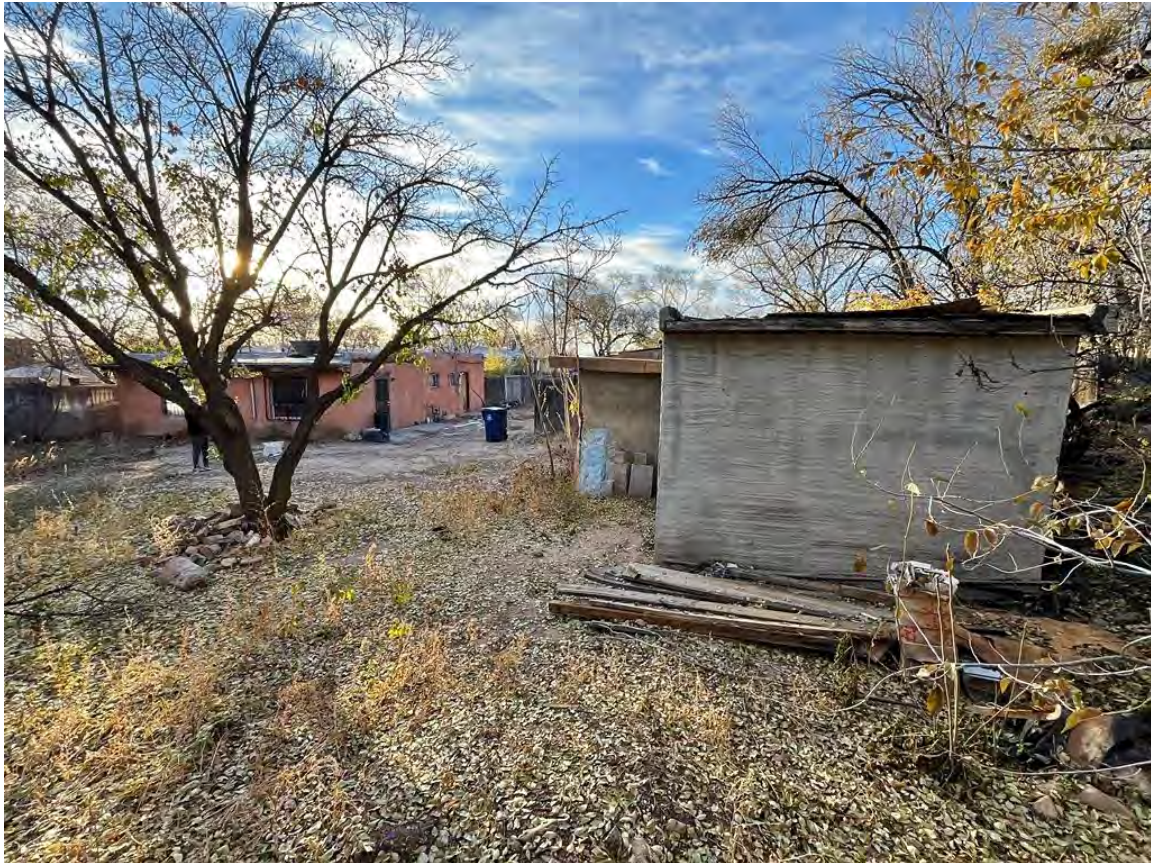
Photo 3: View of property facing southwest. Non-historic shop at foreground right.

Following the original survey, the recommendation is to maintain Non-Contributing status. The house holds little architectural or historical significance. In addition, the 1985 extension increased its footprint by 34%. The shop and its addition appear to postdate 1978 and are poorly constructed.

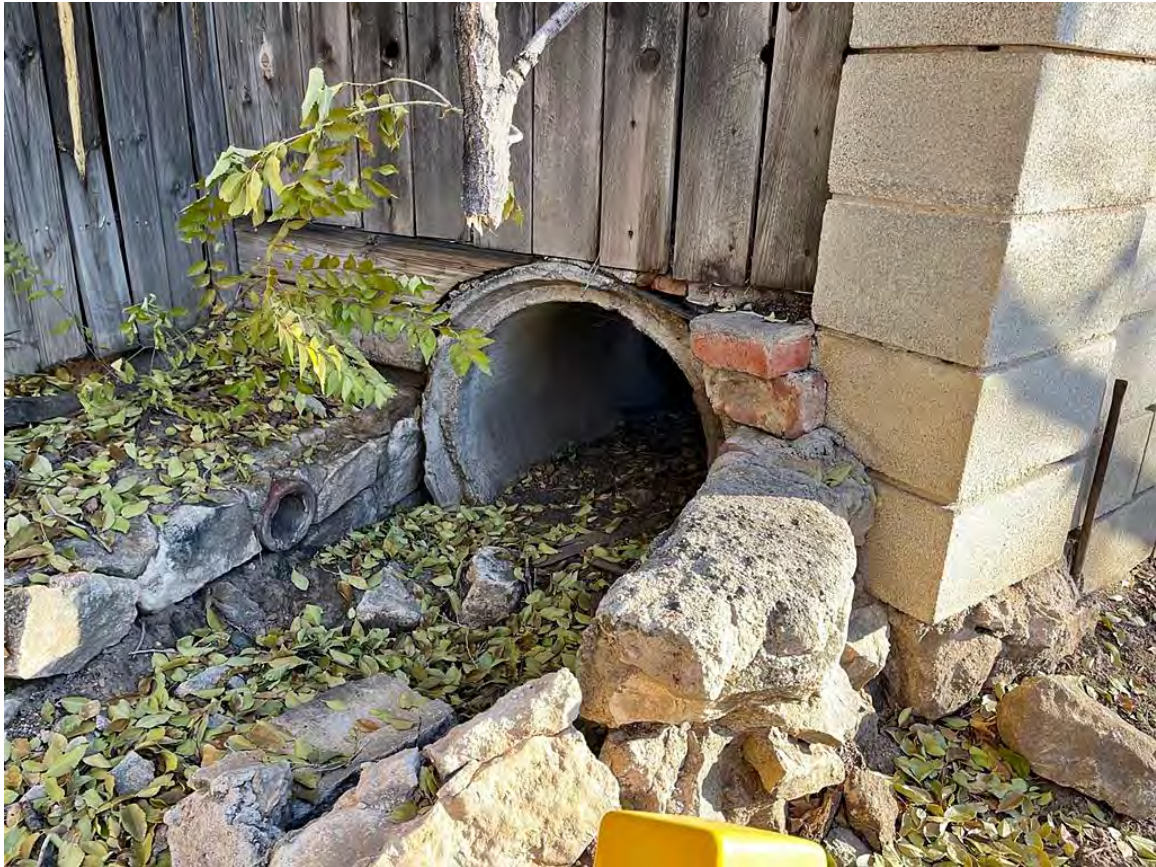
Photo 4: Assumed acequia segment tracing east side of property. Camera facing southeast.

The property includes a post-1978 concrete block shop and storage room, both of which are of substandard construction. Once used for farming, the level lot has two mature apricot trees and several invasive ailanthuses. There is no formal landscaping. A relict acequia, thought to be part of the *Acequia Publica*, courses across the east edge of the property (Photo 4).

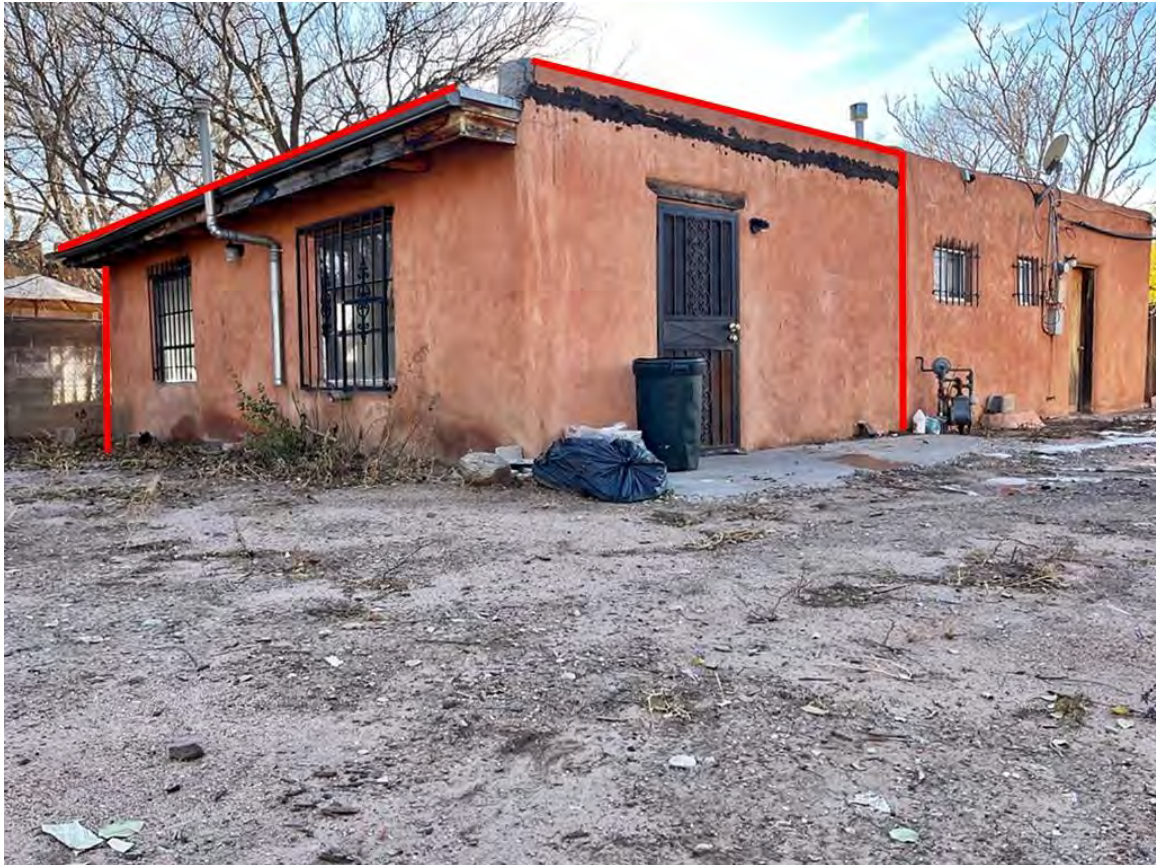
Photo 5: East and north elevations. 1980s addition outlined in red. Camera facing southwest.

The building faces north with mostly a blank façade (Photos 1 & 5). The west half is the earlier constructed dwelling, consisting of four rooms. Separated by an expansion joint is the 1980s addition holding a dining room and living room (Photo 5). The west side is constructed of adobe and rests on a low foundation, though it is too low to be considered a crawl space. Its walls are roughly 12” thick. The construction of the addition is unclear.

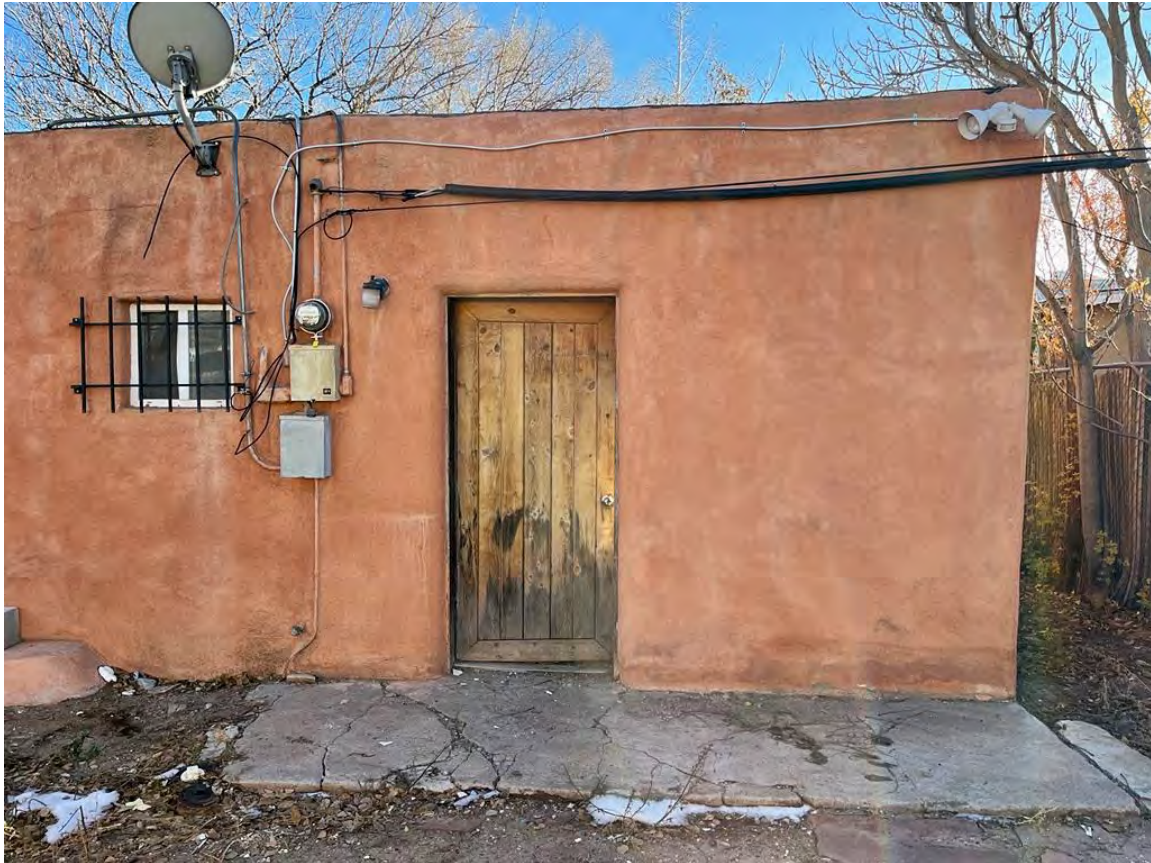
**Photo 6: North elevation representing the northwest room of the original core.
Camera facing south.**

Beginning at the west end is a non-historic faux plank door (Photo 6). Next, still representing the original core, are sliding vinyl windows at the bathroom and kitchen (Photo 7). These windows, like the rest of the units along the portion of the building, are set 3½” to 4½” deep into the wall.

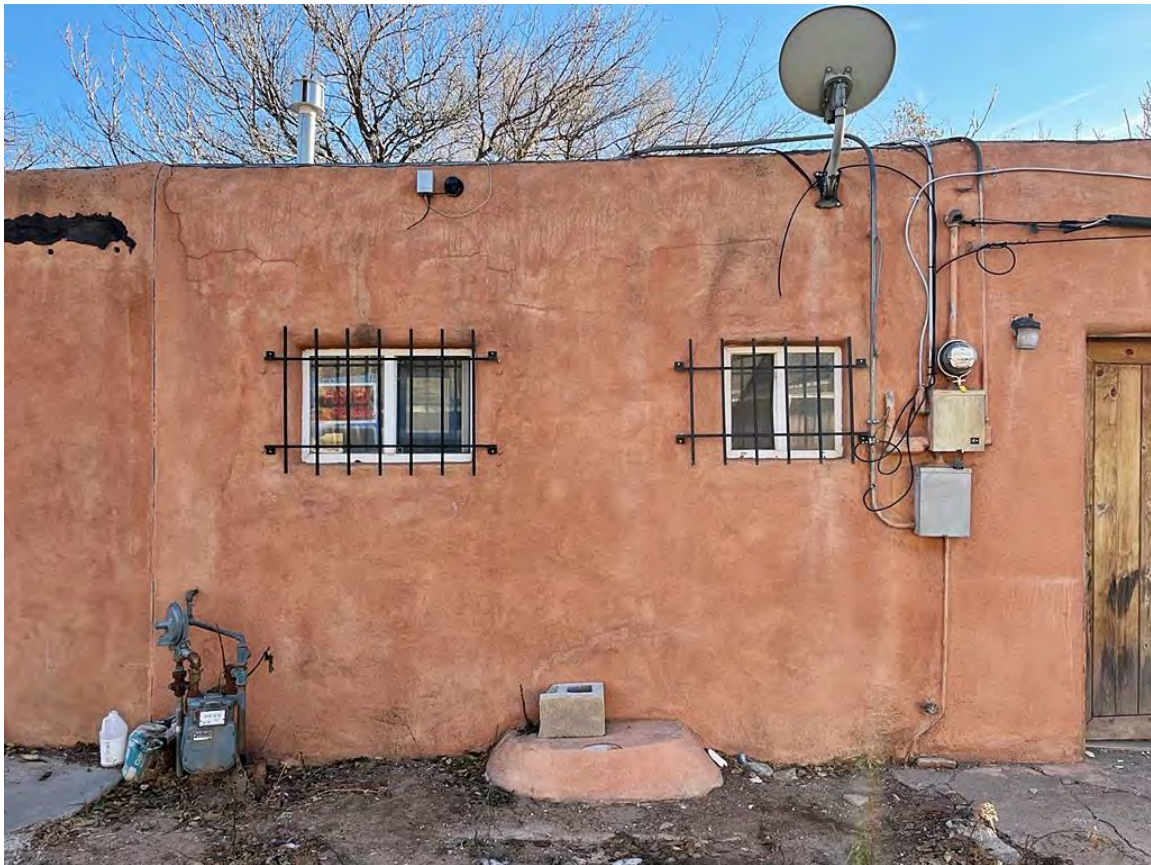
Photo 7: North elevation fenestration representing the kitchen (left) and bathroom (right) of the northeast room of the original core. Camera facing south.

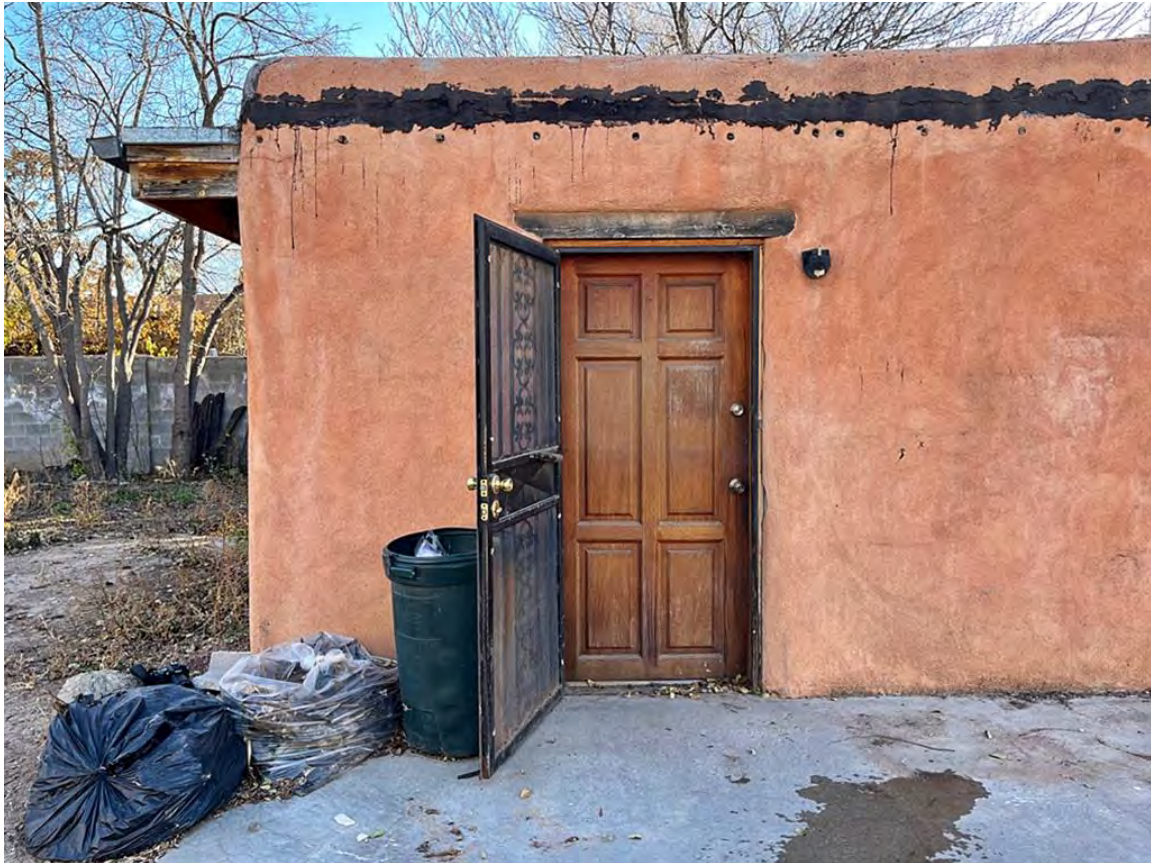
Photo 8: North elevation at east end addition. Camera facing south.

The remaining 14’ of the façade represents the non-historic addition, which is entered by a six-panel wood door (Photo 8). Tar stains above the doorway indicate the presence of a porch that was recently removed.

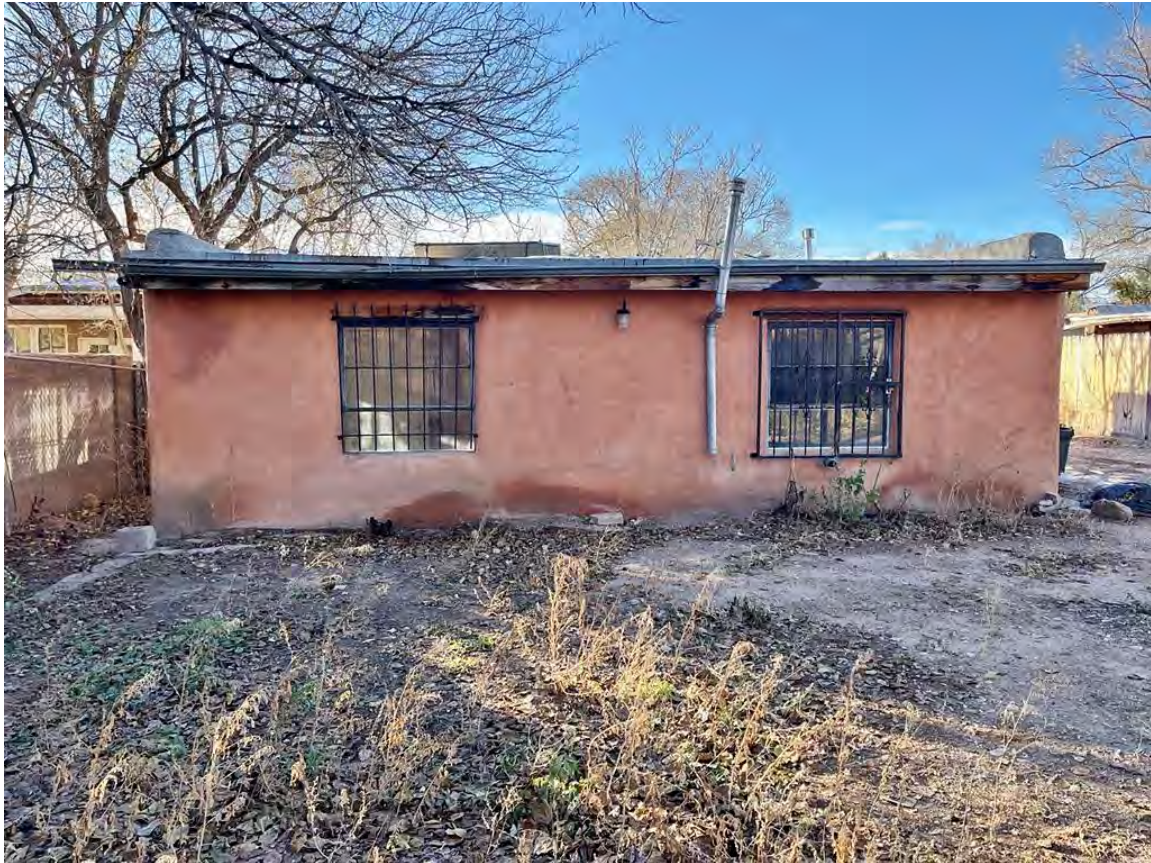
Photo 9: East elevation representing 1980s addition. Camera facing west.

An overhang, which helps drain the roof, traces the east elevation (Photo 9). This portion of the building represents the addition and encloses a large room which is divided into living and dining spaces. The windows on this and the west elevation of the addition are metal fixed units (Photo 10). They are placed nearly flush with the wall.

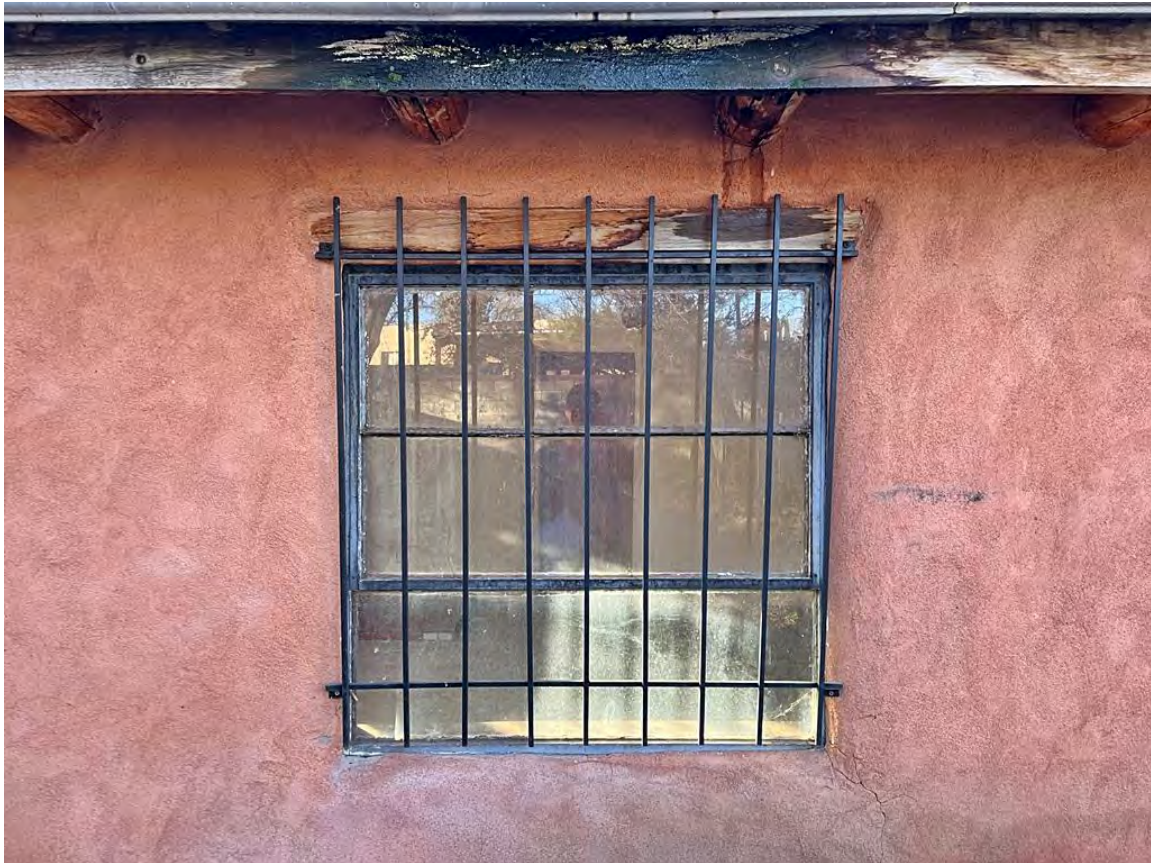
Photo 10: East elevation at 1980s addition. Window detail. Camera facing west.

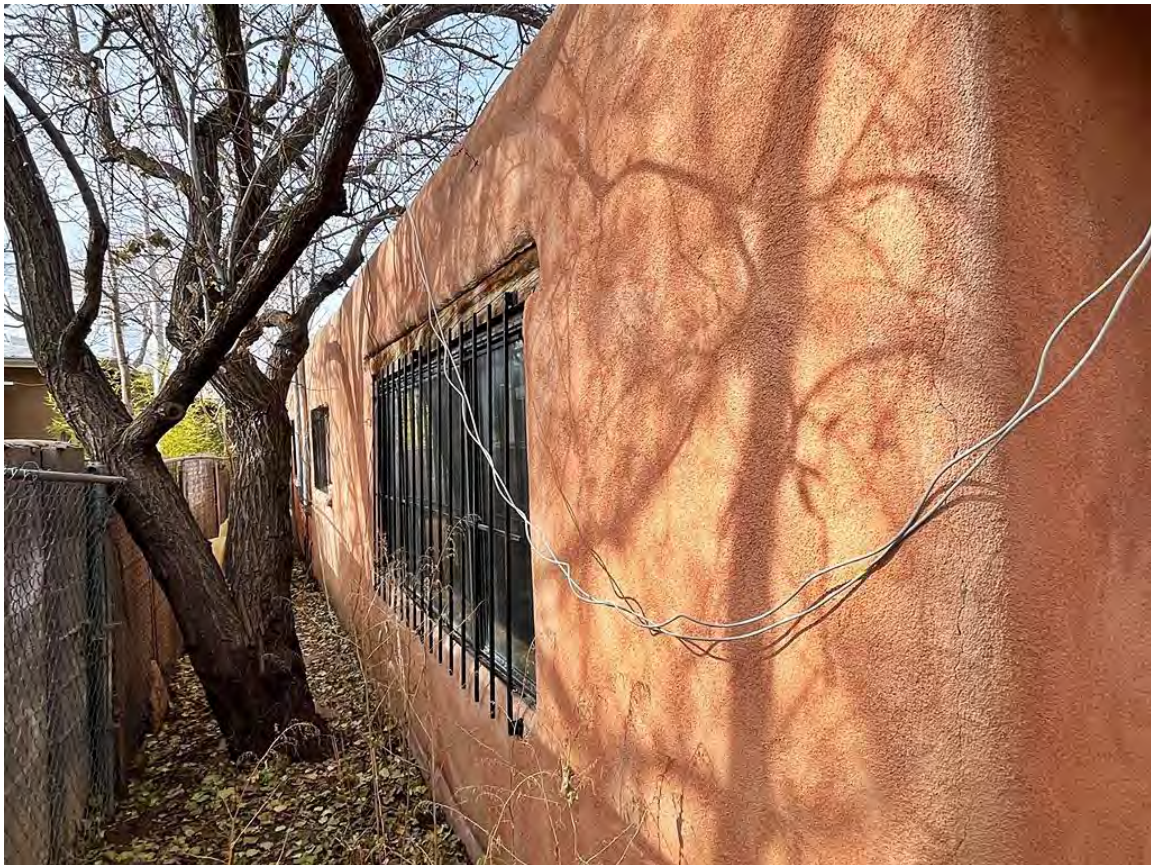
Photo 11: South elevation. Camera facing northwest.

The south side of the building sits close to a block wall (Photo 11). Here stands one of two of the property’s apricot trees. It begins at the east end with a large window at the living room (Photo 12). An expansion joint signals the shift between the addition and the original building (Photo 13). The remaining windows of the façade are large aluminum sliding units with slanted concrete sills (Photos 14 & 15).

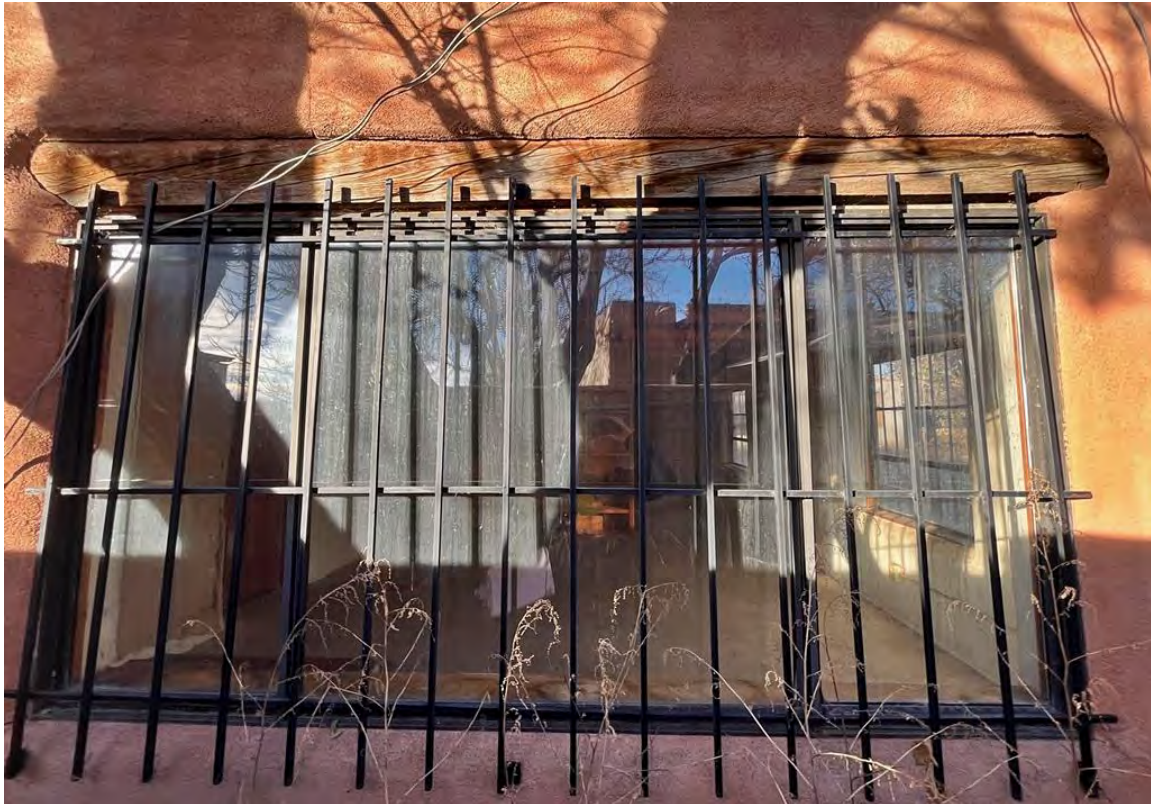
Photo 12: South elevation at 1980s addition. Window at living room. Camera facing north.

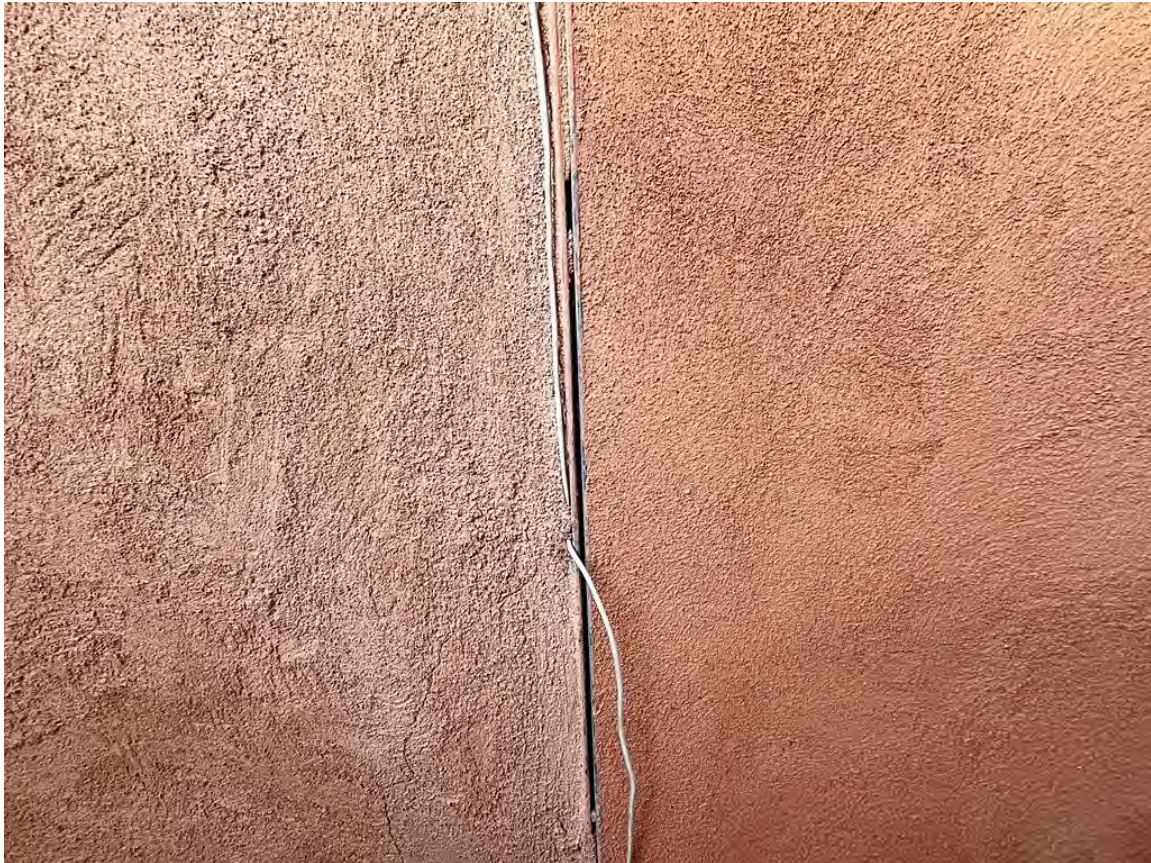
Photo 13: South elevation. Expansion joint between original core (left) and 1980s addition (right). Camera facing north.

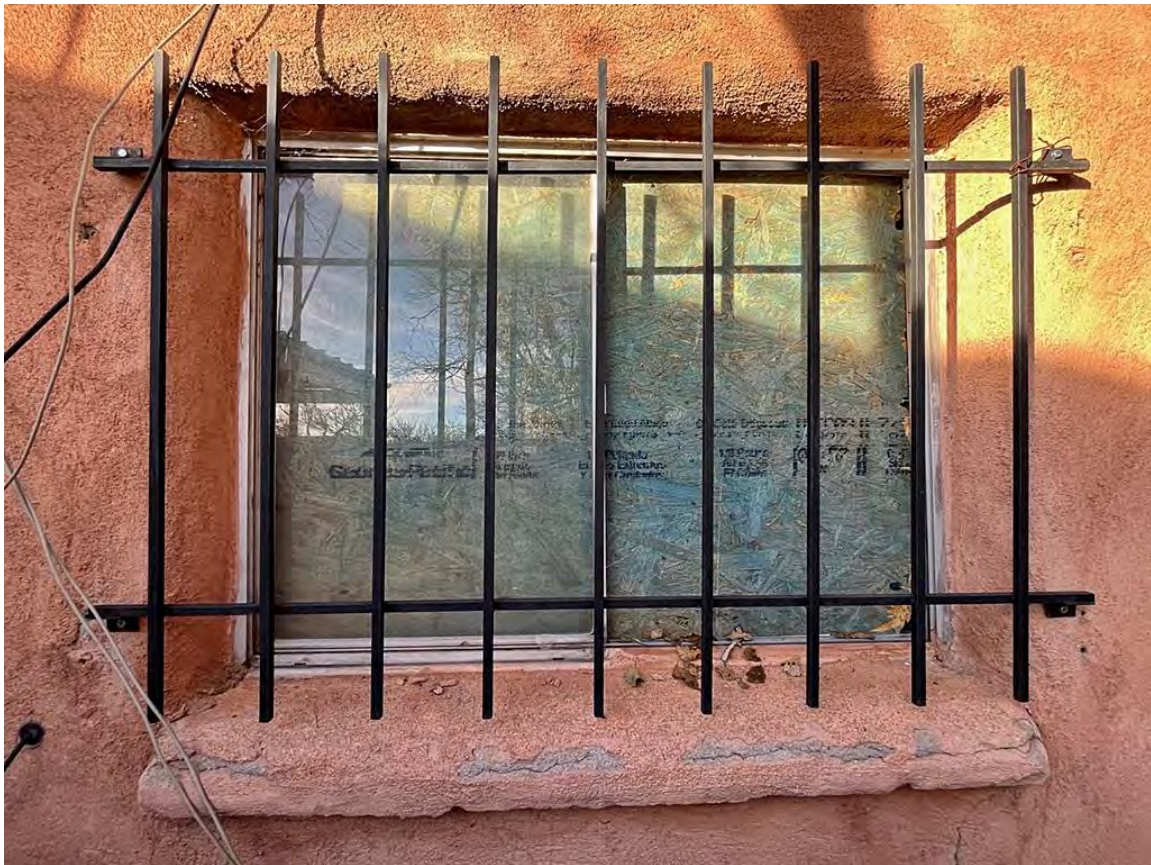
Photo 14: South elevation. Window of southeast room of the original core. Camera facing north.

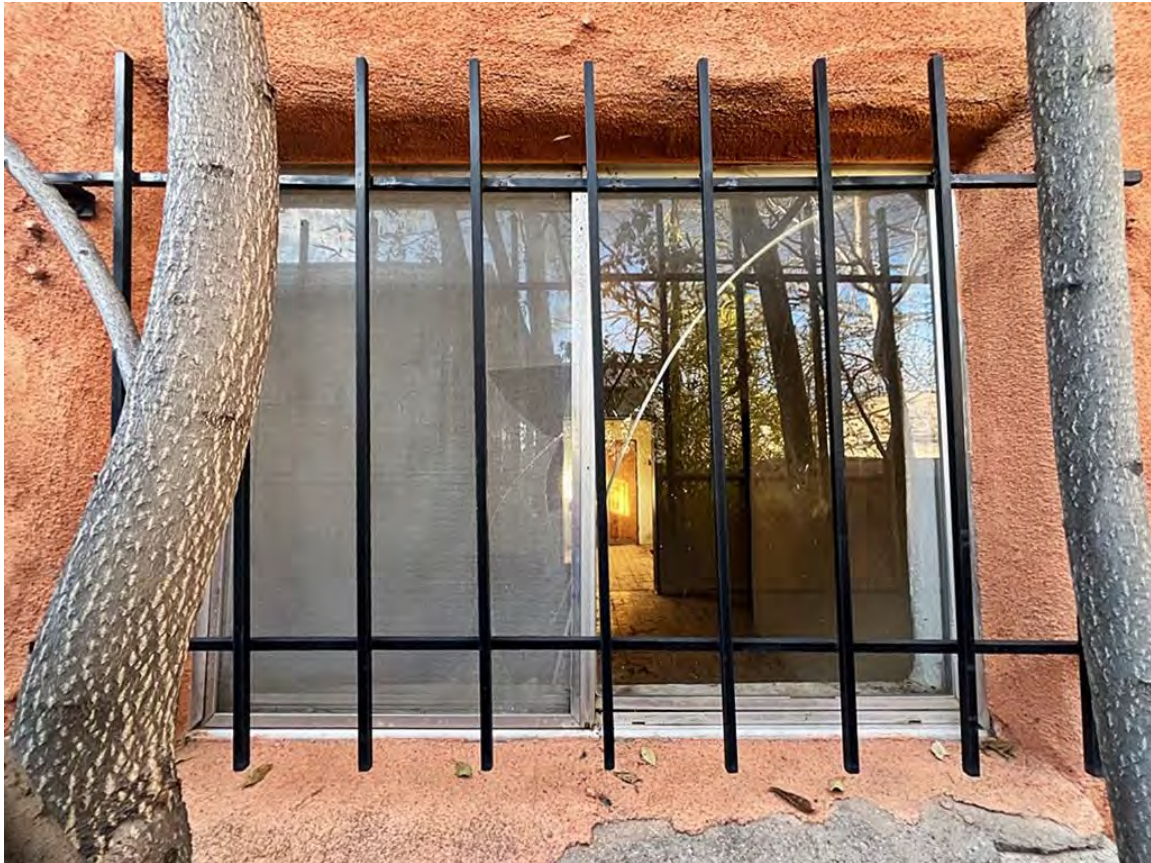
Photo 15: South elevation. Window of southwest room of the original core. Camera facing north.

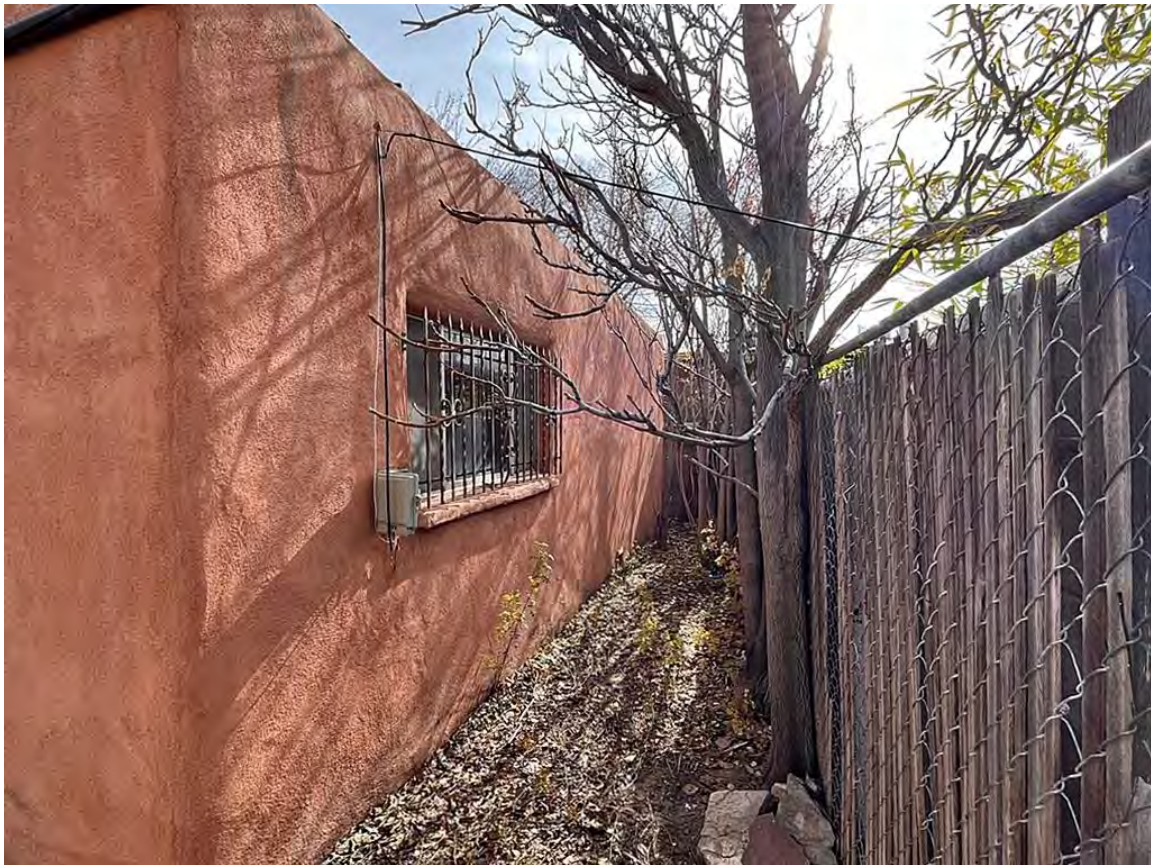
Photo 16: West elevation. Camera facing southeast.

The short west elevation is the side of the building not attached to the addition (Photo 16). It has a single opening holding an aluminum combination window. The opening’s width and the concrete sill’s style seem more of a mid-century vintage.

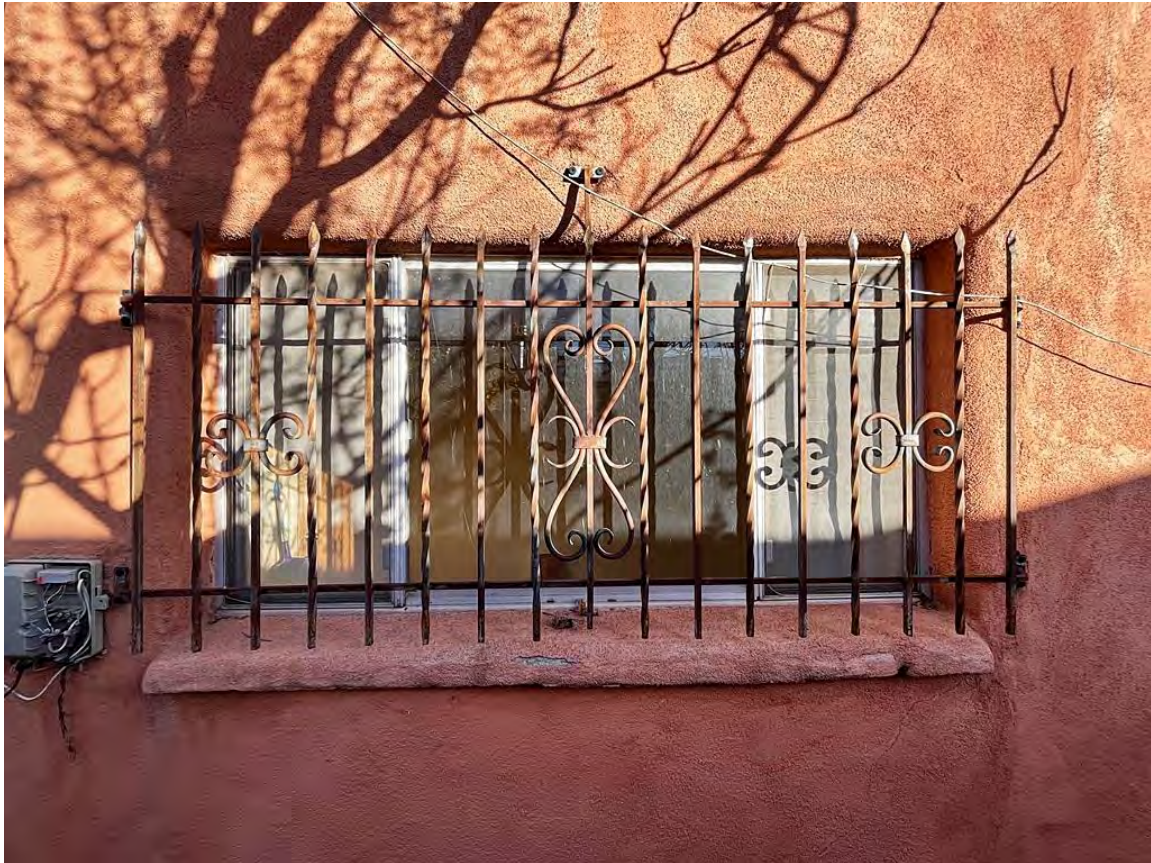
Photo 17: West elevation. Window of northwest room of the original core. Camera facing east.

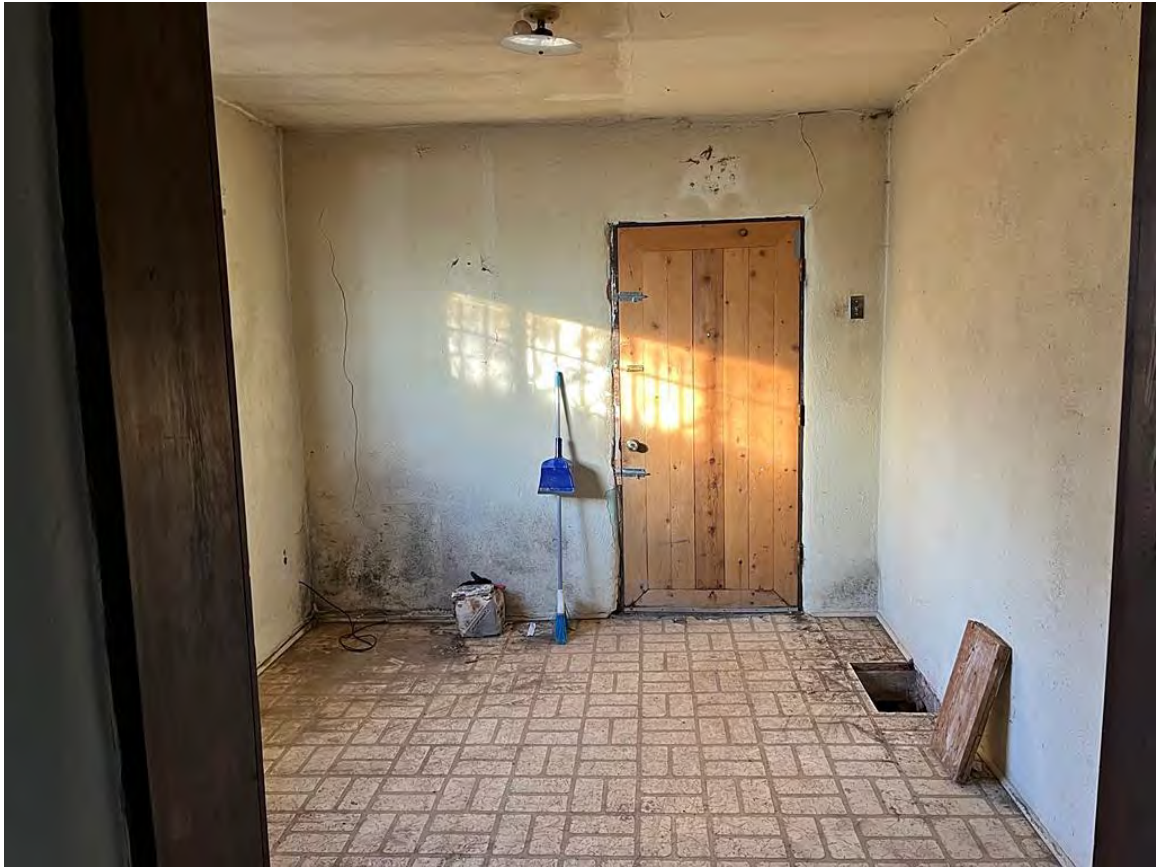
The interior of the older adobe section has four rectangular rooms that are connected by shared doorways rather than a hallway. The ceiling heights vary, with the tallest ceiling measuring 8’ 6” in the northwest entry room (Photo 18). The rooms are spare, lacking moldings or closets, and are all covered with non-historic flooring materials (Photos 18-20). Each room was heated with a stove. The fourth room, located in the northeast corner, is divided into a small bathroom and a kitchen (Photo 21).

Photo 18: Northwest room of the original core. Camera facing north.
