Historic Cultural Properties Inventory (HCPI) Detail Form (FORM 2)

1. Name of property: 127 Duran Street, Rear House Guadalupe and Simonia Chavez House Martha J. Baca House	2. Location: 127 Duran Street (Rear) Westside-Guadalupe Historic District - Santa Fe	3. Local Reference Number: Santa Fe ID: Old # 051613057 4. County: Santa Fe 5. Date of Survey: November 24 & 25, 2024																																	
ARCHITECTURAL AND CONSTRUCTION DETAILS:

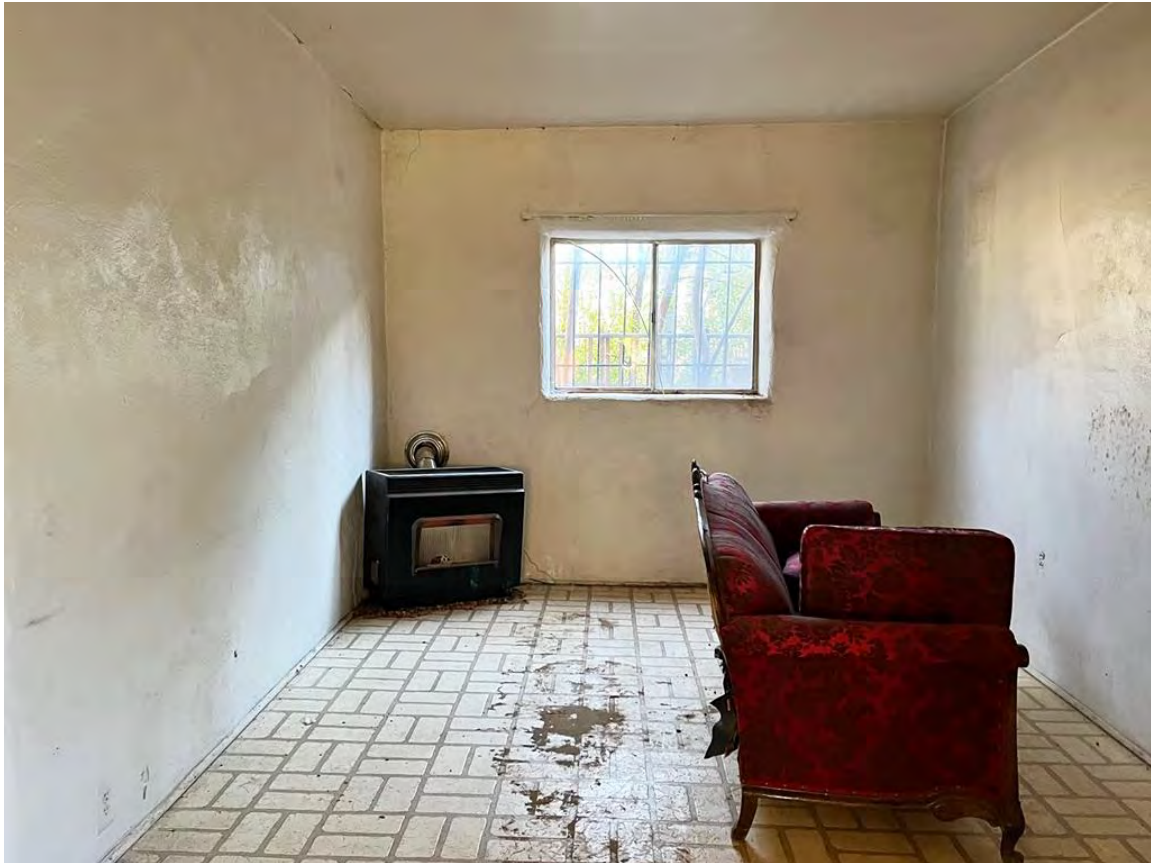
Photo 19: Southwest room of the original core. Camera facing south.

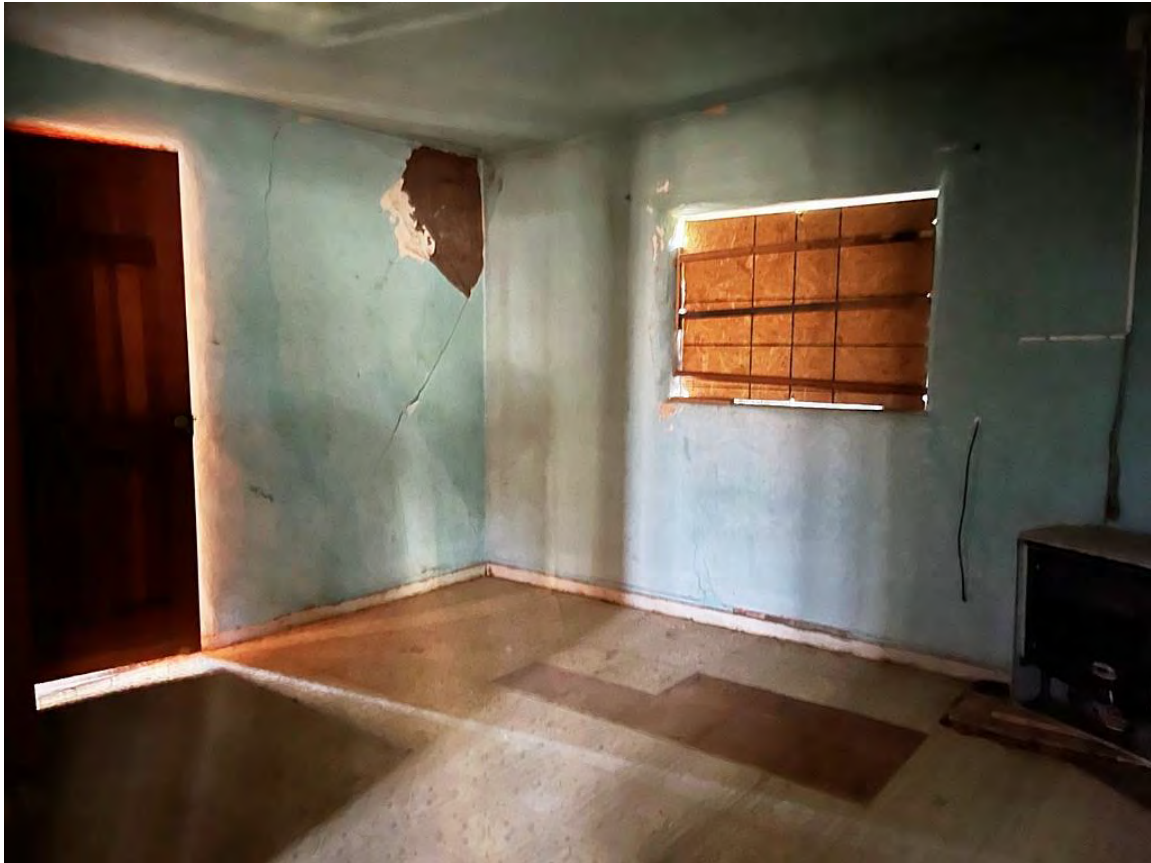
Photo 20: Southeast room of the original core. Camera facing southeast.

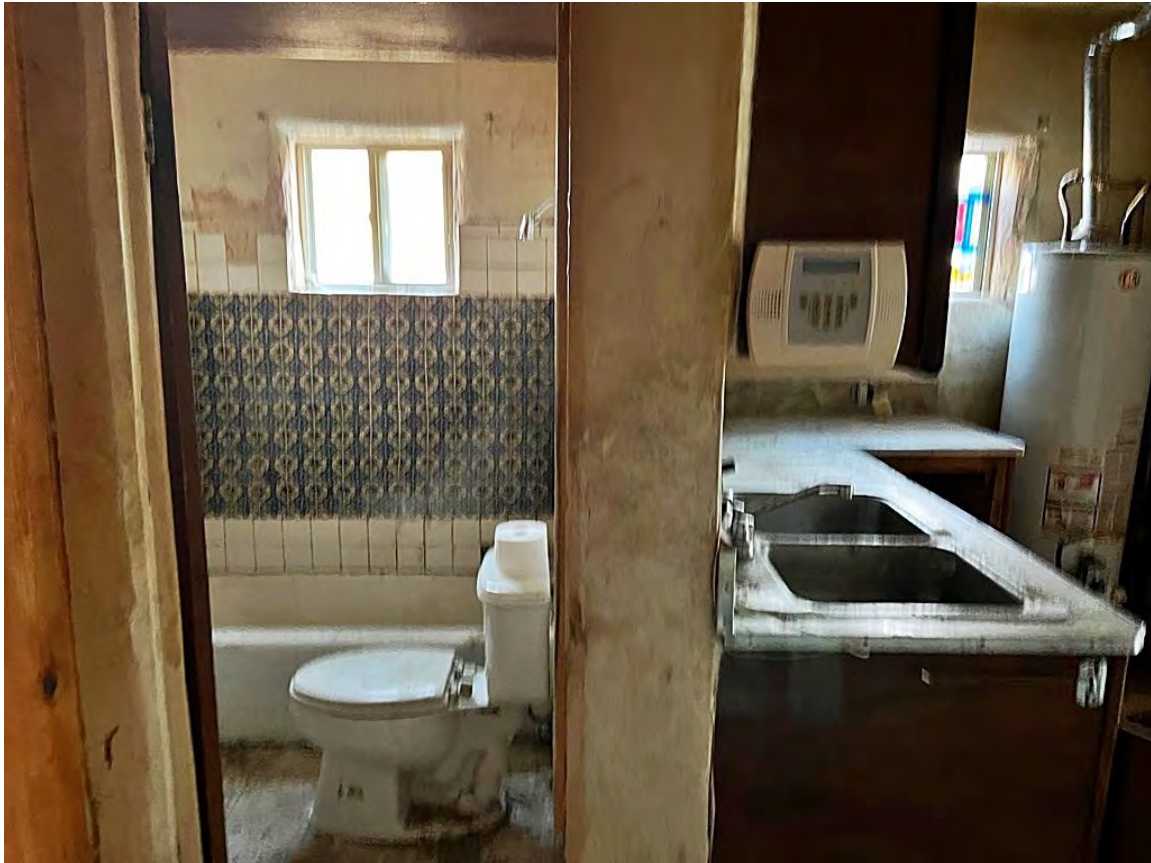
Photo 21: Northeast room of the original core, combining bathroom and kitchen. Camera facing north.

The interior of the older adobe section has four rectangular rooms that are connected by shared doorways rather than a hallway. The ceiling heights vary, with the tallest ceiling measuring 8’ 6” in the northwest entry room (Photo 18). The rooms are spare, lacking moldings or closets, and are all covered with non-historic flooring materials (Photos 18-20). Each room was heated with a stove. The fourth room, located in the northeast corner, is divided into a small bathroom and a kitchen (Photo 21).

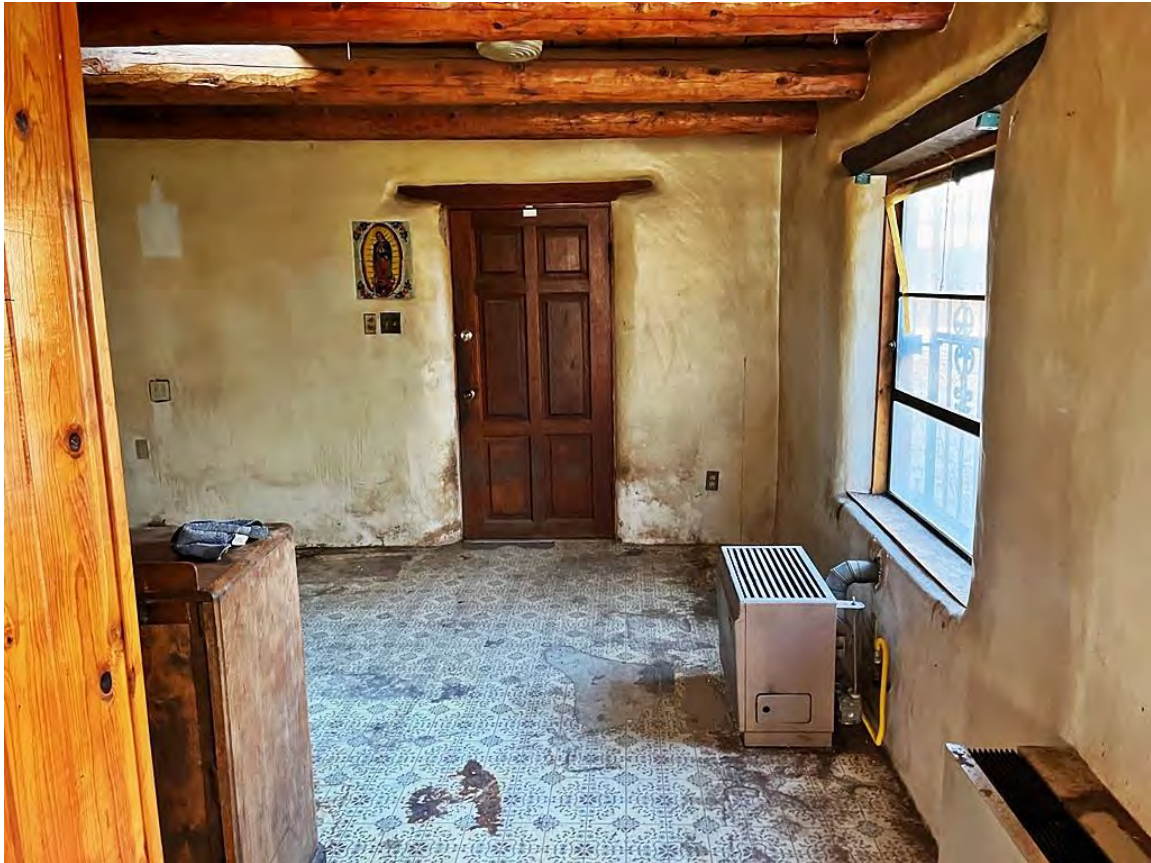
Photo 22: 1980s addition. Camera facing north.

The addition has a plywood floor covered with vinyl tiling and a viga-spanned ceiling, interrupted by a skylight (Photo 22).

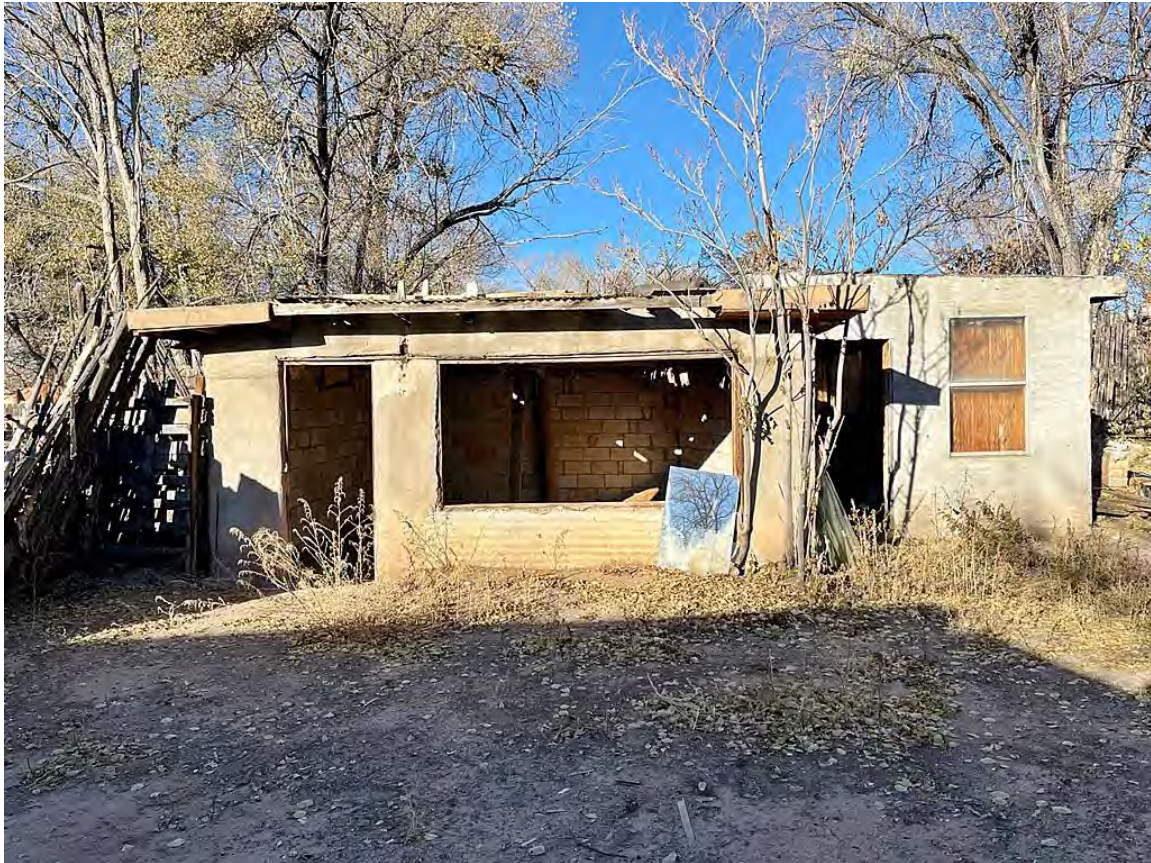
Photo 23: Shop. South elevation. Camera facing north.

Standing at the northeast corner of the property is a shop — perhaps potentially first used as a garage — and an attached storage room (Photo 23). Constructed of concrete masonry units, the shop has a rectangular, dirt-floor room (Photo 24). Its frame roof structure rests precariously on two poles, supported by tilting posts. An adjacent frame storage room is covered with gray coat stucco (Photo 25). Essentially a lean-to, its structure is even more precarious (Photo 26).

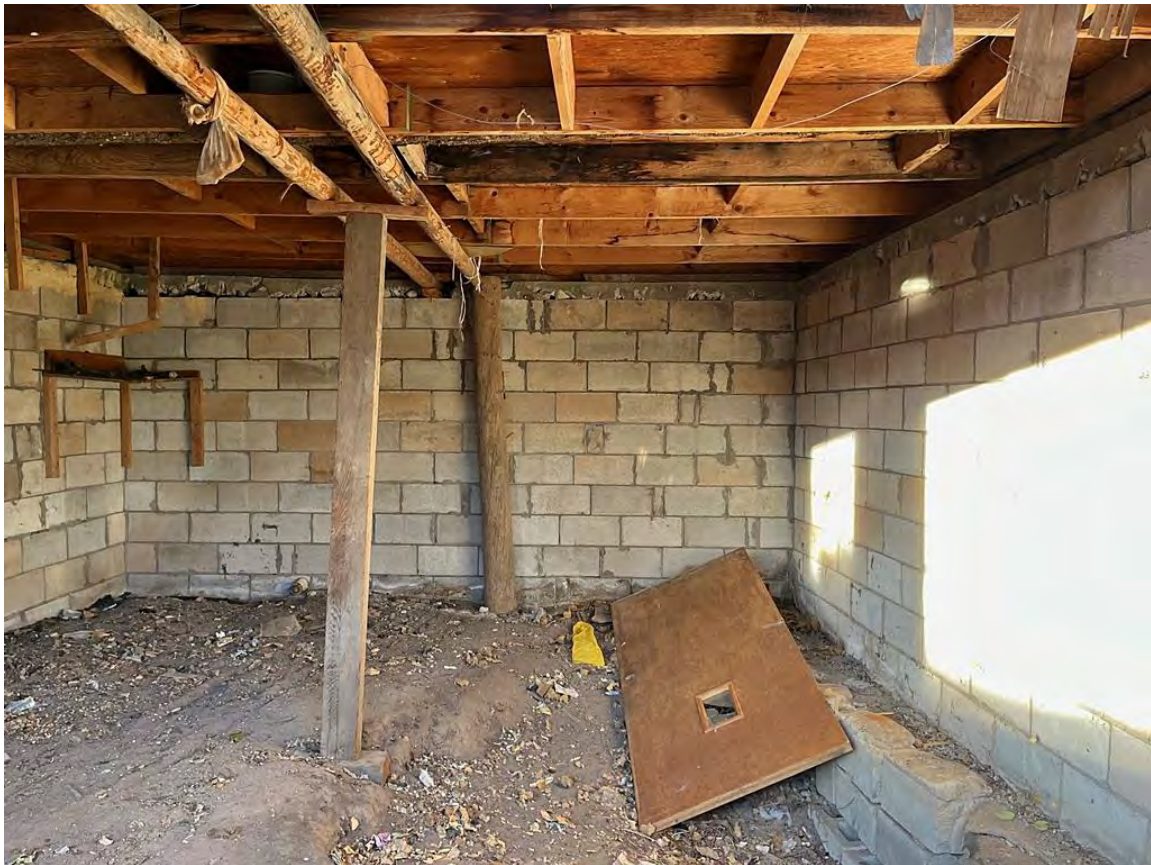
Photo 24: Shop. Interior. Camera facing north.

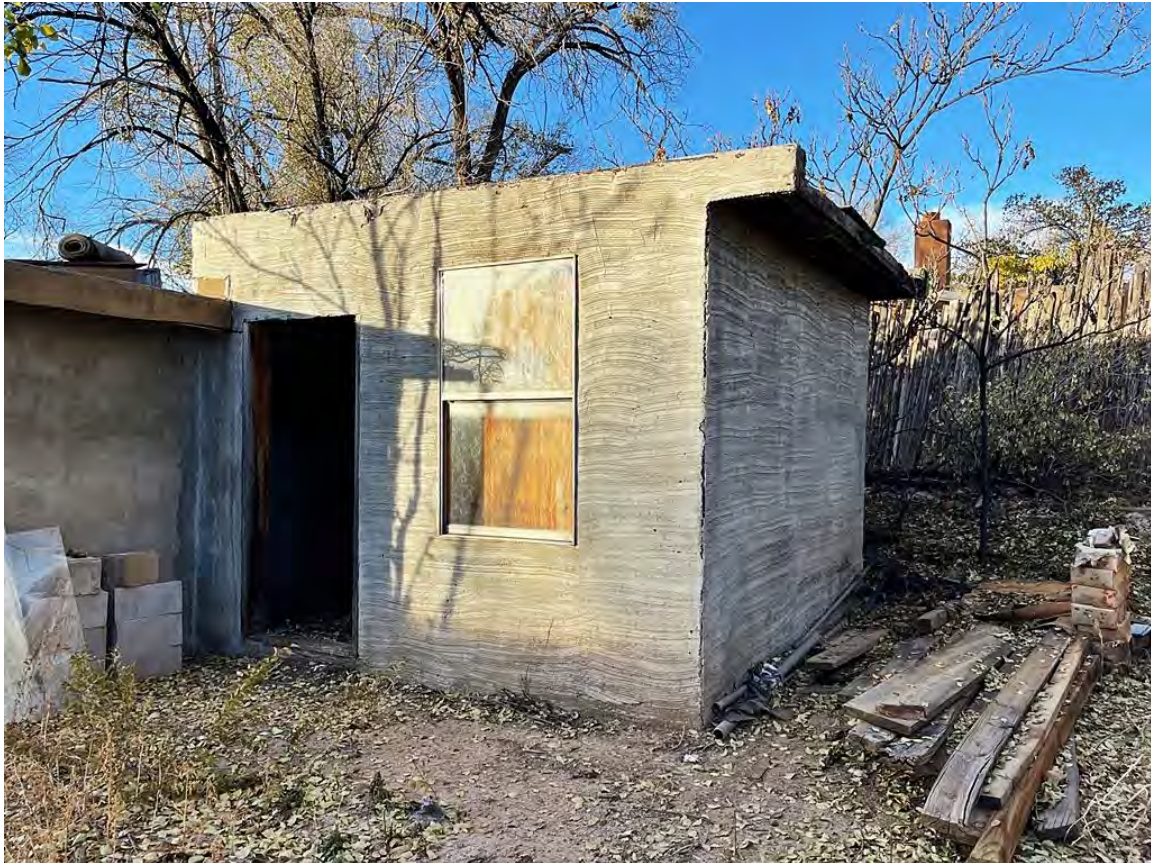
Photo 25: Shop. Addition. Camera facing northwest.

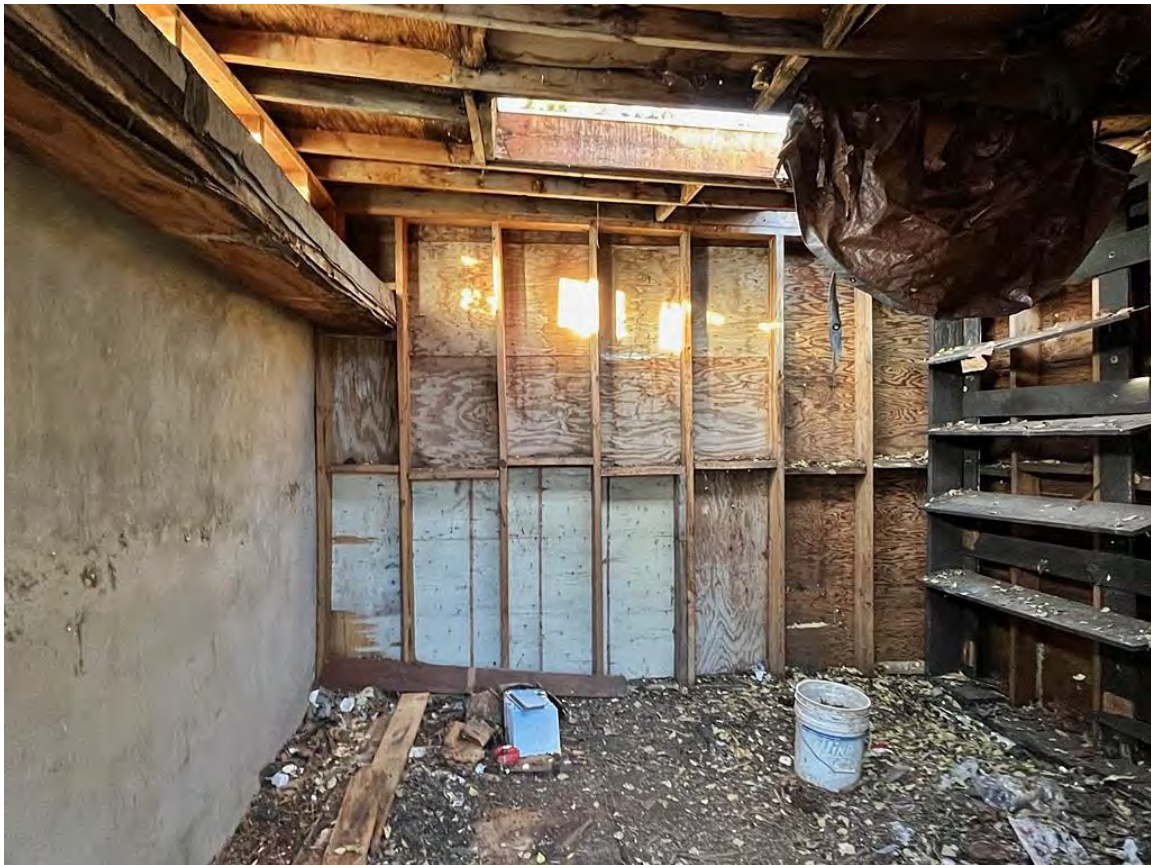
Photo 26: Photo 25: Shop. Addition, interior. Camera facing north.
