PROJECT 2025-010870-HDRB, 549 ½ Agua Fria St., Westside Guadalupe Historic District, Not
DESC: Surveyed, Robert Kreger, agent for Catherine Wynne, owner, requests status review with primary façade designation(s) if applicable.

Historic Cultural Properties Inventory (HCPI) Base Form (FORM 1)

Historic Cultural Properties Inventory (HCPI) Detail Form (FORM 2)

1. Name of property: Charles and Mamie Hesch Property – Garage Hesch-Gonzales Cottage	2. Location: 459 ½ Agua Fria Street Westside-Guadalupe Historic District – Santa Fe	3. Local Reference Number: Santa Fe ID: H-226	4. County: Santa Fe		5. Date of Survey: May 23, 2025																																
ARCHITECTURAL AND CONSTRUCTION DETAILS:

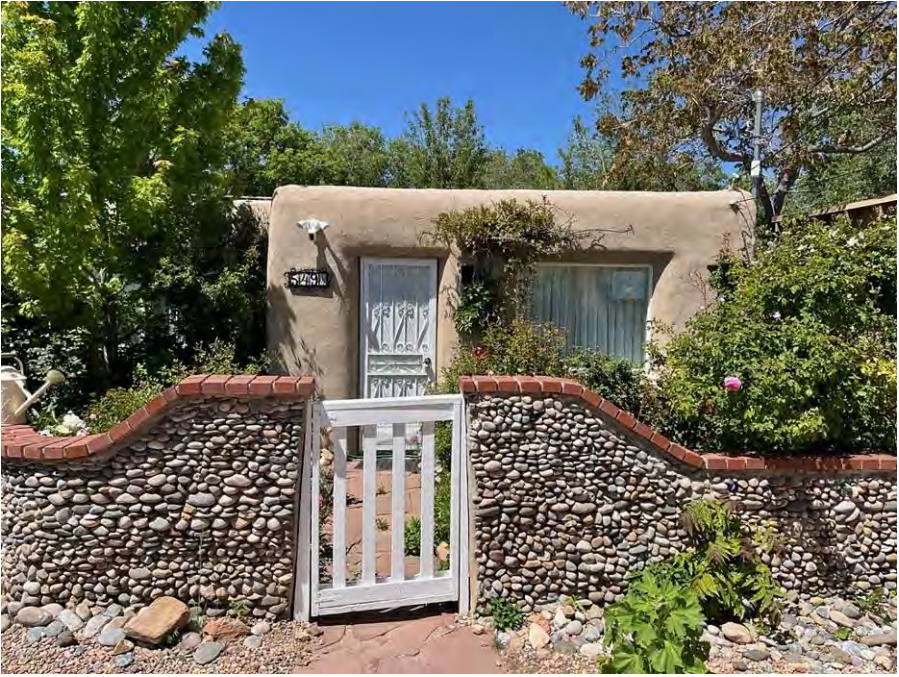
8. Name of Project: HDRB Status Evaluation		
9. Lat/Long: 35.68658,-105.9506579		
10. Photo Information: John W. Murphey, photographer. Photo 1: South (front) elevation. Camera facing north.

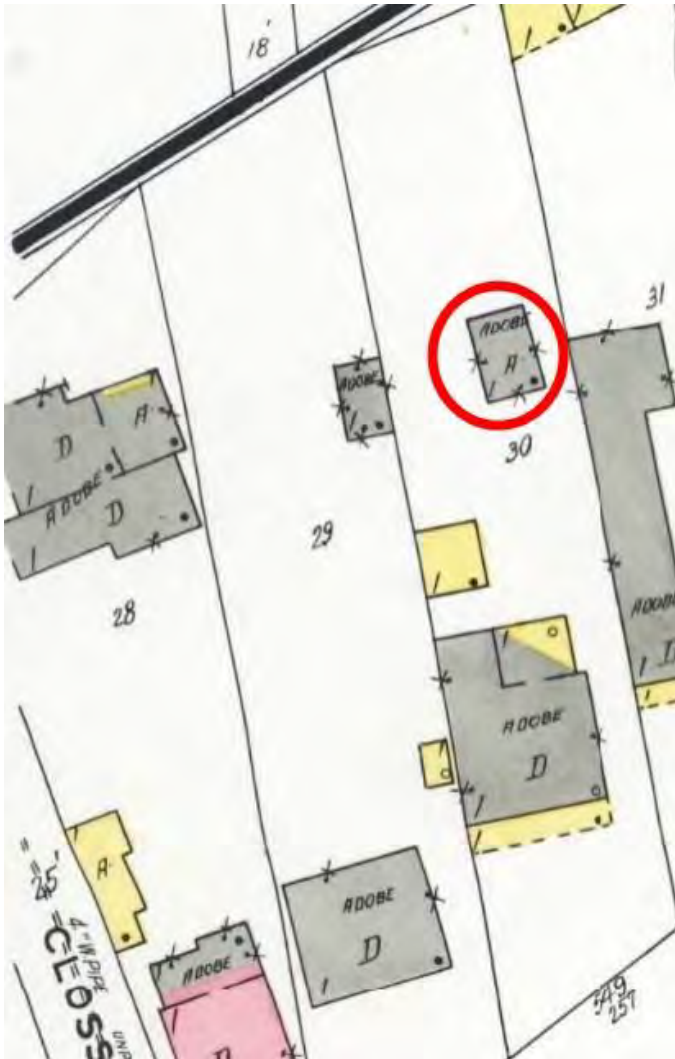
Figure 2: Sanborn Map Company, “Santa Fe, Santa Fe County, New Mexico,” January 1930. Original garage configuration.

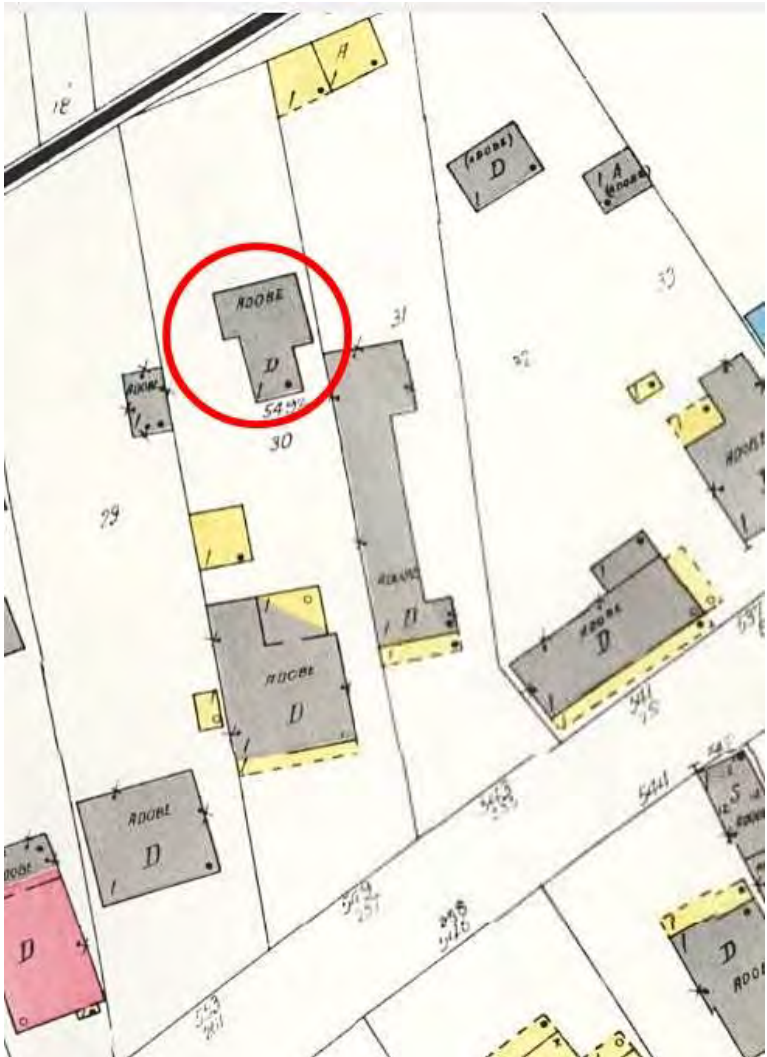
Figure 4: Sanborn Map Company, "Santa Fe, Santa Fe County, New Mexico," January 1930, correction layer, August 1948. Garage converted to small apartment for Howard Hesch.

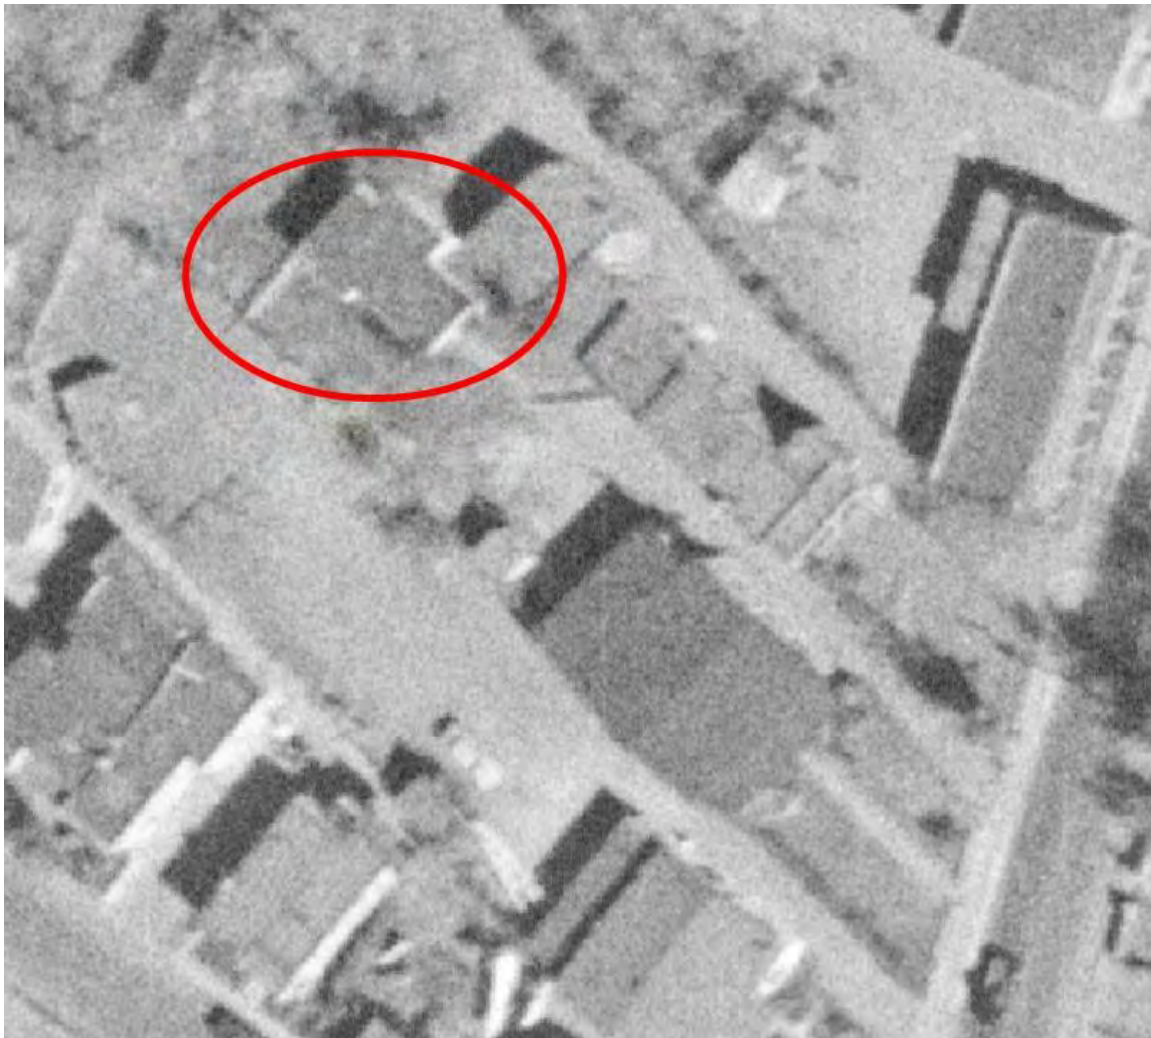
Figure 5: November 10, 1958, aerial photograph. Former garage has retained 1940s apartment footprint.

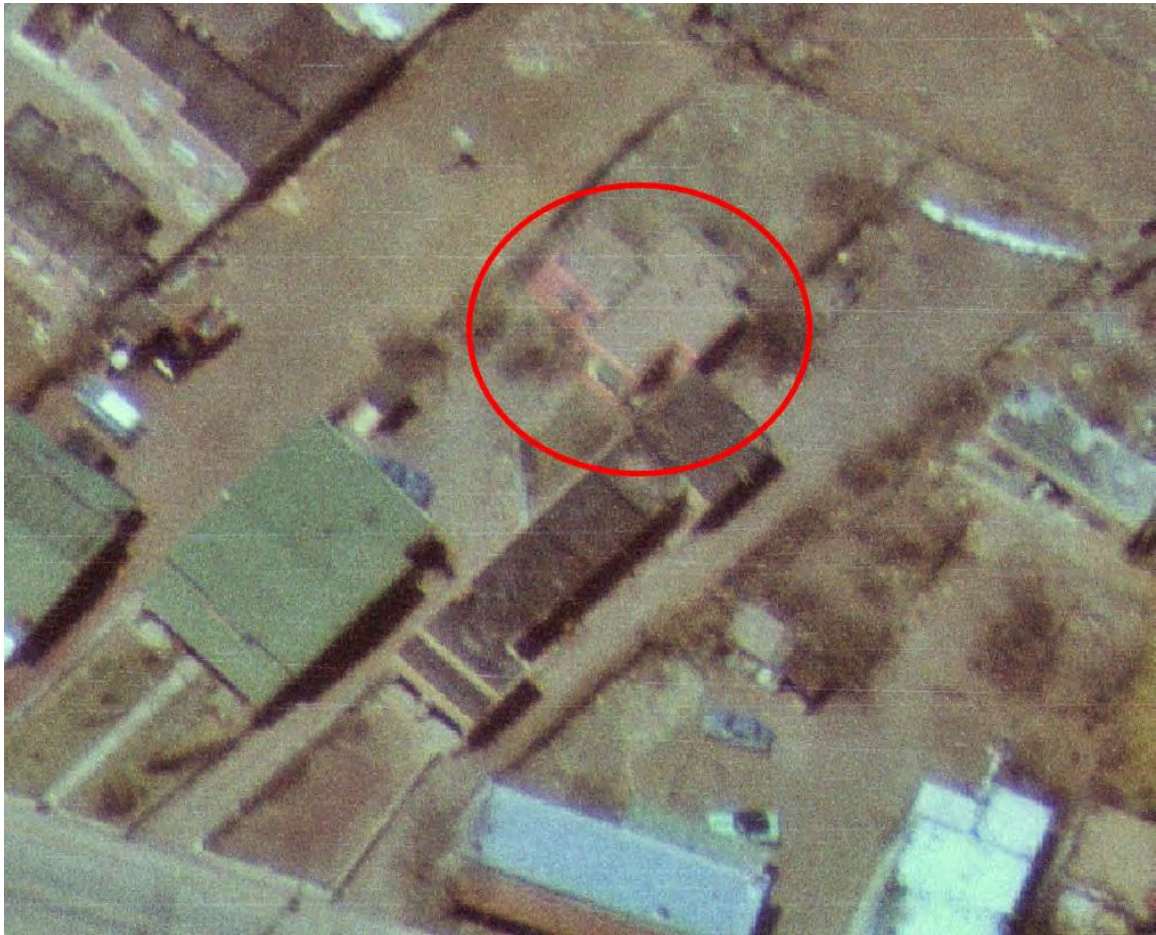
Figure 6: February 27, 1969, aerial photograph. Former garage has expanded to the west with an addition reflecting its use during the Maude Gonzales period.

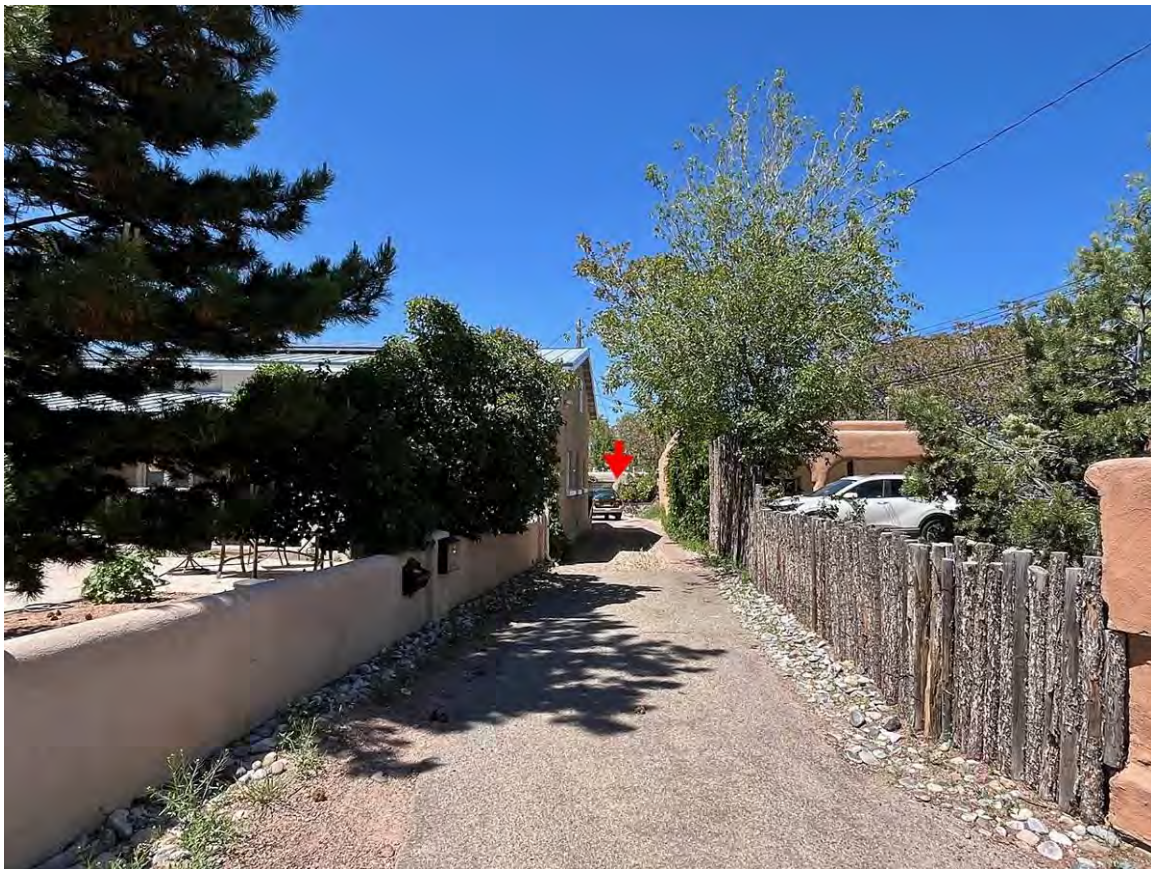
The Hesch-Gonzales Cottage is located approximately 160 feet north of Agua Fria Street, positioned at the rear of a narrow lot (Photo 2). It stands behind the much larger and older Hilario Ortiz House, which underwent extensive remodeling in the 2000s (Photo 3). The contrast in architectural eras between the two structures is immediately apparent. Access to the cottage is via a narrow gravel driveway that terminates in front of the building. A visually striking cobblestone wall marks the approach (Photo 4), backed by a well-tended rose garden that contributes to the property’s cottage-like character.

Photo 2: View of Hesch-Gonzales Cottage (arrow) from north side on Agua Fria Street. Camera facing north.

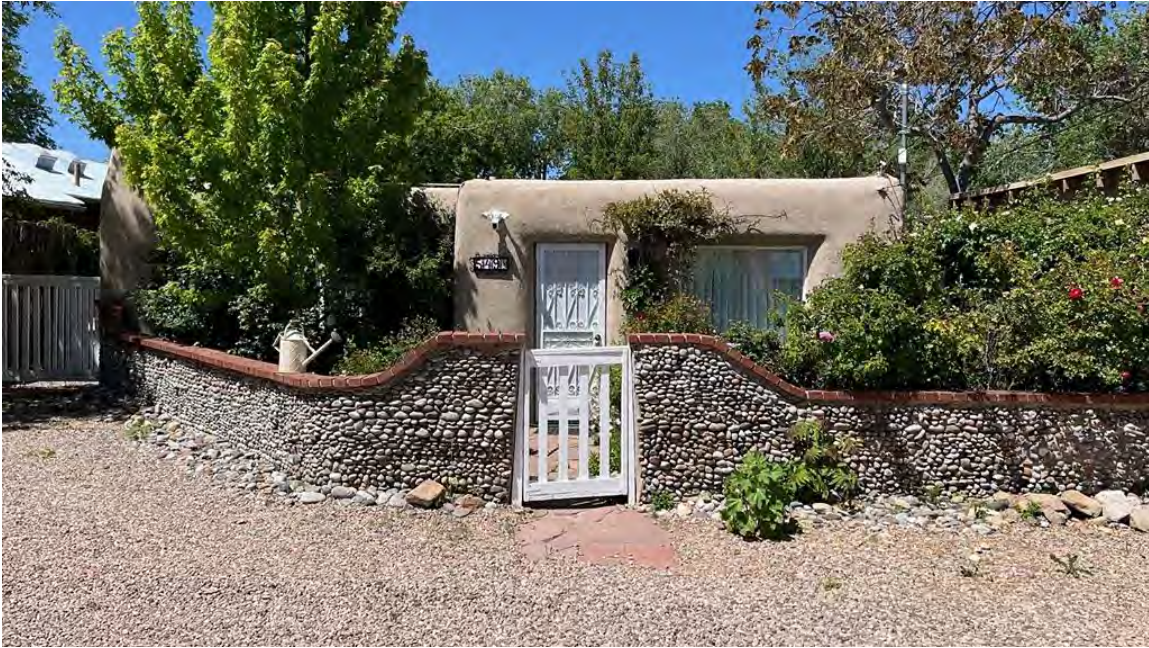
A decorative cobble and brick garden wall encloses the small front yard and rose garden, evoking an English cottage-style aesthetic (Photo 4). The wall is constructed of tightly packed river cobbles set in mortar, with a curving, scalloped profile that rises to frame a central gate opening (Photo 14).

Photo 4: Subject dwelling and context. Camera facing north.

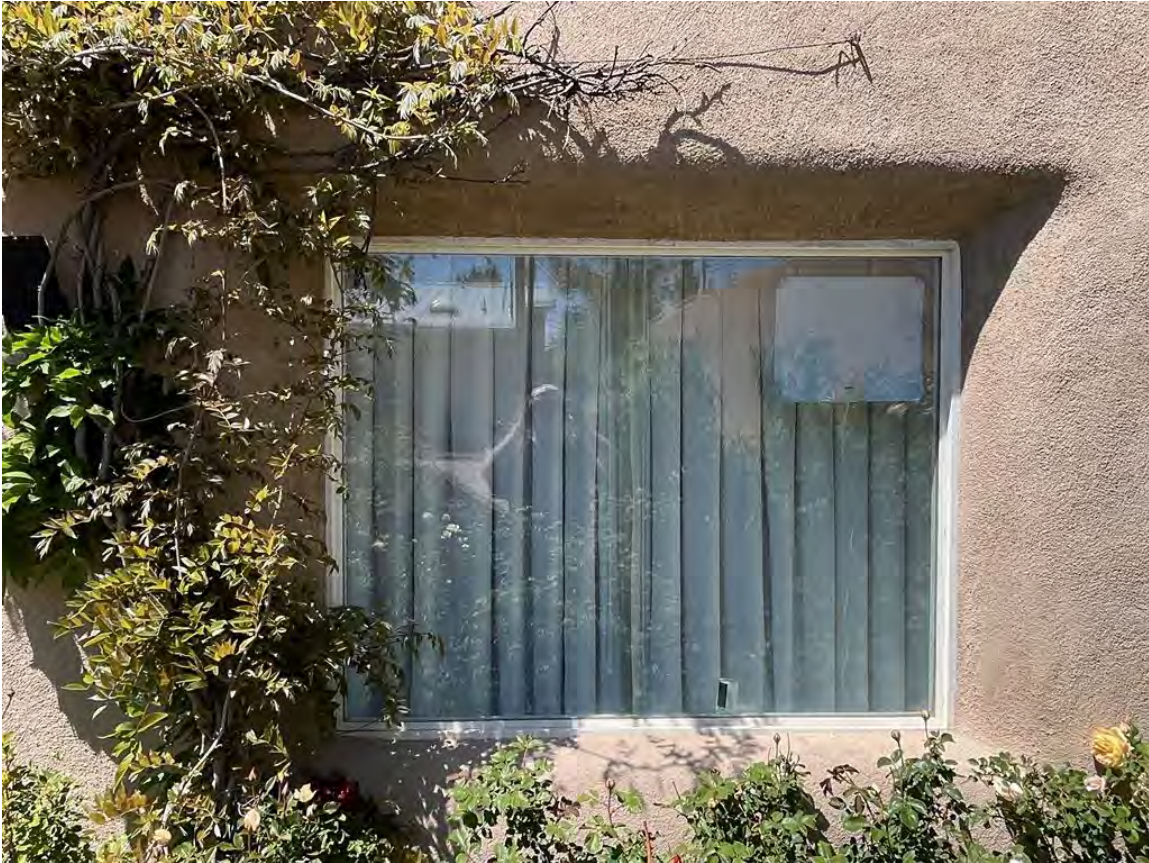
The south elevation reveals both the earliest and most recent phases of construction. On the east side, a large picture window—measuring approximately 3’10” by 4’11” — occupies what was likely the original garage door opening (Photo 5). The unit is recessed 4 inches into the adobe wall. All windows on the house, including this one, are modern vinyl replacements.

Photo 5: South elevation. Window set in original garage door opening. Camera facing north.

Its most distinctive feature is the south (front) façade, which retains characteristic massing and Pueblo Revival style hallmarks. The remaining elevations are utilitarian in character and have been compromised by replacement fenestration.

For this reason, the building is recommended as Contributing, with its south elevation designated as the primary façade. The non-historic windows are excluded from this designation.

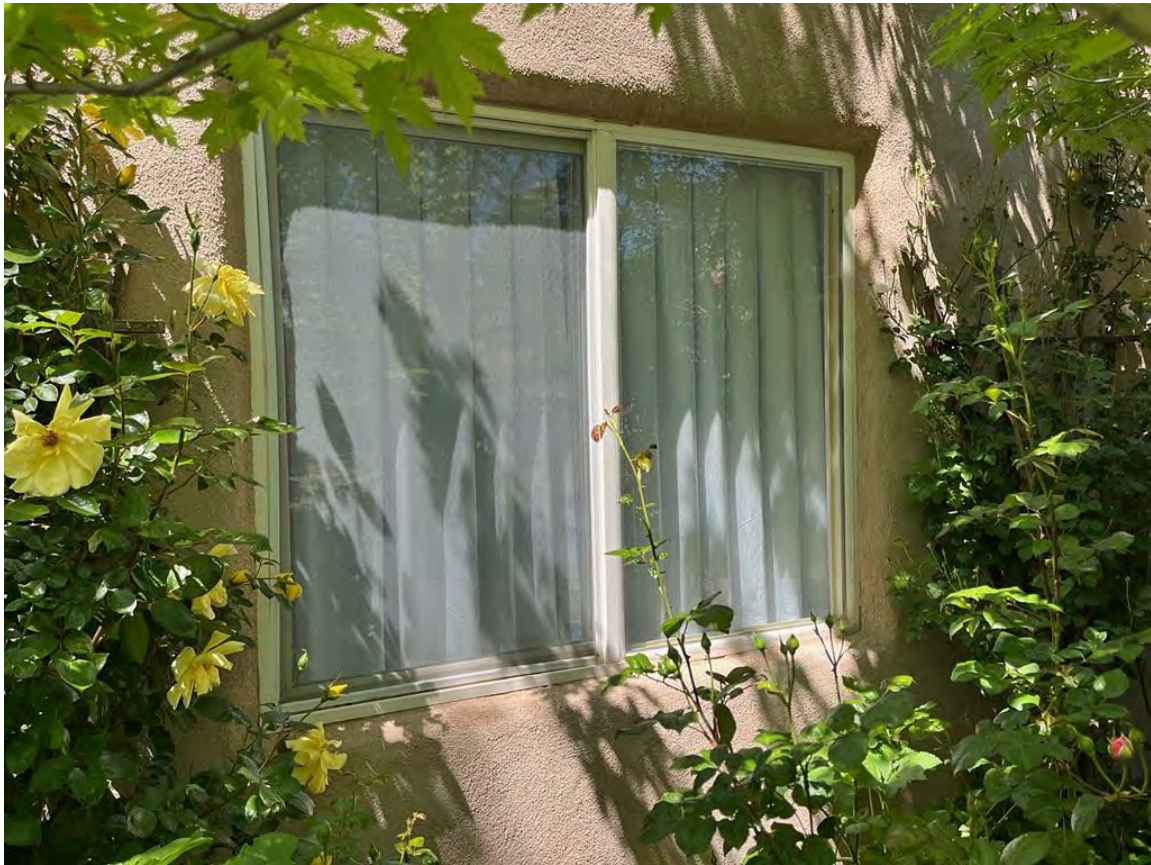
To the west is a steel grate security door, though the function of the entry behind it is unclear. Set back 7’ 5” from the original wall plane is the 1960s addition, which also includes a large vinyl sliding window measuring 4’4” by 4’9” (Photo 6). The elevation terminates at the west end with a stuccoed corner chimney, also dating to the 1960s expansion.

Photo 6: South elevation. Window in 1960s addition. Camera facing northeast.

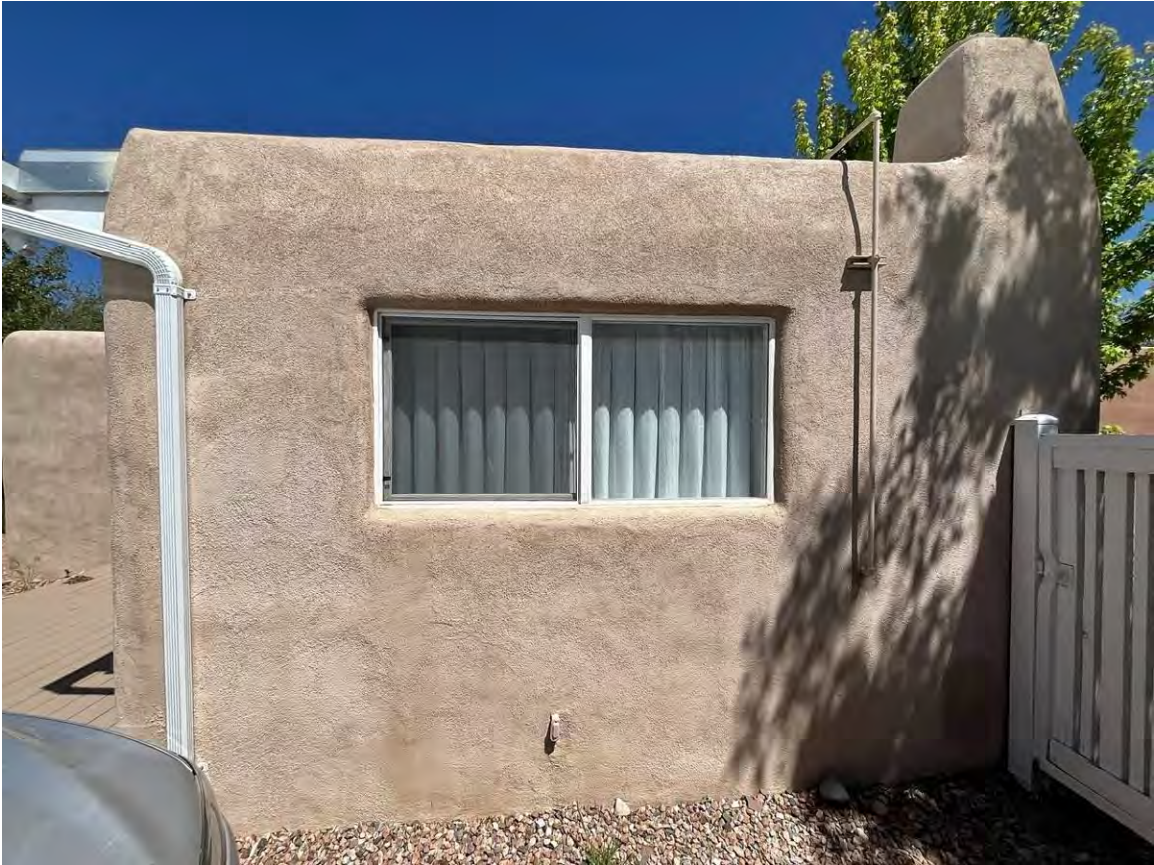
The west elevation comprises both the 1940s and 1960s additions. At the south end, the 1960s volume is punctuated by a centered vinyl sliding window (Photo 7). Set back approximately 12’10”, the earlier 1940s addition faces a recent deck (Photo 8). This façade has a single 1/1 vinyl window positioned unusually close to the south corner, suggesting that the 1960s addition disrupted what may have been a more balanced original design. An oversized, decorative scupper box draws attention at the roofline. Both sections of the west elevation are plain and lack distinctive architectural detailing.

Photo 7: West elevation. Window in 1960s addition. Camera facing east.

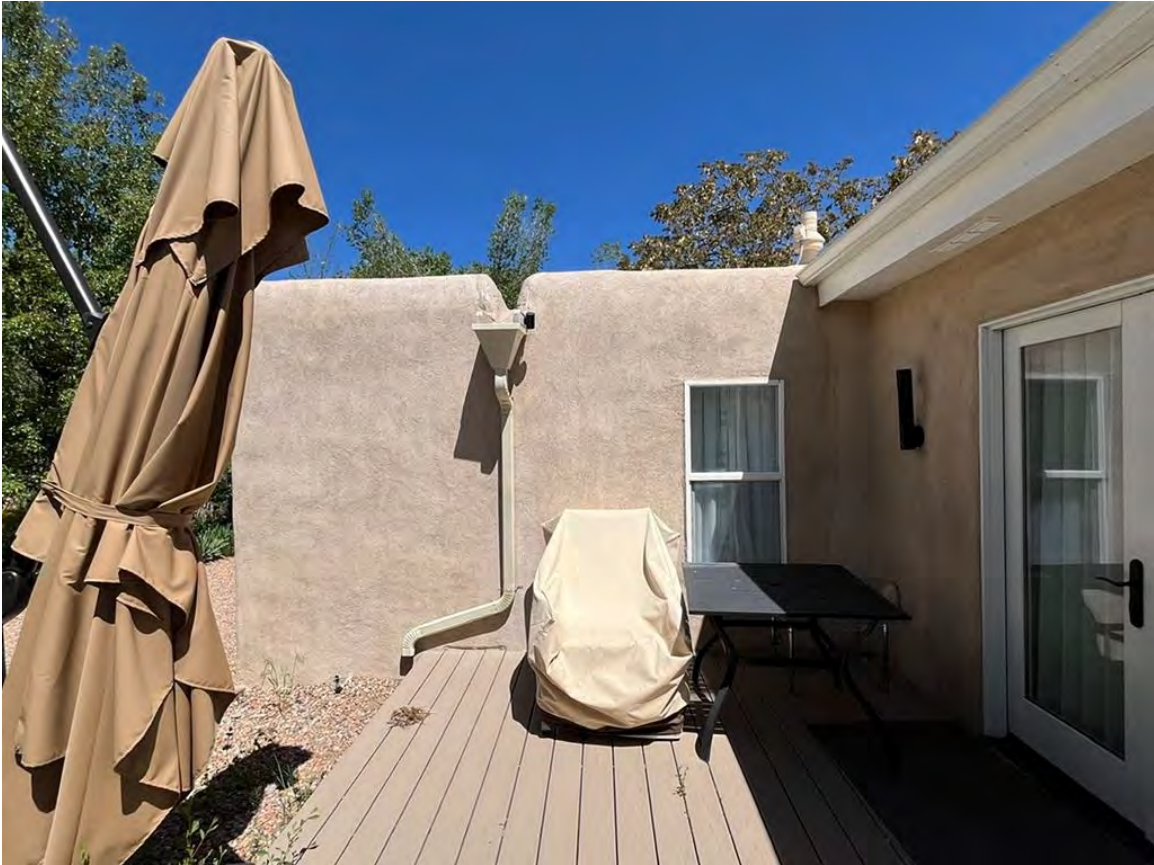
Photo 8: West elevation. Window in 1940s addition. Camera facing east.

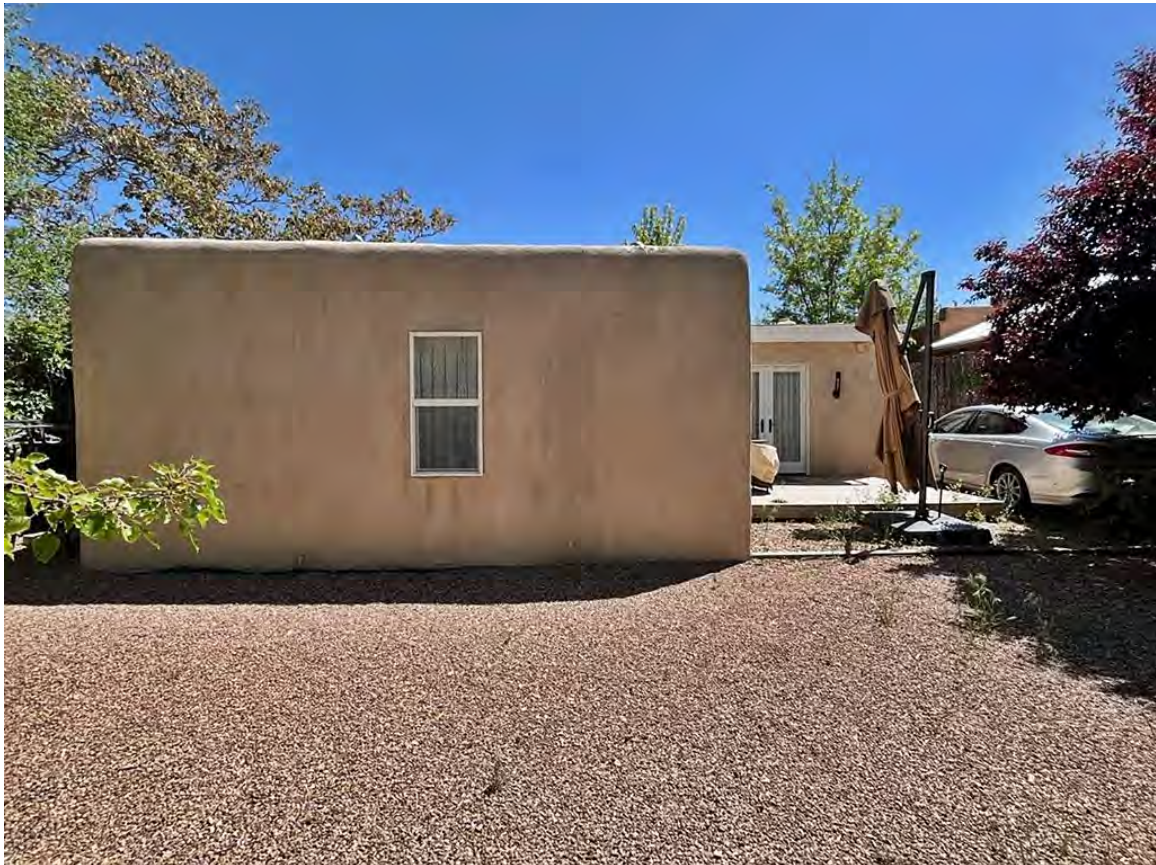
The north side of the home opens onto a landscaped garden featuring a curving gravel path, mature trees, and flowering shrubs. In contrast, the rear of the cottage is architecturally simple and minimally fenestrated (Photo 9). The west section includes a pair of recent double doors set beneath a boxed soffit with a shallow fascia board—visually suggestive of a Territorial detail that contrasts with the building’s otherwise Pueblo Revival styling (Photo 10). The east portion presents a blank stuccoed wall interrupted only by a single off-center 1/1 vinyl window, modestly recessed (Photo 9).

Photo 9: North elevation. Camera facing south.

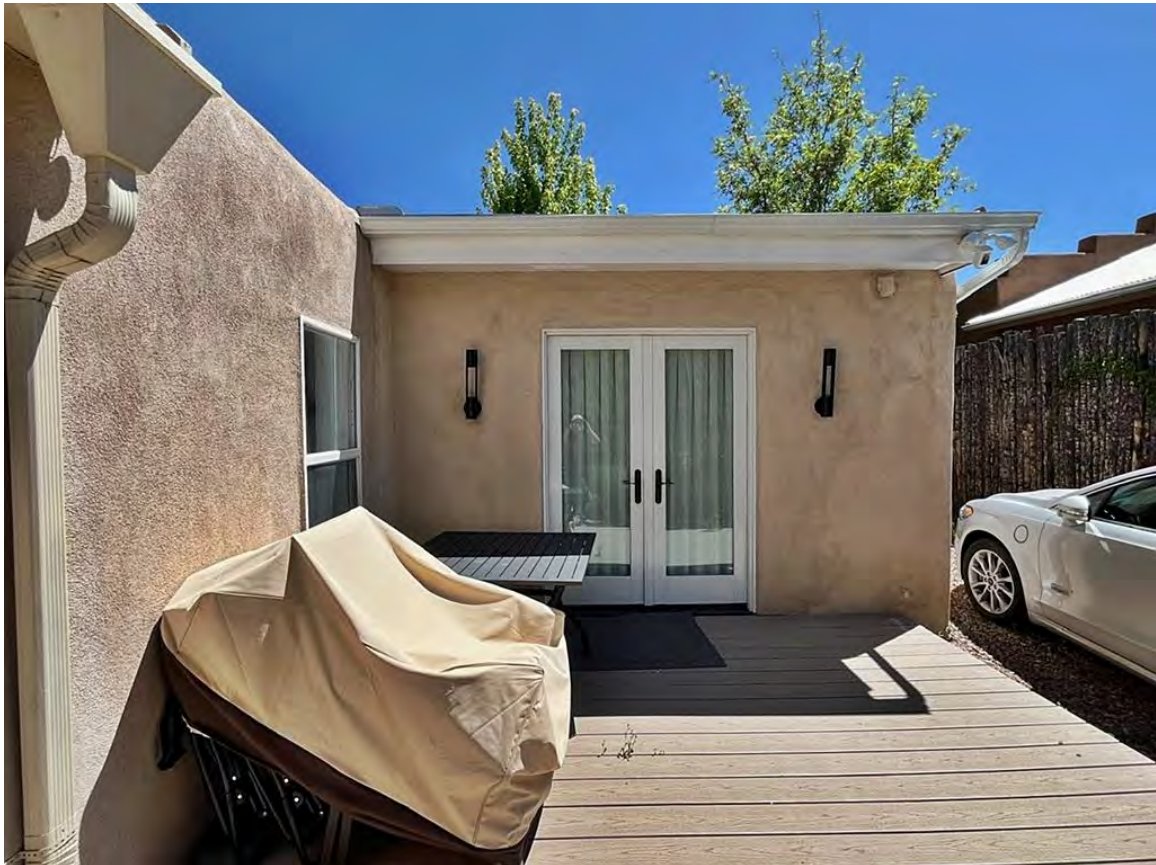
Photo 10: North elevation. Recent doors in 1960s addition. Camera facing south.

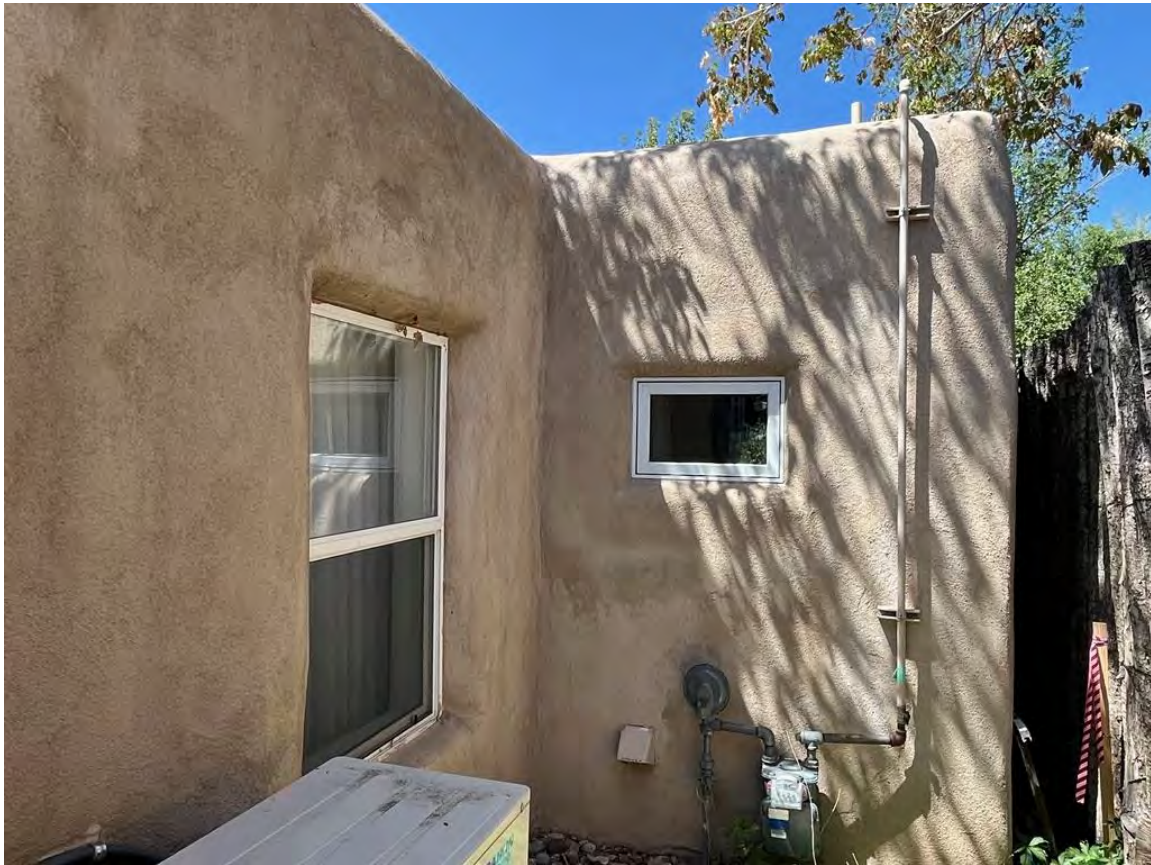
A portion of this elevation resides less than 12” from the neighboring property. The south end, representing the original garage and late 1940s addition, has two vinyl windows, including a small awning unit at the laundry room (Photo 11). The north end includes an entry fitted with a half-light and three-panel wood door and a vinyl awning window (Photo 12). Between these two points, the elevation edges close to the neighboring property and includes a single 1/1 vinyl sash unit (Photo 13).

Photo 11: East elevation, south end. Windows in original garage and 1940s addition. Camera facing northwest.

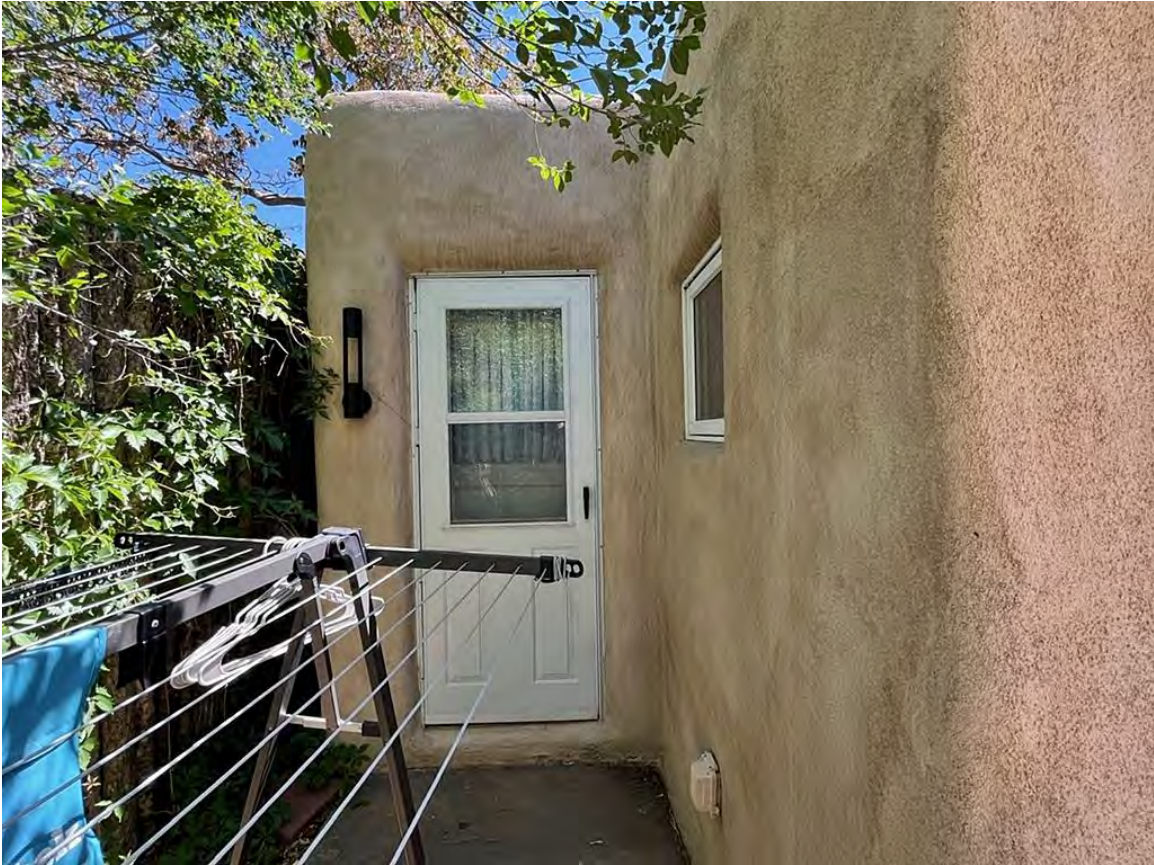
Photo 12: East elevation, north end. Window and door in 1940s addition. Camera facing south.

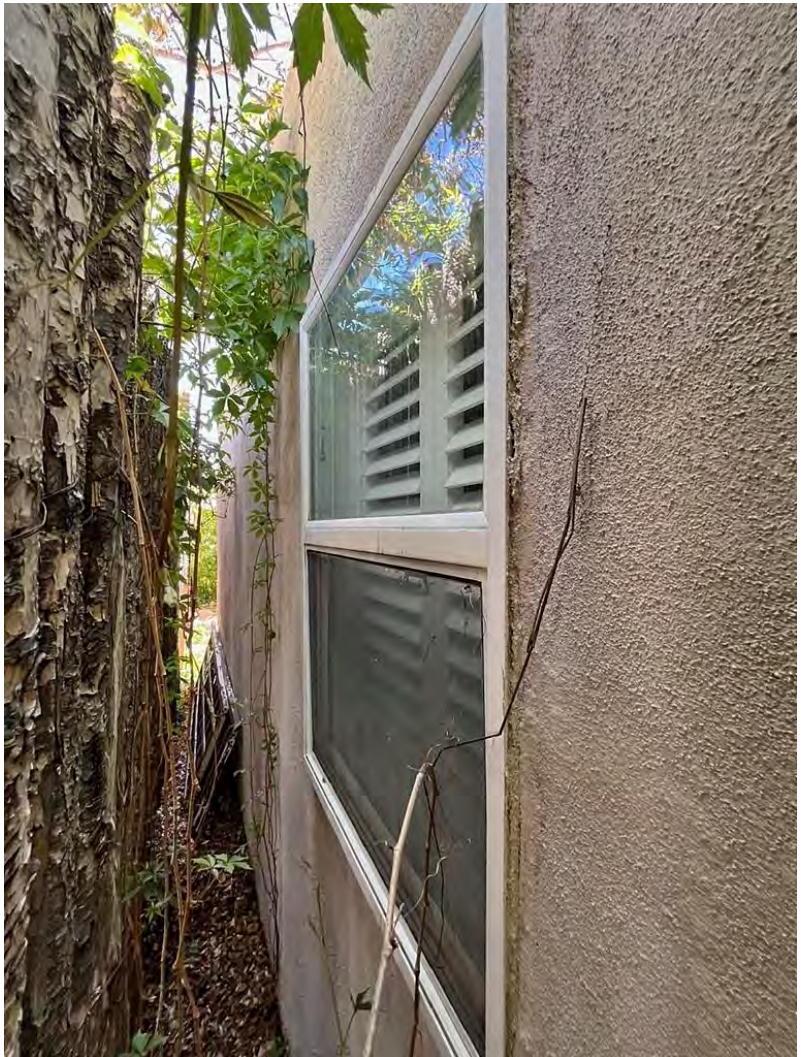
Photo 13: East elevation. Window in 1940s addition. Camera facing southwest.

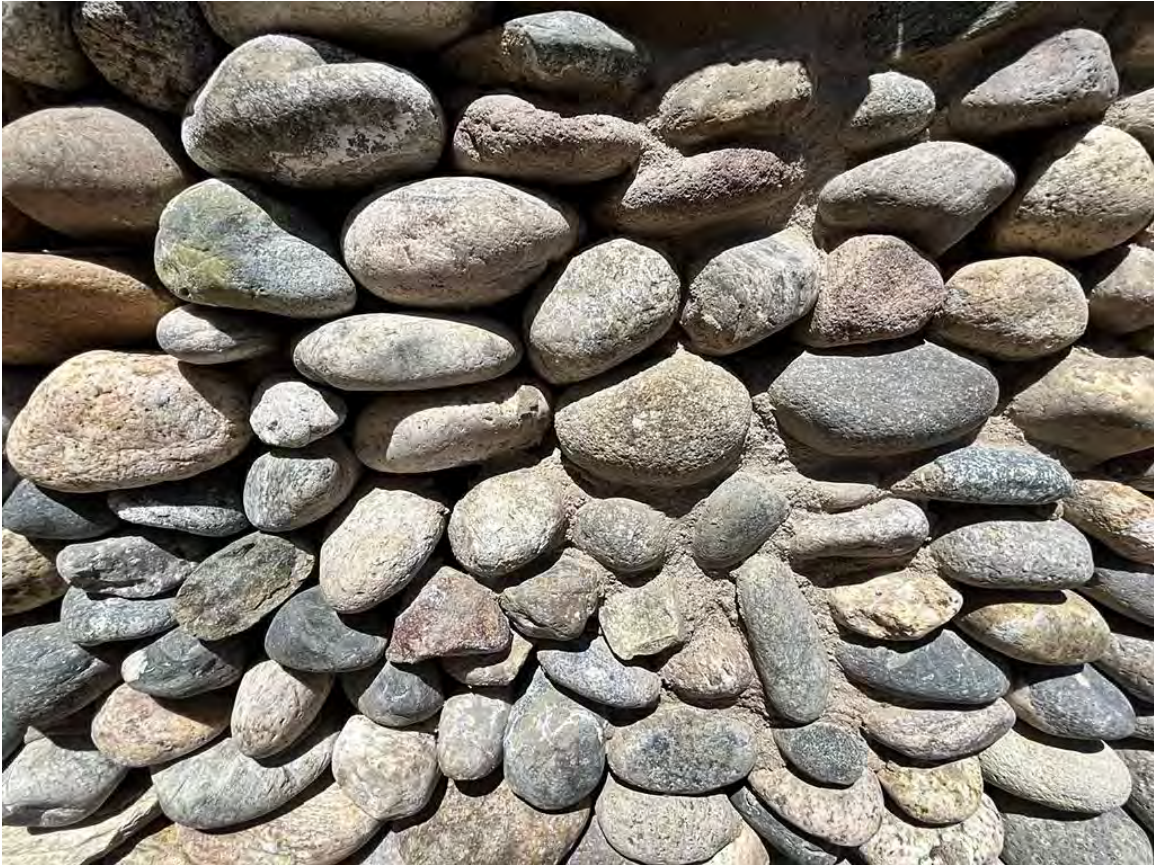
Photo 14: Front Garden Wall. Detail of masonry. Camera facing north.

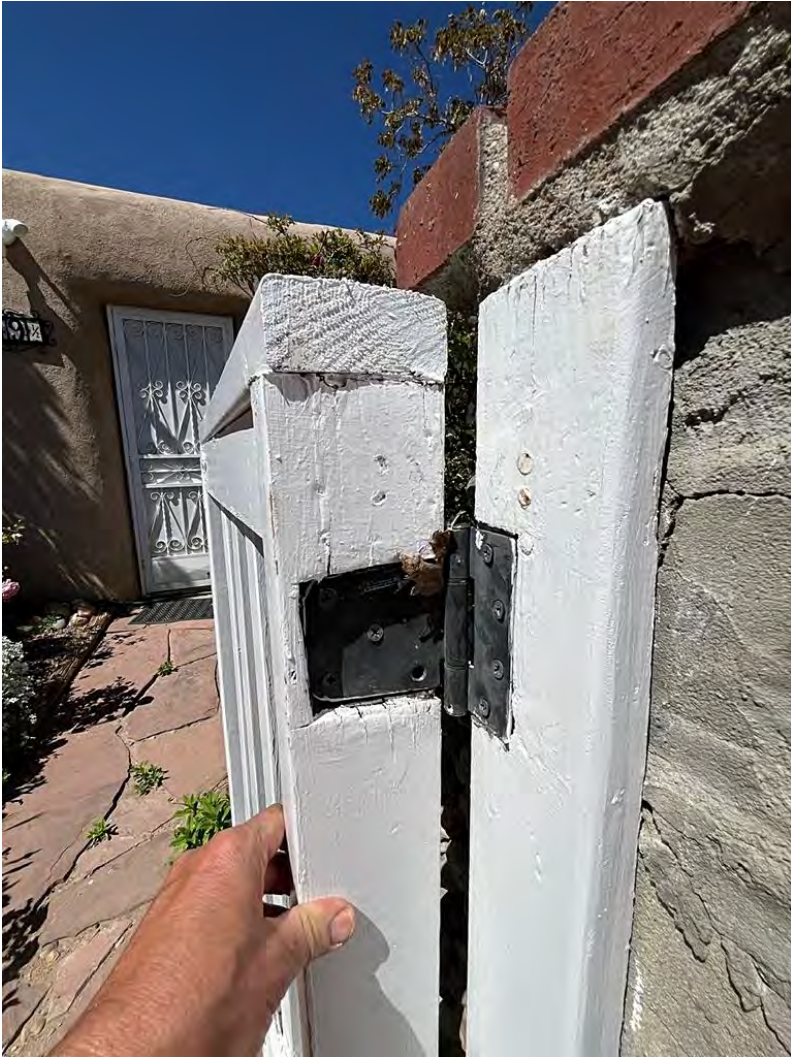
Photo 15: Gate. Detail of construction. Camera facing north.
