City of Santa Fe, New Mexico

memo

2025-010664-HDRB, 619 W Alameda St., Westside-Guadalupe Historic District, non-contributing, Dura Build Construction, agent for Max Scott, owner, requests a historic status review with primary facade(s) designation, if applicable, for a residential structure.

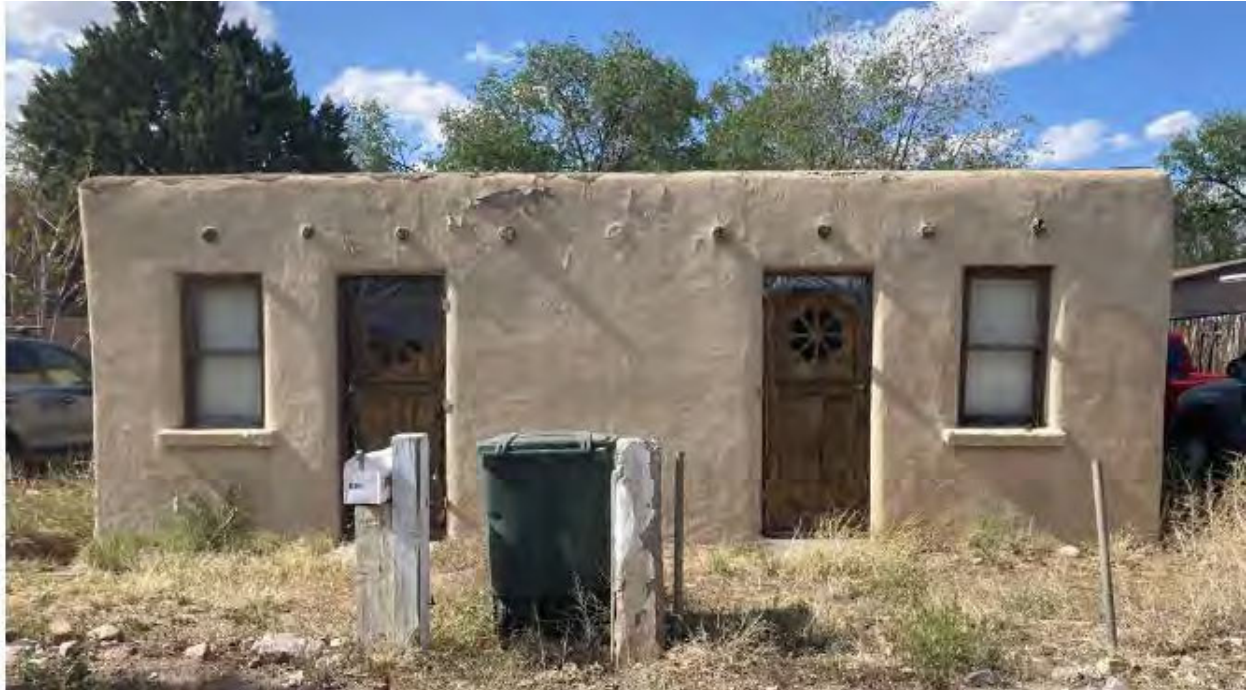
Figure 3: South Façade of Residence.

The southern portion of the window holds the greatest historic integrity of the building, with the adobe construction, viga ends, double front doors with corresponding windows, inset windows and doors, and concrete windowsills. The front doors are handmade front doors. The west façade shows the growth of the building from adobe to the pen tile addition and holds historic inset wood
